**Department of Energy**

Subject: *2019 Annual Site Inspection and Monitoring Report for Uranium Mill Tailings  
Radiation Control Act Title I Disposal Sites*

Enclosed are seven copies of the *2019 Annual Inspection and Monitoring Report for Uranium Mill Tailings Radiation Control Act Title I Disposal Sites*. The report covers the annual inspections of the 19 Title I disposal sites managed by the U.S. Department of Energy Office of Legacy Management.

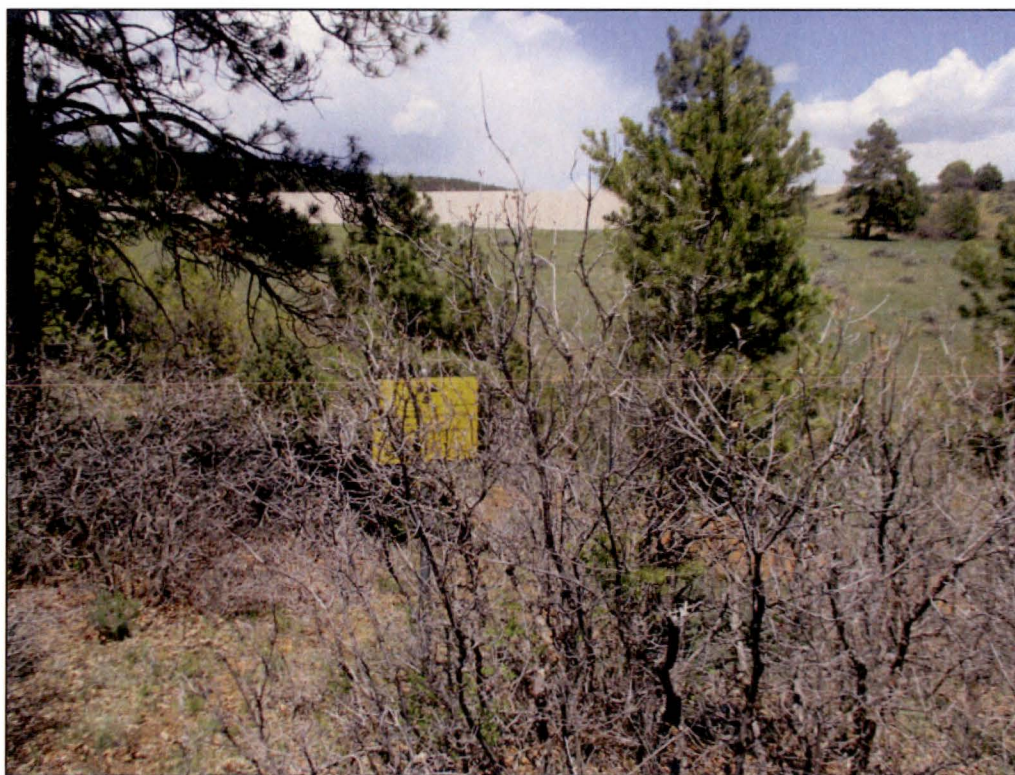
*PL-2. Vegetation Blocking Perimeter Sign P4 (Removed Following Inspection)*

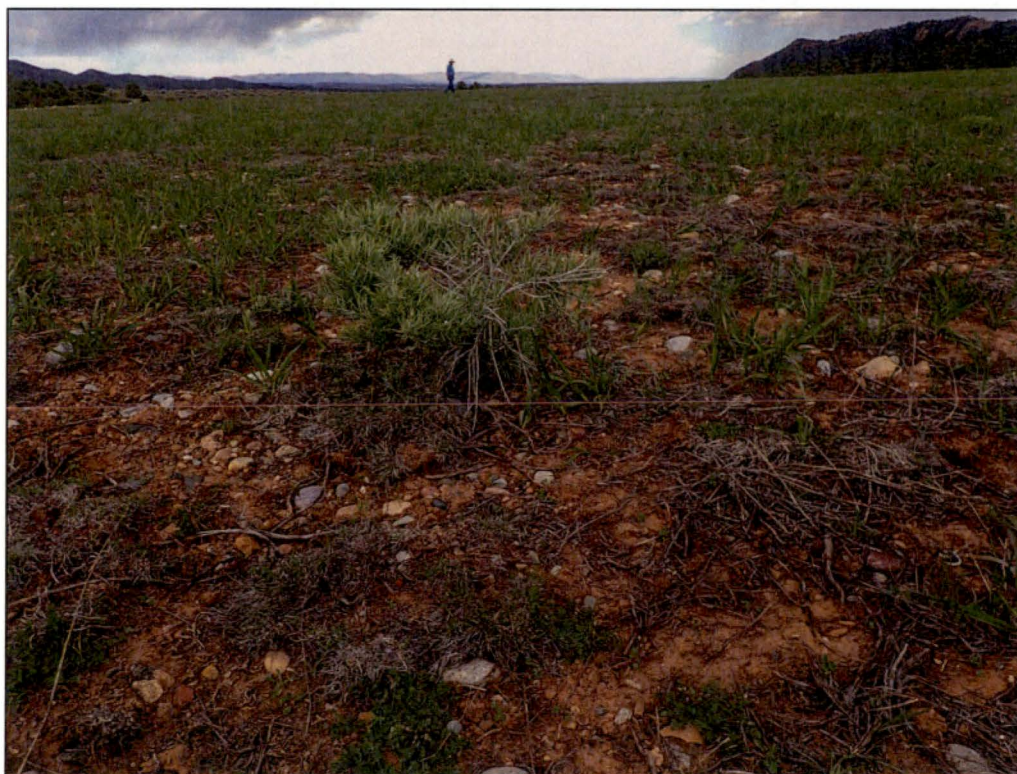
*PL-6. Rabbitbrush on Disposal Cell Top*

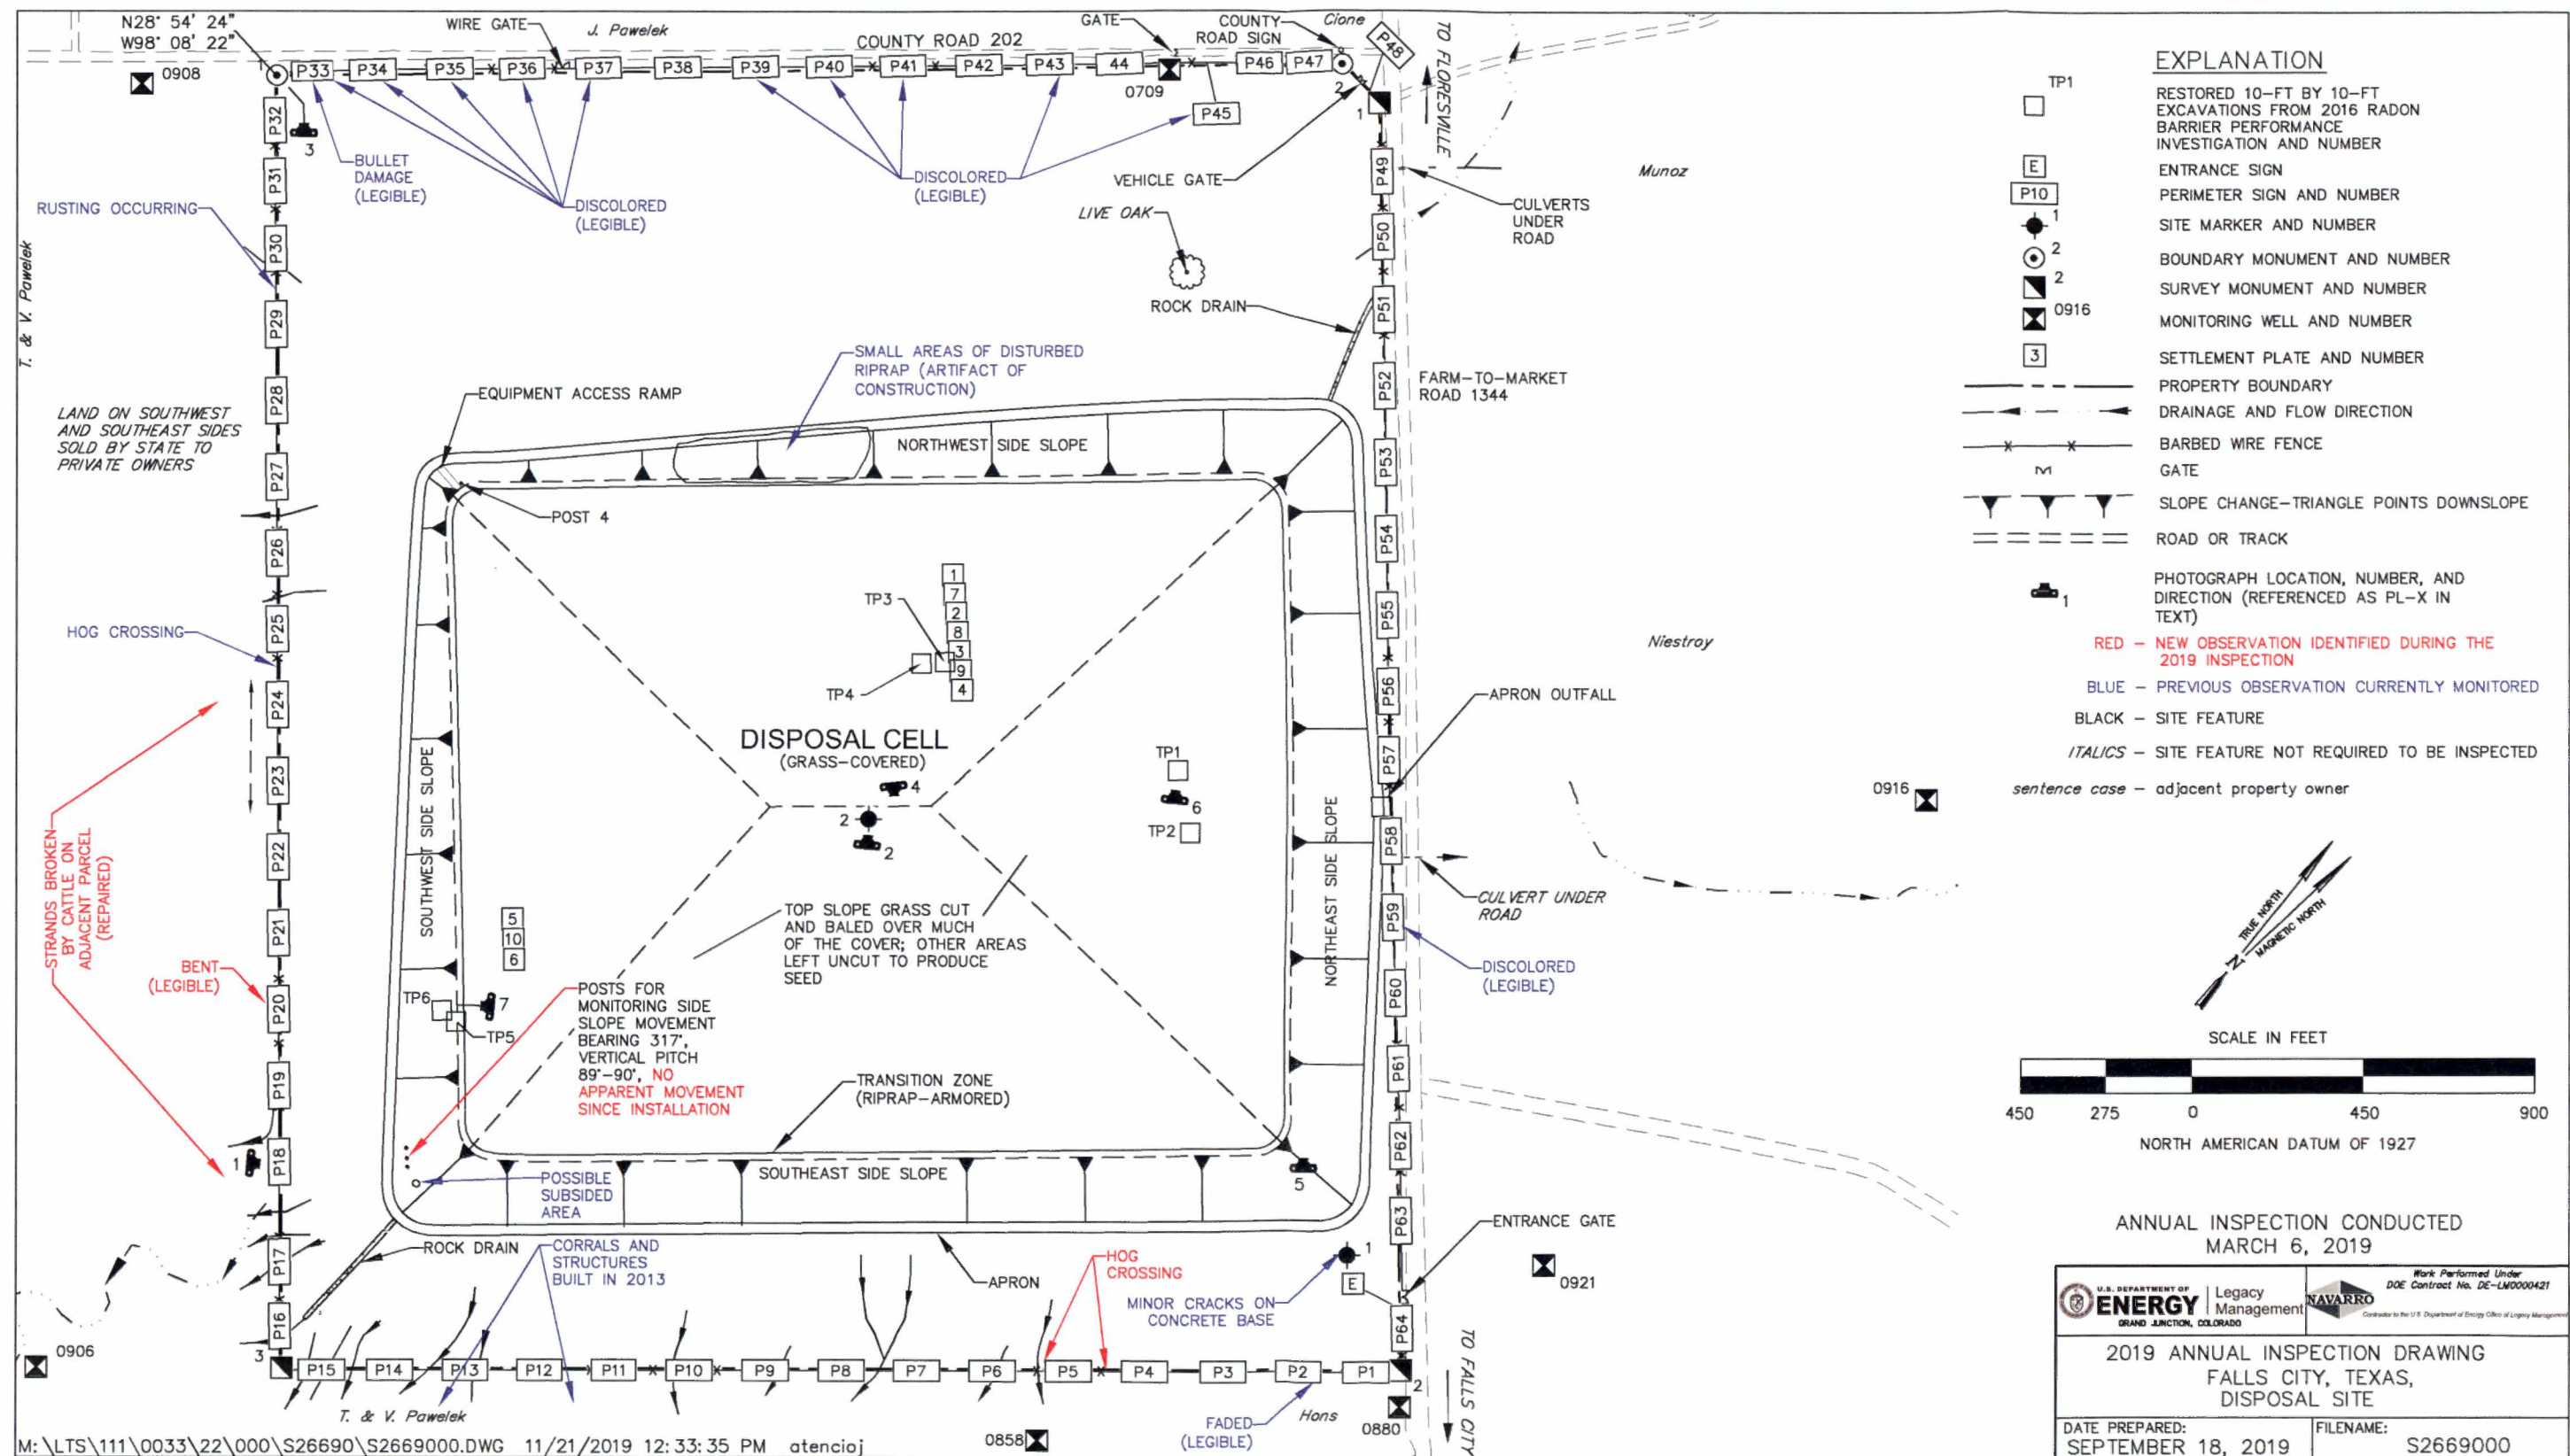
Figure 5-1. 2019 Annual Inspection Drawing for the Falls City, Texas, Disposal Site

Figure 5-1 shows the locations of site features in black, including site surveillance features and inspection areas. Site features that are present but not required to be inspected are shown in italic font. Observations from previous inspections that are currently monitored are shown in blue text, and new observations identified during the 2019 annual inspection are shown in red. Inspection results and recommended maintenance activities associated with site surveillance features are described in the following subsections. Photographs to support specific observations are noted in the text and in Figure 5-1 by photograph location (PL) numbers. The photographs and photograph log are presented in Section 5.10.

A five-strand barbed-wire perimeter fence encloses the site. As noted in previous inspections, perimeter fence strands and posts are beginning to rust except along the northwest side, where the fence was replaced in 2006. Broken strands along the southwest side were identified during the inspection and were repaired by the maintenance subcontractor following the inspection.

There are 64 perimeter signs, attached to steel posts set in concrete, positioned along the property boundary and set back 5 feet (ft). Perimeter sign P33 has bullet damage but remains legible. Additional perimeter signs are fading but remain legible (PL-1). Perimeter sign P20 was bent but remains legible. No other maintenance needs were identified.

The site has two site markers. Site marker SMK-1 is just inside the entrance gate. The corners of the concrete base around the marker are cracked. The cracks appear to be unchanged from last year, and repairs are not needed at this time. Site marker SMK-2 is on the top slope of the disposal cell (PL-2). No maintenance needs were identified.

Broken fence strands were identified during the inspection and repaired by the maintenance subcontractor following the inspection. No other maintenance needs were identified.

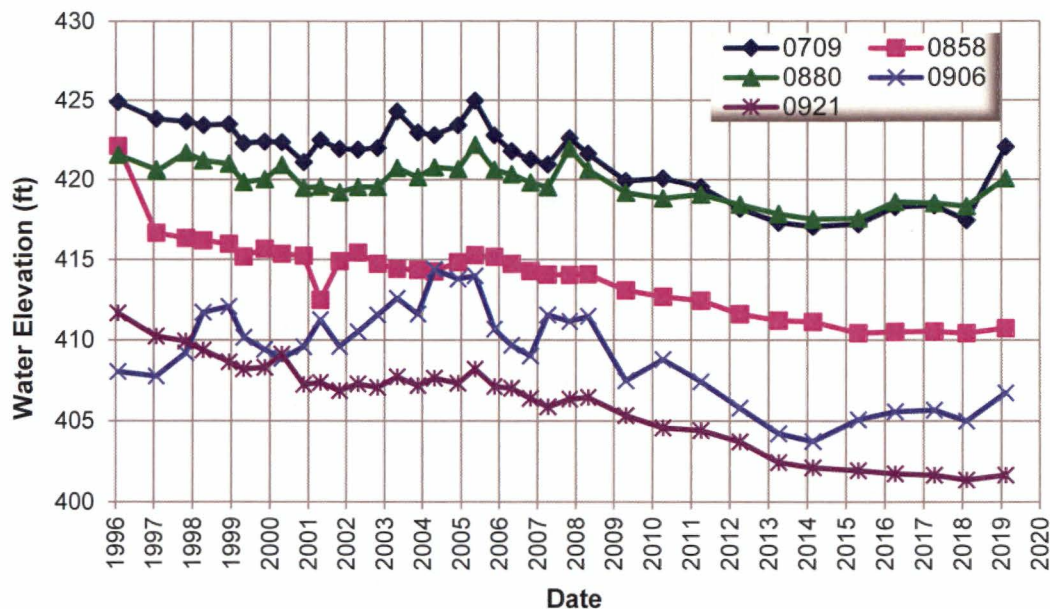
Figure 5-3. Water-Level Measurements at Disposal Cell Performance Monitoring Wells at the Falls City, Texas, Disposal Site

Since 1996, groundwater levels in the disposal cell performance monitoring wells have decreased overall, with decreases ranging from approximately 3 to 12 ft (Figure 5-3). In 2019, water levels in monitoring wells 0709, 0880, and 0906 increased at a steeper rate of change than has occurred in recent years (Figure 5-3), while water levels in monitoring wells 0858 and 0921 increased less abruptly. The water level in monitoring well 0906 has fluctuated more than water levels in the other monitoring wells, showing other short-term increases while decreasing over the longer period. The reason why 0906 fluctuates more than other wells is unknown. The general decrease in water levels across the entire disposal cell performance monitoring network might reflect (1) the dissipation of the processing site-related groundwater mound beneath the disposal cell or (2) the reduction of transient drainage from the disposal cell. Monitoring wells 0908 and 0916 are not shown in Figure 5-3 nor subsequent time concentration plots

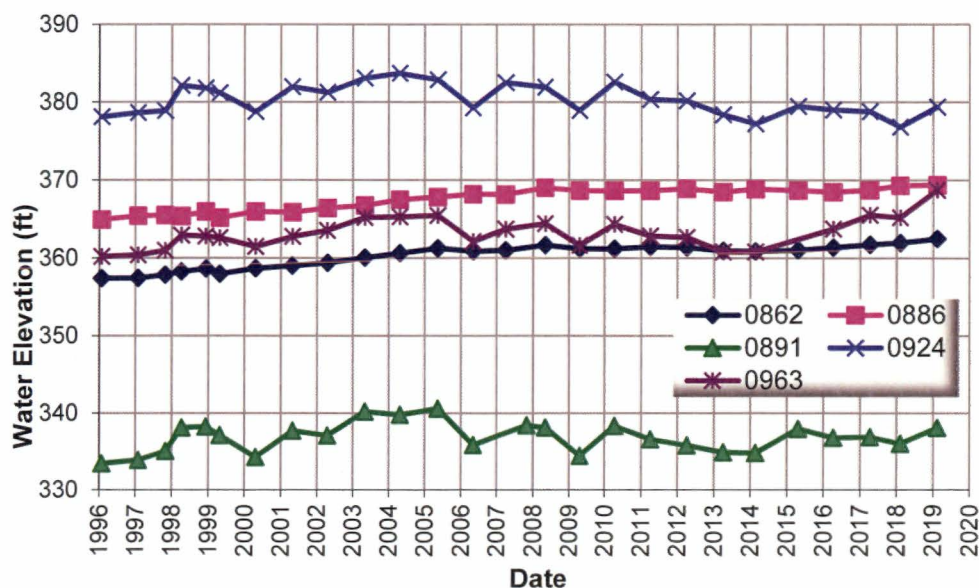
Figure 5-4. Water-Level Measurements at Groundwater Compliance Monitoring Wells at the Falls City, Texas, Disposal Site

Mann-Kendall testing indicates water level trends are generally increasing in the groundwater compliance monitoring wells 0862, 0886, 0891, and 0963 (Figure 5-4). Overall, these water levels have increased about 4 ft since 1996. Mann-Kendall testing indicates no trend in water levels at monitoring well 0924.

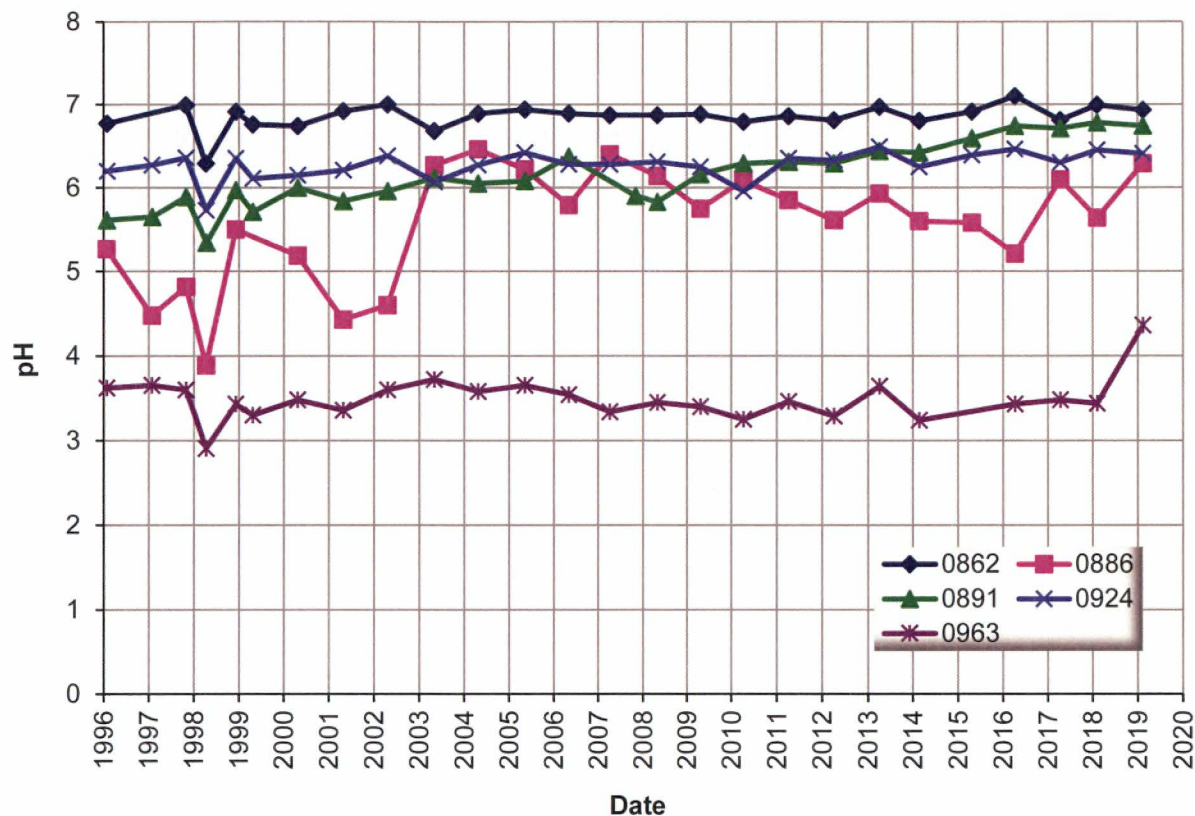
Figure 5-6. pH at Groundwater Compliance Monitoring Wells at the Falls City, Texas, Disposal Site

At the groundwater compliance monitoring wells, pH levels have historically been greater than the pH in groundwater contaminated by processing activities, with no significant upward or downward trends. Mann-Kendall testing indicates no trend in pH values at monitoring wells 0862, 0886, and 0963 and an increasing trend at monitoring wells 0891 and 0924. In 2019, the pH levels for monitoring wells 0886 and 0963 increased, while the pH levels for monitoring wells 0862, 0891, and 0924 slightly decreased (Figure 5-6). The 2019 pH levels were within the range of historical values for all groundwater compliance monitoring wells except monitoring well 0963, where the pH has increased above the historical maximum. The pH in monitoring

well 0963 historically has been lower than at the other locations, and in 2019 it remains similar to the pH in the tailings pore fluids.

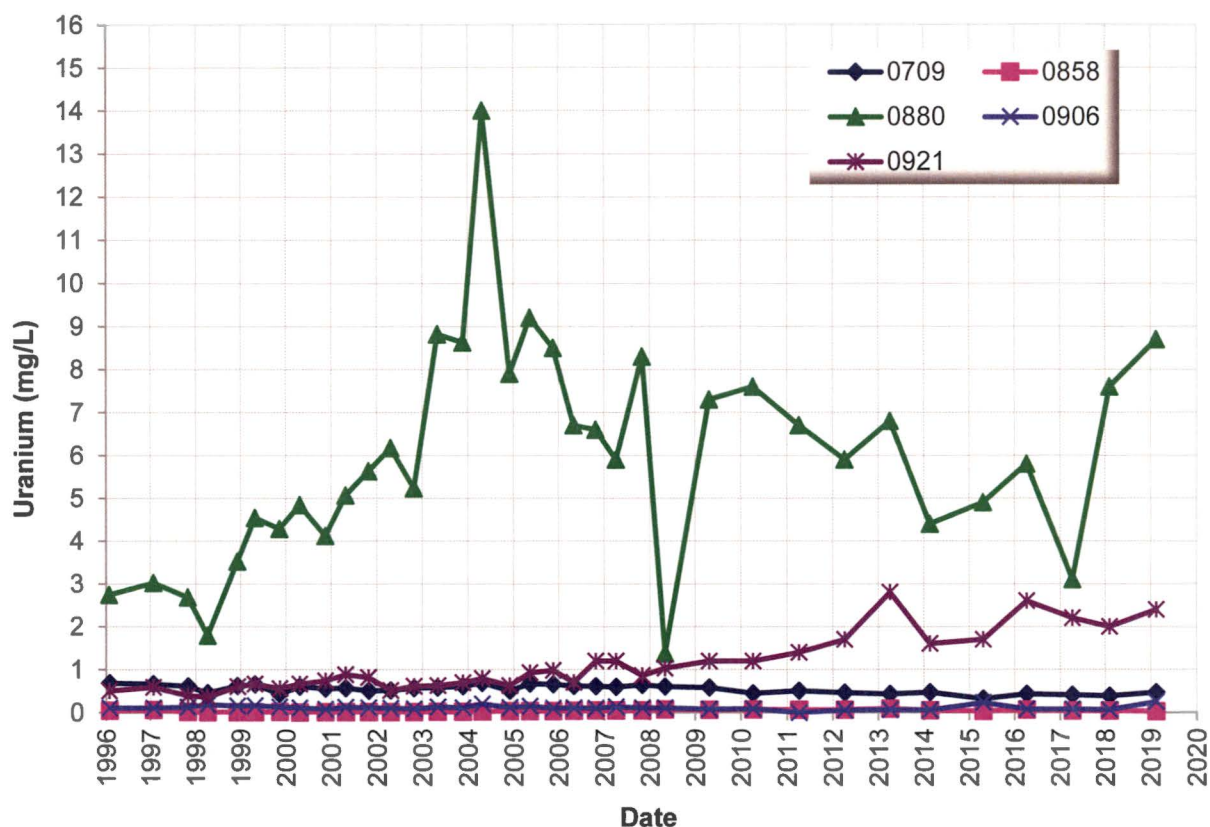
Figure 5-7. Uranium Concentrations at Disposal Cell Performance Monitoring Wells at the Falls City, Texas, Disposal Site

**Uranium:** The 2019 uranium concentrations for disposal cell performance monitoring wells were within the range of historical values for all groundwater compliance monitoring wells (Figure 5-7). In 2019, the uranium concentrations for monitoring wells 0709, 0906, and 0858 remained generally constant when compared with previous results. The uranium concentration in monitoring well 0921 increased slightly, maintaining a generally increasing trend. The concentration in monitoring well 0880 increased from 7.6 milligrams per liter (mg/L) to 8.7 mg/L. Uranium concentrations in monitoring well 0880 show considerable variation, ranging from a low of 1.38 mg/L in 2008 to a high of 14 mg/L in 2004, and the 2019 uranium concentration is within the range of historical concentrations.

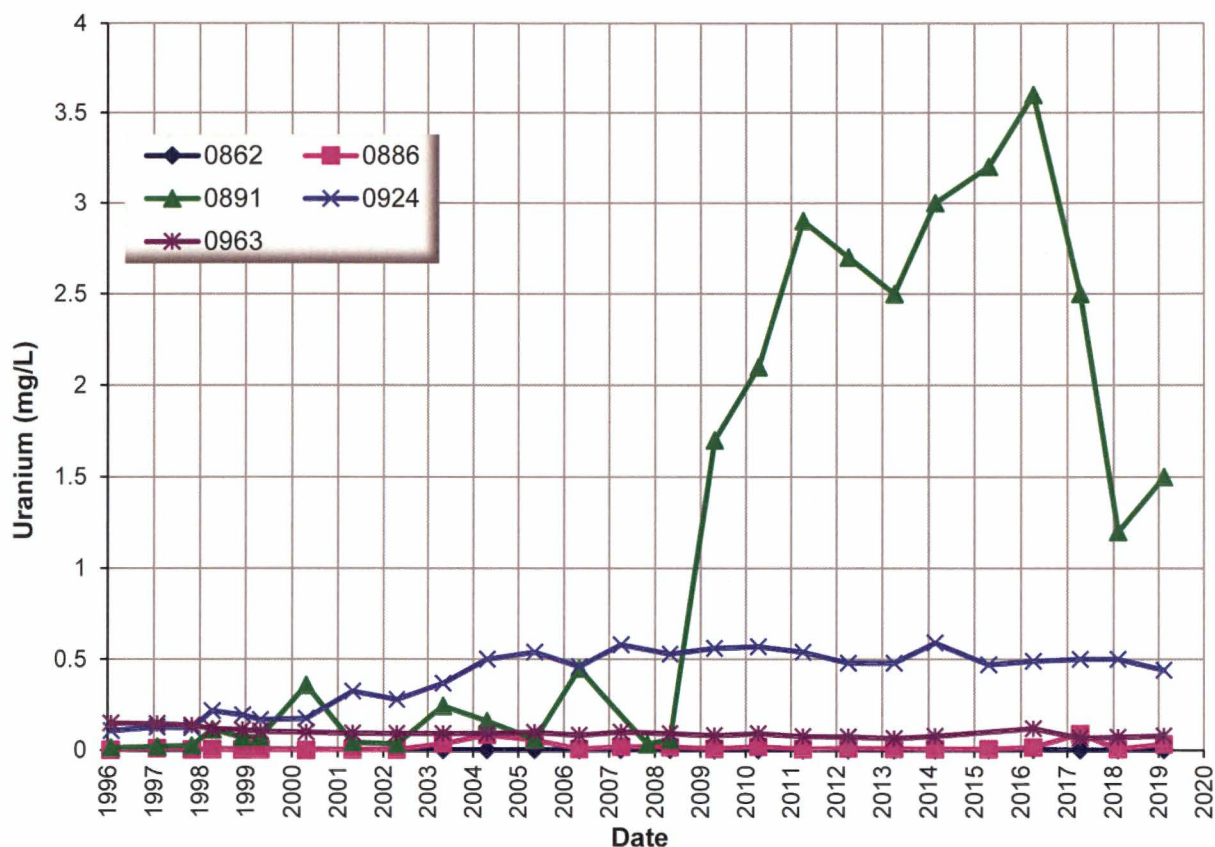
Figure 5-8. Uranium Concentrations in Groundwater Compliance Monitoring Wells at the Falls City, Texas, Disposal Site

The 2019 uranium concentrations for groundwater compliance monitoring wells were within the range of historical values for all groundwater compliance monitoring wells (Figure 5-8). The uranium concentration at monitoring wells 0862, 0886, and 0963 remains less than 0.2 mg/L. The uranium concentration at monitoring well 0924 has been relatively stable since 2004, fluctuating between 0.4 mg/L and 0.6 mg/L. Since 2008, the uranium concentrations measured at monitoring well 0891 have been greater than at other monitoring wells and are currently elevated when compared to the historical range for the well but not for the historical range of the aquifer (DOE 2010). The 2019 uranium result (1.5 mg/L) at monitoring well 0891 is slightly greater than the 2018 result at this location (1.2 mg/L) but remains significantly less than the 2016 uranium result of 3.7 mg/L and less than the uranium concentration value used for groundwater in the Dilworth aquifer in the *Baseline Risk Assessment of Ground Water*

Contamination at the Uranium Mill Tailings Site Near Falls City, Texas (3.04 mg/L) (DOE 1995). This suggests that a slug of groundwater with elevated uranium has flowed past this location.

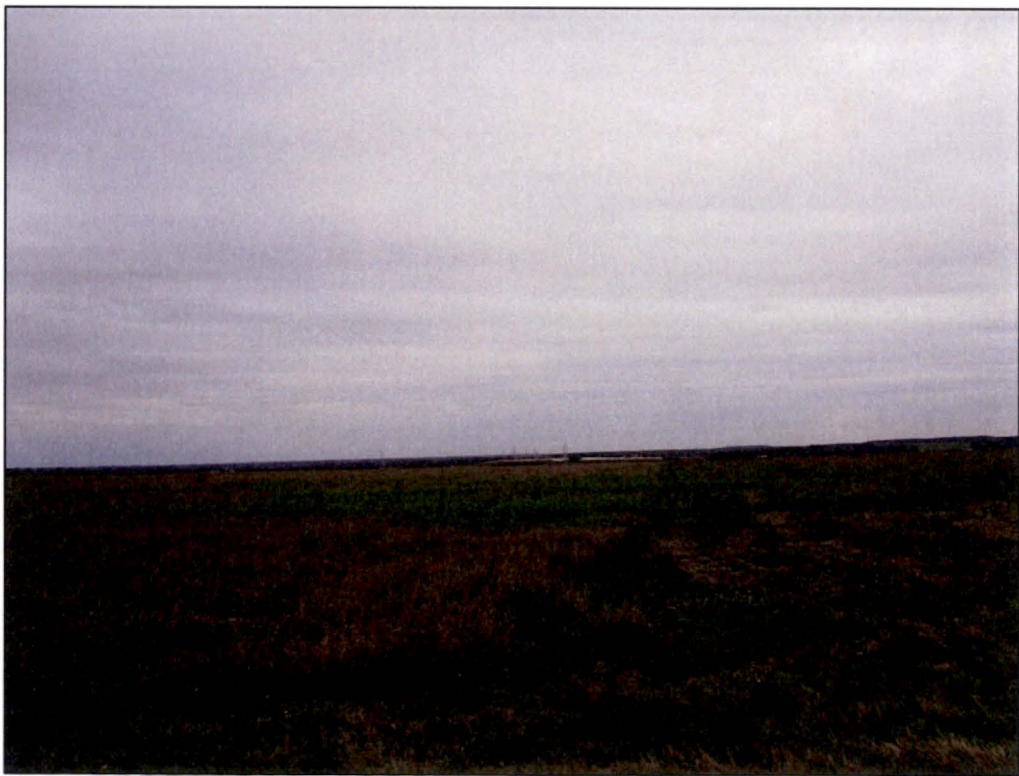
*PL-4. Looking East Across Disposal Cell Top Slope*

The disposal cell, completed in 1994, occupies 127 acres. Its vegetated cover consists primarily of well-established coastal Bermudagrass and kleingrass, with other species interspersed (PL-4). The site, including the disposal cell, is managed for hay production, which ensures that turf vitality is maintained. The site maintenance subcontractor can take as many as three cuttings of hay each year from the site. The maintenance subcontractor will spot-spray woody vegetation that inspectors found distributed sporadically in the uncut grass. At the time of the inspection, hay bales were present on the property.

There was no evidence of erosion, settling, slumping, or other modifying processes that might affect the integrity of the disposal cell. This year, as in past inspections, the surface of the soil on top of the disposal cell had small desiccation cracks, which are especially common in clayey or loamy soils when soil conditions are dry. No areas of ponded water or areas of settlement were observed on top of the disposal cell during the 2019 inspection.

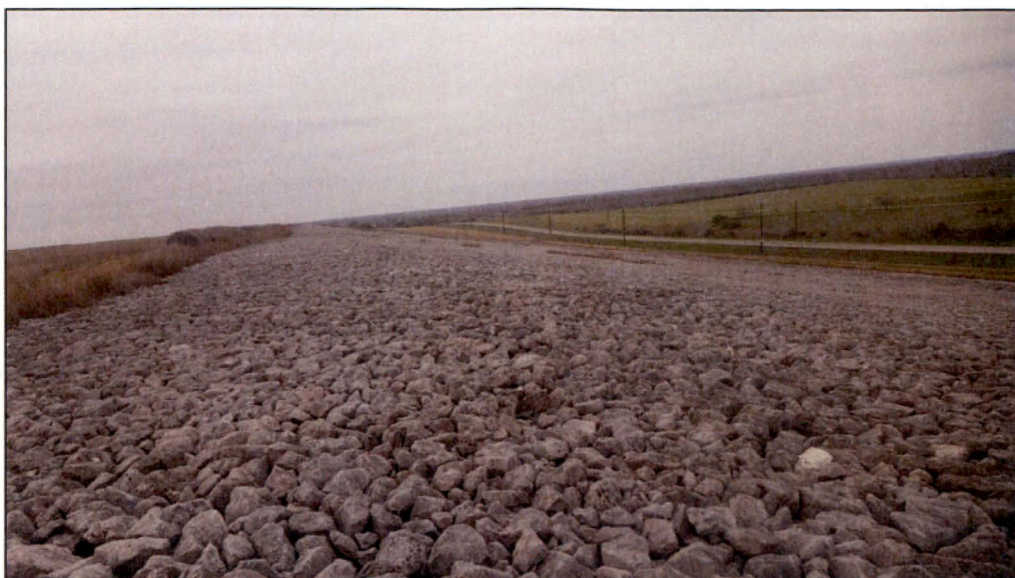
*PL-5. Northeast Side Slope*

The disposal cell side slopes and a transition zone where the top slope meets the side slopes are armored with riprap (PL-5). LM has monitored several small depressions on the northwest side slope of the disposal cell since 2010. These depressions do not compromise the protectiveness of the riprap side slope, and no changes have been observed since 2010. Inspectors will continue to monitor these areas.

Fractured riprap has been observed on the disposal cell side slopes since it was completed. Pieces of riprap are fractured in place, indicating that the fracturing occurred after placement. Fracturing is likely a consequence of mechanical placement or thermal expansion and contraction; the riprap condition appears stable. LM periodically takes photos of riprap at the base of T-post 4 on the west corner of the disposal cell. On the basis of a qualitative evaluation of the photos in 2018, there is no indication that the riprap is degrading, but its durability will continue to be monitored. Because of the stable condition of the riprap indicated by these photos, no photo was taken in 2019, but photos should continue to be taken periodically. If the number of fractured rocks appears to be increasing, LM will establish a more quantitative monitoring program.

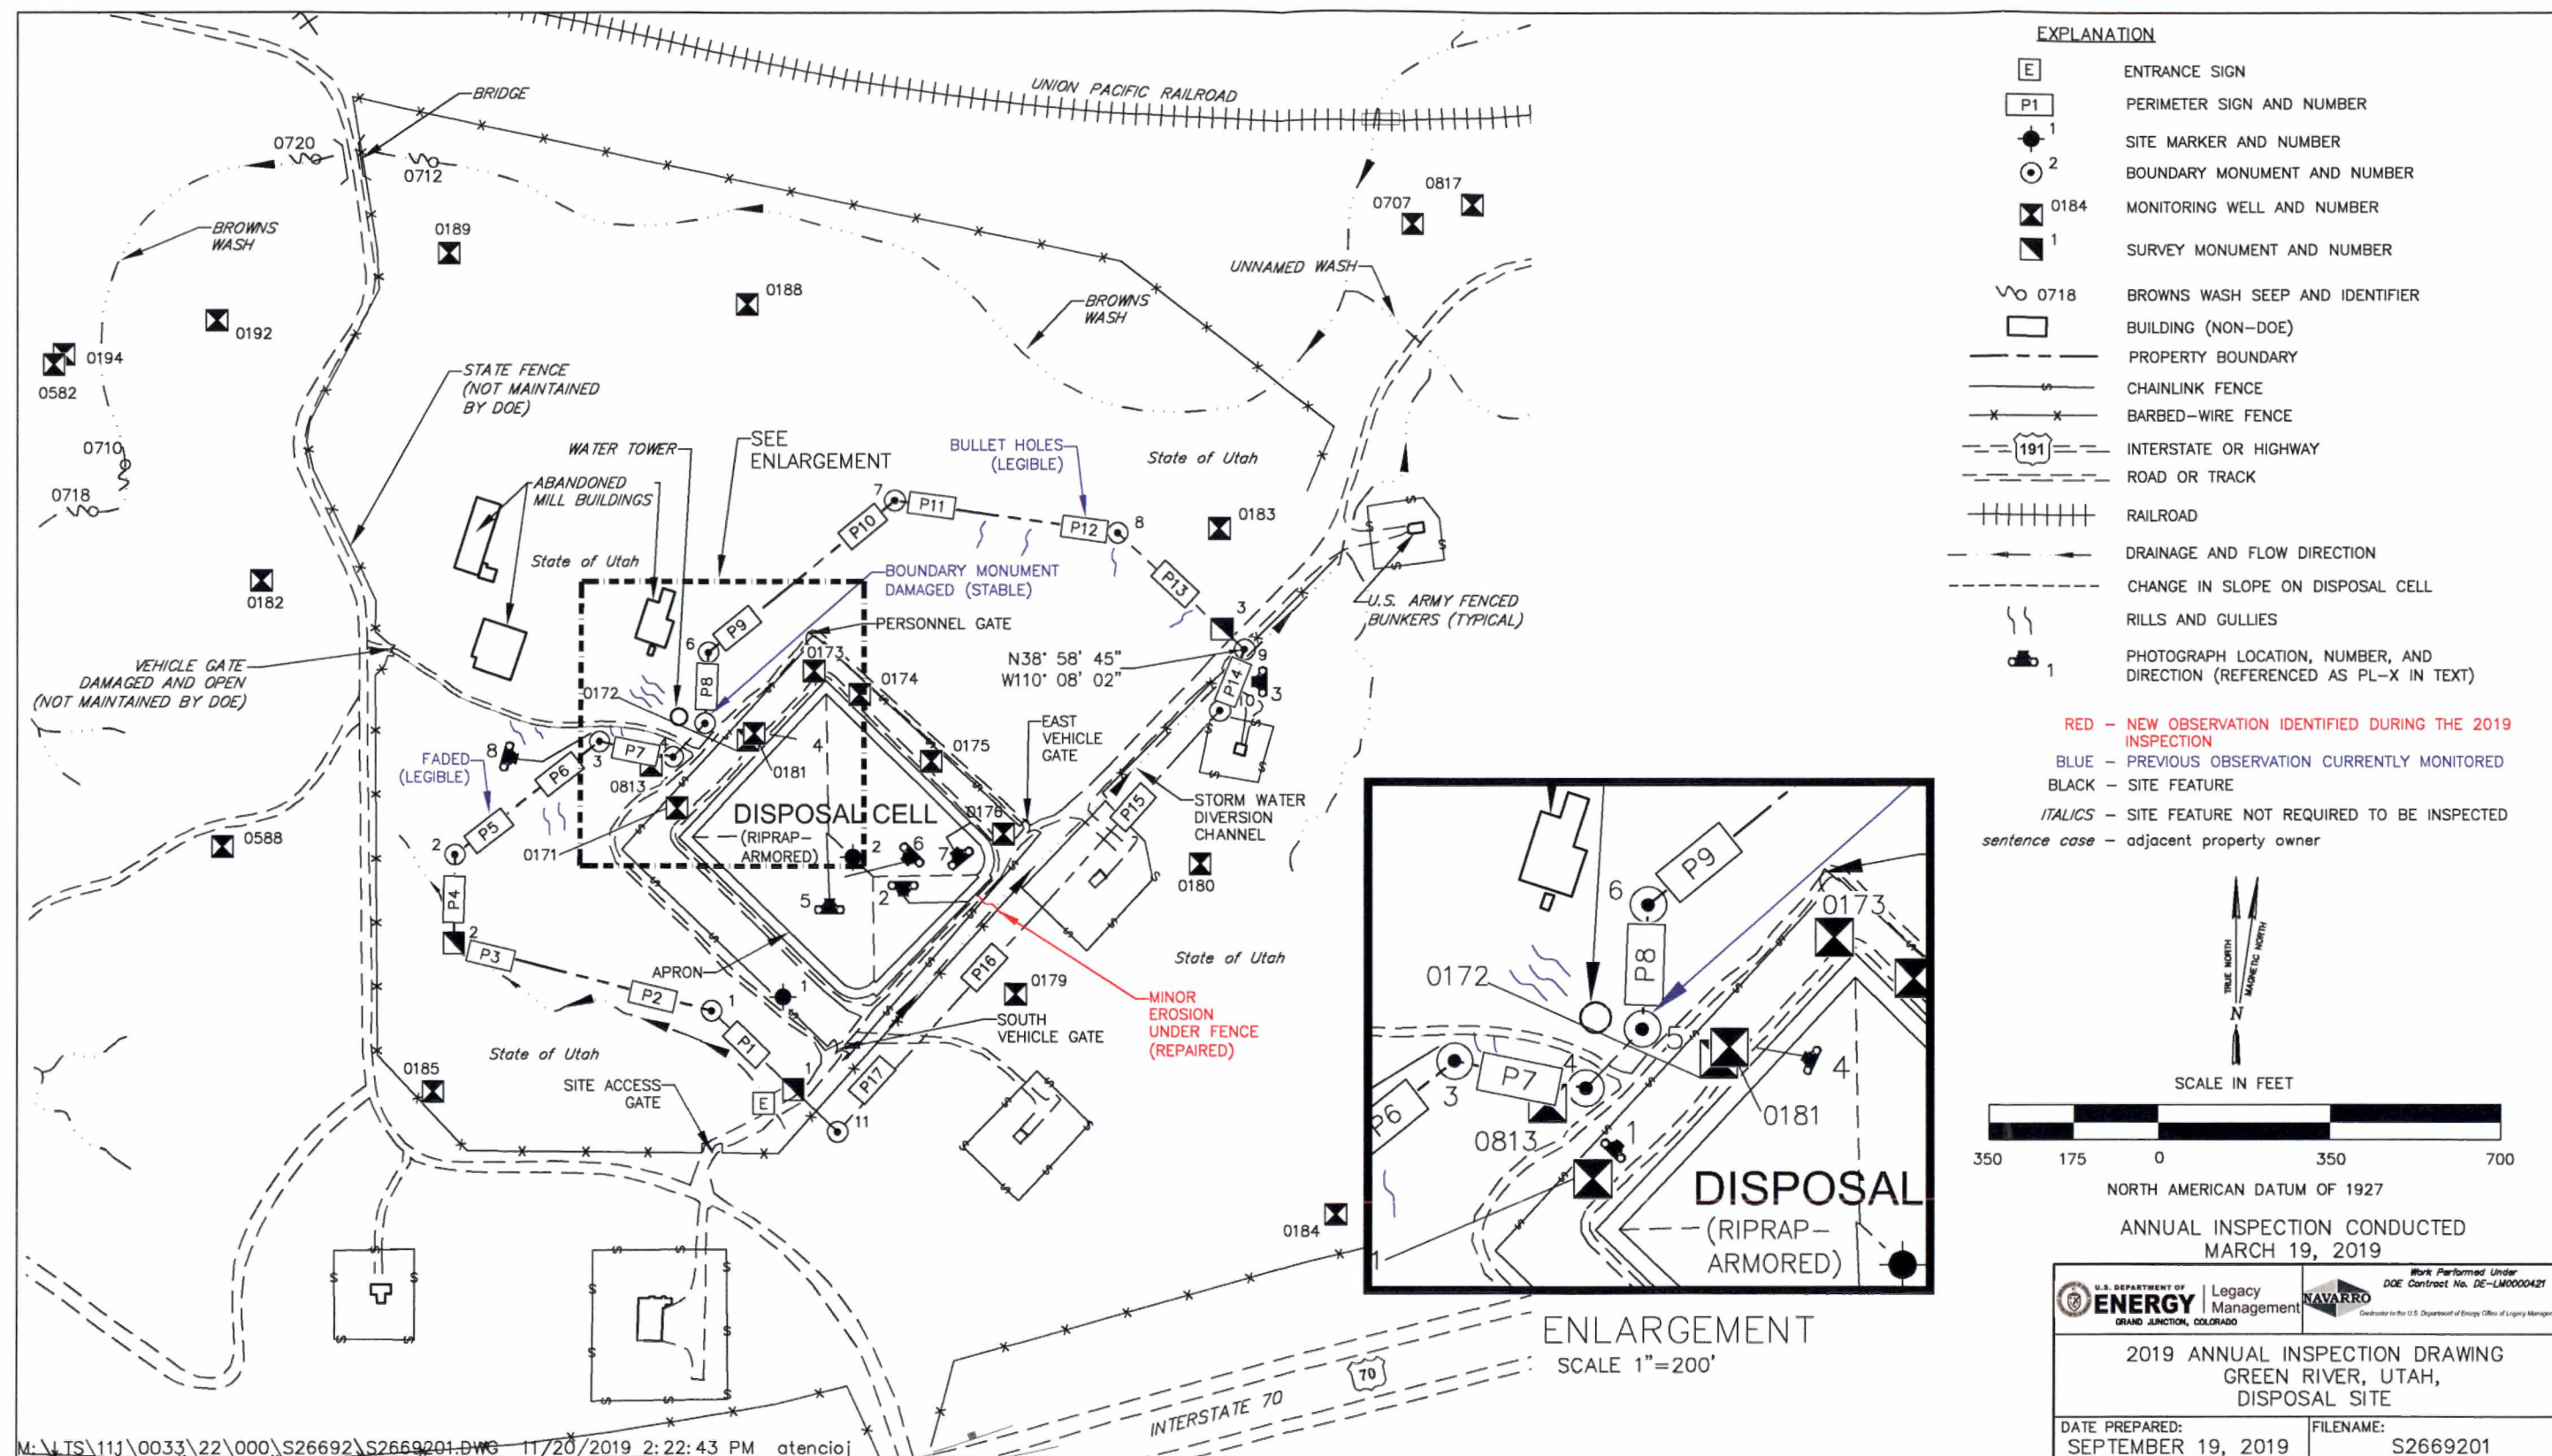
Figure 7-1. 2019 Annual Inspection Drawing for the Green River, Utah, Disposal Site

A chainlink security fence encloses the portion of the site that contains the disposal cell. Two vehicle gates are at the south and east corners of the security fence line, and a personnel gate is at the north corner of the security fence line. The security fence (PL-1) was intact, and the gates were locked. Minor erosion was identified under the southeast fence line (PL-2), but it does not compromise the integrity of the fence at this time. The erosion was repaired at the time of the inspection.

There are 17 perimeter signs (PL-3), attached to steel posts set in concrete, positioned along the unfenced property boundary. Perimeter sign P5 was faded but remains legible. No other maintenance needs were identified.

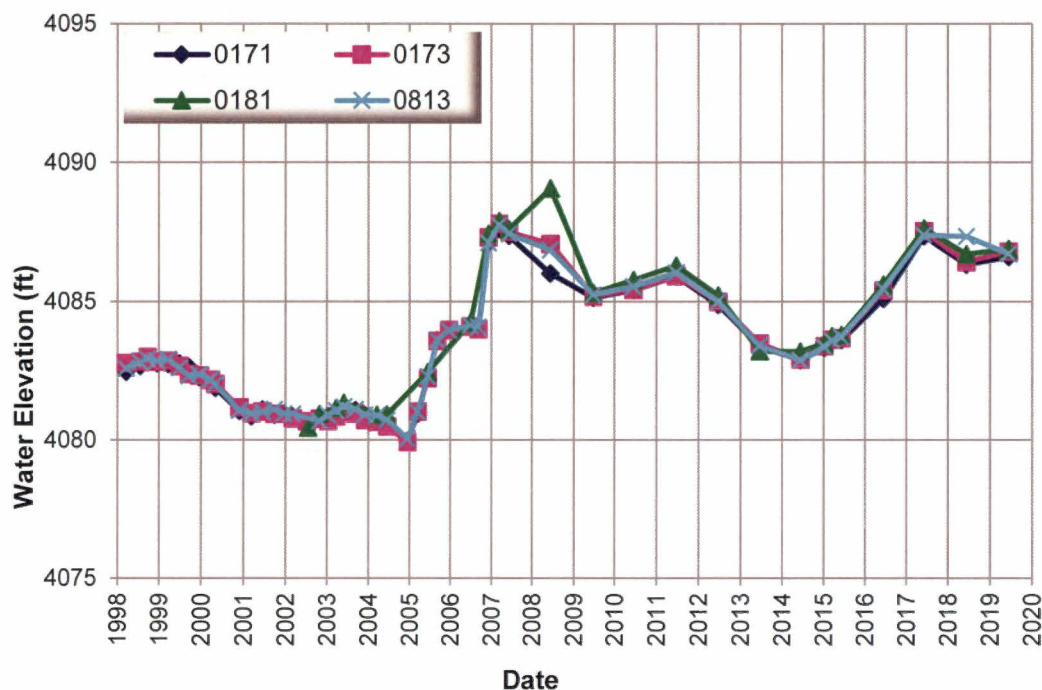
Figure 7-3. Groundwater Elevations at the Green River, Utah, Disposal Site

Water levels in the POC wells decreased slightly from 2017 to 2018 (Figure 7-3). Historically, the groundwater levels in these wells decreased approximately 3 ft overall from 1998 through 2004 and then increased approximately 8 ft between 2004 and 2007. Water level decreases ranged from 4 to 5 ft from 2007 through 2014. From 2014 to 2019, the water levels increased to elevations near the 2007 levels.

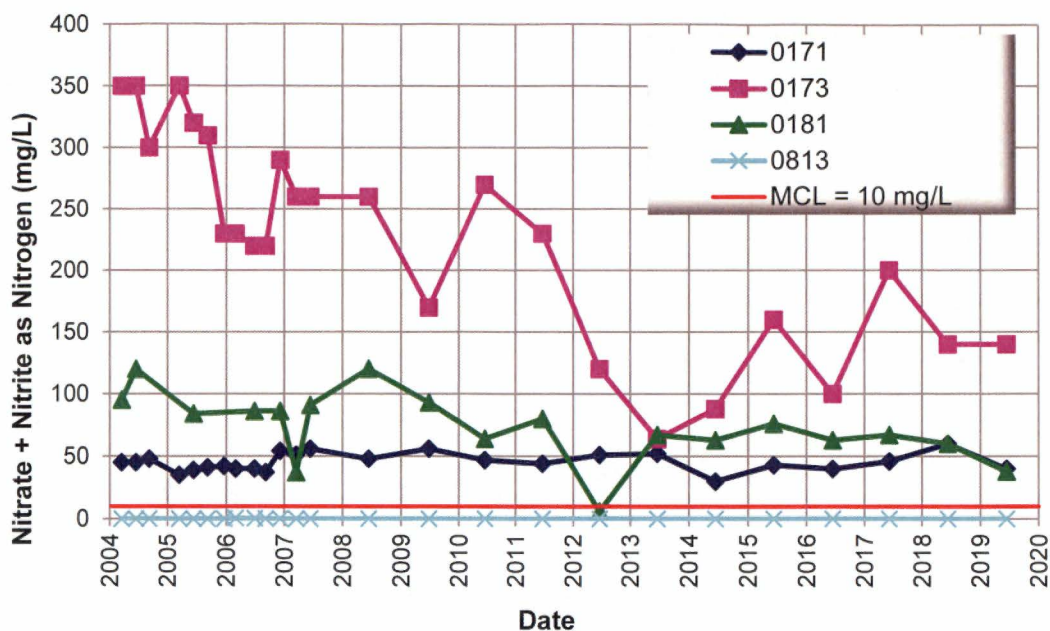
Figure 7-4. Nitrate at Point of Compliance Wells at the Green River, Utah, Disposal Site

Nitrate concentrations continue to exceed the MCL in POC wells 0171 and 0173. The 2019 nitrate concentrations were within the range of historical values for all POC wells (Figure 7-4).

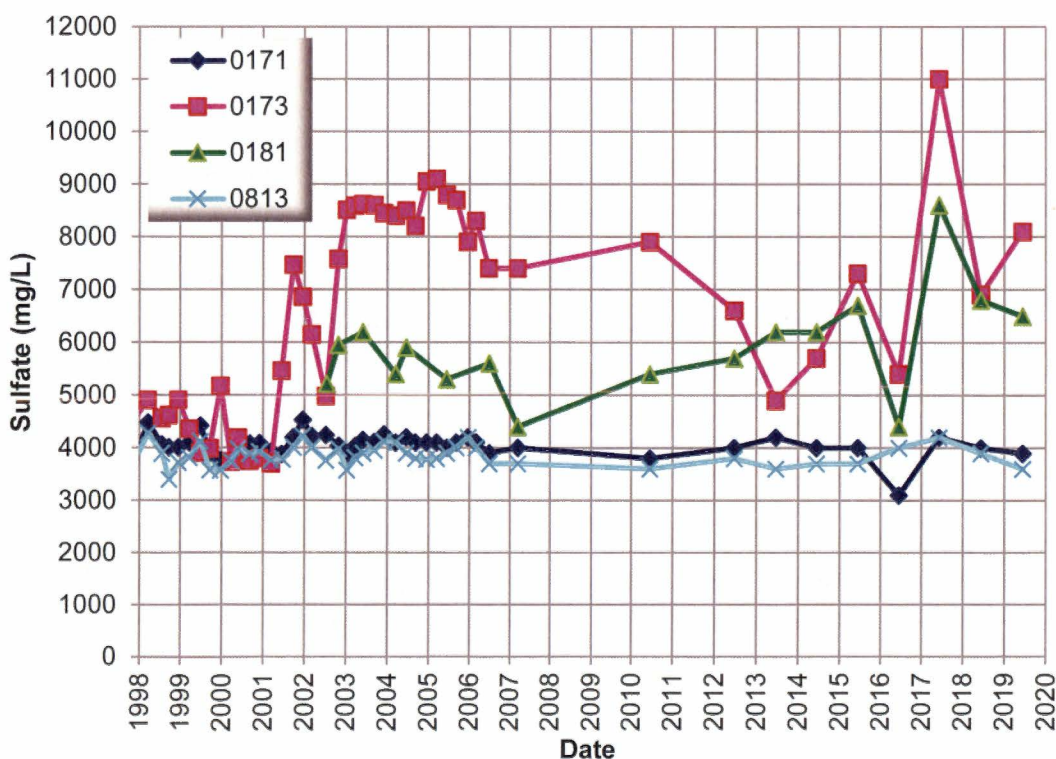
Figure 7-5. Sulfate at Point of Compliance Wells at the Green River, Utah, Disposal Site

Sulfate concentrations exceeded the LTSP background concentrations in all POC wells (Table 7-3) except POC well 0813. The 2019 sulfate concentrations were within the range of historical values for all POC wells (Figure 7-5).

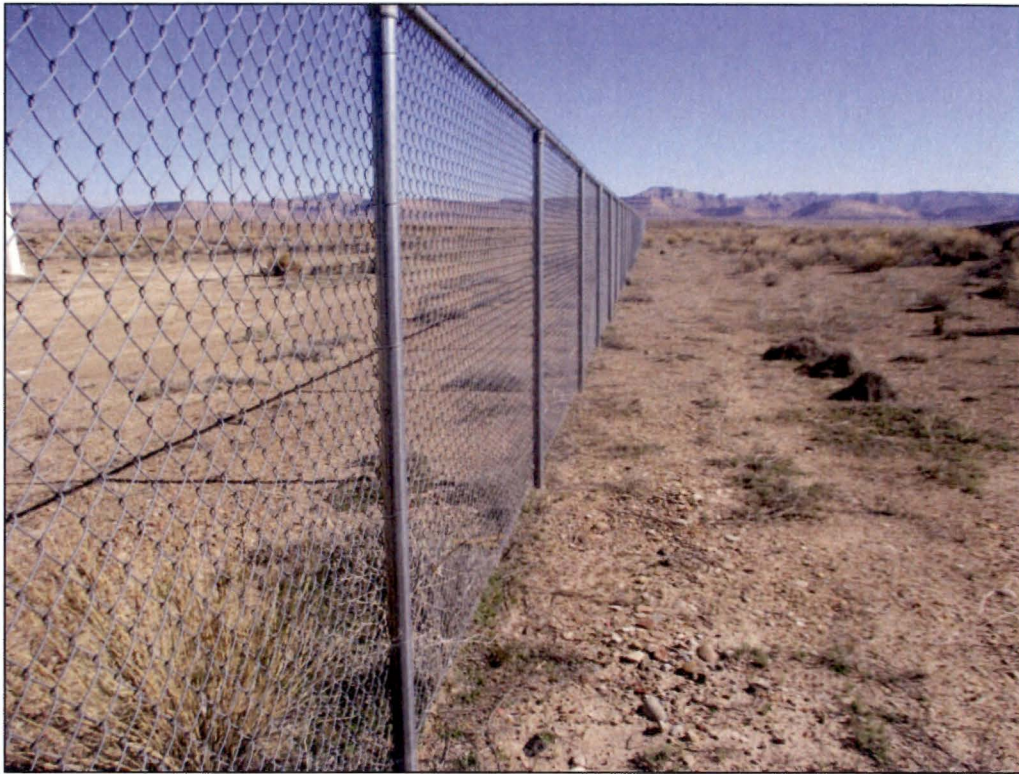
*PL-1. Northwest Security Fence Line*

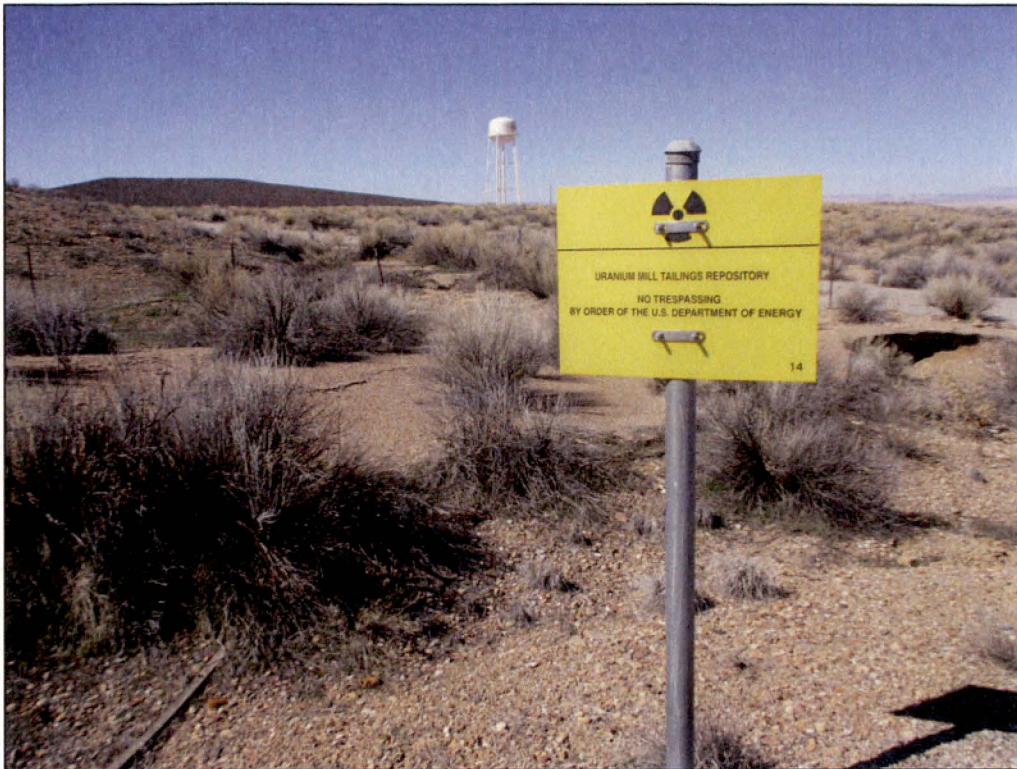
*PL-3. Perimeter Sign P14 (Disposal Cell in Background)*

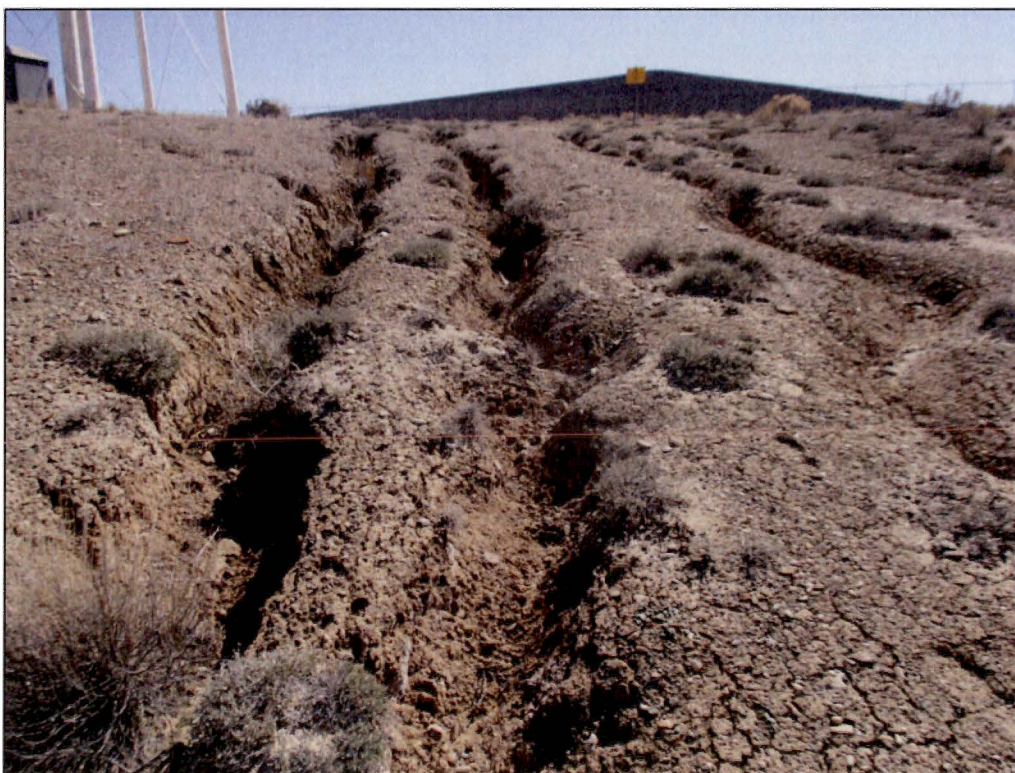
*PL-8. Gullies Near Water Tower and Boundary Monument BM-3*
