**Department of Energy**

Subject: *2019 Annual Site Inspection and Monitoring Report for Uranium Mill Tailings  
Radiation Control Act Title I Disposal Sites*

Enclosed are seven copies of the *2019 Annual Inspection and Monitoring Report for Uranium Mill Tailings Radiation Control Act Title I Disposal Sites*. The report covers the annual inspections of the 19 Title I disposal sites managed by the U.S. Department of Energy Office of Legacy Management.

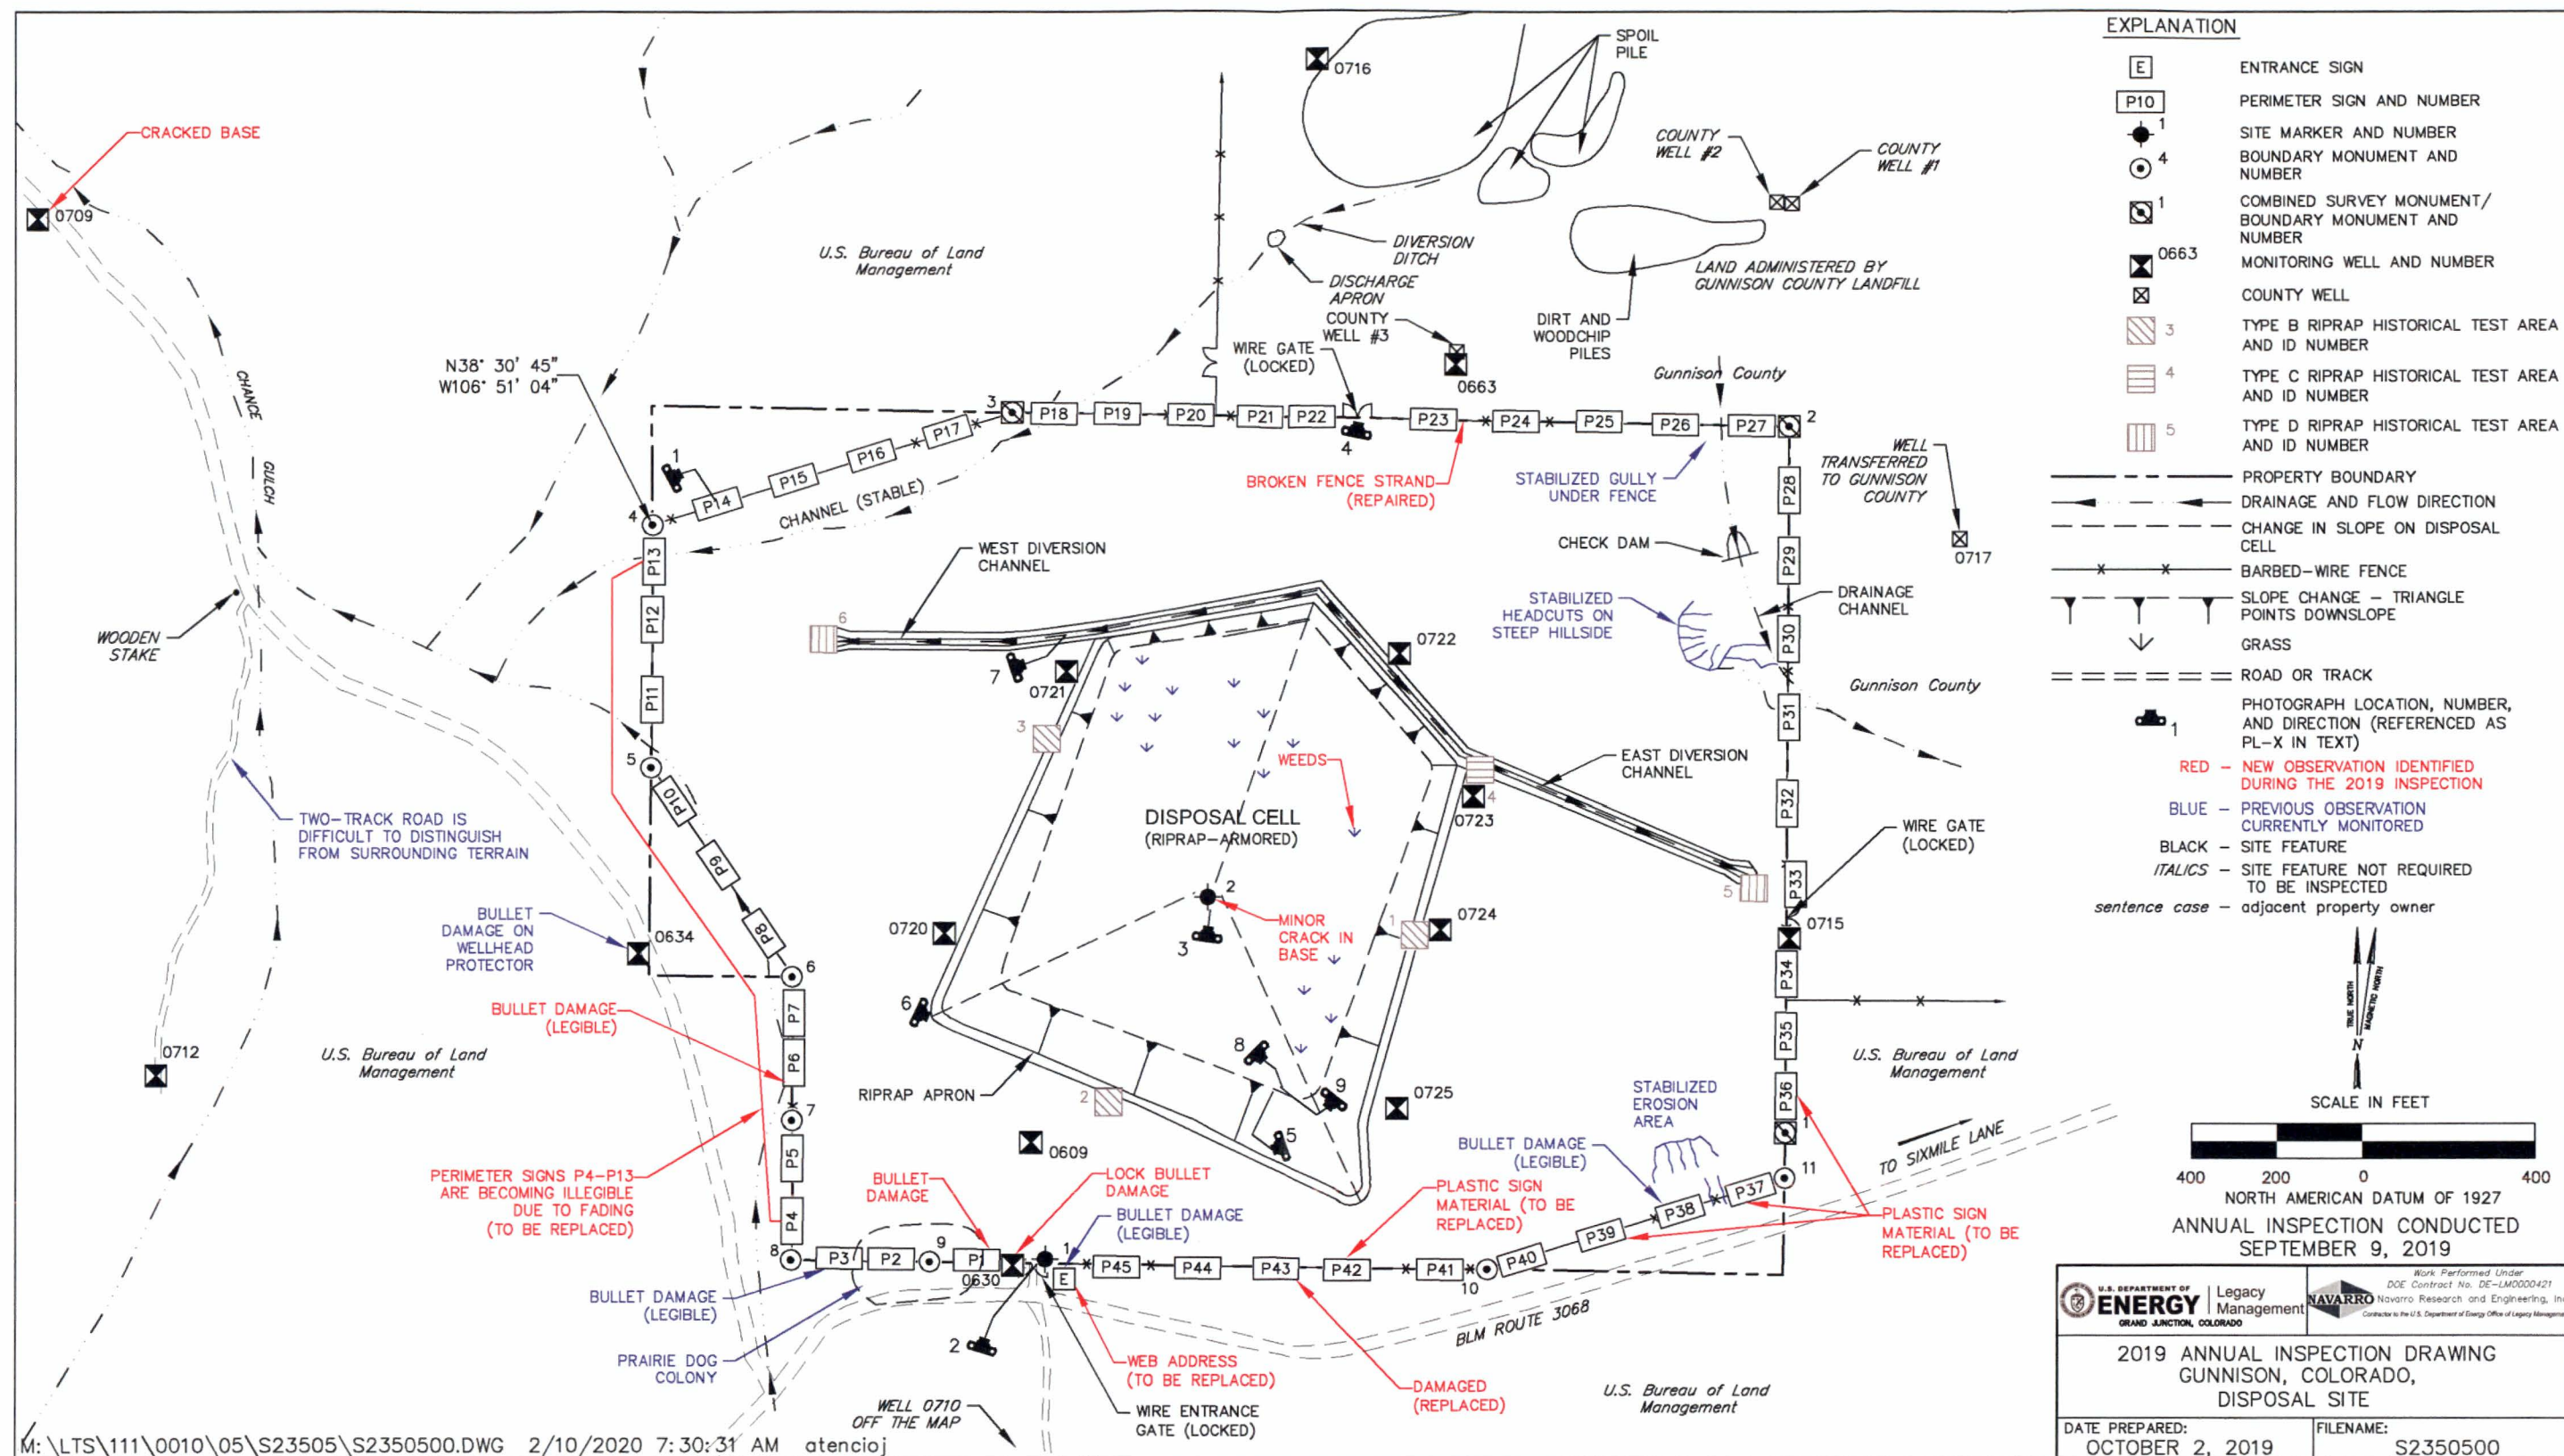
Figure 8-1. 2019 Annual Inspection Drawing for the Gunnison, Colorado, Disposal Site

The site has two granite site markers. Site marker SMK-1 is just inside the entrance gate (PL-2), and site marker SMK-2 is on the top slope of the disposal cell. The base of SMK-2 has a small, insignificant crack and remains stable (PL-3). No maintenance needs were identified.

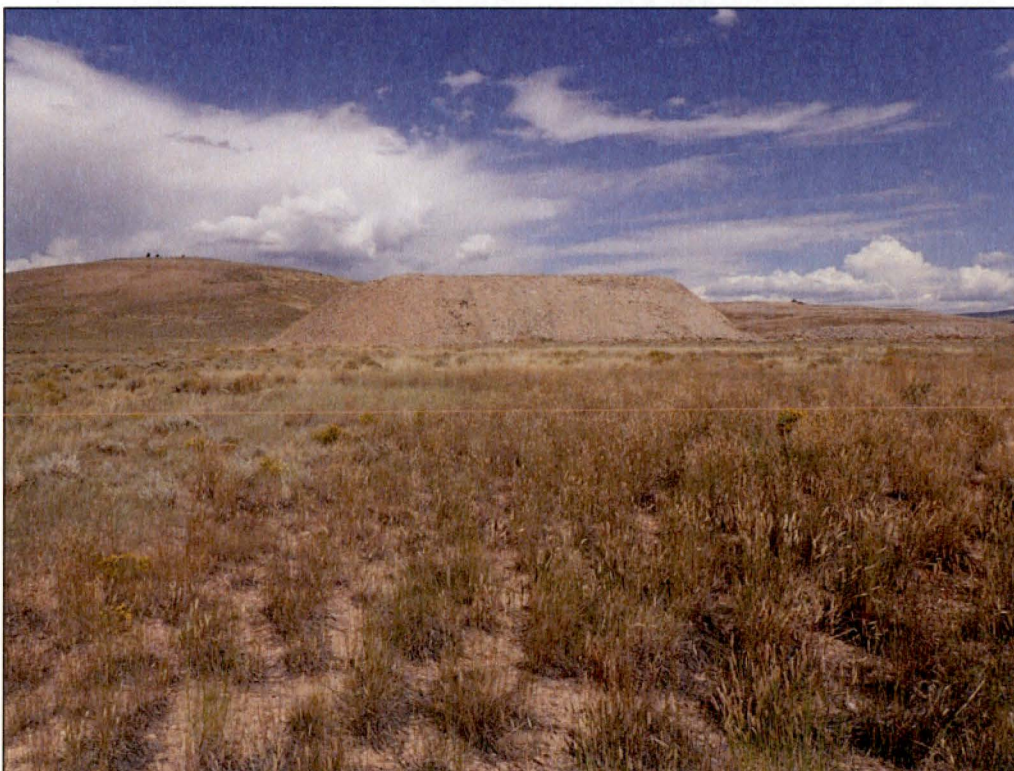
*PL-4. Gunnison County Landfill Operations*

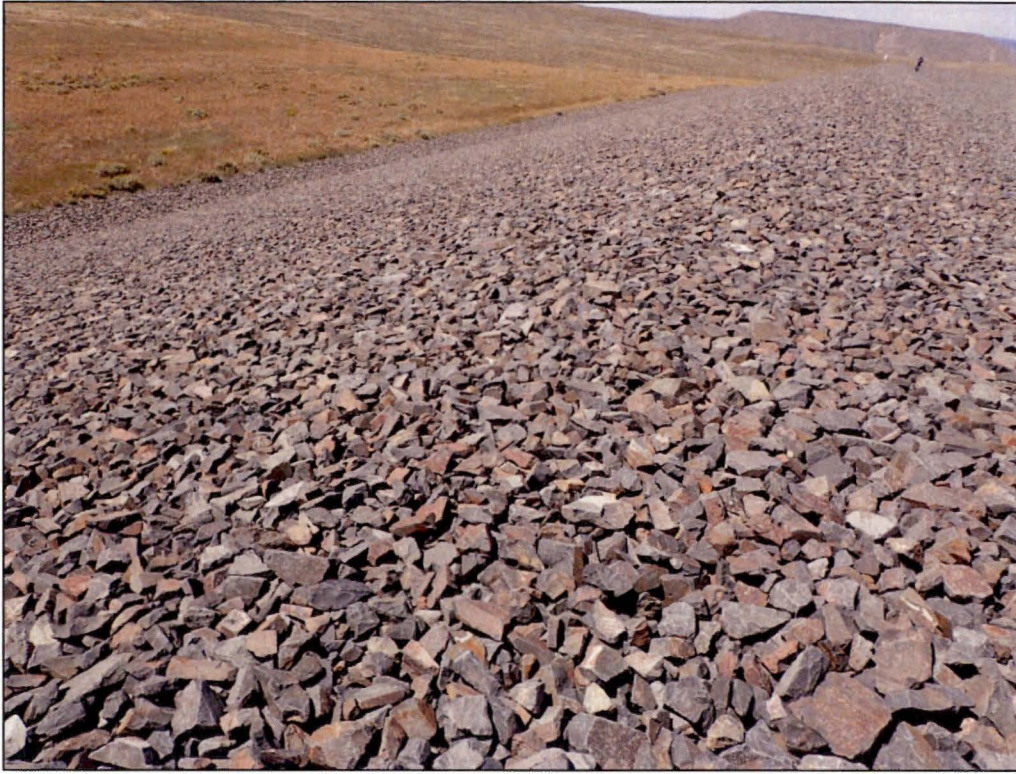
*PL-5. South Side Slope of Disposal Cell*

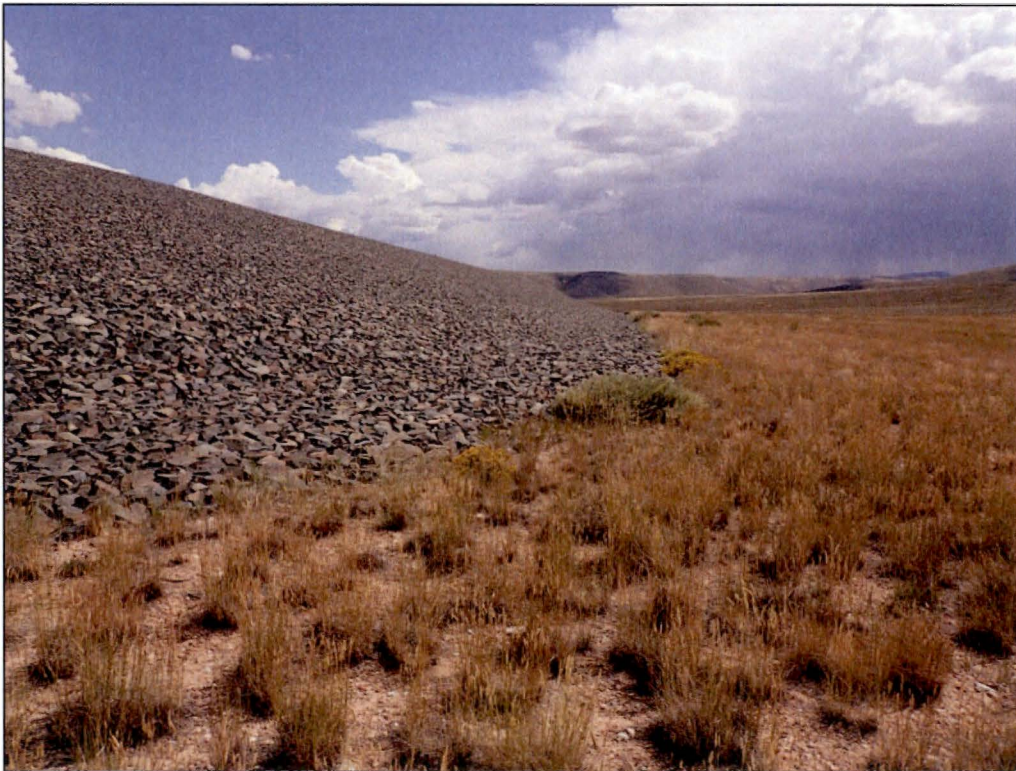
*PL-6. South Riprap Apron*

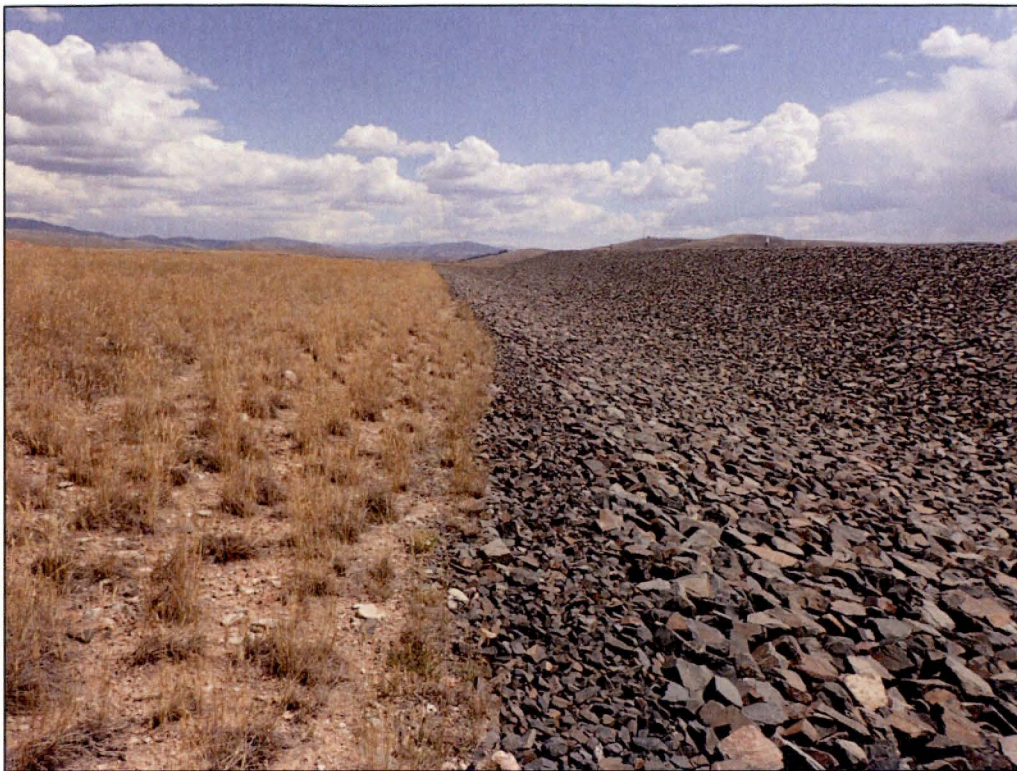
*PL-7. West Diversion Channel*

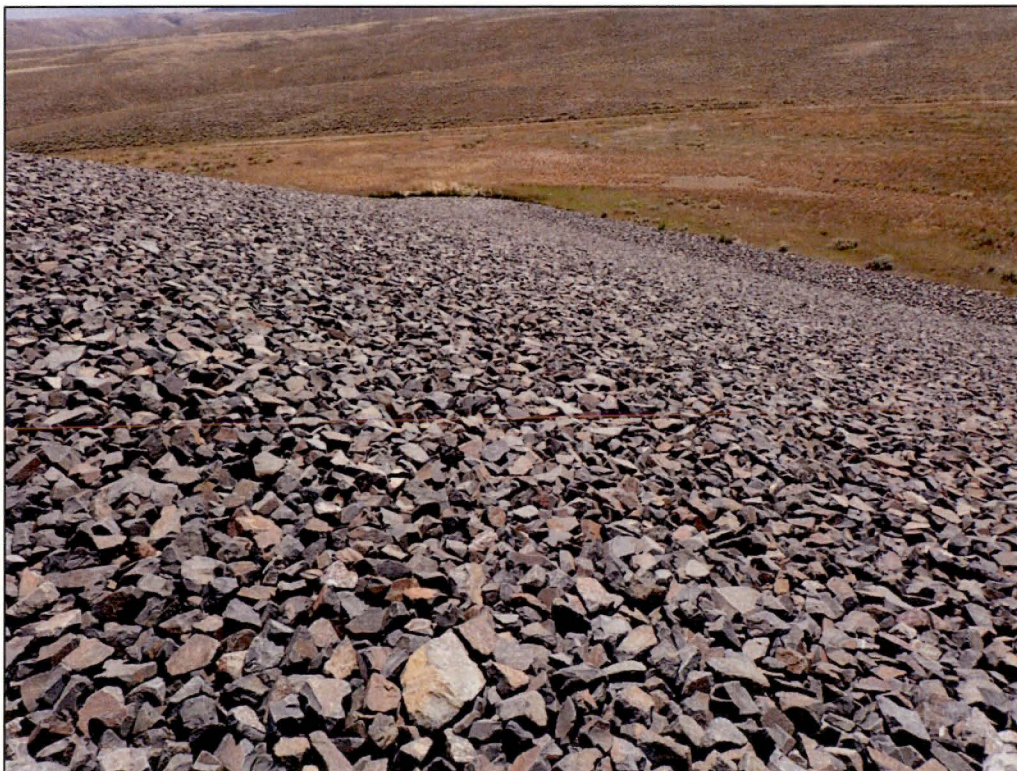
*PL-8. Southeast Corner of Disposal Cell*

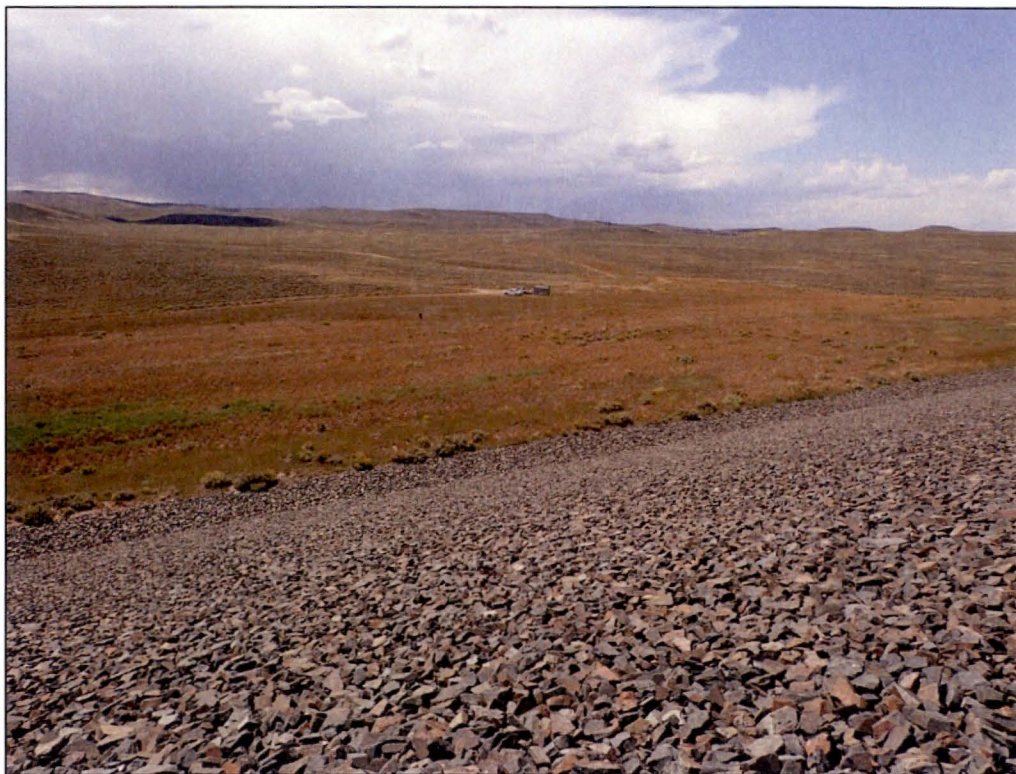
*PL-9. Reclaimed Area Along South Fence Line*

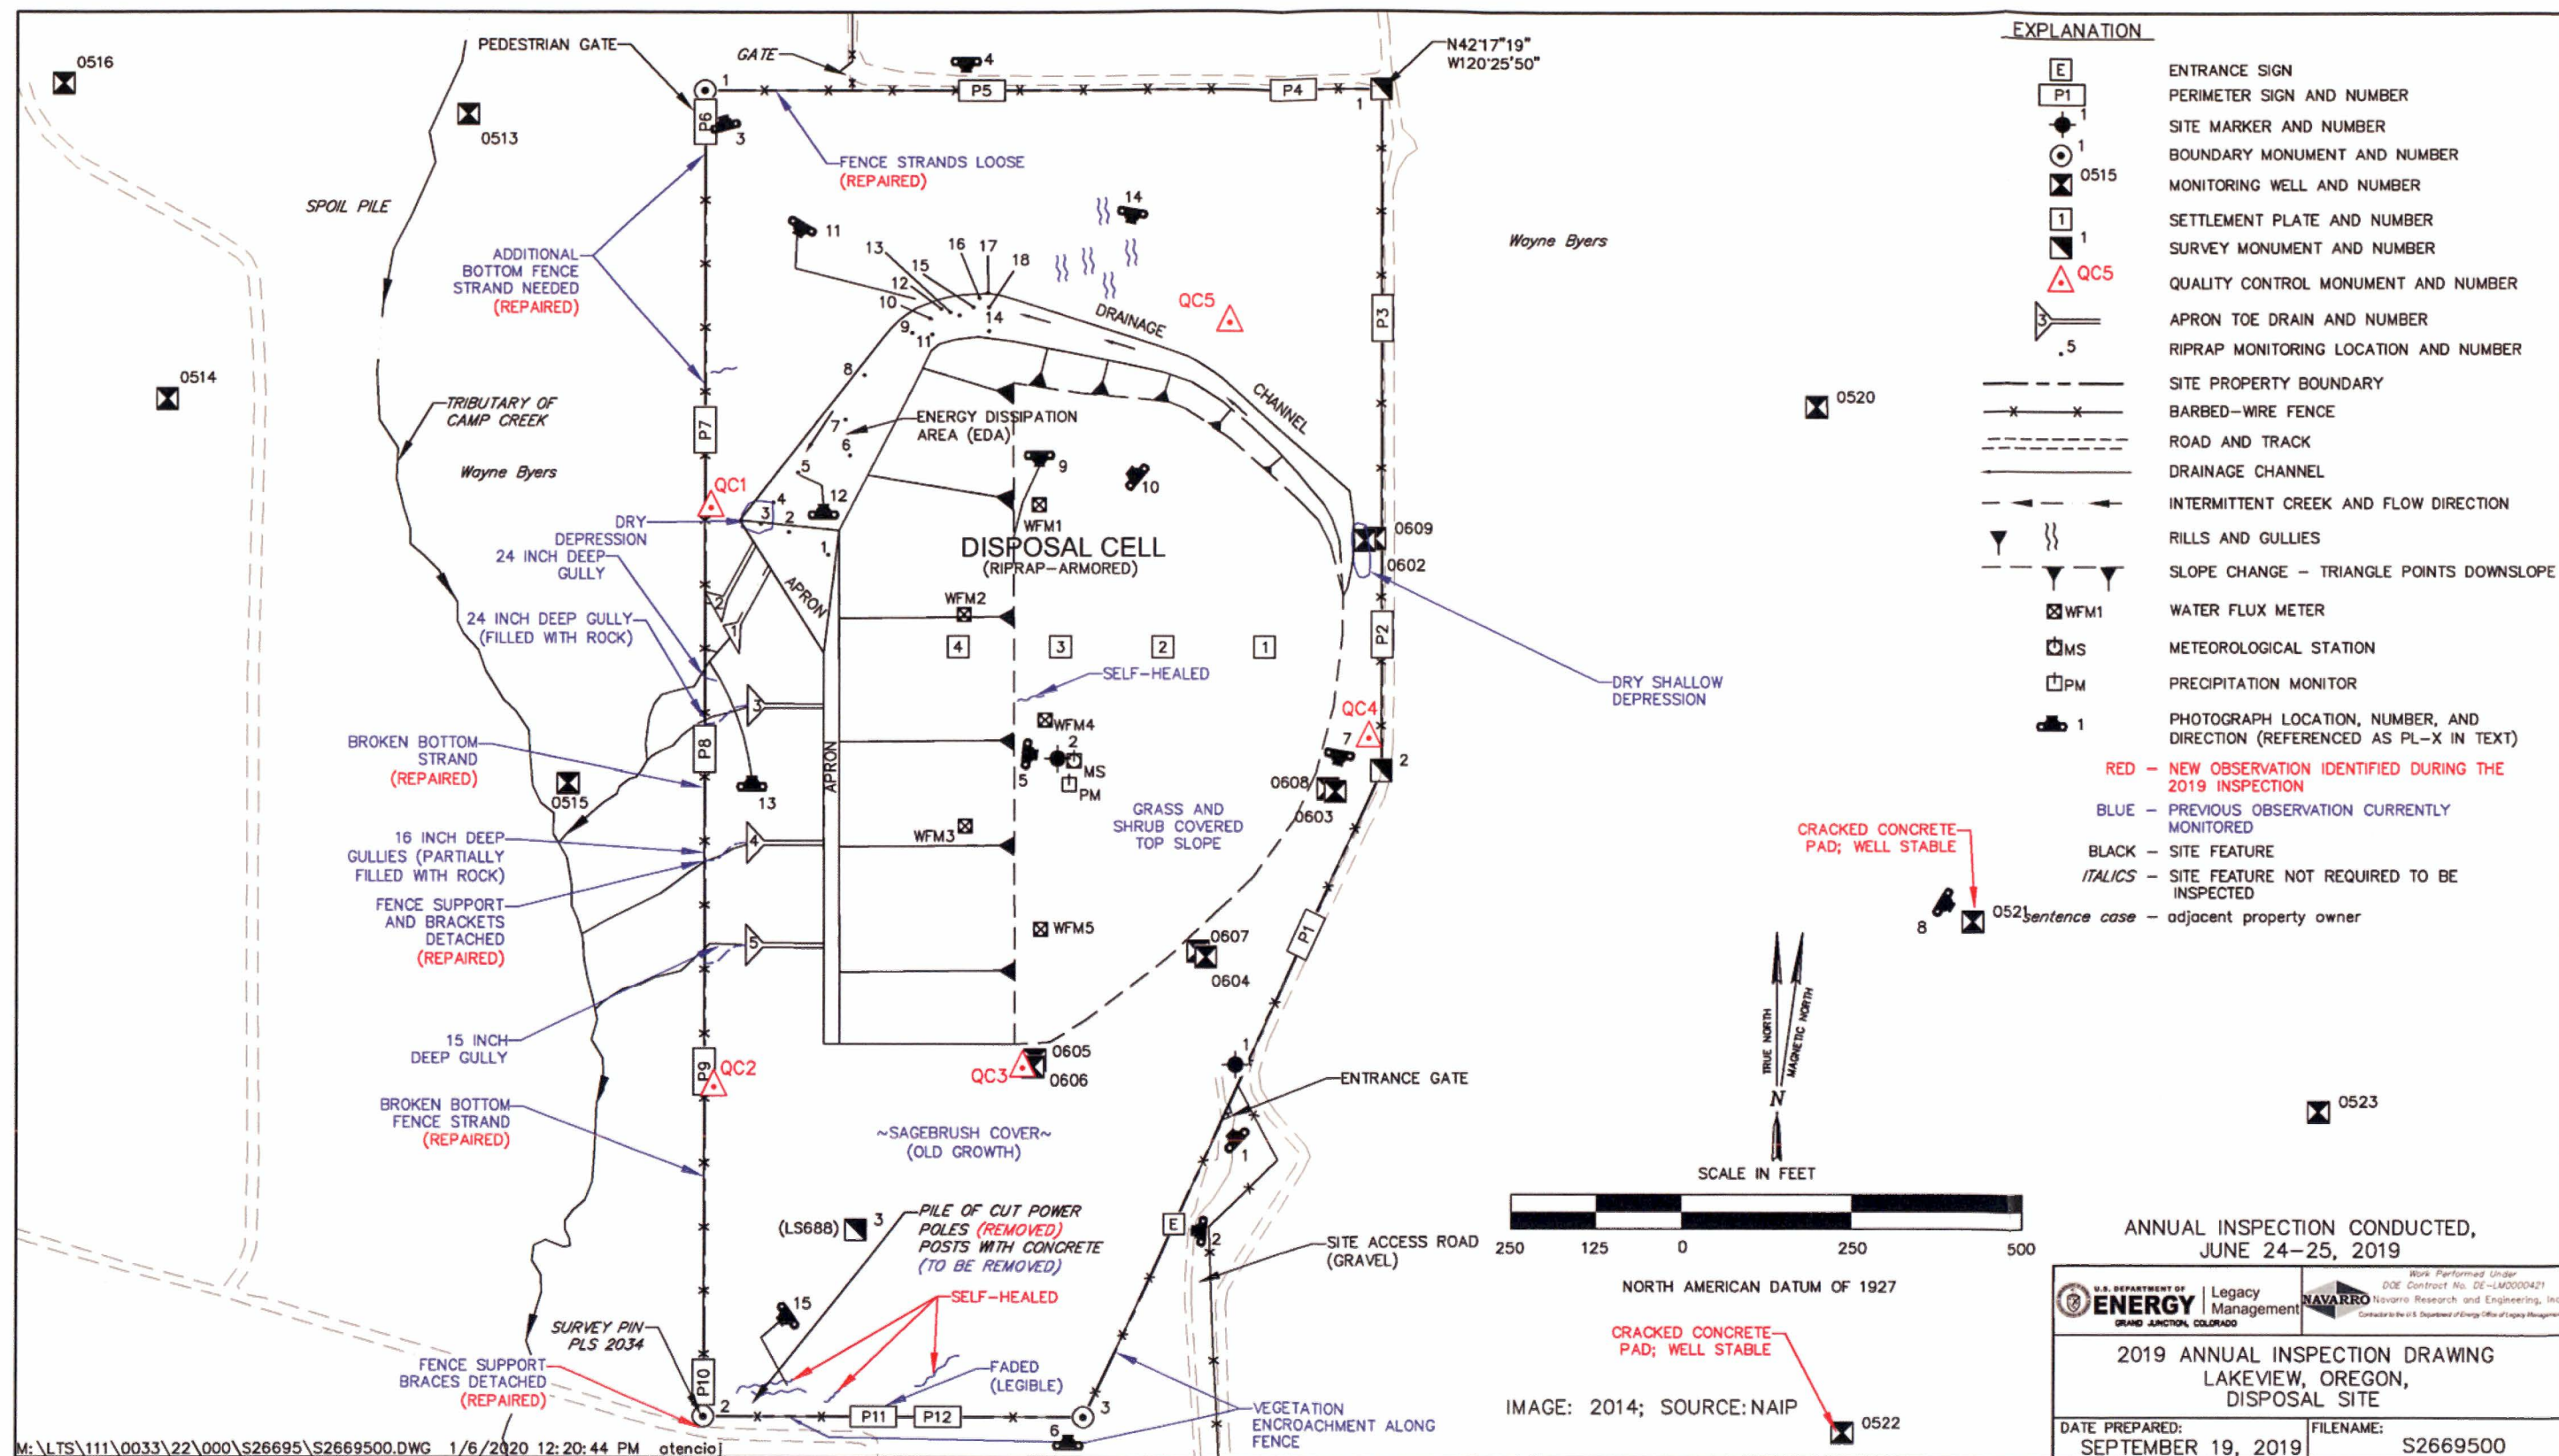
Figure 9-1. 2019 Annual Inspection Drawing for the Lakeview, Oregon, Disposal Site

Figure 9-1 shows the locations of site features in black, including site surveillance features and inspection areas. Site features that are present but not required to be inspected are shown in italic font. Observations from previous inspections that are currently monitored are shown in blue text, and new observations identified during the 2019 annual inspection are shown in red. Inspection results and recommended maintenance activities associated with site surveillance features are included in the following subsections. Photographs that support specific observations are identified in the text and in Figure 9-1 by photograph location (PL) numbers. The photographs and photograph log are presented in Section 9.10.

In August 2019, following the inspection, eight permanent quality control monuments were installed at the site in preparation for a baseline aerial survey of the disposal cell. The quality control monument locations are shown in Figure 9-1. No other maintenance needs were identified.

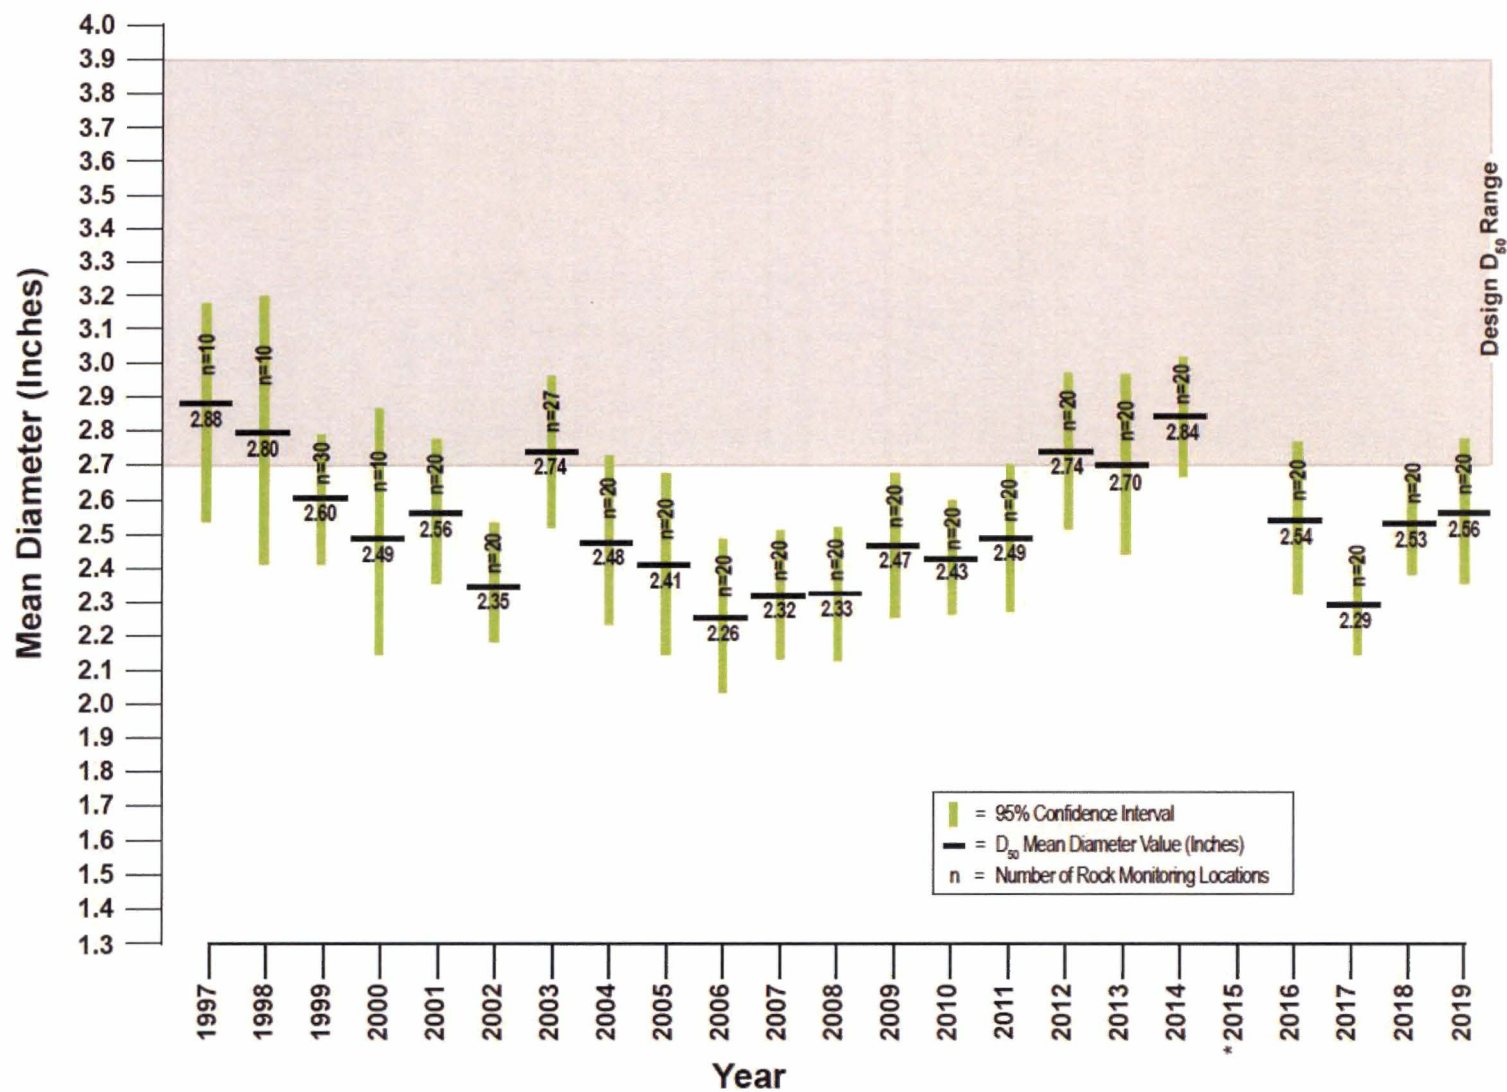
Figure 9-2. Riprap Gradation Monitoring  $D_{50}$  Values (1997-2019)

Figure 9-2 is a graph that shows the results of the gradation monitoring since 1997. During the 2015 annual inspection, the rock monitoring approach deviated from the normal procedure, at NRC's request, by using a preestablished monitoring grid in a subset area of the west side slope. This changed the measurement approach from random to biased, thus potentially compromising data comparability. Therefore, the 2015 data were not included on the graph of historical riprap gradation monitoring  $D_{50}$  values.

A statistical trend analysis of the  $D_{50}$  values was completed using EPA's ProUCL 5.1 statistical software (last updated June 20, 2016) (<https://www.epa.gov/land-research/proucl-software>). Both Mann-Kendall and Theil-Sen trend tests were performed to evaluate if a significant trend in rock size was present. At the 95% confidence level, no trend was observed. While the lack of a significant trend does not indicate a static  $D_{50}$  value, it does indicate that the  $D_{50}$  value has not significantly decreased in 23 years of observation.

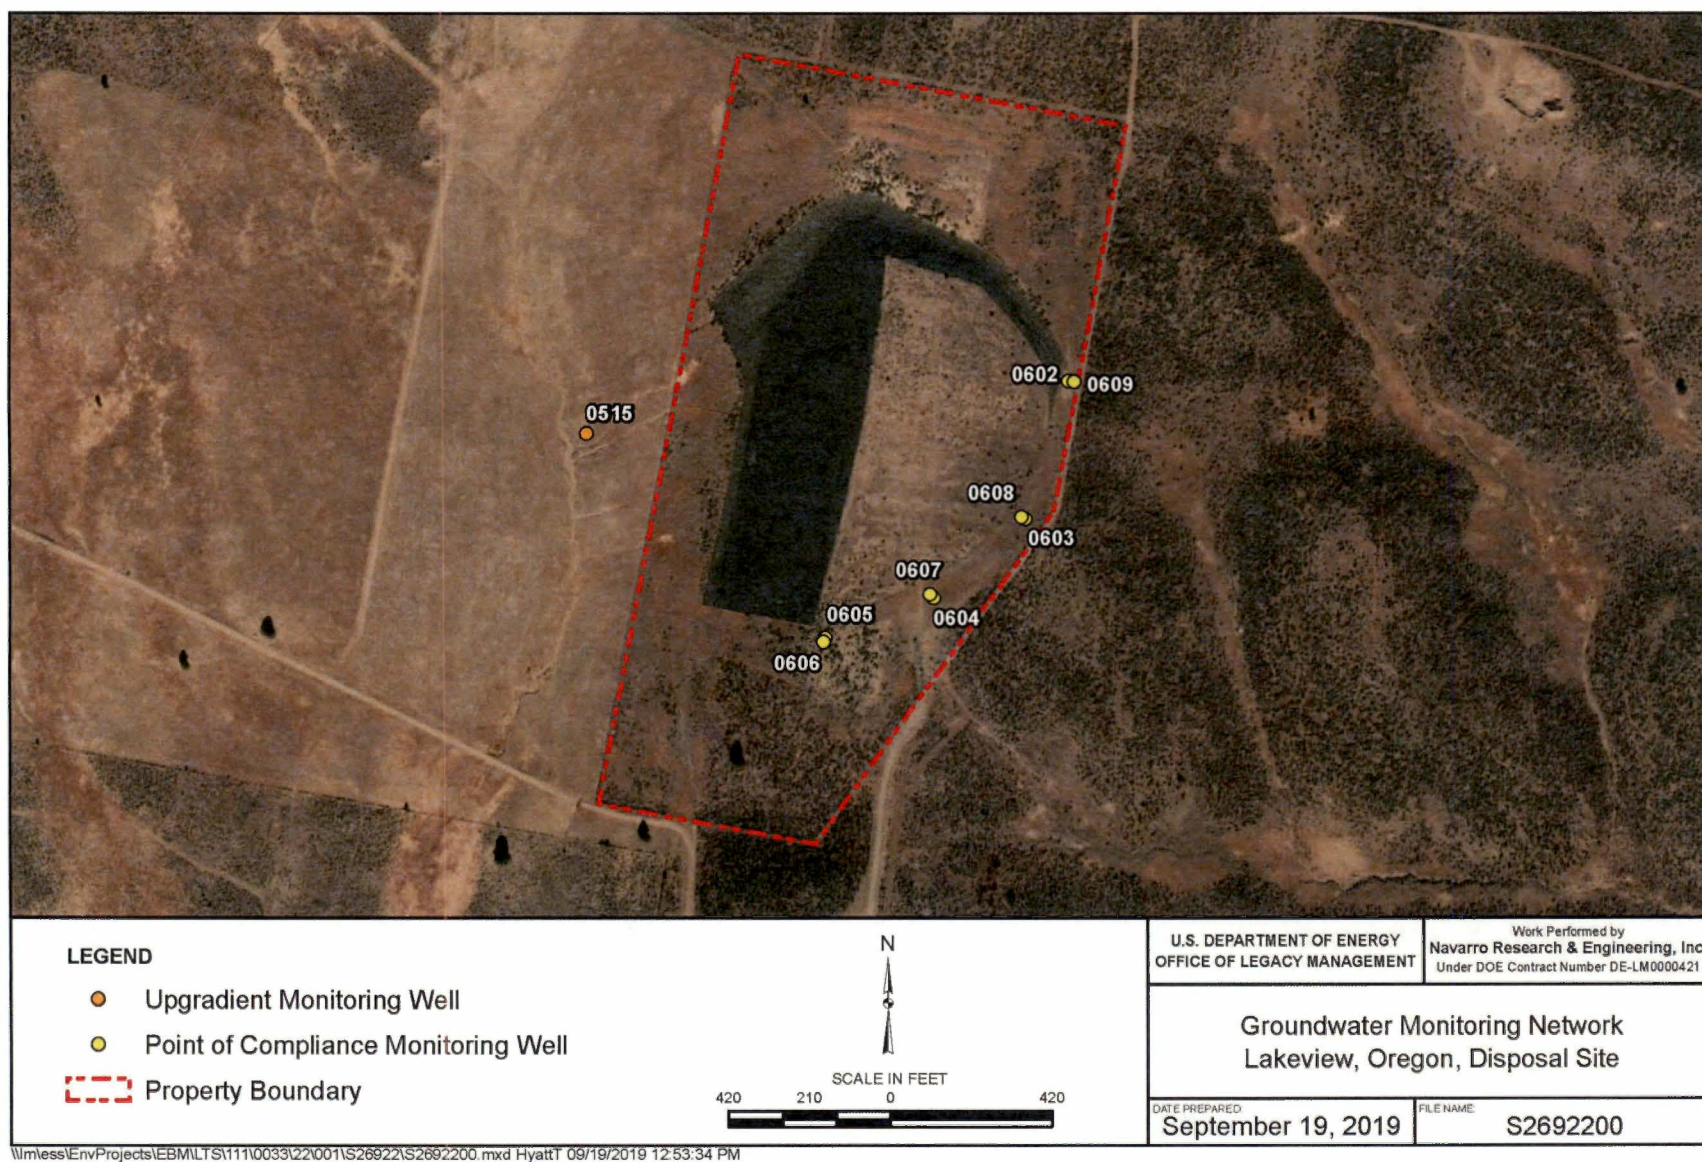
Figure 9-3. Groundwater Monitoring Network Lakeview, Oregon, Disposal Site

The groundwater monitoring network consists of nine monitoring wells, including eight downgradient point of compliance (POC) wells and one upgradient background monitoring well (Table 9-2 and Figure 9-3). Four of the nine monitoring wells were observed to be dry on June 13, 2019, and could not be sampled. Seven additional LM-owned monitoring wells (0513, 0514, 0516, 0520, 0521, 0522, and 0523) are on private property adjacent to the site but are no longer required to be sampled as identified in the LTSP (Figure 9-1). The hazardous constituents monitored in site groundwater are arsenic, cadmium, and uranium. EPA established MCLs for these analytes in groundwater in 40 CFR 192 Table 1 Subpart A (Table 9-3).

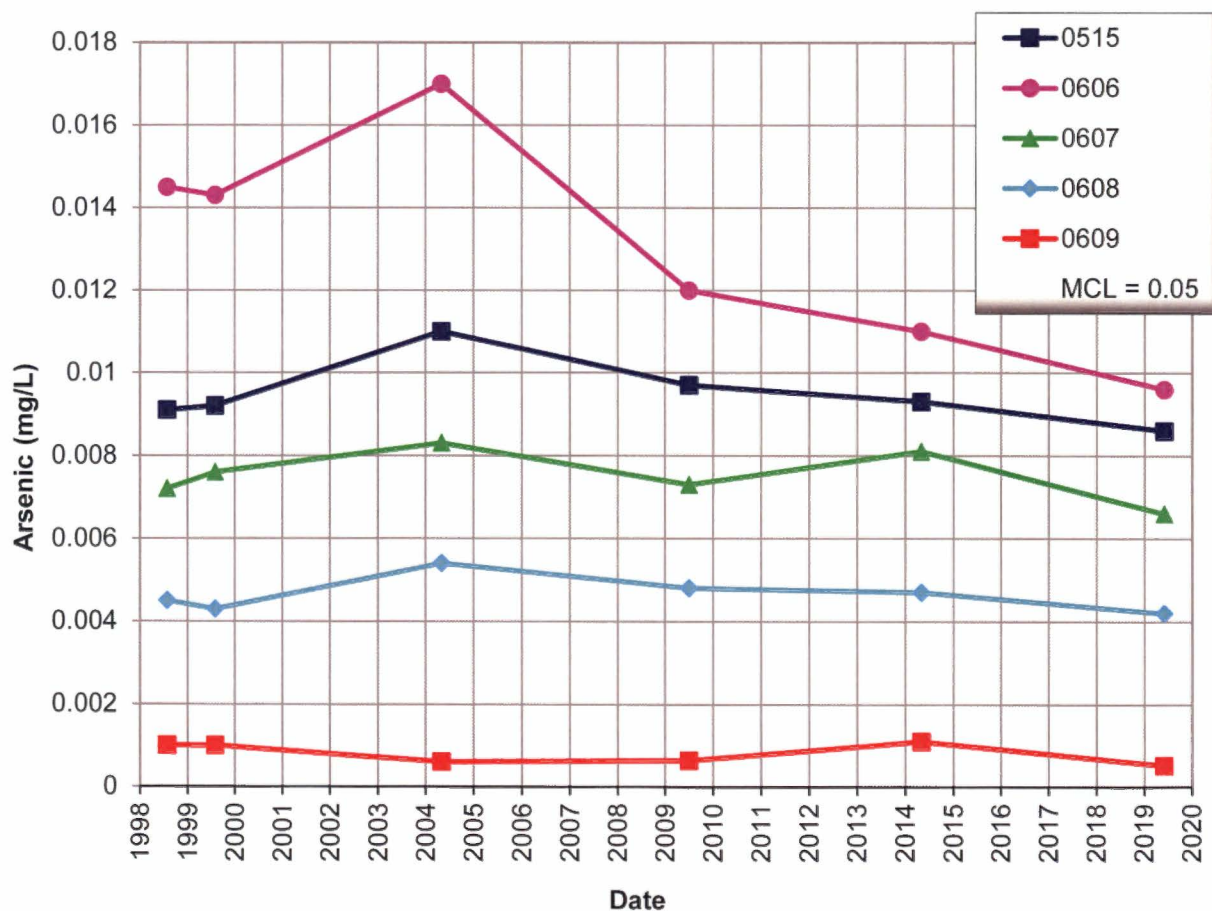
Figure 9-4. Arsenic in Groundwater at the Lakeview Disposal Site  
(Arsenic MCL is not Shown Because the MCL is Significantly Higher Than Groundwater Monitoring Concentrations)

Concentrations of these constituents continued to remain significantly below their respective MCLs in 2019. Arsenic concentrations were similar to the prior 2014 results (Figure 9-4), all cadmium concentration results were below the laboratory detection limit of 0.000083 mg/L, and uranium concentrations remained stable or have slightly increased (Figure 9-5). The next disposal cell performance monitoring is scheduled for 2024.

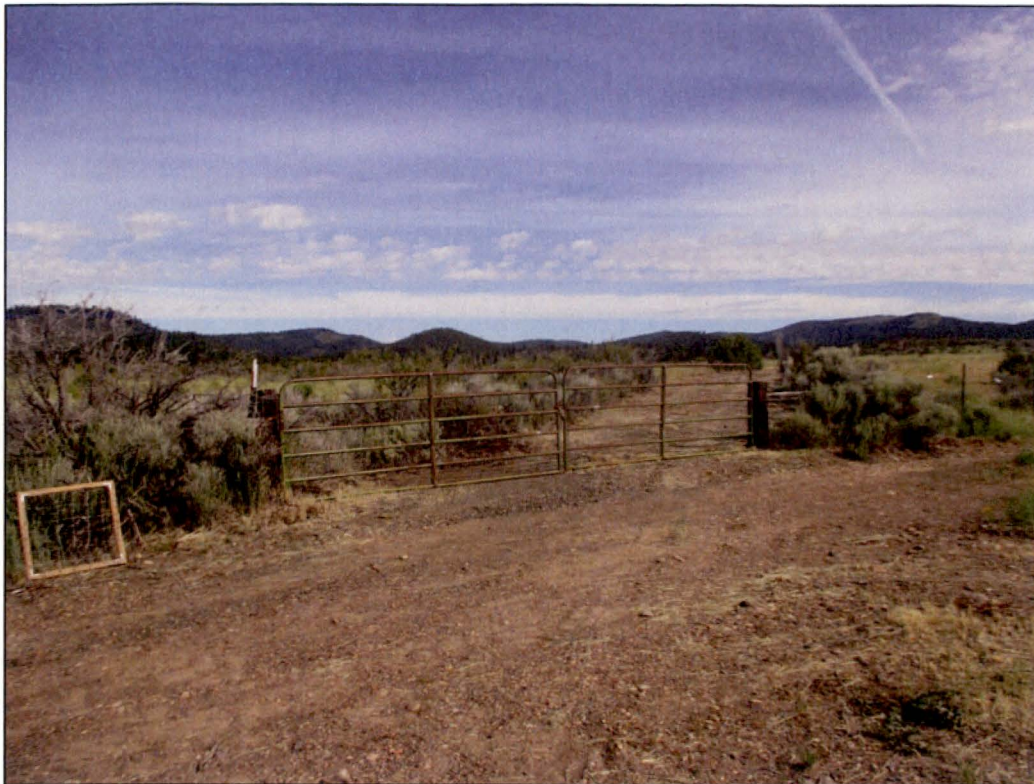
*PL-1. Entrance Gate*

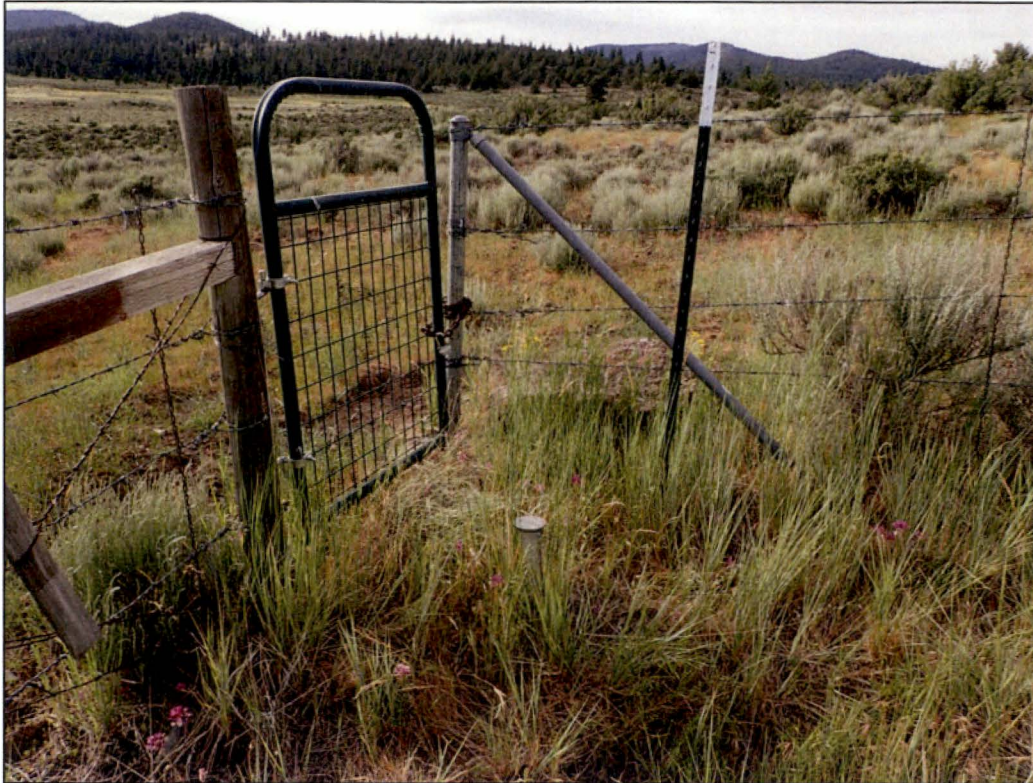
Access to the site is from a gravel road that heads west from Lake County Road 2-16B. DOE was granted a perpetual easement on the approximately 1.2-mile access road between the county road and the property boundary. A lockable gate across the access road on the adjacent privately owned land limits access to the site. The entrance gate to the site is in the southeast corner of the perimeter fence (PL-1). The entrance gate was locked and undamaged. The entrance sign is attached to a steel post set in concrete along the access road and was undamaged (PL-2). A pedestrian gate in the northwest corner of the site was locked and undamaged (PL-3). No maintenance needs were identified.

*PL-3. Boundary Monument BM-1 and Pedestrian Gate*

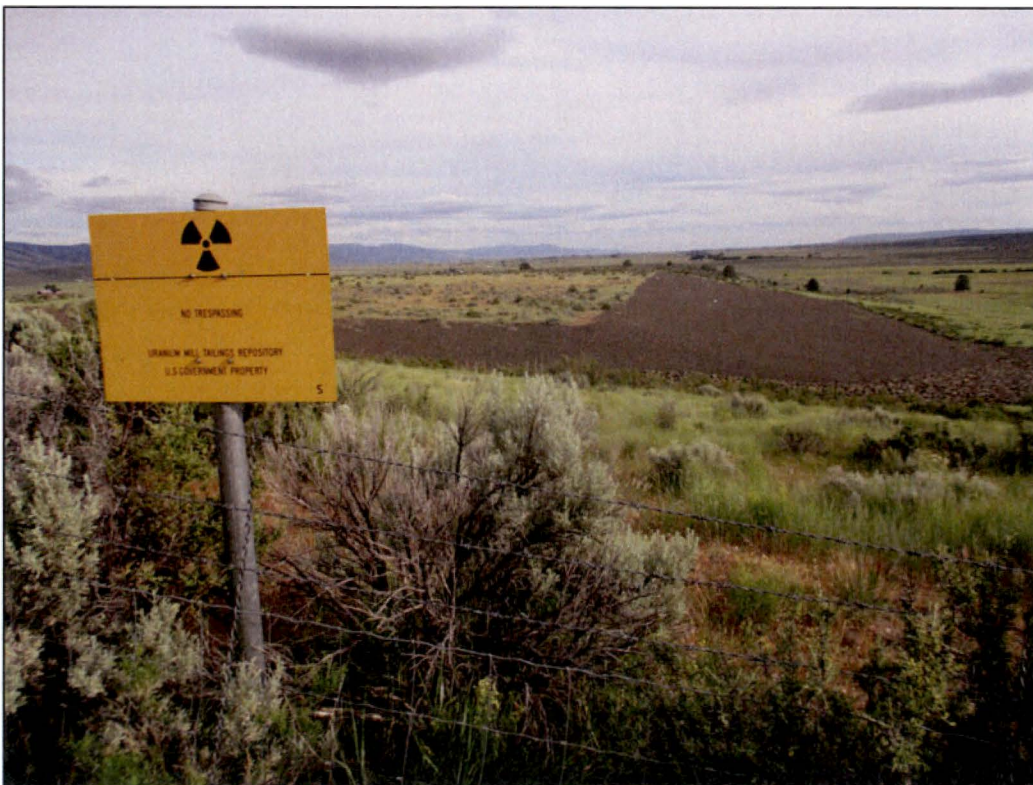
*PL-4. Perimeter Sign P5 with Disposal Cell in the Background*

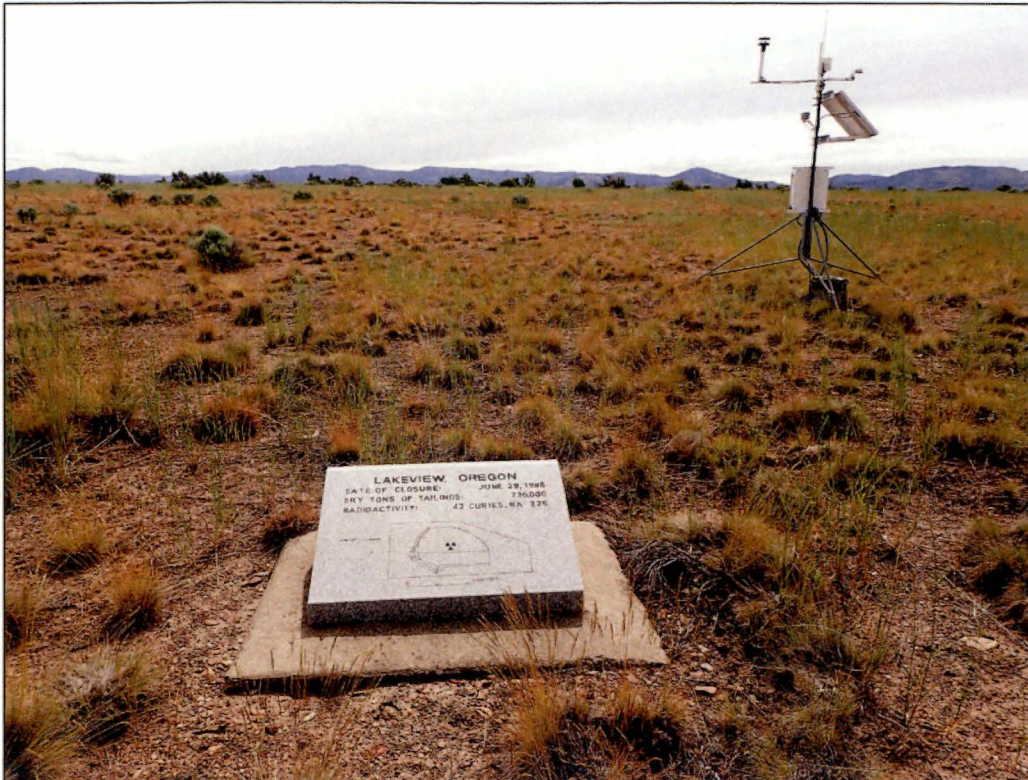
*PL-5. Site Marker SMK-2 with Meteorological Station in Background*

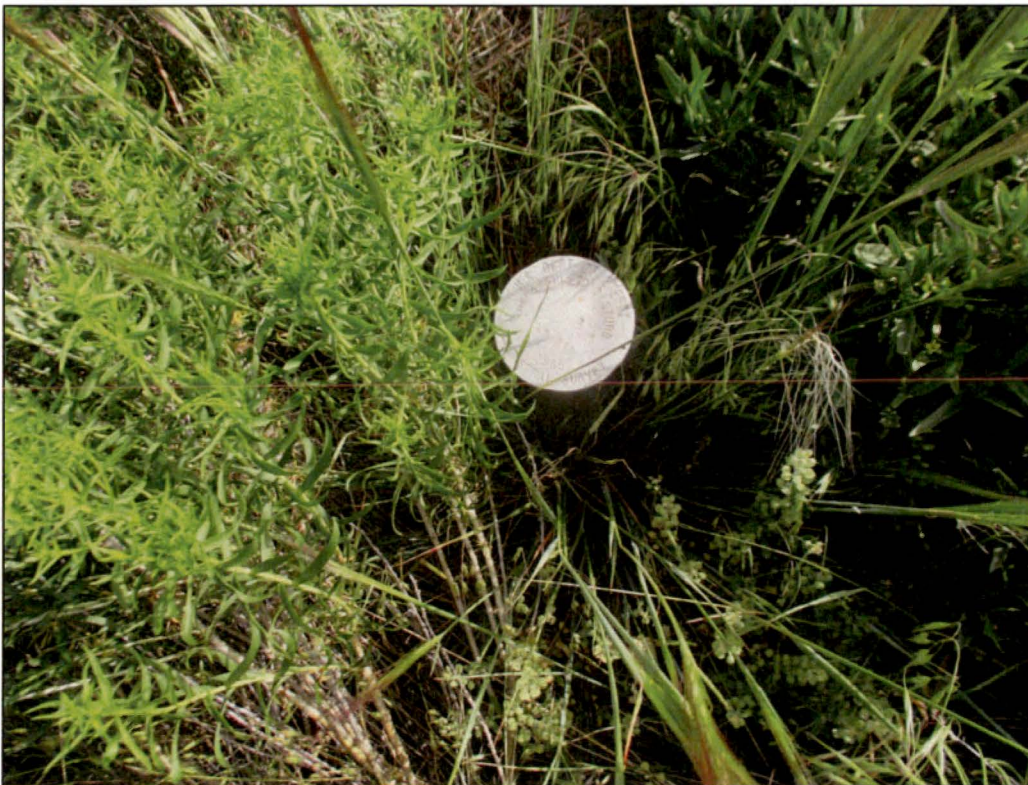
*PL-6. Boundary Monument BM-3*
