**Department of Energy**

Subject: *2019 Annual Site Inspection and Monitoring Report for Uranium Mill Tailings  
Radiation Control Act Title I Disposal Sites*

Enclosed are seven copies of the *2019 Annual Inspection and Monitoring Report for Uranium Mill Tailings Radiation Control Act Title I Disposal Sites*. The report covers the annual inspections of the 19 Title I disposal sites managed by the U.S. Department of Energy Office of Legacy Management.

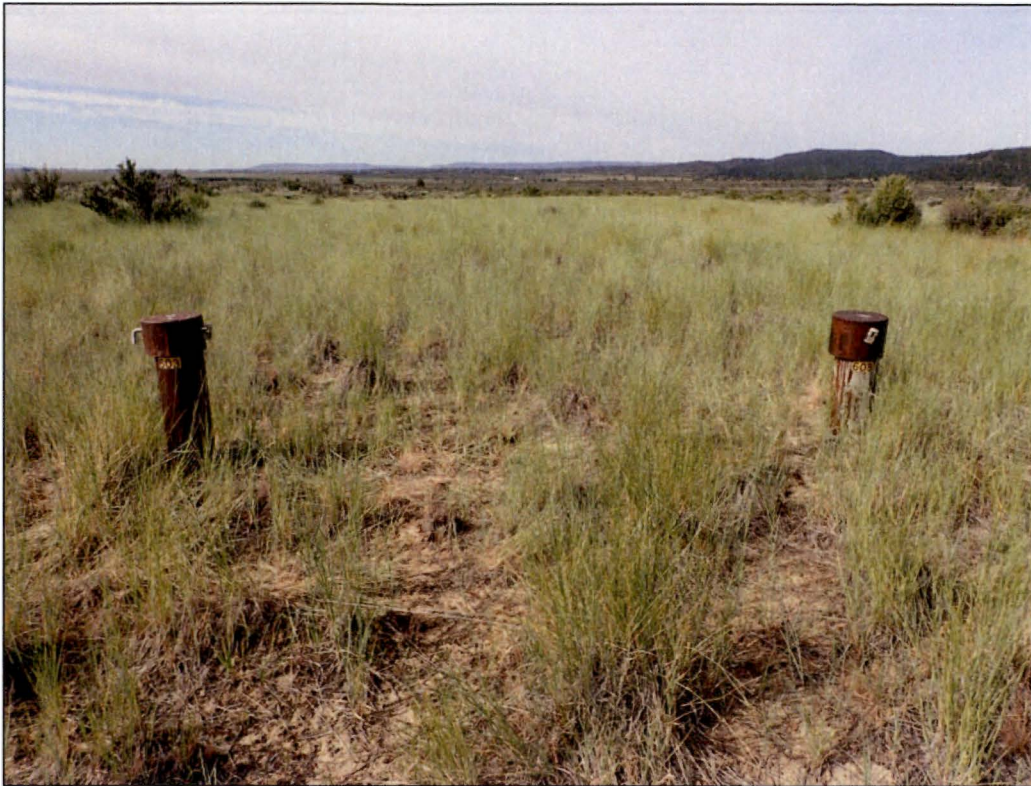
The site has 12 downgradient groundwater monitoring wells (PL-7) and four upgradient groundwater monitoring wells offsite to the west of the site. A few of the concrete bases were cracked but the wellhead protectors remain stable (PL-8). The wellhead protectors were locked and undamaged. No maintenance needs were identified.

*PL-7. Monitoring Wells 0603 and 0608*

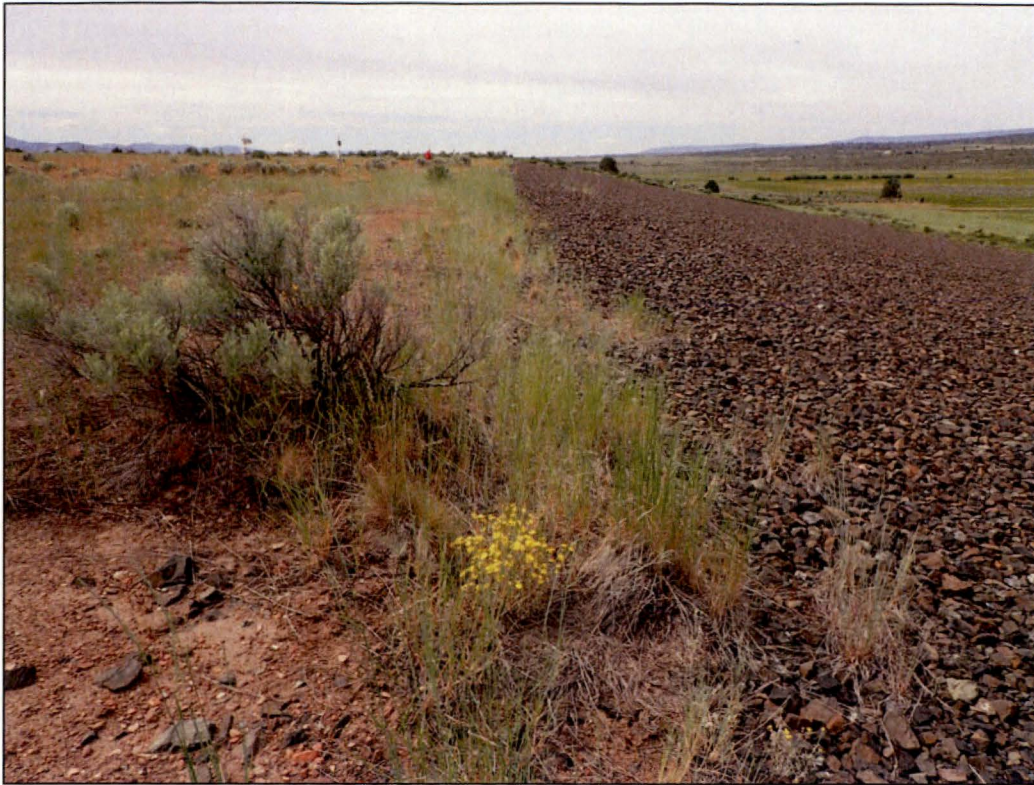
*PL-10. Reclaimed Cover Study Test Plot*

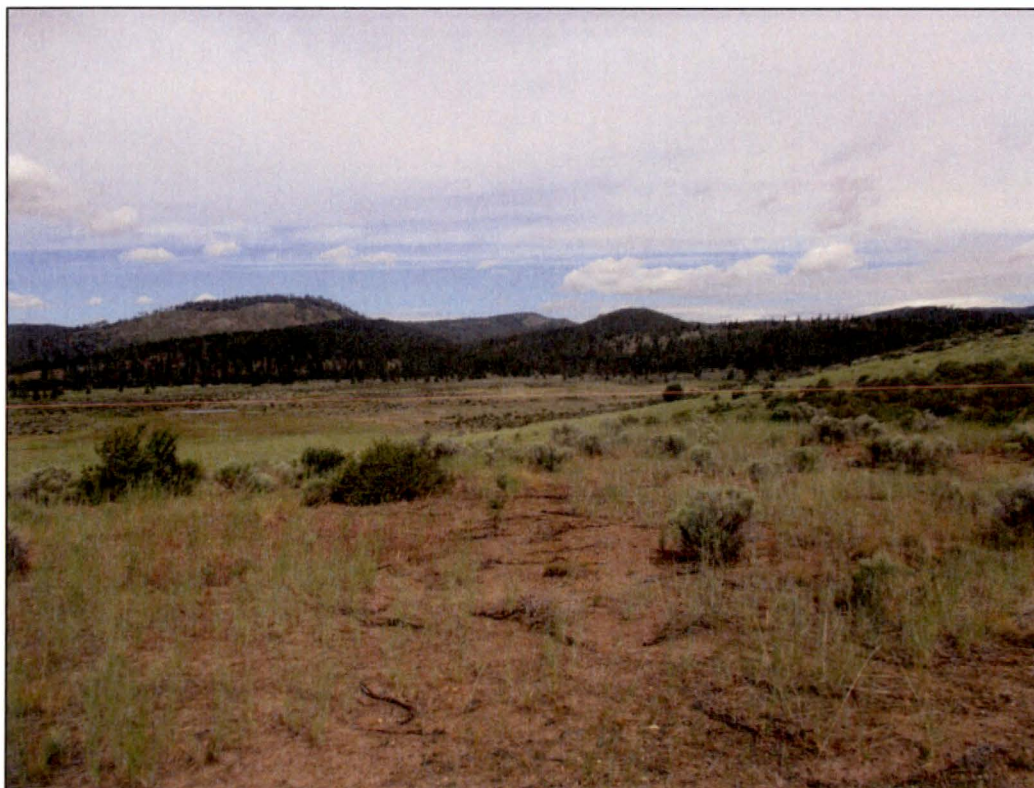
Minor rock degradation has been observed in the EDA (PL-11) since monitoring began at the original 10 photograph locations established in 1997 and at the eight additional locations established in 2000. Annual photographic monitoring of the 18 locations for long-term rock monitoring was conducted during the 2019 inspection. In 2018, it was observed that some of the numbered rocks had faded labels, and they were repainted before the 2019 annual inspection. Location 15 was missed and will be repainted next year. The rock at photo monitoring location 5 is shown in PL-12. No significant degradation of the EDA rock has been observed since monitoring began.

*PL-11. Energy Dissipation Area Downstream of Drainage Channel North of Disposal Cell*

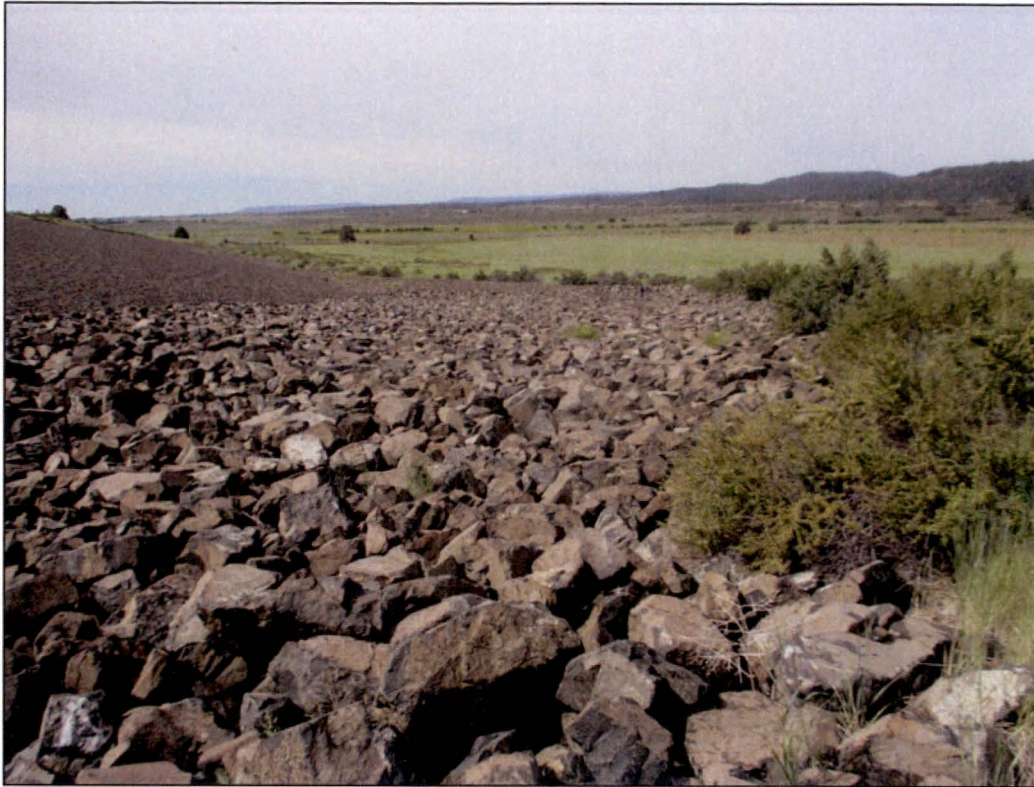
*PL-12. (a) Riprap Monitoring Location Number 5 in Energy Dissipation Area—2019*

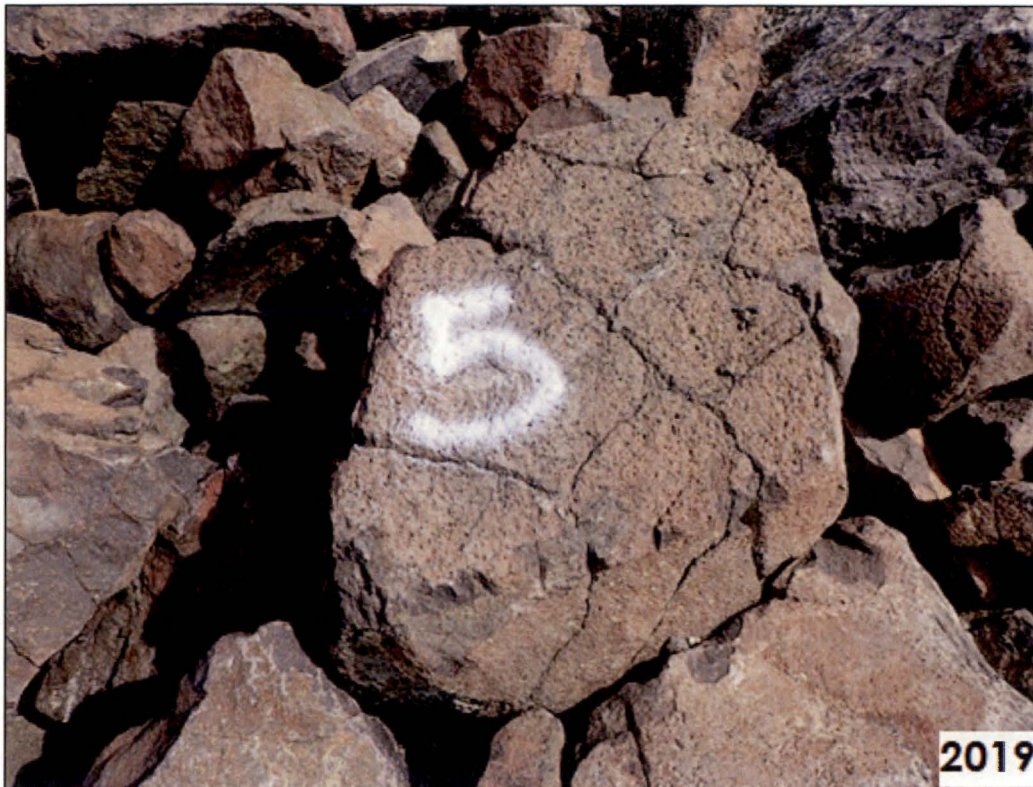
*PL-12. (b) Riprap Monitoring Location Number 5 in Energy Dissipation Area—2004 Photo for Comparison*

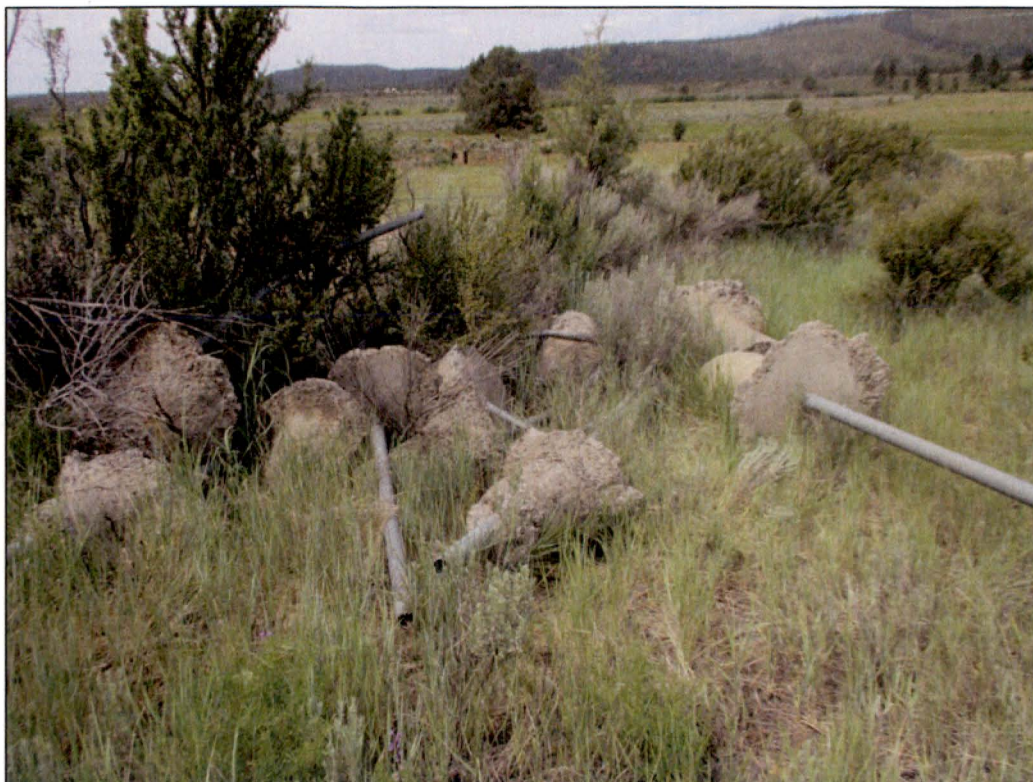
*PL-15. Abandoned Metal Signposts with Concrete Bases*
