DOCKET NO. 50-266
FINAL REPORT OF STEAM GENERATOR TUBE INSPECTION
POINT BEACH NUCLEAR PLANT UNIT 1

MICROSCOPIC AND OTHER EXAMINATIONS OF
NUCLEAR STEAM GENERATOR TUBING REMOVED
FROM POINT BEACH NO. 1 IN MARCH 1980

RE-EVALUATION OF EDDY CURRENT TAPES FOR TUBES R19C37, R30C41, R26C53, R30C44, R28C38, R32C42, R22C46, AND R30C57

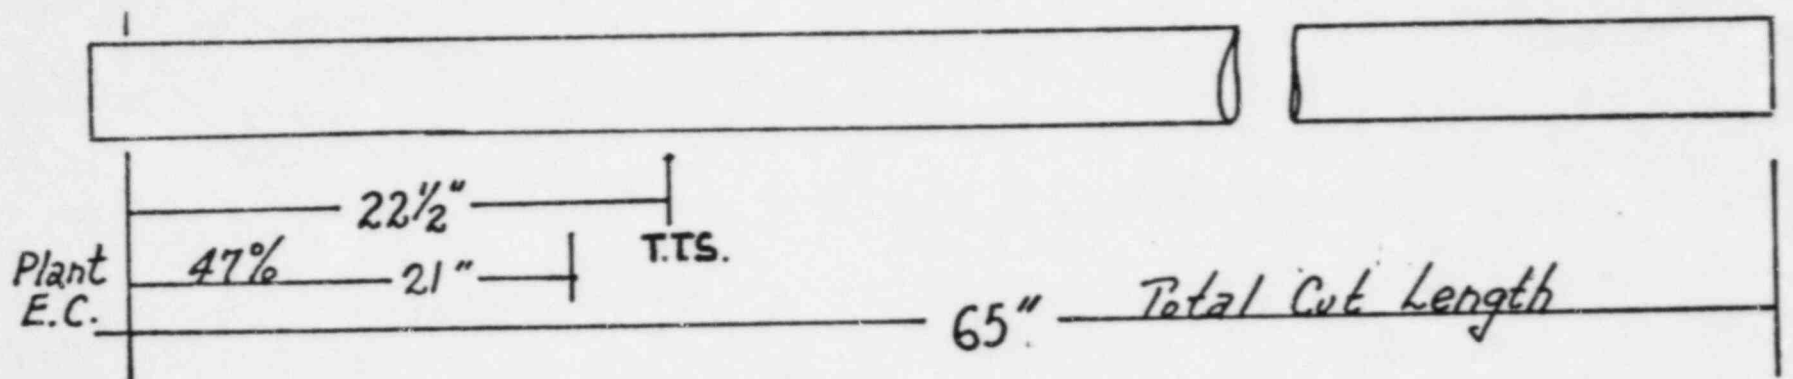
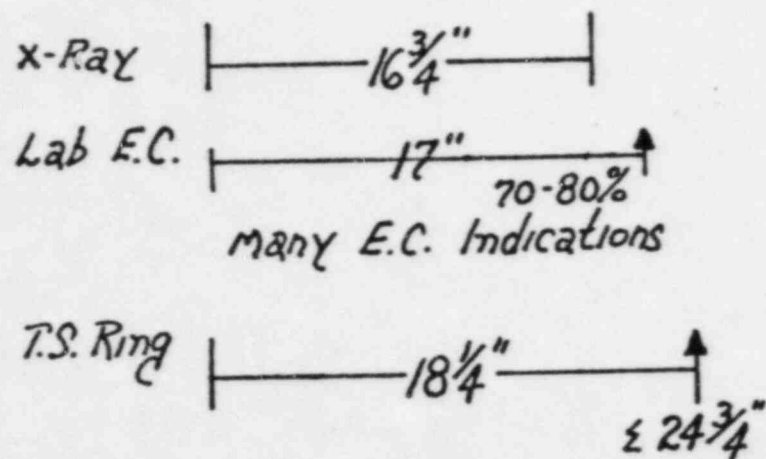
FIGURE 4A. Comparison of plant E.C. signal locations and E.C. findings in the laboratory.

Tube 26-53
 Total Lab Length : 74 9/16"
 Less : 70
 Total Stretch : 4 9/16"
 Stretch Above T.S. : 3.7%
 Stretch Inside Crevice : 25%

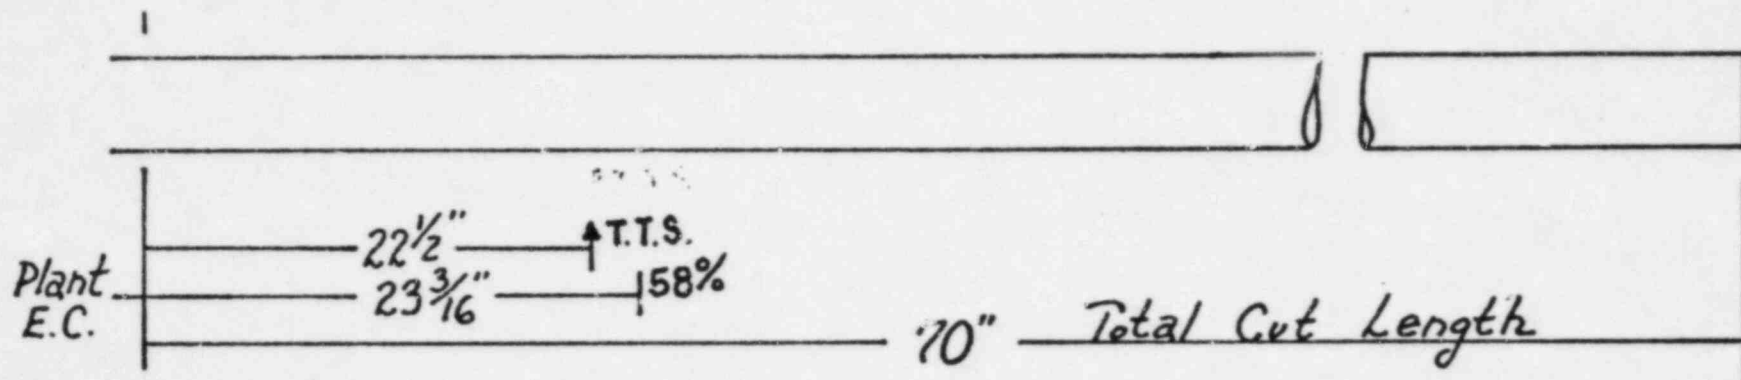
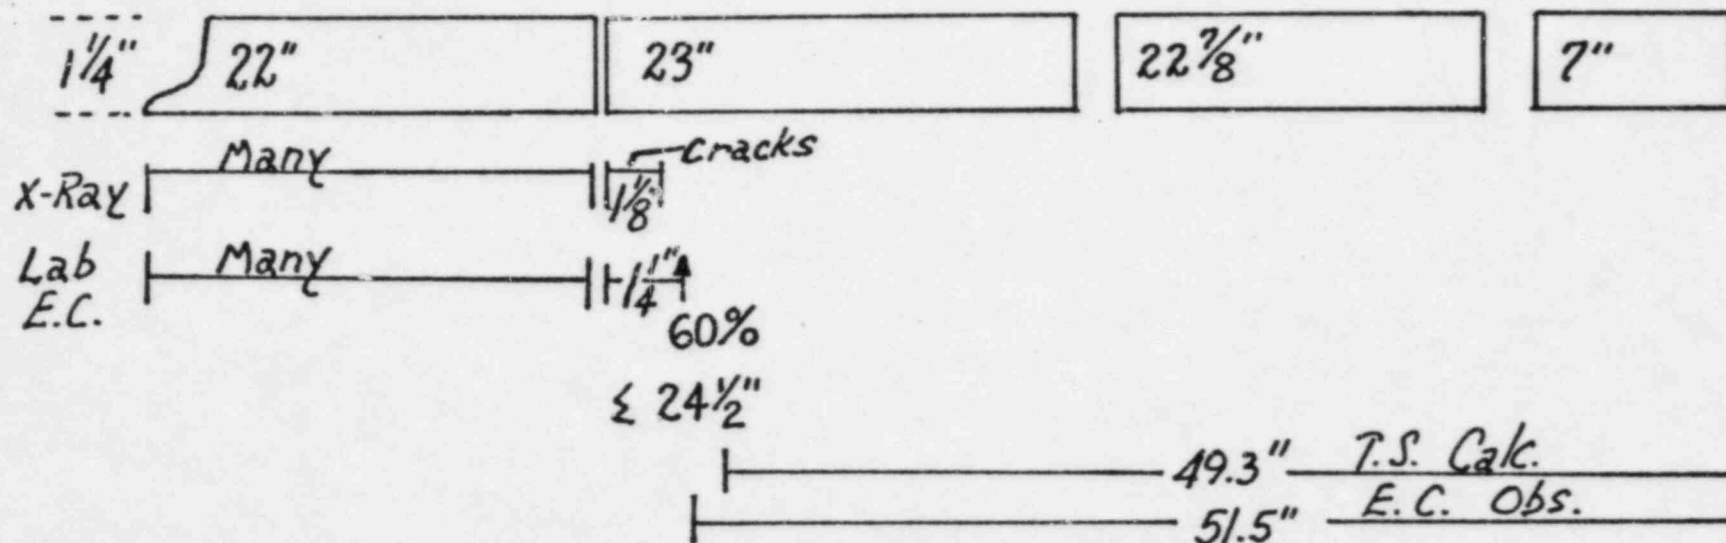
Tube 30-41

Total Lab Length	: 68 7/8"
Less	: 65 "
Total Stretch	: 3 7/8"
Stretch Above T.S.	: 3.7%
Stretch Inside Crevice	: 19%

FIGURE 4B. Comparison of plant E.C. signal locations and E.C. findings in the laboratory.

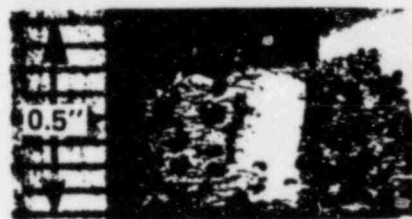
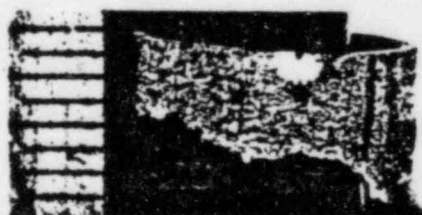
FIGURE 12. B(26-53), Additional Microscopic Samples from within Tube Sheet.
 Top = Sample 3 (Figure 6): SEM fractography
 Top Middle = Sample 4: Bend transverse metallography
 Lower Middle = Sample 5: Transverse metallography
 Bottom = Sample 6: SEM fractography.

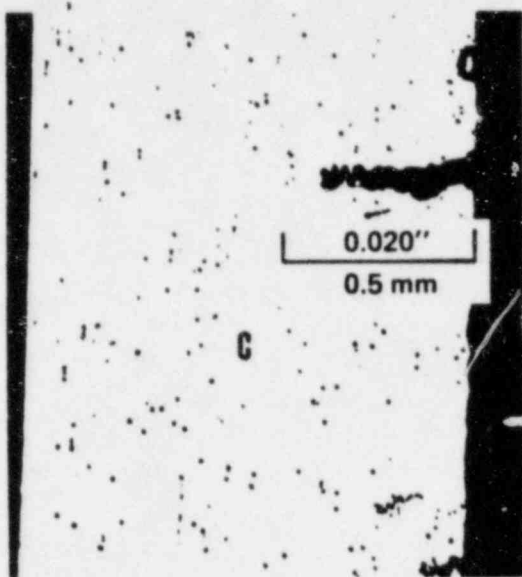
FIGURE 32. B(19-37), Top of Tube Sheet, 2-in.-long Axial Micro. Areas A and B of Figure 31, lower. OD edges are at right; primary flow is upward. Etched with bromine in methanol.

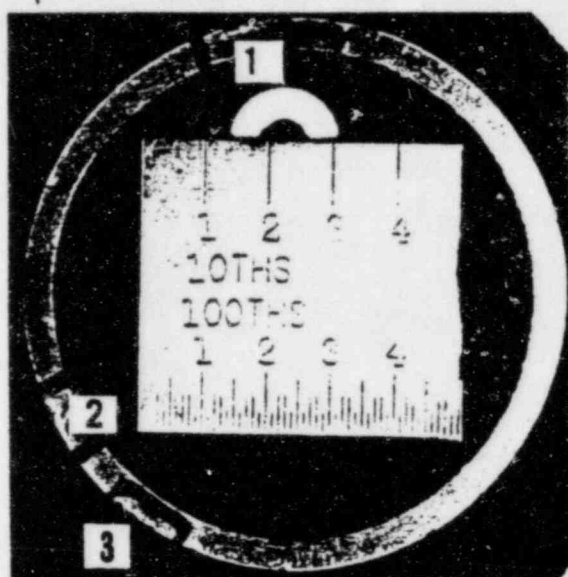
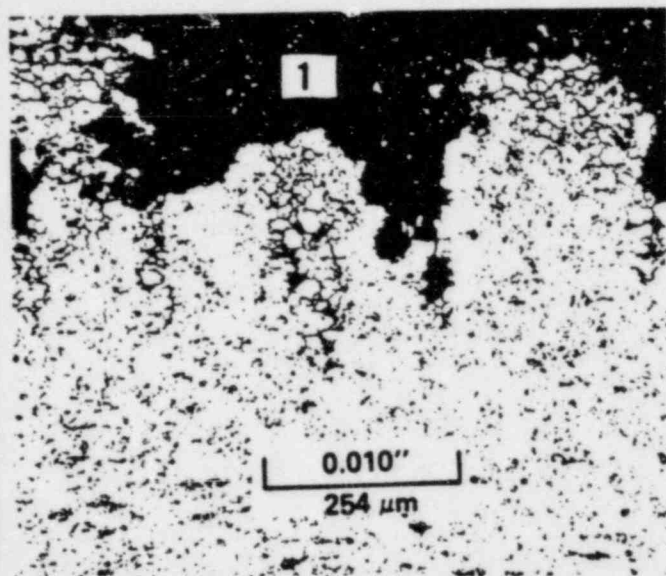
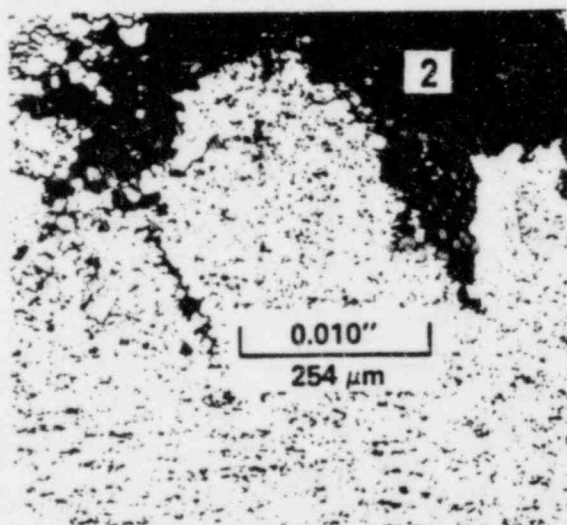
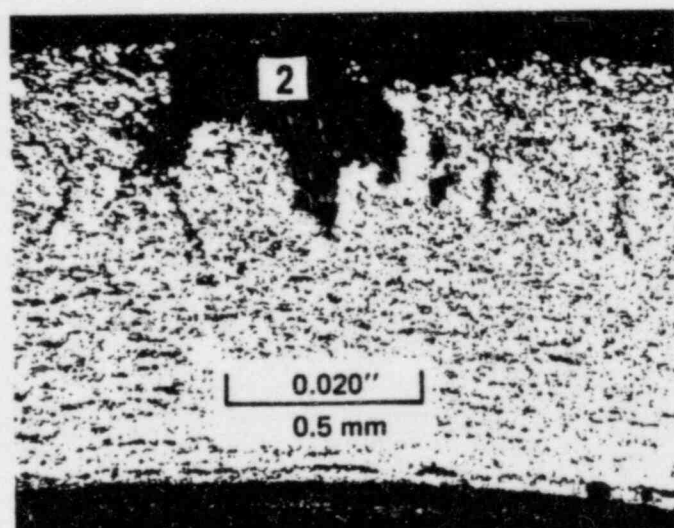
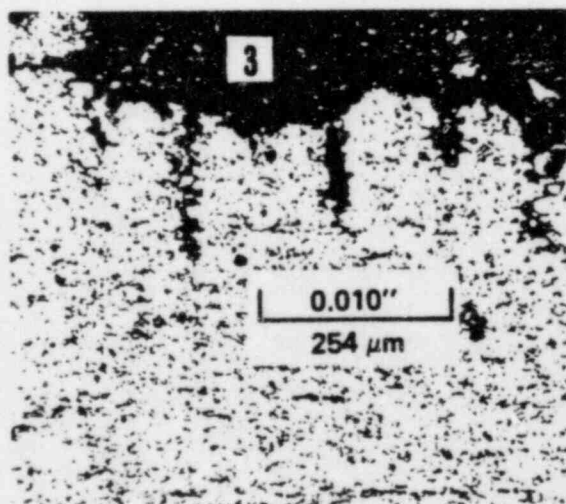
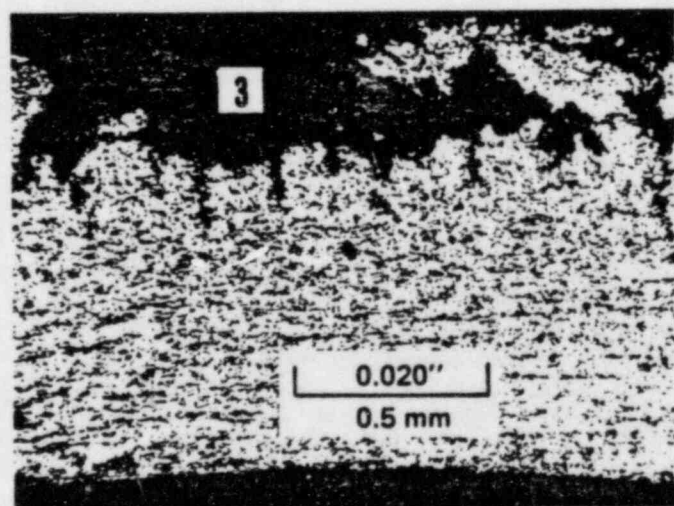
FIGURE 42. B(19-37), Transverse Cross Section from within the Tube Sheet. Sample 4 of Figure 29. The higher magnification pictures show OD edges.

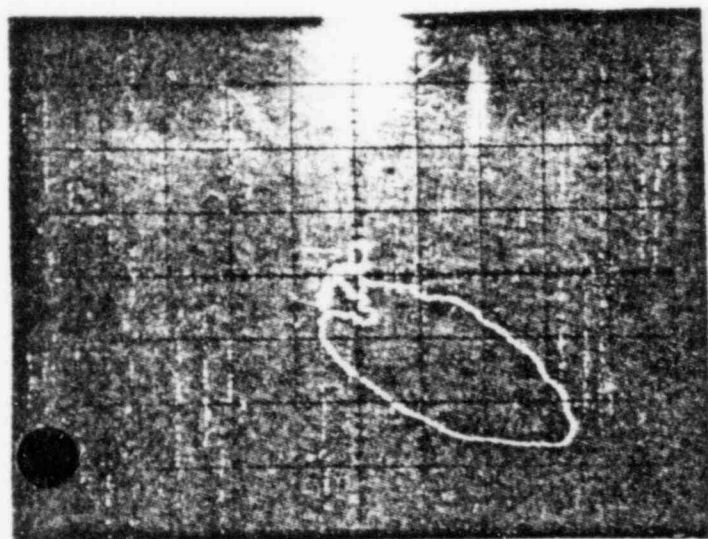
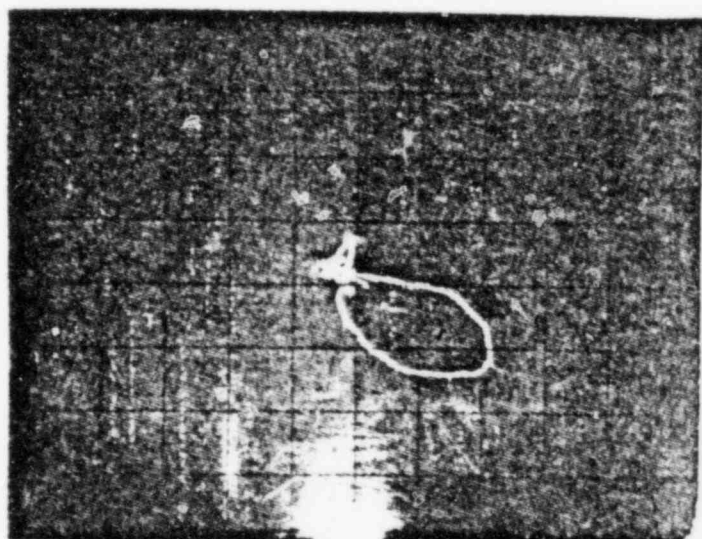
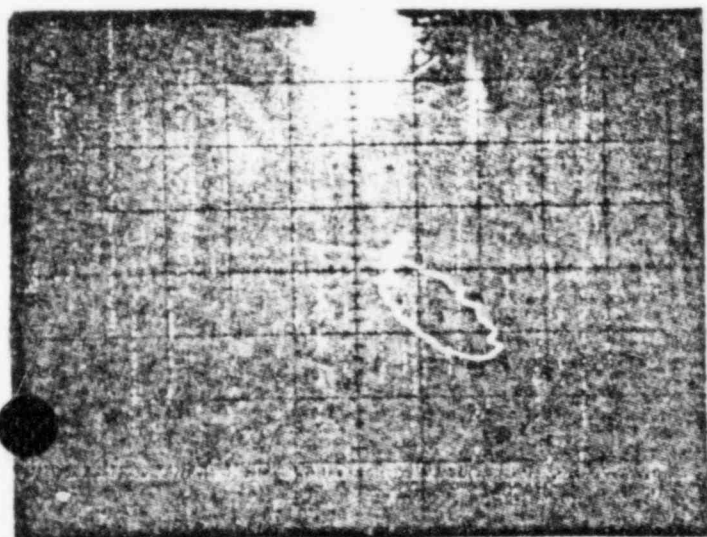
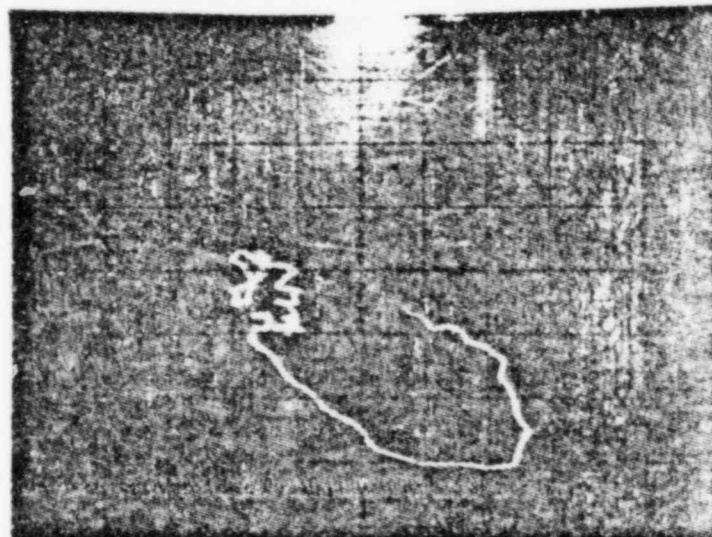
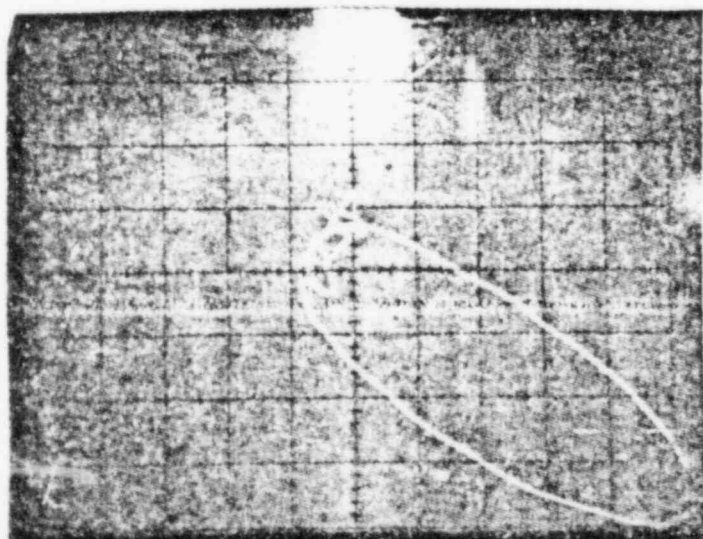
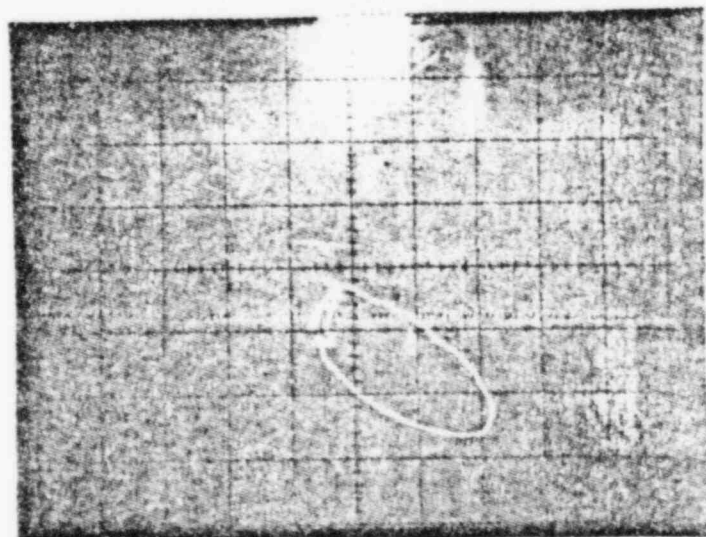
FIG. 1

Row 19 Column 37 (Figure 1)

WEP - POINT BEACH NO. 1
S/G B INLET
R19C37 - 1/2" ABOVE TOP OF TUBESHEET

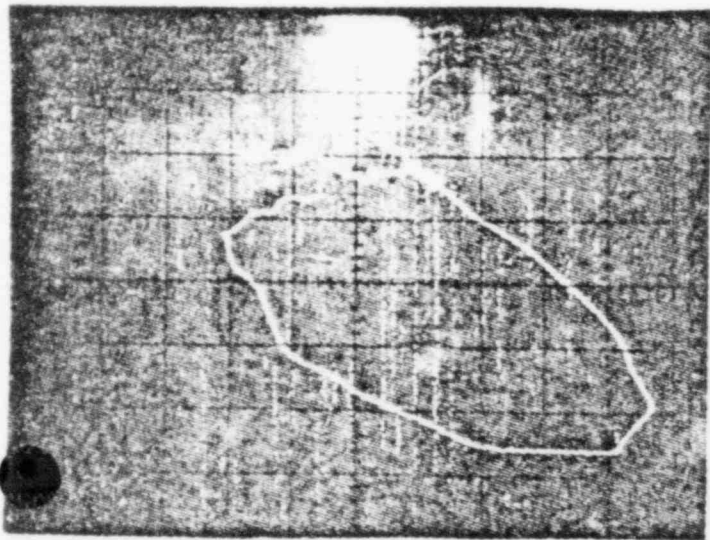
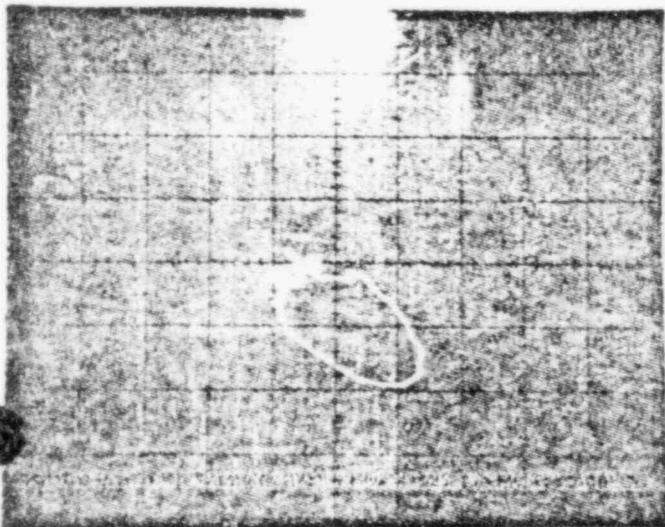
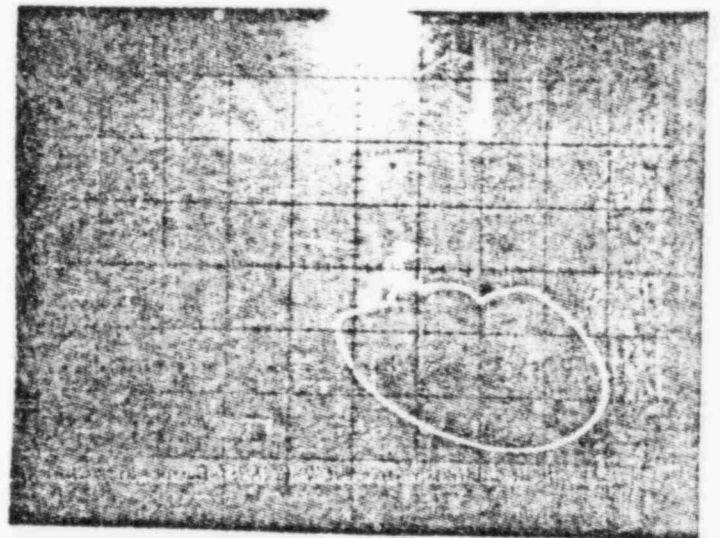
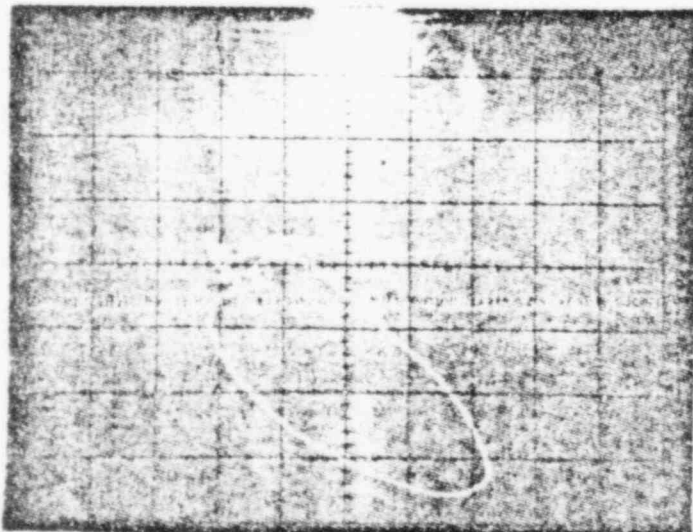
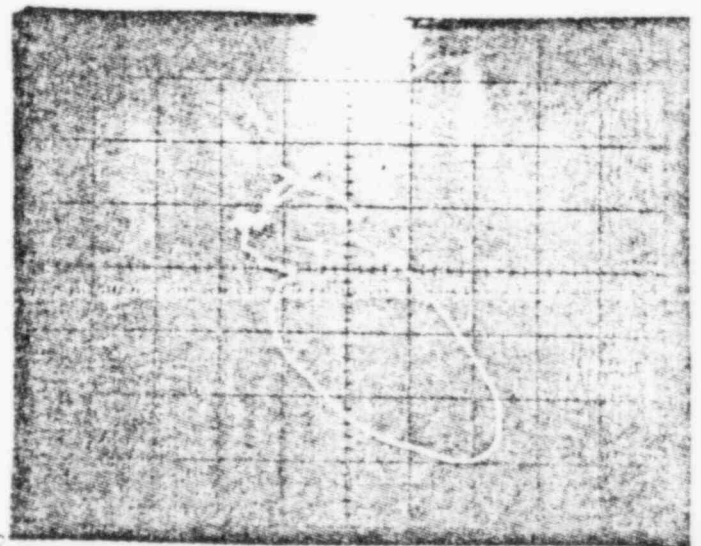
WEP - POINT BEACH NO. 1
S/G B INLET
R30C41 - 1/2" BELOW TOP OF TUBESHEET

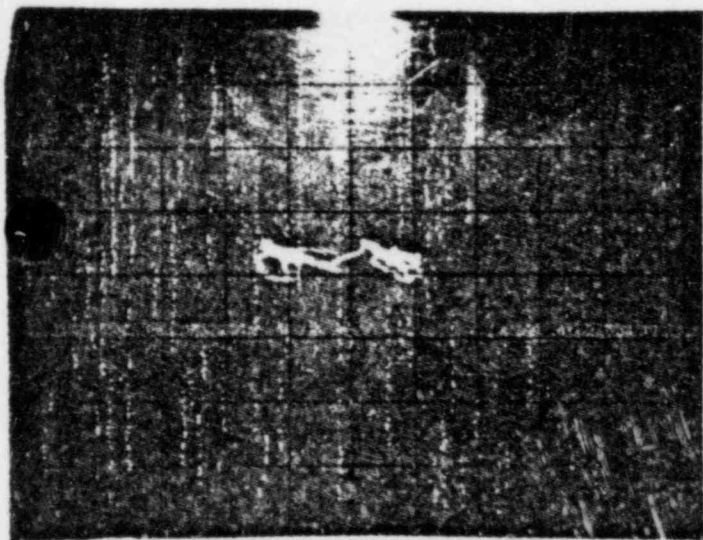
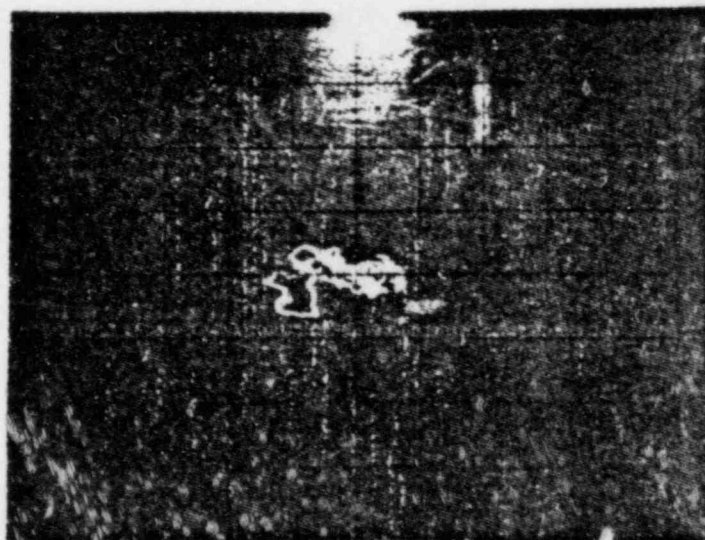
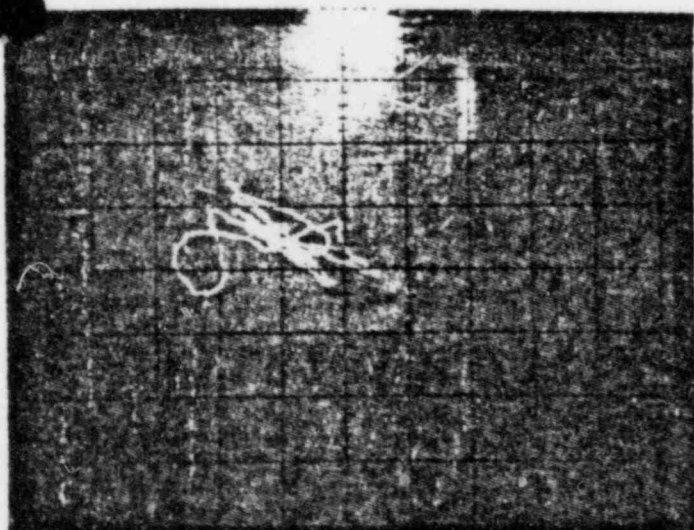
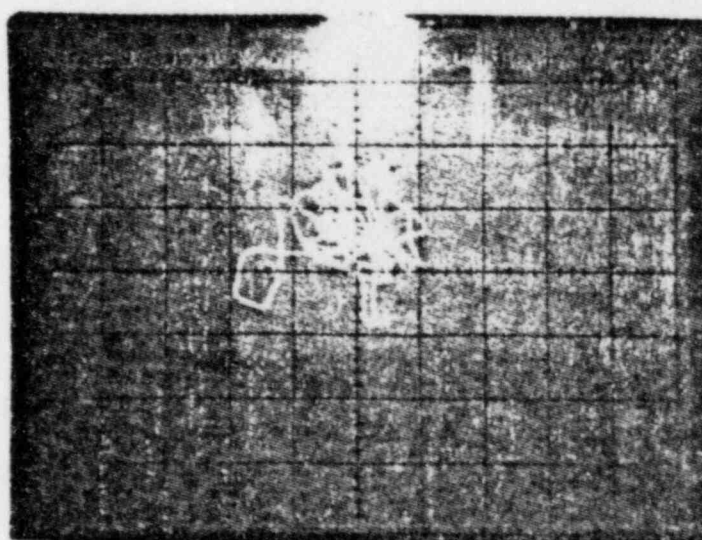
FIG. 3

Row 26 Column 53 (Figure 3)

R26C53 - IN TUBESHEET

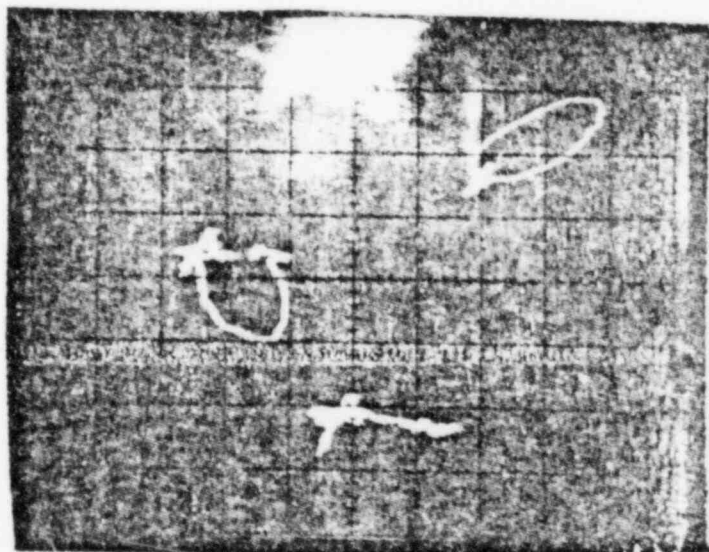
TOP LEFT - 400 kHz
TOP RIGHT - 100 kHz
BOTTOM - MIX
61 1/2" ABOVE TUBESHEET
