B&W OWNERS GROUP

BOLTING TASK FORCE

SUMMARY REPORT OF
NUCLEAR REGULATORY COMMISSION/
BABCOCK & WILCOX OWNERS GROUP
MEETING ON
REACTOR VESSEL INTERNALS BOLTING
MAY 6, 1983

SUMMARY REPORT OF
NUCLEAR REGULATORY COMMISSION /
BABCOCK & WILCOX OWNERS GROUP
MEETING ON
REACTOR VESSEL INTERNALS BOLTING
MAY 6, 1983
BAW 1784

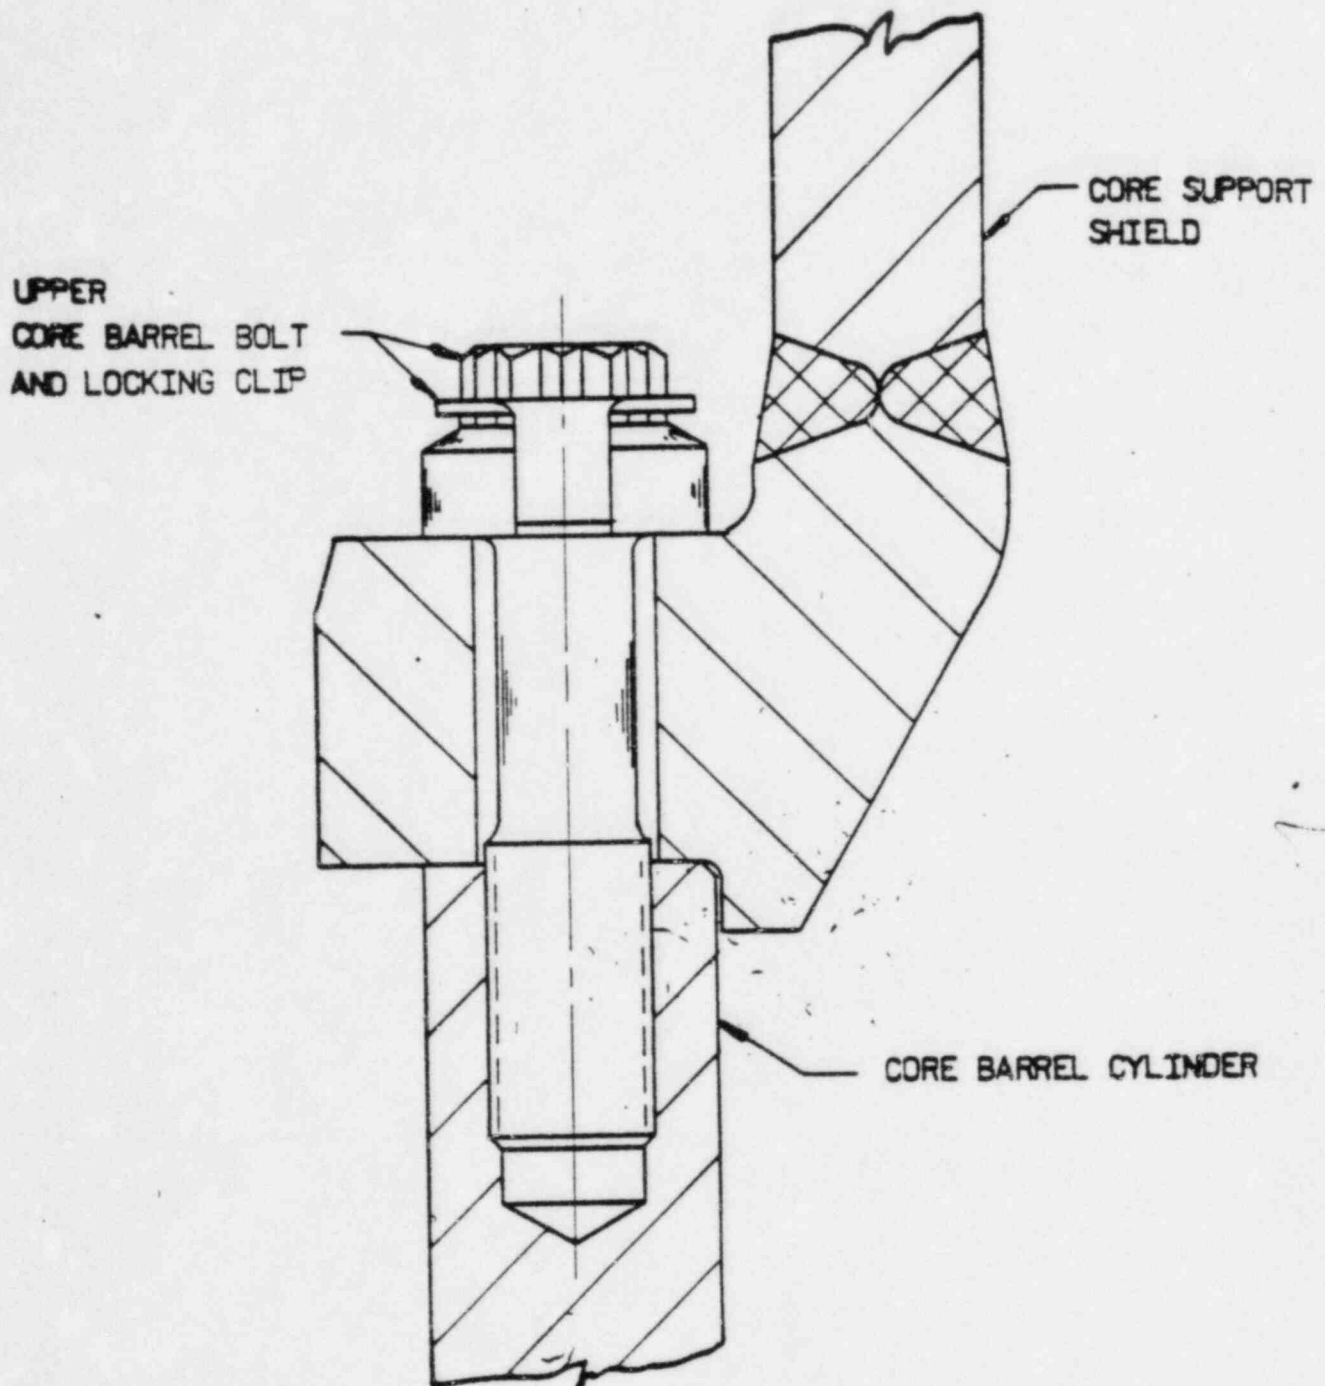
Fig. 2.3

UPPER CORE BARREL TO CORE SUPPORT
SHIELD BOLTED JOINT DETAIL

After core drop, the bolt heads would be held in place by the locking clips, thus precluding becoming loose parts and the bolt shanks would remain captured within the core support shield bolt holes. The nominal radial clearance between the bolt shank and the bolt hole is 0.142". While there may be some damage to peripheral fuel assemblies by contact between the baffle plate and upper end fitting of the fuel assemblies, both lateral and rotation motion of the upper core barrel and core would be restrained by the bolt shanks and coolable core geometry would be maintained. Likewise the guide lugs and guide blocks with a 25 mil maximum (range 0.20-0.25 mils) clearance would provide similar restraint at the bottom of the core (See Fig. 2.7). In addition, the combination of bolt shanks at the upper end of the core barrel and guide lugs and guide blocks at the lower end would prevent core tilt in the dropped condition.

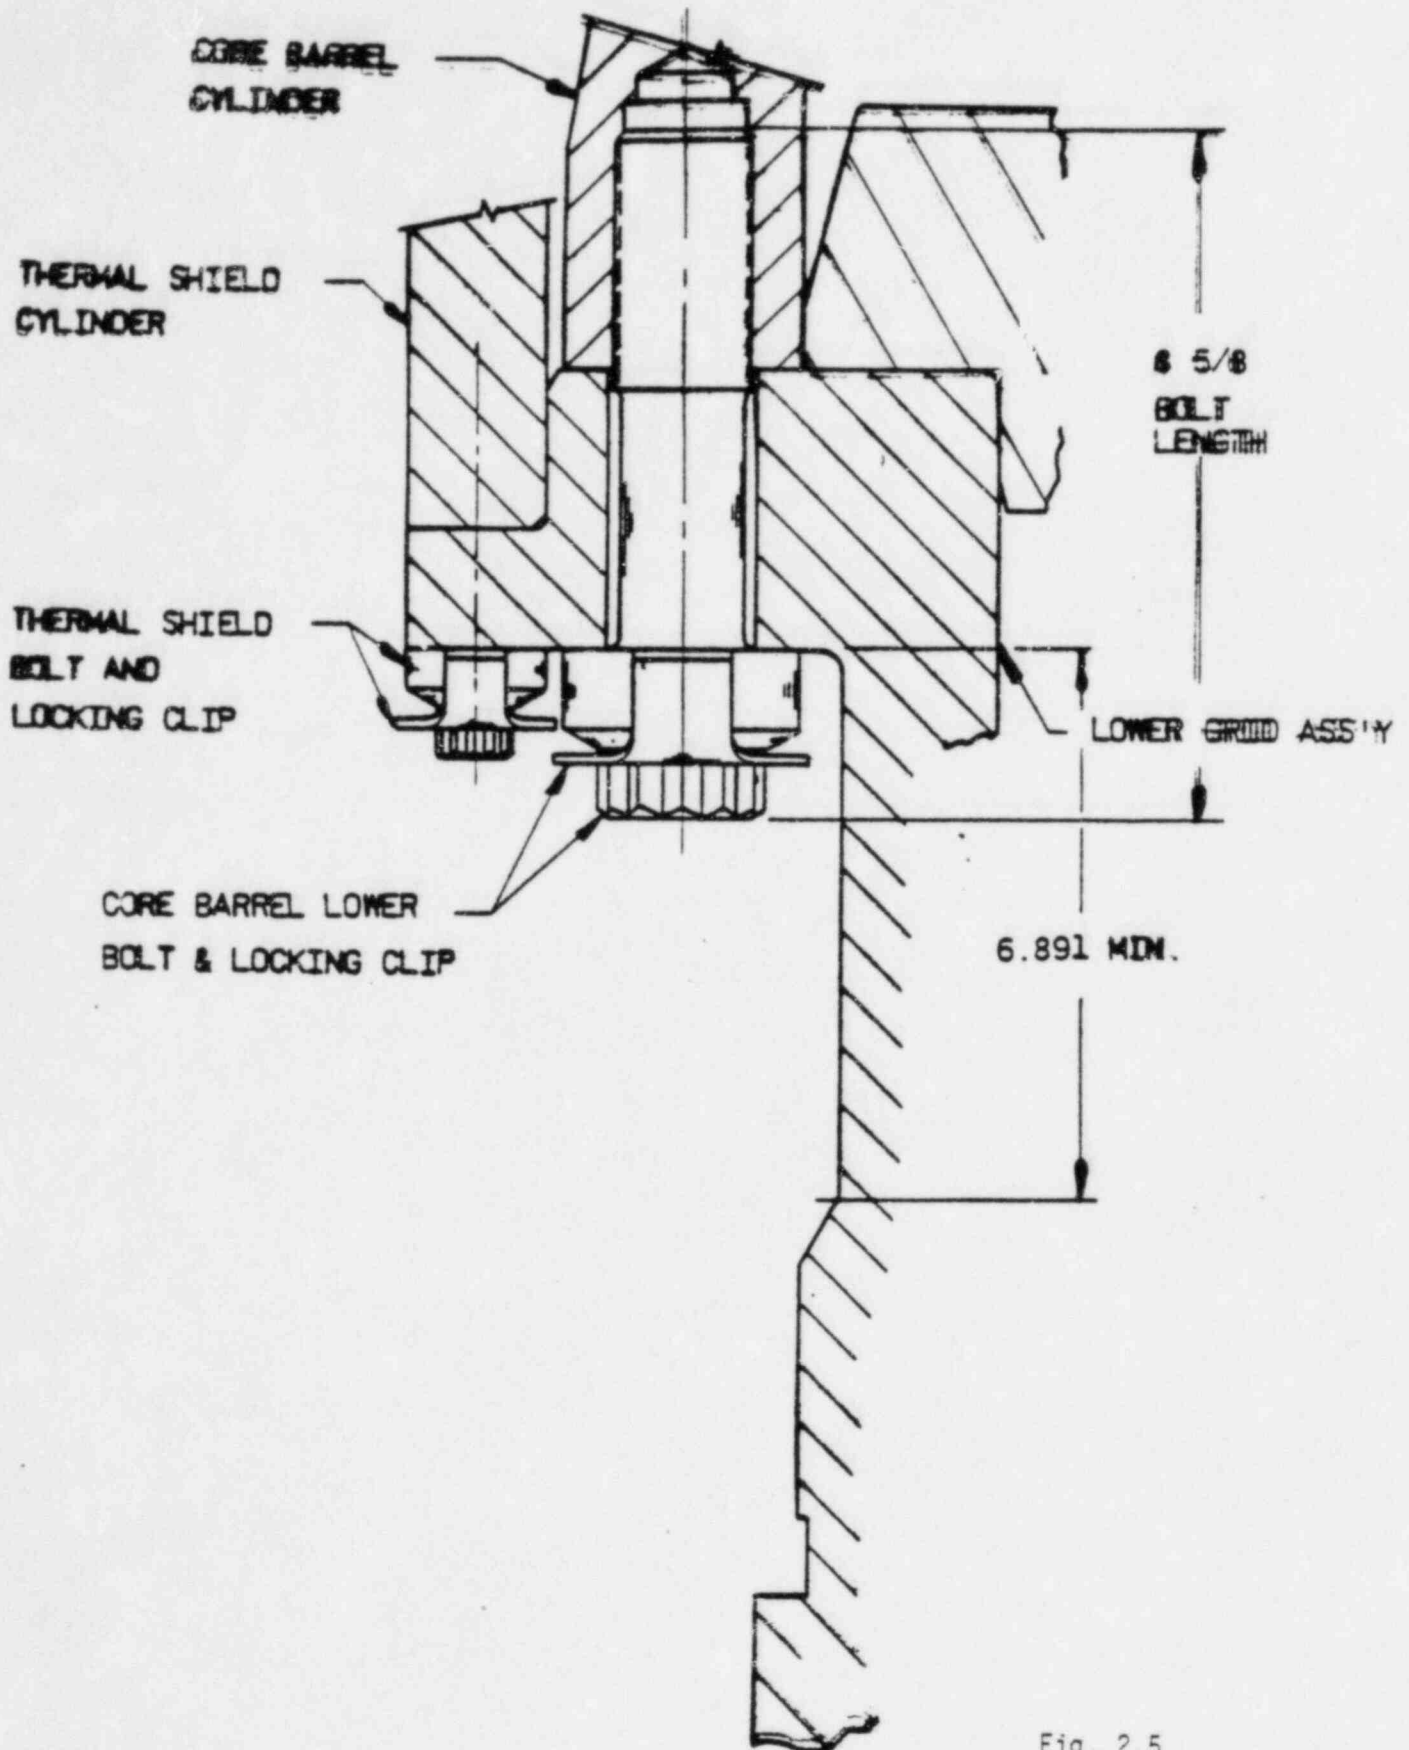
Fig. 2.5

LOWER CORE BARREL TO LOWER GRID JOINT DETAIL

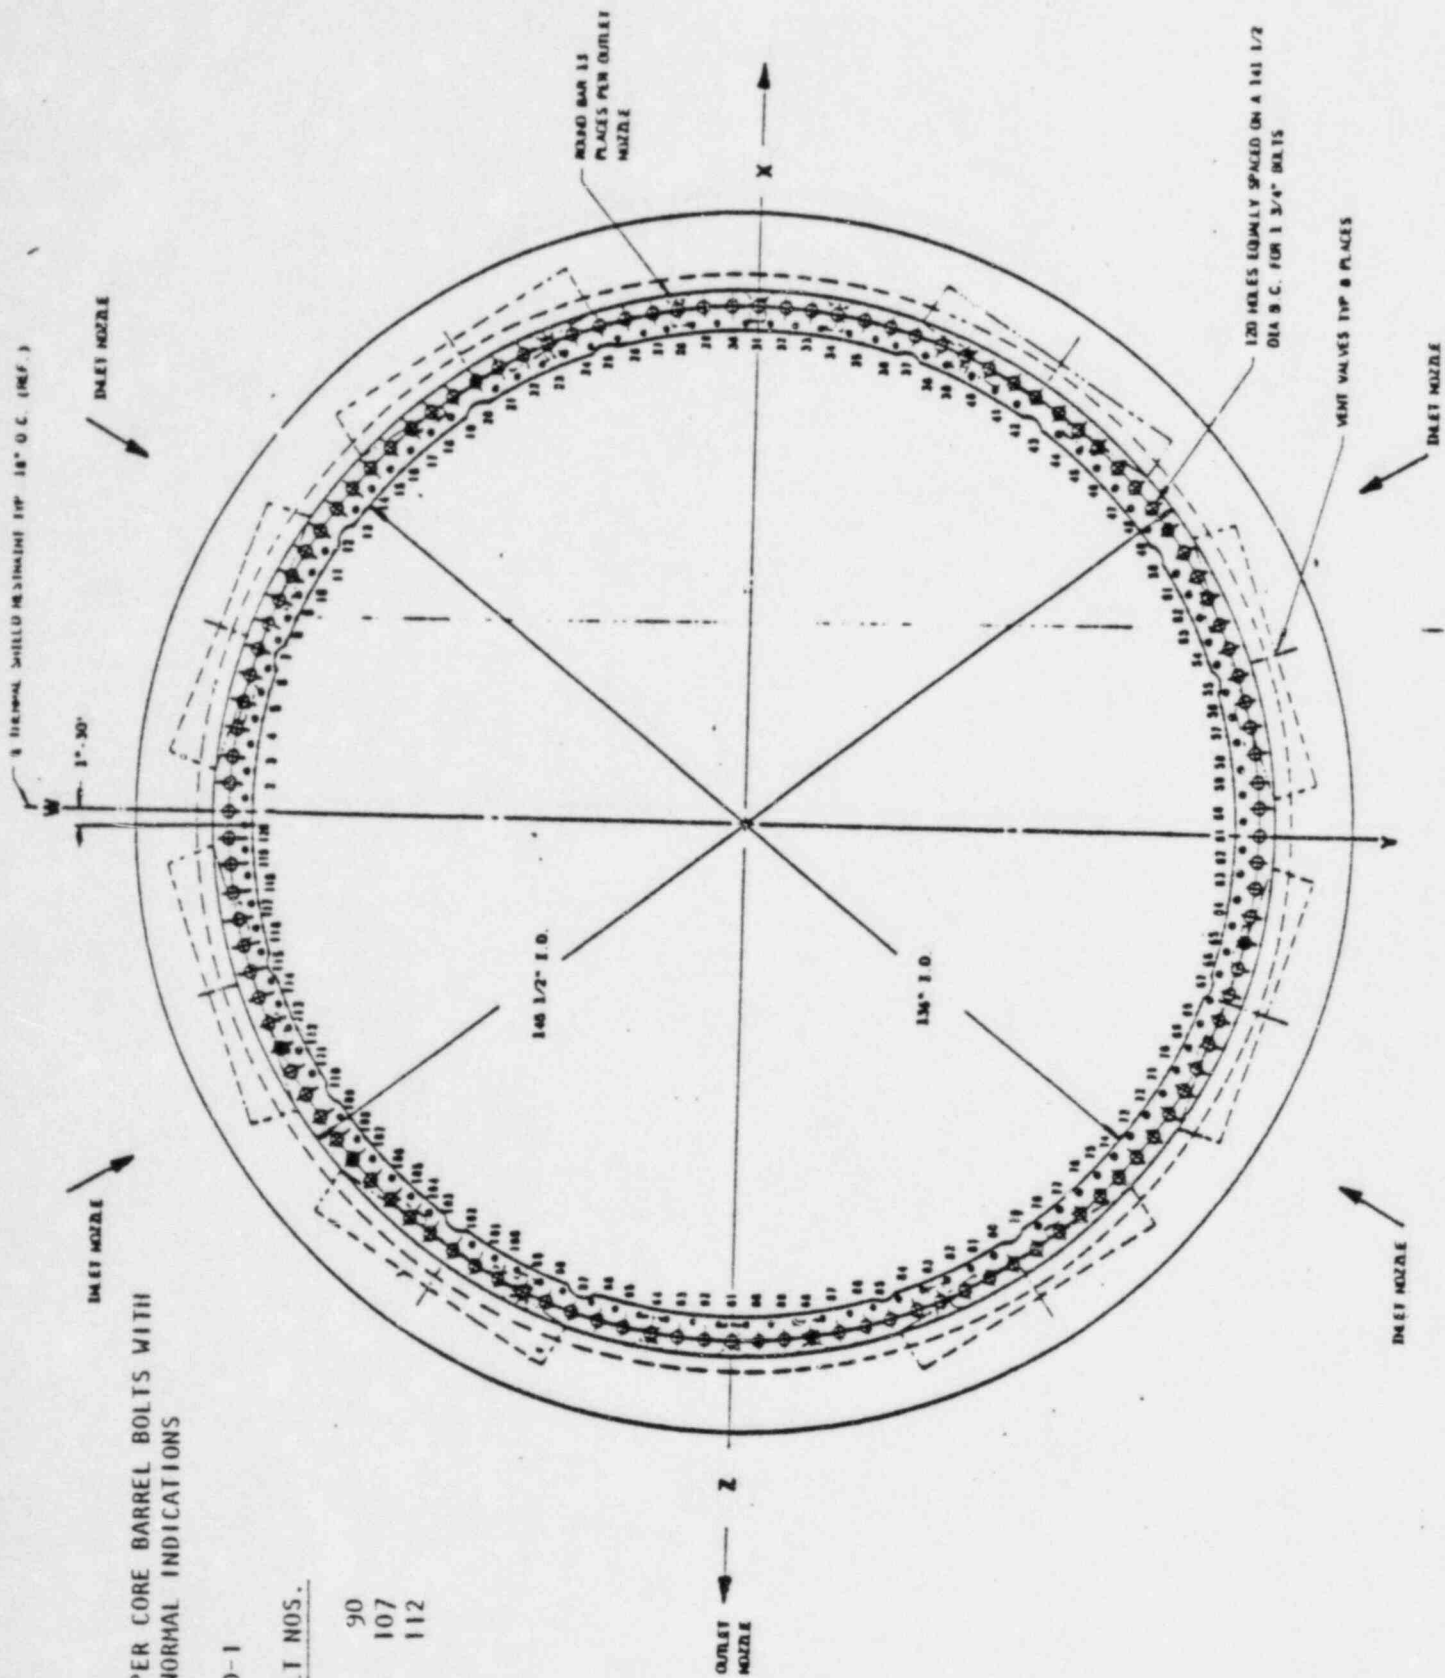
UPPER CORE BARREL BOLTS WITH
ABNORMAL INDICATIONS

AND-1

Bolt Nos.

5	25	54	73	96
6	26	57	76	97
12	28	58	79	101
13	34	60	82	108
14	35	61	83	109
15	43	62	87	110
16	44	64	88	111
17	46	66	92	113
18	48	67	93	118
19	52	72	94	119
