Southern Nuclear Operating Company

July 29, 1994

Joseph M. Farley Nuclear Plant
Response to NRC Safety Audit of the
Service Water Pond Dam on February 2 & 3, 1993

Response to NRC Safety Audit of the
Service Water Pond Dam on February 2 & 3, 1993

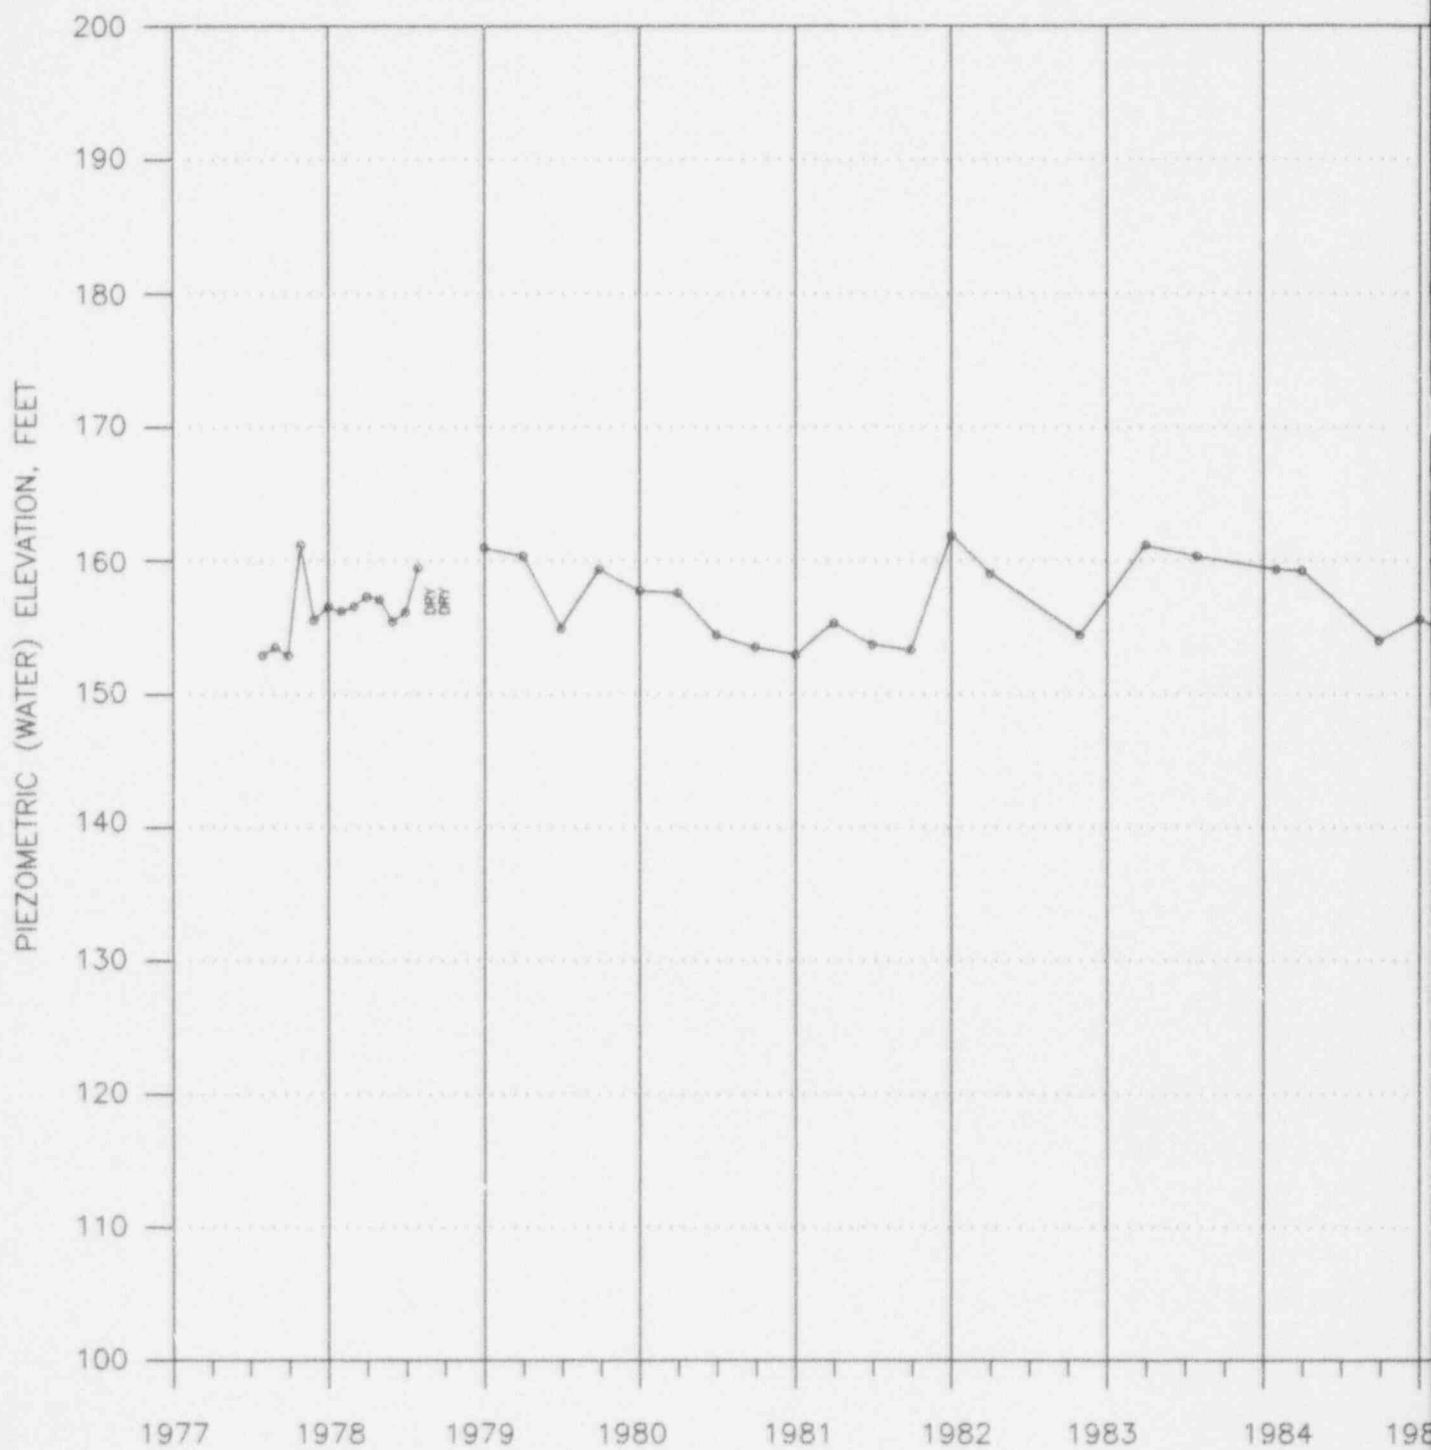
FIGURE 5
OBSERVATION WELL OW-17B

Further evidence of a localized effect is seen in the time-line plots and dam cross-sections for other wells adjacent to OW-17C. The time-line plot, Figure 5 for OW-17B (located 50 feet upstream of OW-17C at the same station) shows no actual water level in that well over the years of reservoir operation. All points shown on Figure 5 are mud readings at the bottom of the well rather than piezometric water surface readings. The time-line plots for wells OW-13, 15 and 17A show water levels consistently below the expected design phreatic surface. Consistently low water levels in downstream well OW-18 (located 150 feet downstream of OW-17C at Station 13+60) adds further confirmation of a localized condition.

NOTE: ALL POINTS SHOWN ABOVE ARE
MUD READINGS AT THE BOTTOM
OF THE WELL, NOT PIEZOMETRIC
WATER SURFACE READINGS.

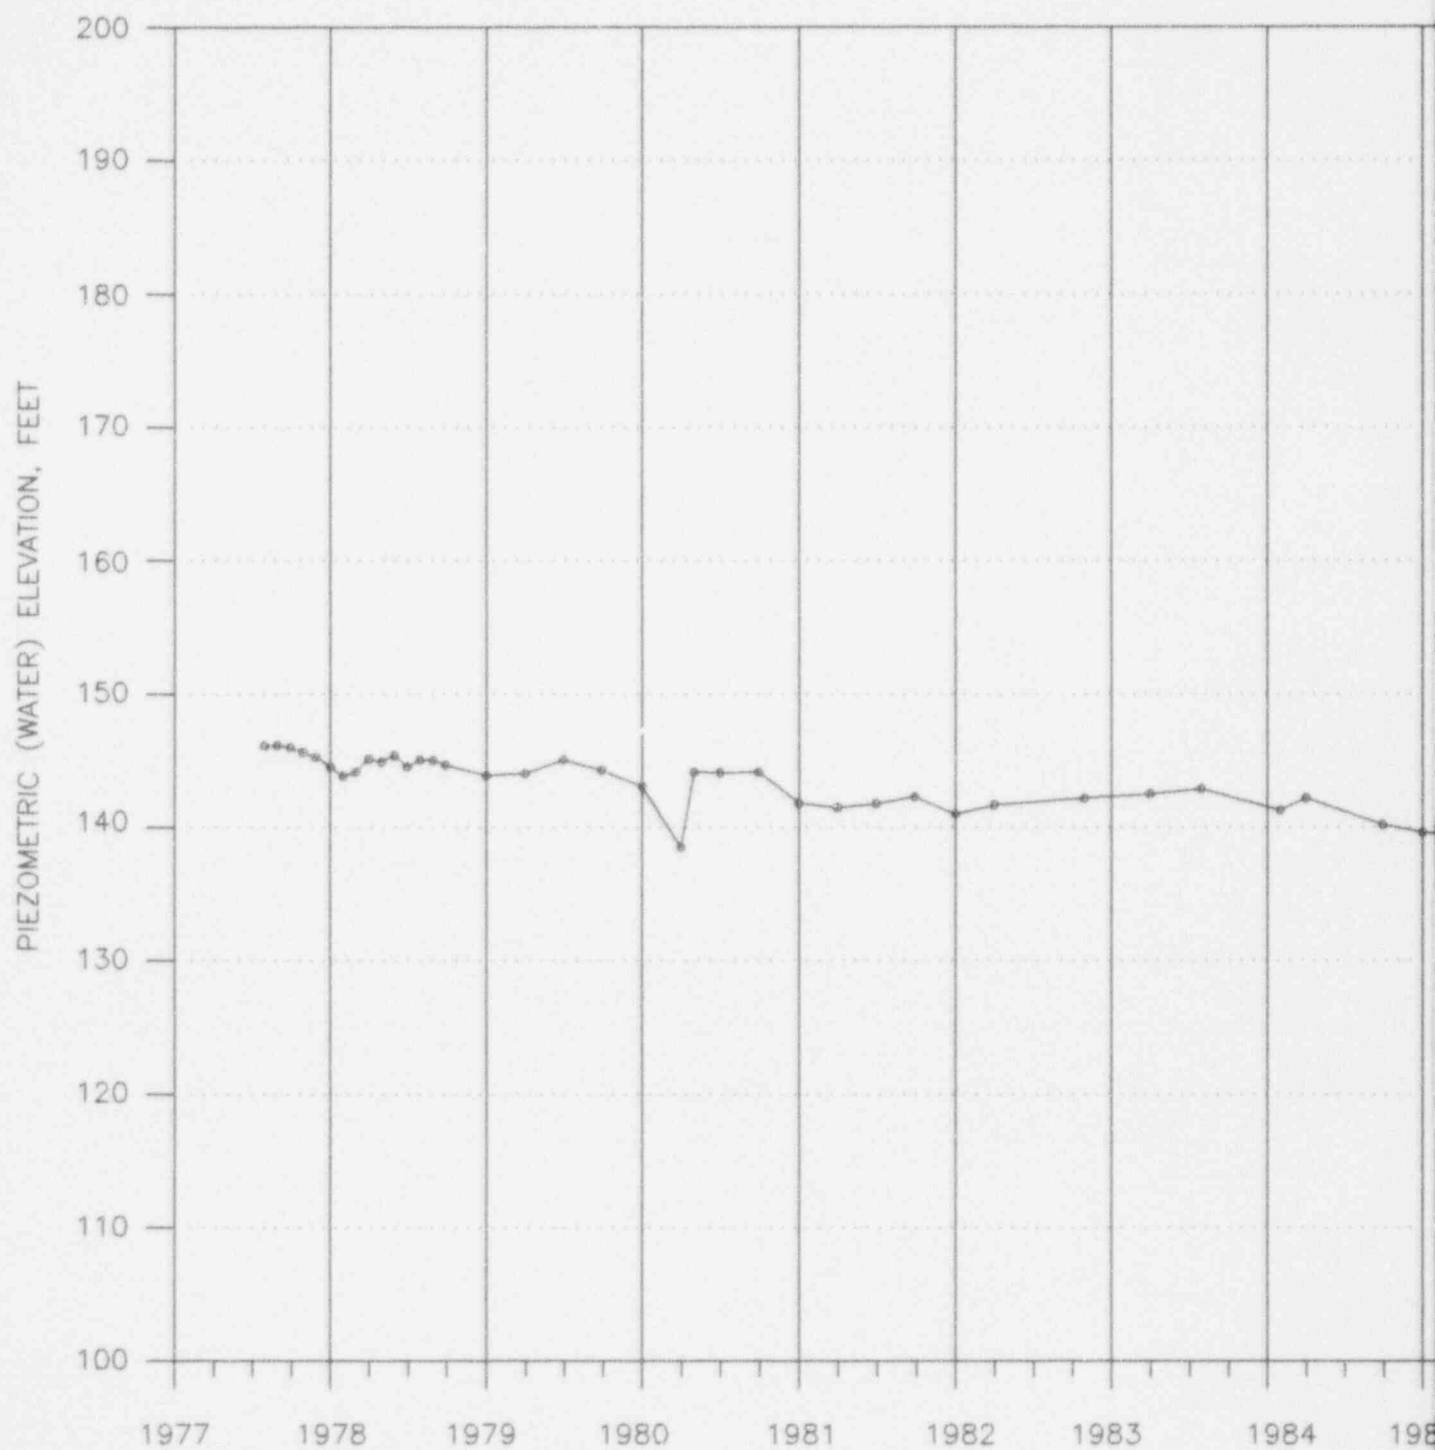
FIGURE 6
OBSERVATION WELL OW-17C

An examination of the time-line plots, Figures 5 and 6 indicates that the high water level being indicated in OW-17C is the result of localized rain runoff collecting at the toe of the dam rather than any reservoir effect. This is discussed below.

As shown on Figure 6, the time-line plot for OW-17C, the water levels within this well ranged from a minimum of approximate elevation 152.8 feet to a maximum at elevation 163.5 feet over the years of monitoring. Since the water levels within this well are not consistent over time, they are not considered to be a result of any reservoir influence.

The actual phreatic surface at OW-17C would not affect the safety factors for the design failure surfaces presented in Figure 2B7-18 of the FSAR. There is a possibility that the higher phreatic surface may only slightly decrease the safety factor against a shallow failure surface through the downstream slope. However, none of the critical failure surfaces shown in Figure 2B7-18 of the FSAR are shallow circles, indicating that a shallow surface failure is unlikely and any possible decrease in that safety factor would be of no significance to design.
