## Attachment I

WASHINGTON PUBLIC POWER SUPPLY SYSTEM  
NUCLEAR PROJECT NO. 2  
DOCKET NO. 50-397  
LICENSE NO. CPPR-93  
10CFR50.55(e) CONDITION #216  
RHR RELIEF VALVE VENTS

### INTERIM REPORT

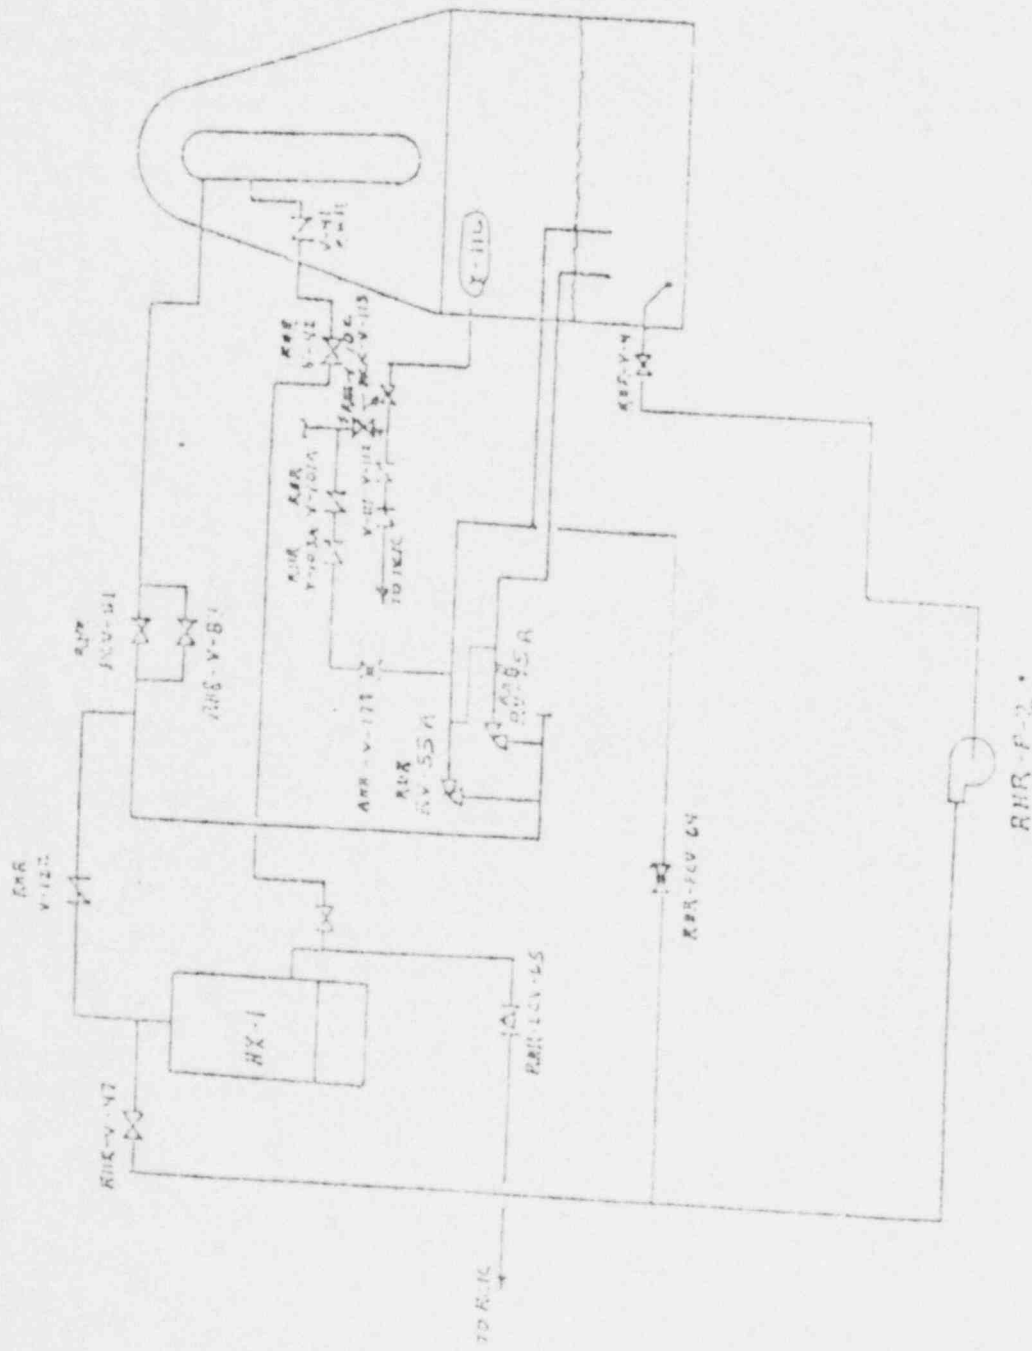
The attached sketch illustrates the situation. Containment penetration X-116 is an open path into the wetwell's gaseous volume. In the steam condensing mode, RHR-V-55A (or B) and RHR-V-95A (or B) protect the RHR heat exchanger from over-pressurization. In order to accommodate condensation in the line between these valves and containment, a vacuum breaker has been installed that consists of penetration X-116, RCIC-V-113, RHR-V-102, RHR-V-101A (or B), RHR-V-103A (or B), and RHR-V-179A (or B).

All of these valves are normally open. Upon a containment isolation signal, the only valve to close would be RCIC-V-113. If it failed to close, and a LOCA had occurred, the wetwell would pressurize, and the wetwell atmosphere would vent down this path. Details of the RHR relief valve show that a flow path exists which would allow the wetwell atmosphere to vent directly to secondary containment.

After a review of possible corrective actions, including incorporation of a bellows seal, the Project has decided to remove the relief valves, eliminate the containment leakage path, and deactivate the steam condensing mode of the RHR system. Supply System and Burns and Roe Engineering are preparing the necessary Project Engineering Directives and FSAR changes to implement the corrective action. We will continue to provide your office with quarterly updates on this subject. The next report will be submitted by November 1, 1983.
