NUCLEAR GENERATION MEMORANDUM

Subject: Final Report-Structural Walkdown

STRUCTURAL WALKDOWN

FINAL REPORT

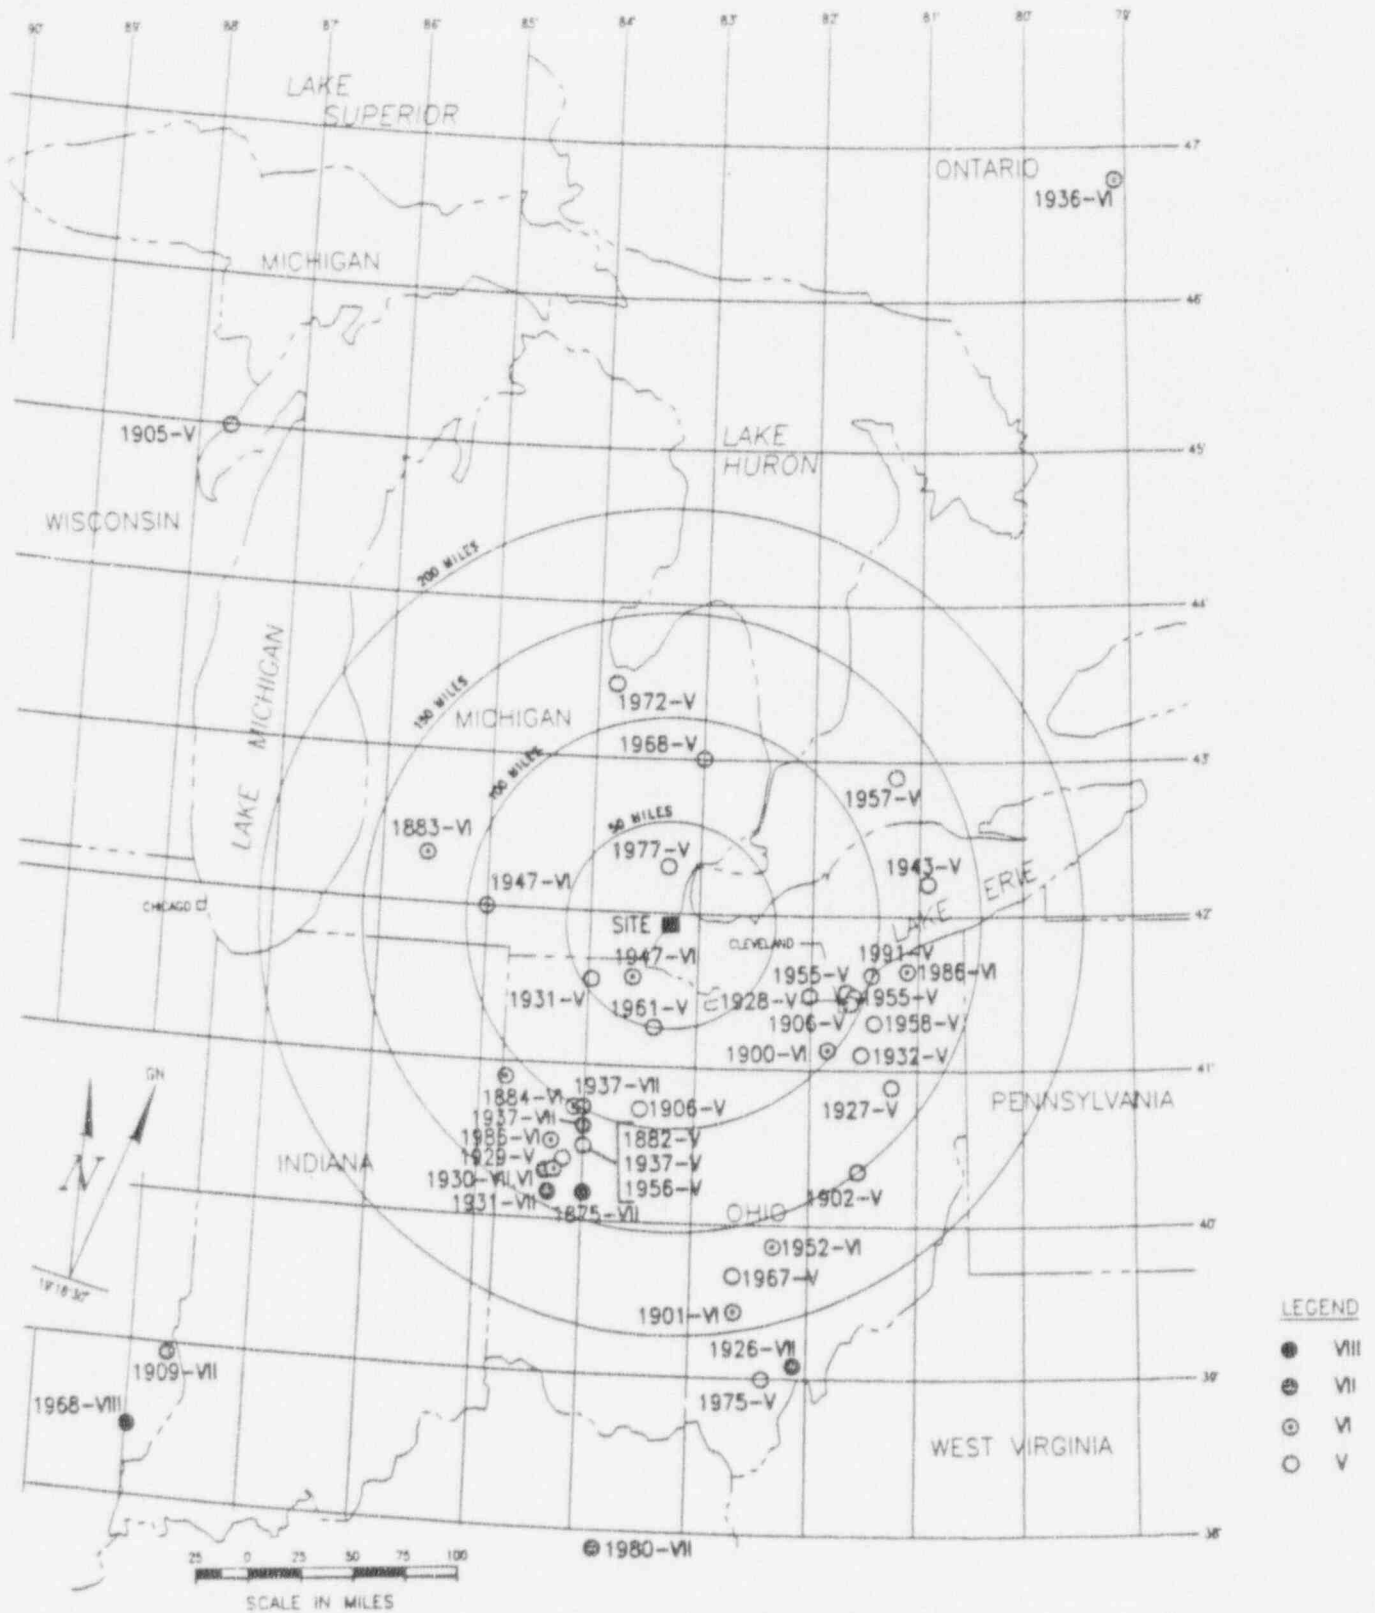
Figure 2.1.1.1

Fermi 2 is located in a relatively seismic stable area. Approximately fifteen intensity VI (Modified Mercalli Scale) or greater earthquakes have occurred within a two hundred mile radius in the last two hundred years (Figure 2.1.1.1). Additionally, nine earthquakes of intensity V or less have occurred within a fifty mile radius of the facility (Figure 2.1.1.2). Although the Fermi 2 OBE is associated with an intensity VI seismic event, it is unlikely the facility will experience such an earthquake within its lifetime.

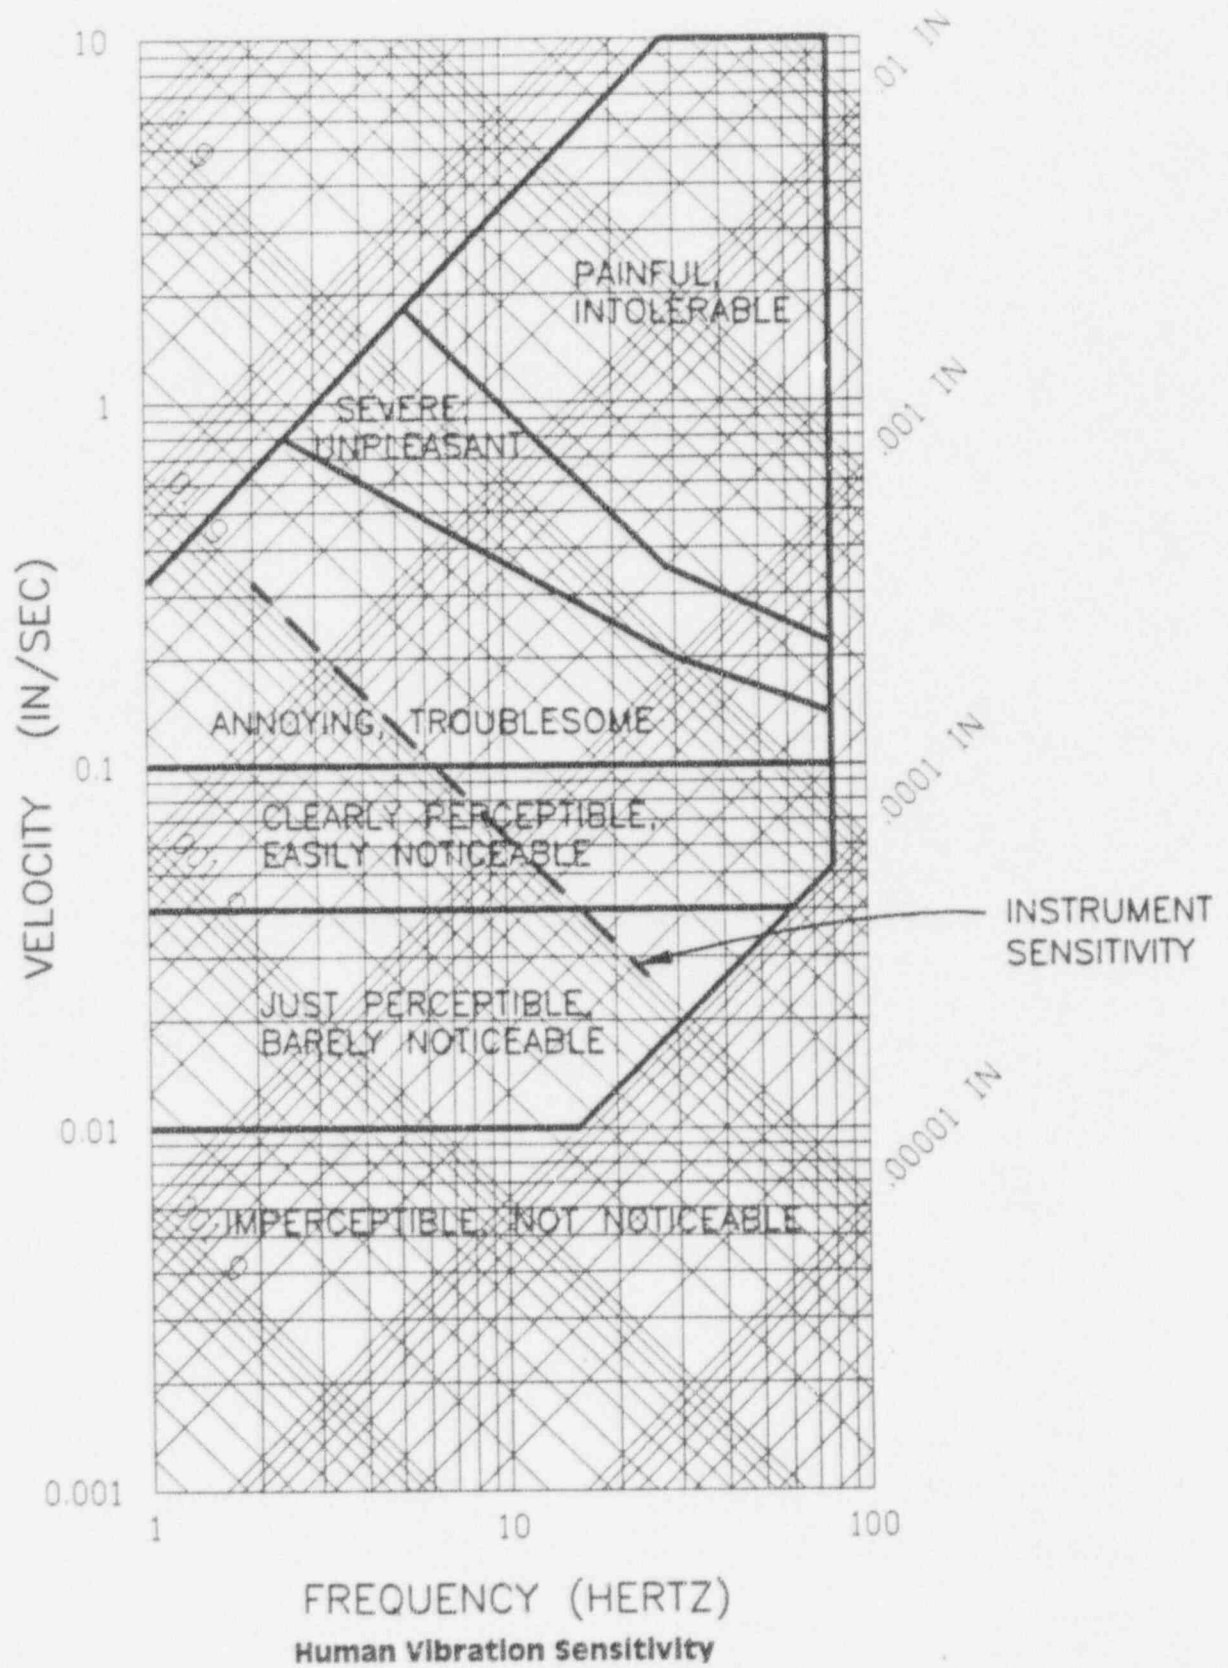
Figure 2.2.4.1

Work conducted by numerous researchers have established physiological limits of human perceptibility to vibration. The studies demonstrate humans can detect vibrations well below the current instrument sensitivity at Fermi 2 (Figure 2.2.4.1).

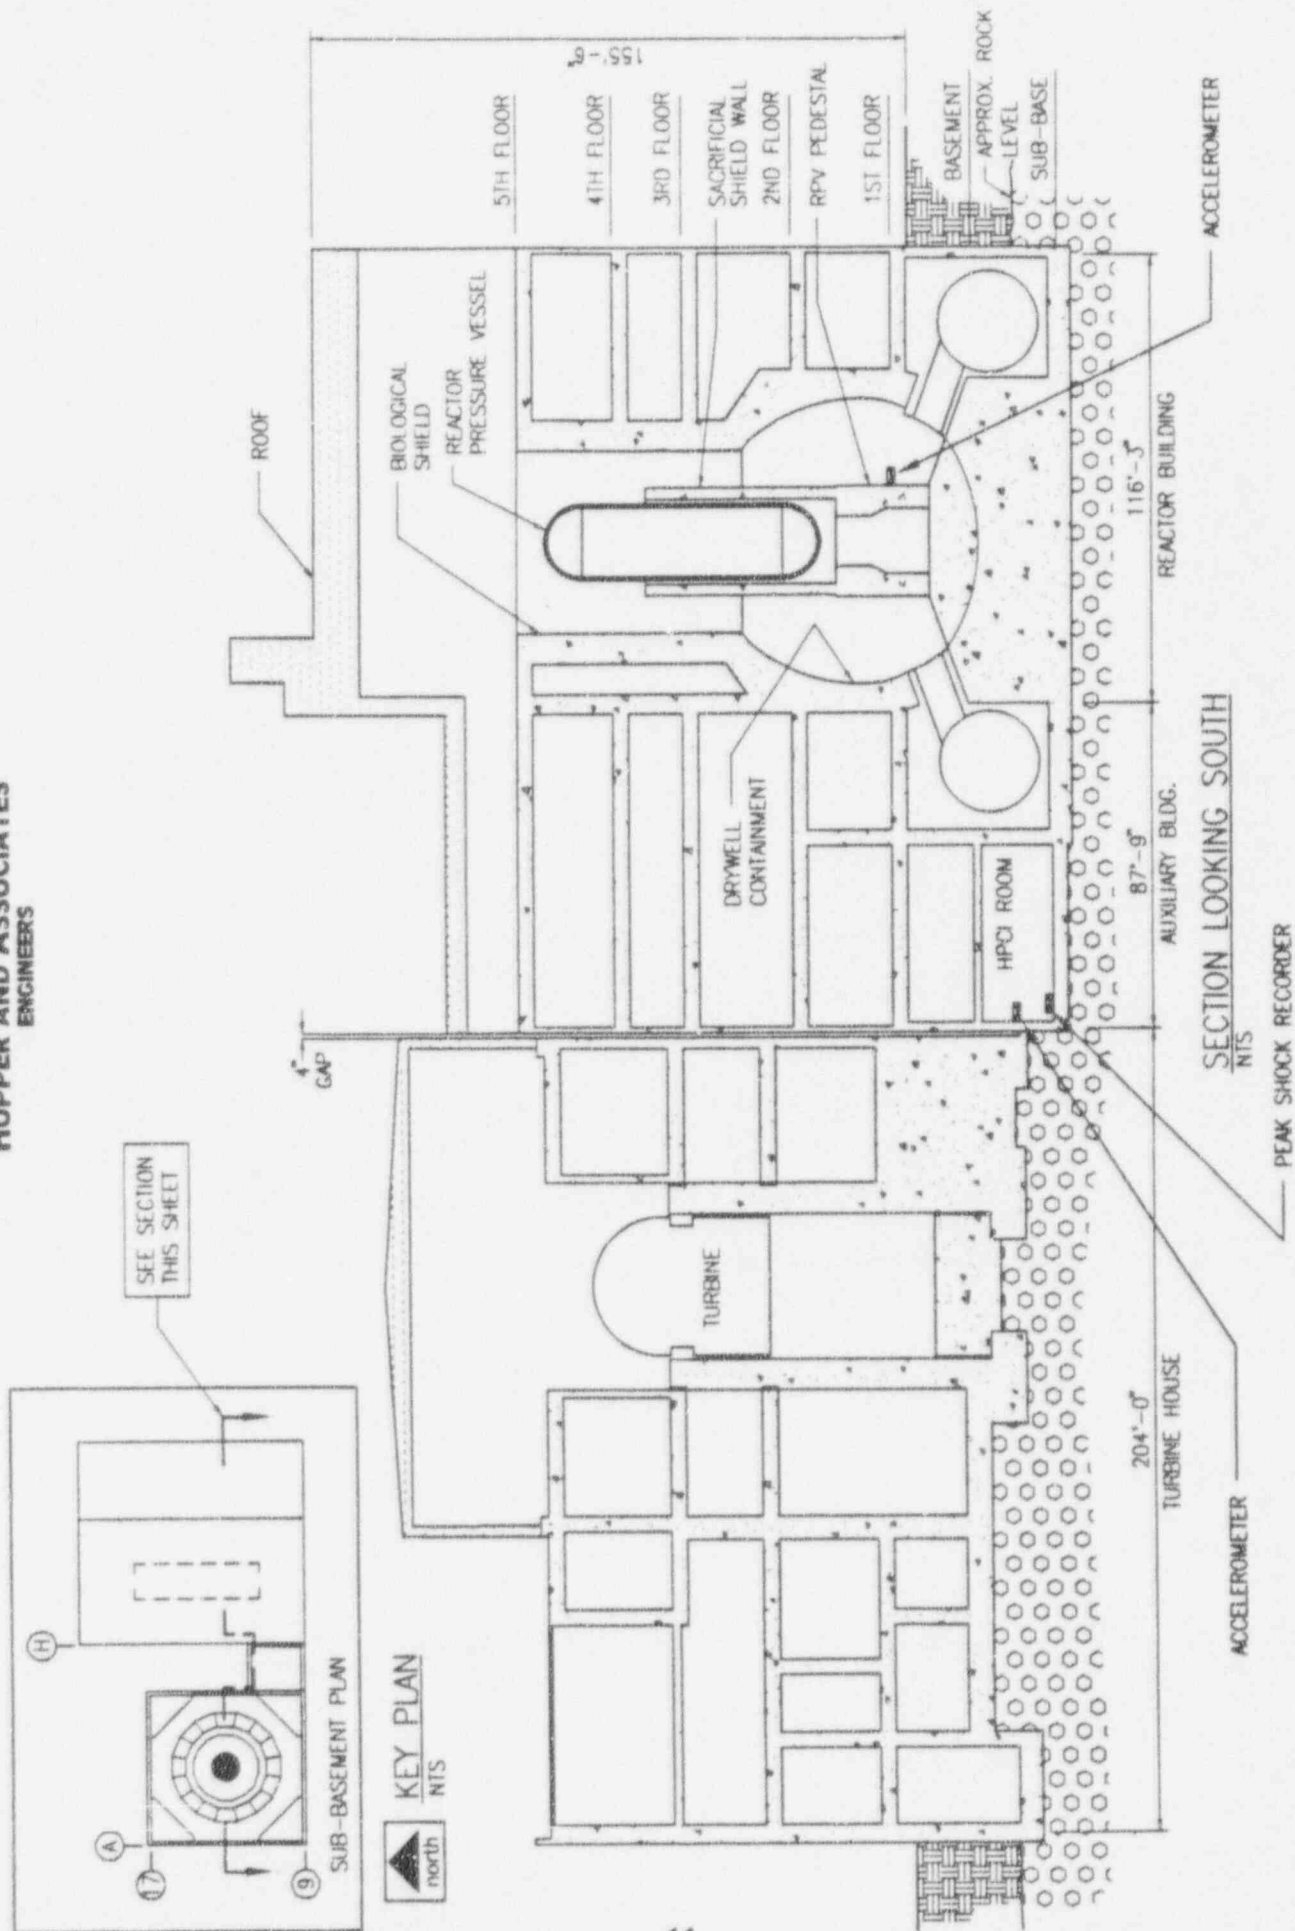
Figure 3.1.1.1

Three Engdahl recorders are located in the Reactor/Auxiliary building, in the HPCI room, the second floor, and the fifth floor (Figures 3.1.1.1 through 3.1.1.3). The recorders are positioned to measure accelerations in the vertical, north/south, and east/west directions at each sensor.

Two Teledyne/Geotech accelerometers are located in the Reactor/Auxiliary building, in the HPCI room sub-basement and at the RPV pedestal (Figure 3.1.1.1). The accelerometers measure longitudinal, transverse, and vertical acceleration, which correspond to the vertical, north/south, and east/west directions of the passive recorders.
