| J) Title <i>Verification of Turbine Building East side Overhead</i> | | |

A) Title (Subject): TURBINE BEARING BEAM REPAIRS

Assessment of Turbine Bearing Beam Cracking

Date: June 21, 1994
To: A. S. Young
From: D. J. Connell *[Signature]*
Subject: Metallurgical Evaluation of Bearing Pedestal Box Beam Weld Cracking,
Fermi 2
Technical & Engineering Services Report 94V70-20

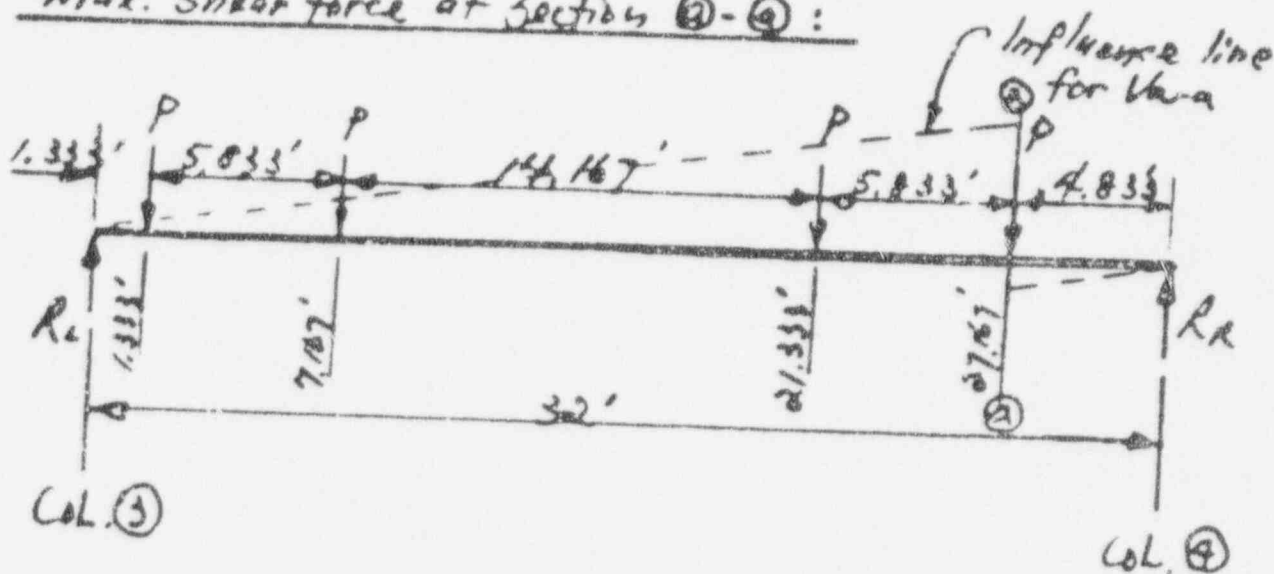
Max. shear force at section ②-②:

Reference: Crane Wheel Loading Diagrams
from Ref. 5 (Dwg. 60701-2100)

$$P = 218 \text{ K}$$

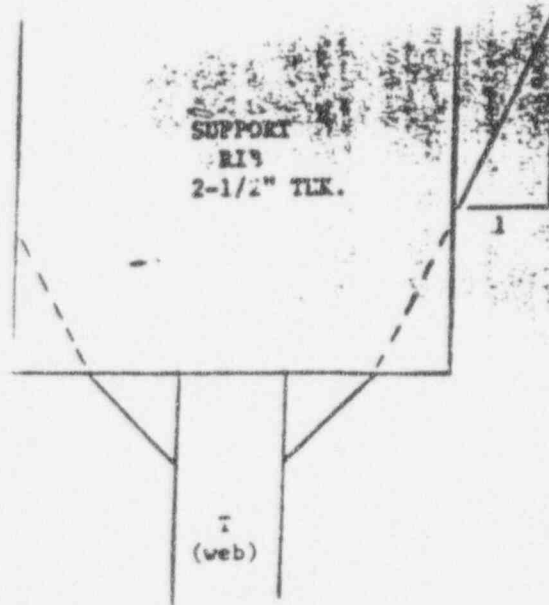
FIGURE 1 - Support Rib to T web Transition

If it is confirmed that fatigue is the cause of cracking, an explanation of why all (except one case) cracks occurred at the support rib to T welds should be determined. These stiffeners are centrally located under the turbine. Also, there is a thickness transition from 2 1/2" to 3/4" (see Fig. 1 of Attachment 4) which represents a stress riser. If this joint was required to be designed for fatigue, the 2 1/2" thick piece would have a 2.5 to 1 slope to blend in with the fillet welds as shown by the dashed lines on Figure 1. Another stress riser was present because the support rib to the web of the T weld was wrapped around the T flange edge to connect with the T flange weld. It should be noted that all the fillet welds that continued around the T flange edge were cracked the entire length. The AWS D1.1 "Structural Welding Code" states that "fillet welds deposited on opposite sides of a common plane of contact between two parts shall be interrupted at a corner common to both welds." When the Commentary to AWS D1.1 Code was introduced in the 1981 edition it stated that testing has shown that connecting such welds will result in lower fatigue strength.
