CLINCH RIVER BREEDER REACTOR PLANT PROJECT (CRBRP) FAULT EVALUATION REPORT

FAULT EVALUATION REPORT

FAULT NO. 1

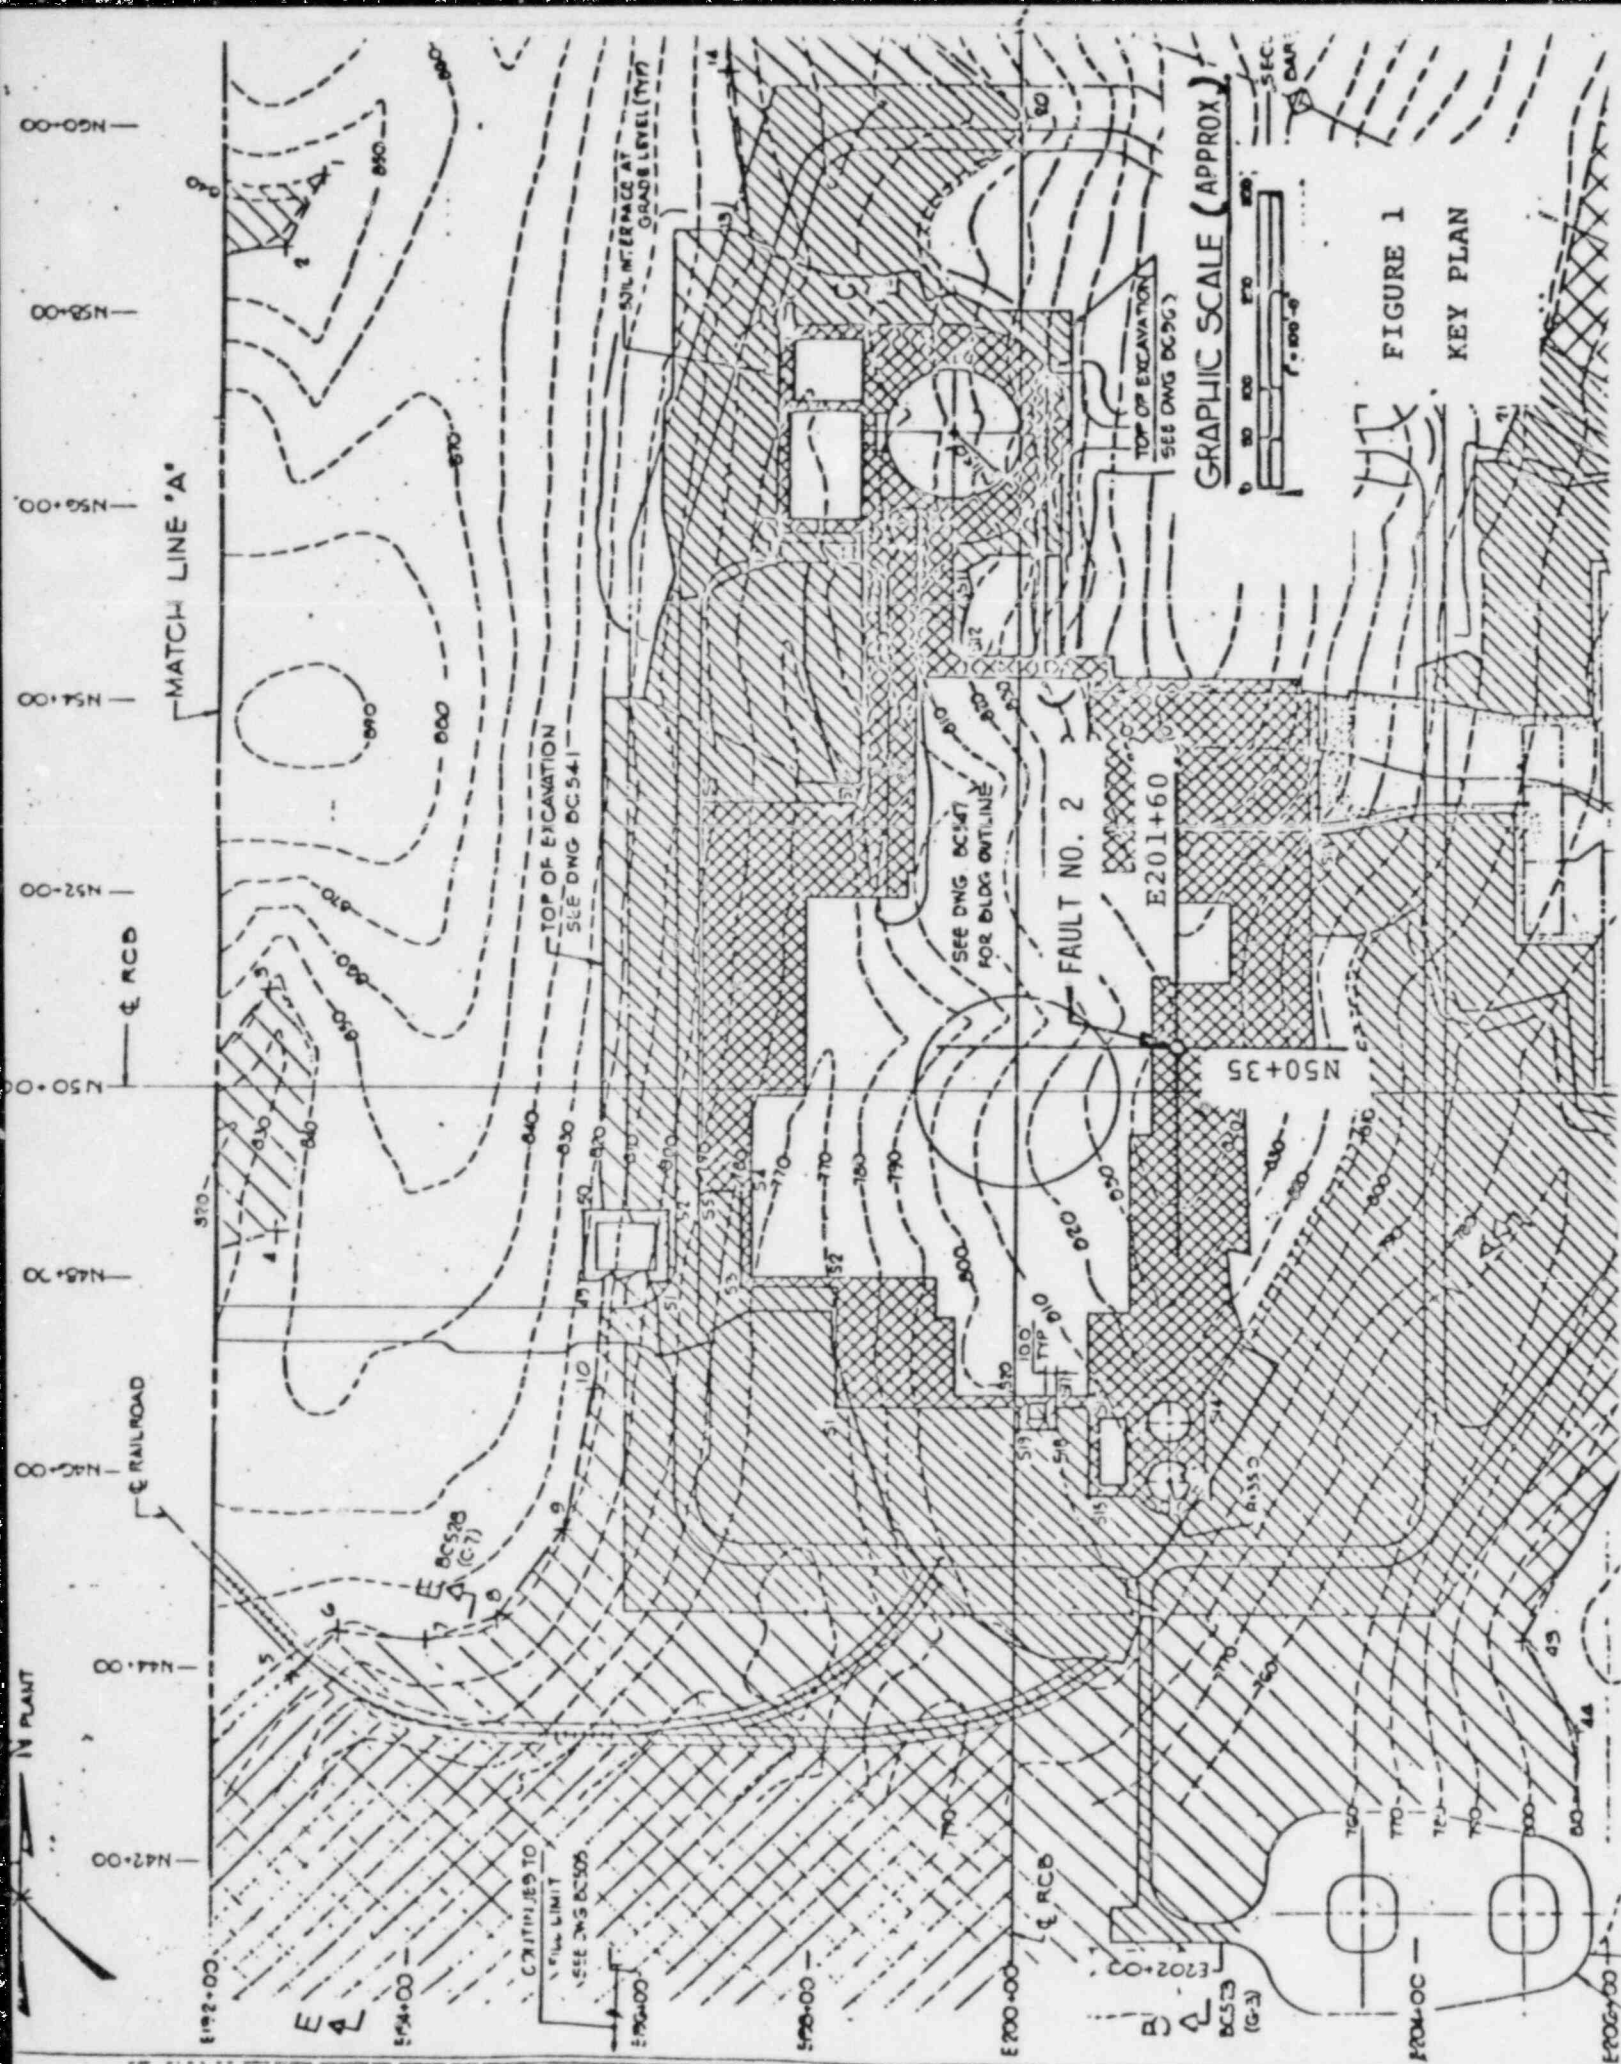
Excavation in the Nuclear Island area has exposed a transverse fault on the East side of the excavation located approximately at plant coordinates N50+35, E201+60, at Elevation 783. This is identified as Fault No. 2 on the attached Key Plan (Figure 1).

The main fault trace is located in the Unit B limestone, strikes N12°W to N47°W and dips 32° to 70° NE. The trace is defined by a partially weathered - calcite healed fracture with slickensides which indicate motion toward the NNW, and is limited to an approximately 15 foot thick stratigraphic sequence. The updip terminus of the main fault is located within an individual bed and the downdip terminus is located at a bedding plane containing slickensides. Left lateral displacement is measured at 0.4 foot, maximum.

The main fault, and an associated fracture which produced minor displacement, are approximately three feet apart and are shown on the attached Fault Map (Figure 2). A second associated fracture with minor displacement is approximately 25 feet to the North and is almost identical to the two features identified above. Photographs of the fault are presented in Appendix A.

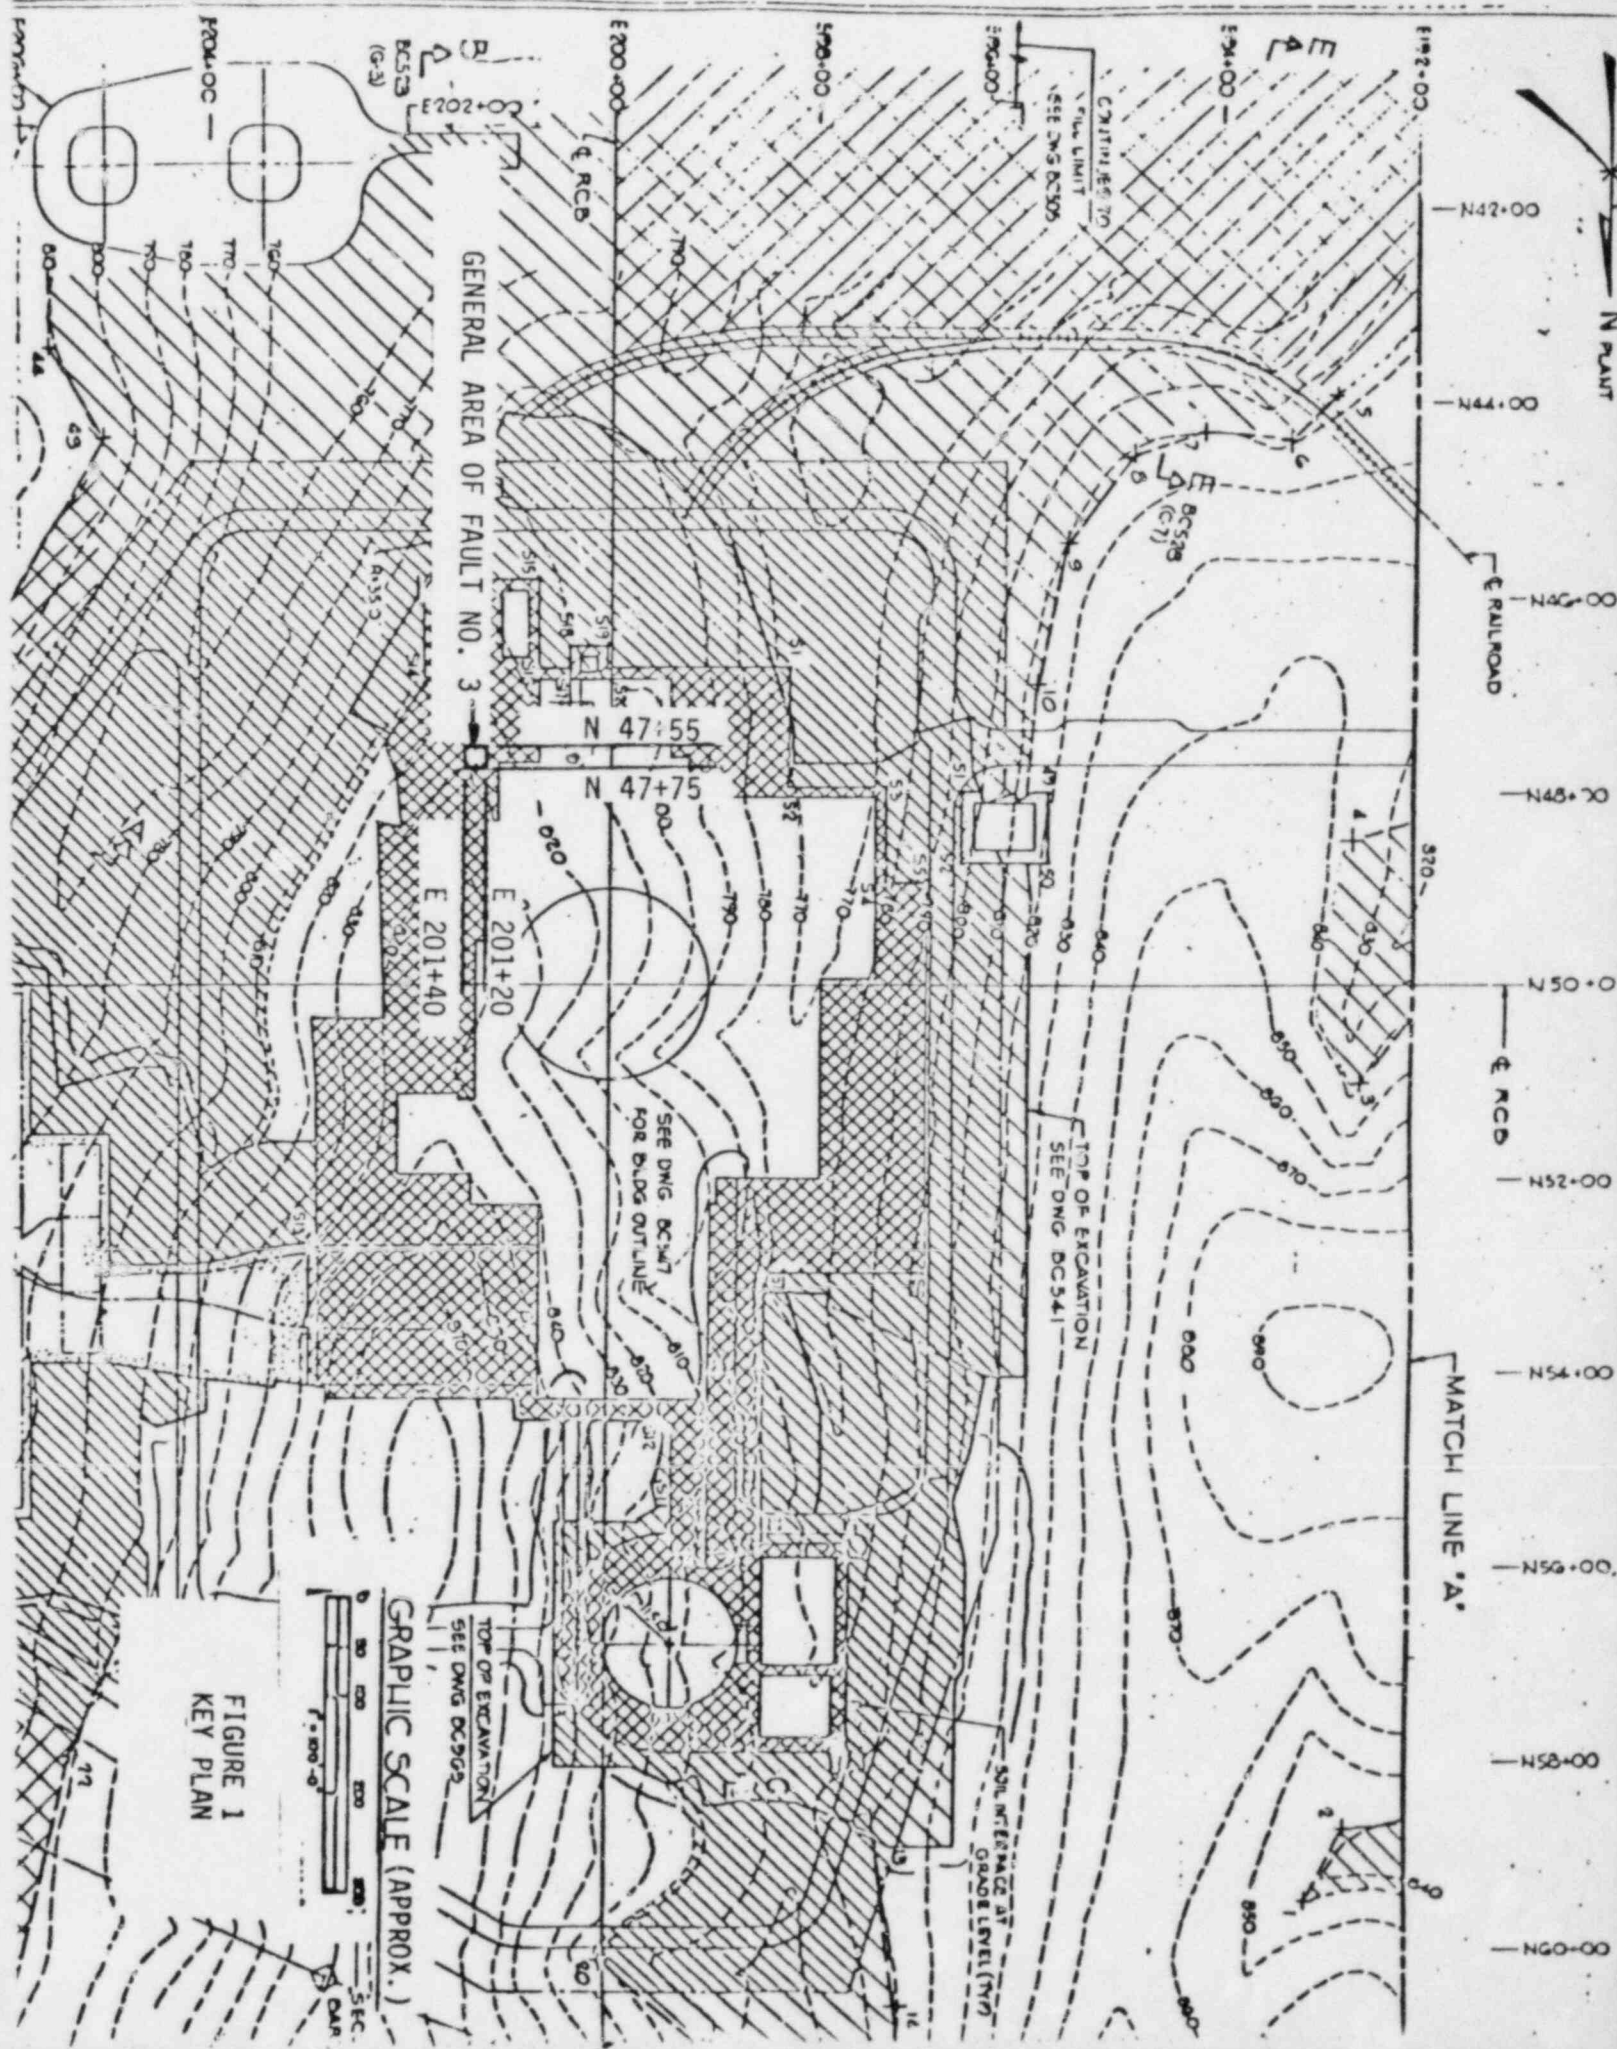
FIGURE 1  
KEY PLAN

Excavation in the Nuclear Island area has exposed a fault on the East side of the excavation located approximately within the plant coordinate range N47+55 to N47+75 and E201+20 to E201+40, at Elevation 780 feet. This fault is identified as Fault NO. 3 on the attached Key Plan (Figure 1).
