NYN- 95004

January 16, 1995

Subject: Licensee Event Report (LER) 94-010-01: Potential Fuel Damage Due to RCP Turning  
Vane Capscrew Locking Cup Failure

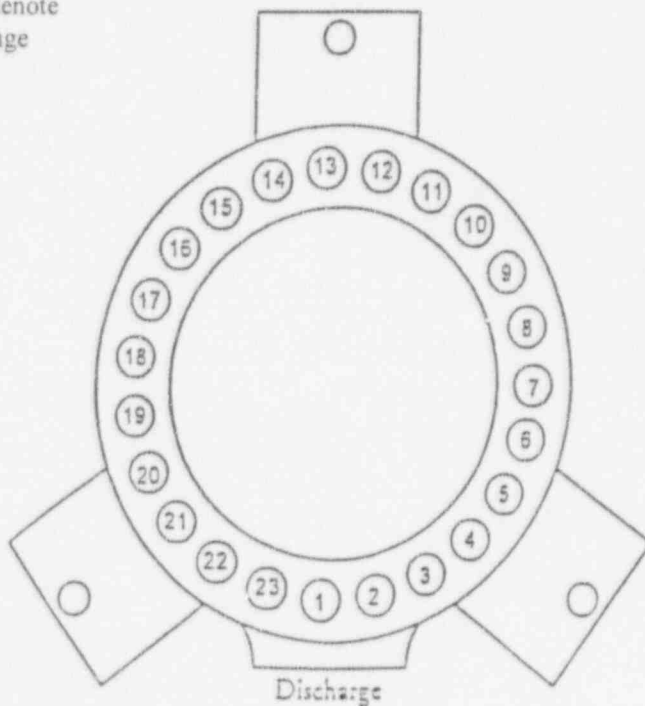
**Figure 1**  
**Location of Bottom Nozzle Damage**

On June 21, 1994, it was discovered that the bottom nozzle of two fuel assemblies (Assembly C26 and E33, see Table 2 and Figure 1) were eroded by a foreign object. No degradation to the fuel pins themselves was discovered. On June 22, 1994, based upon the extent of the erosion to the two fuel assemblies, North Atlantic made a non-emergency 4 hour report pursuant to 10CFR50.72(b)(2)(i) due to the potential for further degradation of the fuel assembly bottom nozzles leading to possible future fuel degradation. Although the TVCSs are not considered to be a basic component, the wearing of the fuel assembly bottom nozzle did have the potential to eventually erode into the fuel pin cladding. The fuel pins are considered to be a basic component because the cladding is a fission product barrier which functions to keep offsite exposure within the limits of 10CFR100. Westinghouse Electric Corporation, the reactor coolant pump vendor, has evaluated the locking cap and TVCS failure and determined that the event is not reportable pursuant to 10CFR21. North Atlantic has also evaluated the aforementioned condition and determined that it did not constitute a significant safety hazard in accordance with 10CFR21.
