Project No. 8304
September 19, 1983
W3-HE-LP-007

Subject: Waterford III SES
Analysis of Cracks and Water Seepage in
Foundation
Report No. 8304-1

WATERFORD III SES
ANALYSIS OF CRACKS AND WATER SEEPAGE
IN FOUNDATION MAT
LOUISIANA POWER & LIGHT COMPANY
REPORT NO. 8304-1
SEPTEMBER 19, 1983

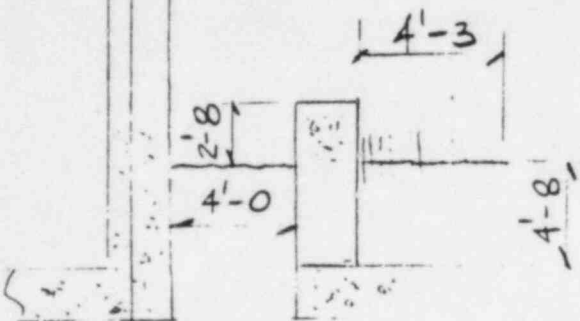
GAS SURGE TANK ROOM

*FR**BASELINE CRACK MAP*

- NOTES:
1. NO
 2. YES - SHADED AREA
 3. DRY - SHADED AREA
DAMP - UNSHADED AREA
 4. HAIRLINE CRACK

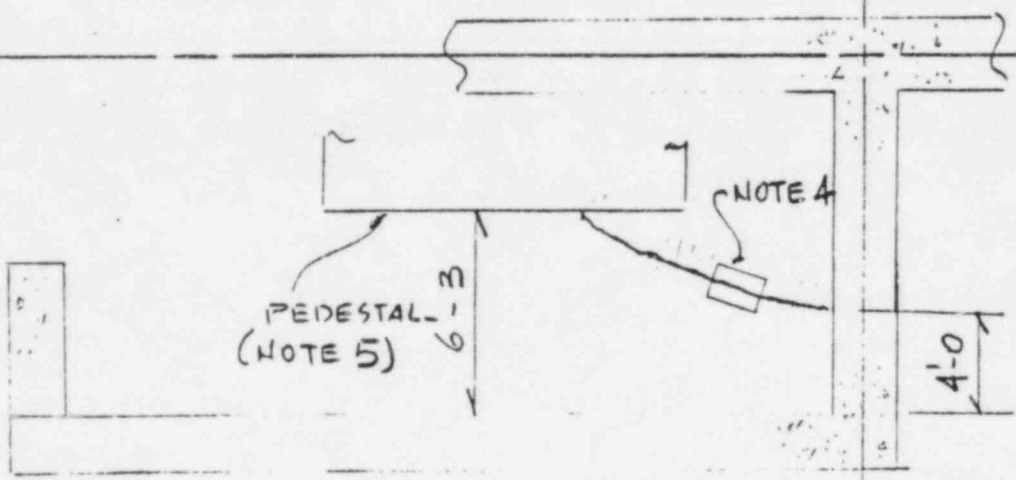
WASTE GAS COMPRESSOR ROOM

BASELINE CRACK MAP

- NOTES:
1. NO
 2. YES - SHADIED
 3. DAMP
 4. PREVIOUSLY GRINDED AREA FOR INSPECTION
 5. UNABLE TO DETERMINE WHETHER CRACK RUNS UNDER PEDESTAL
 6. HAIRLINE CRACK

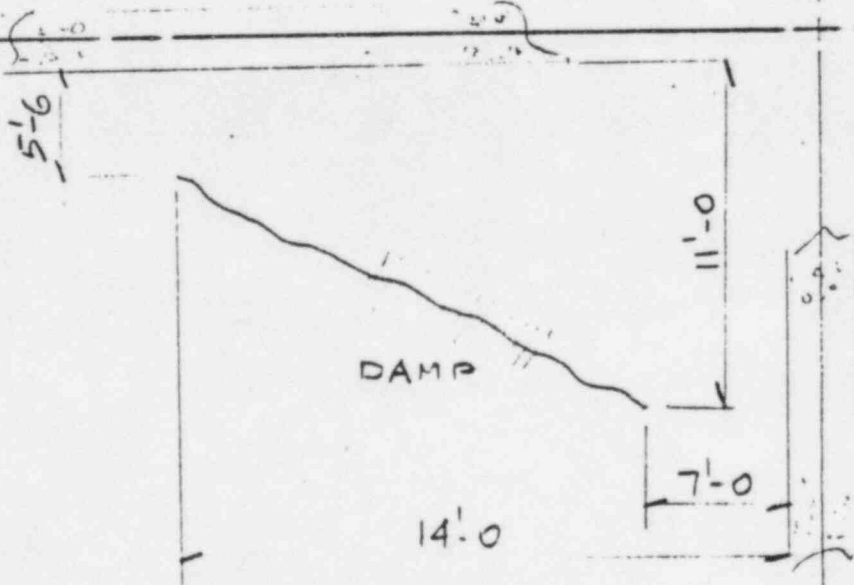
NOTES: 1. NO
2. NO
3. NO
4. HAIRLINE CRACK

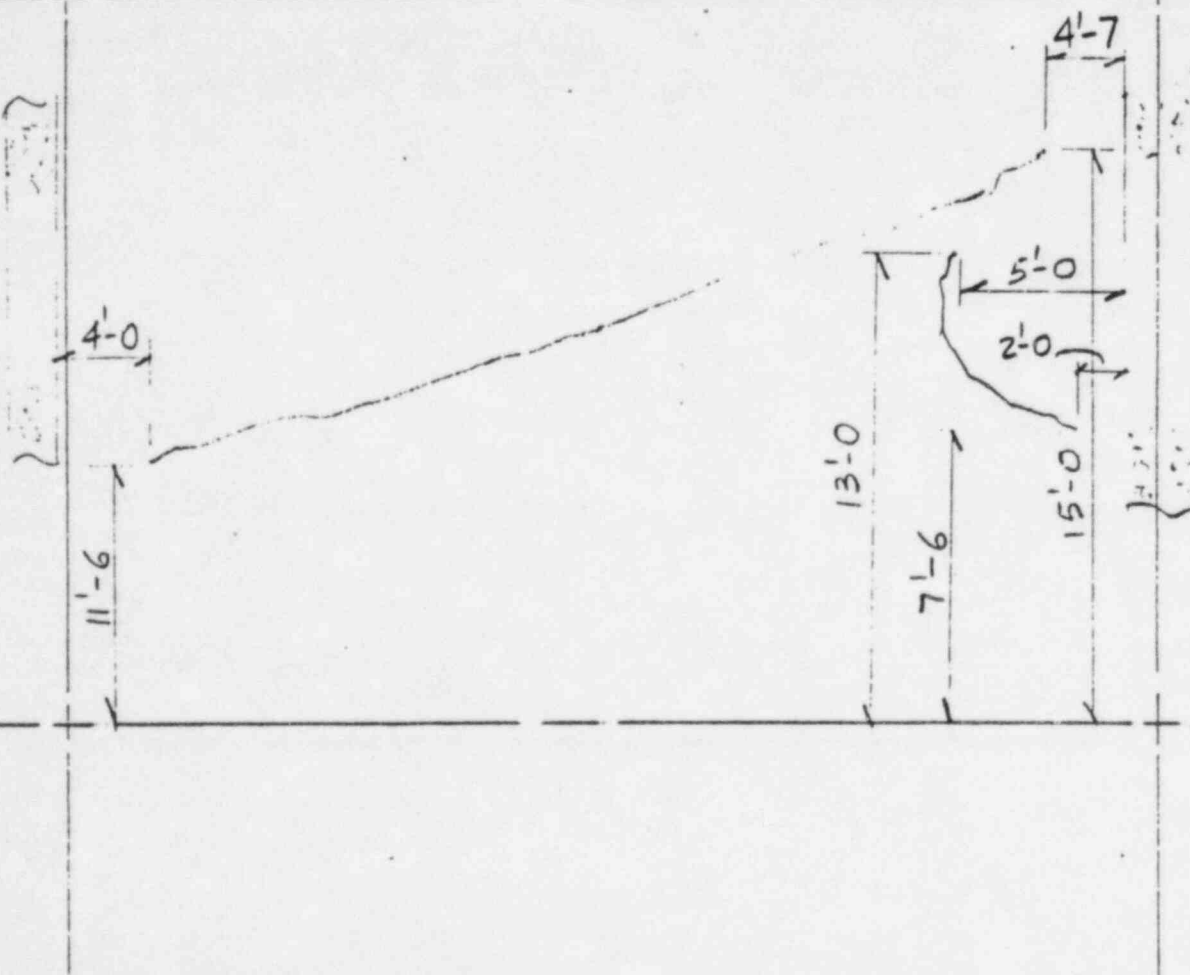
NOTES: 1. NO
2. NO
3. NO
4. HAIRLINE CRACK

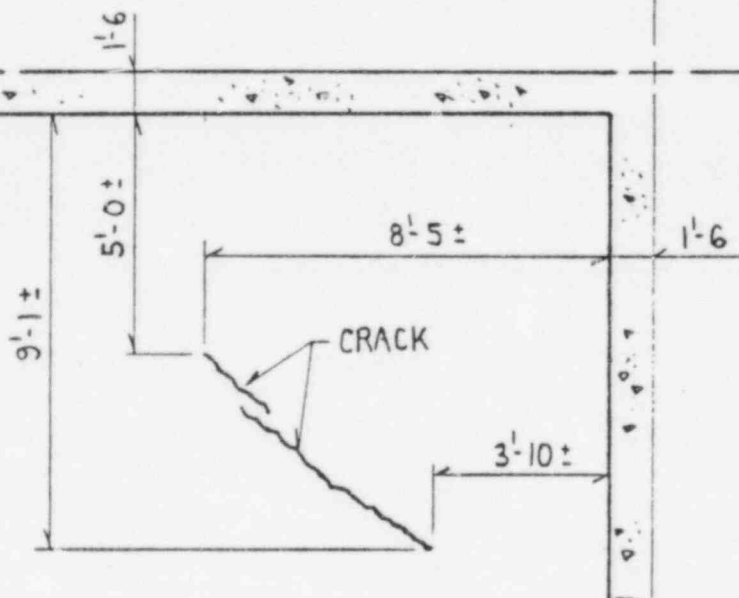
PLAN EL - 34.75'

1. REPAIR ATTEMPTED
2. NO FLOOR FINISH
3. NO EVIDENCE OF SEEPAGE
4. HAIRLINE CRACK

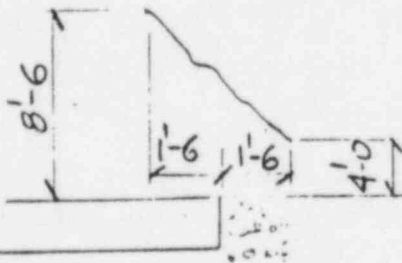
1. NO REPAIR -
2. FLOOR IS FINISHED
3. SEEPAGE EXISTS
4. HAIRLINE CRACK

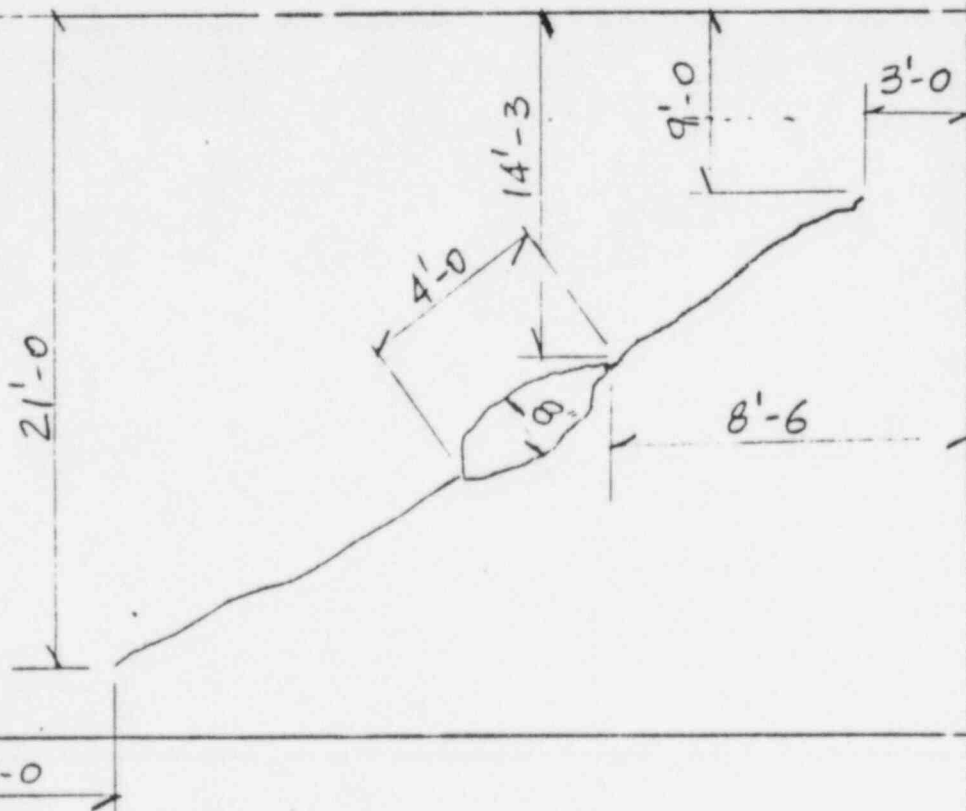
- NOTES: 1. NO
2. NO
3. YES-DAMP
4. HAIRLINE CRACK

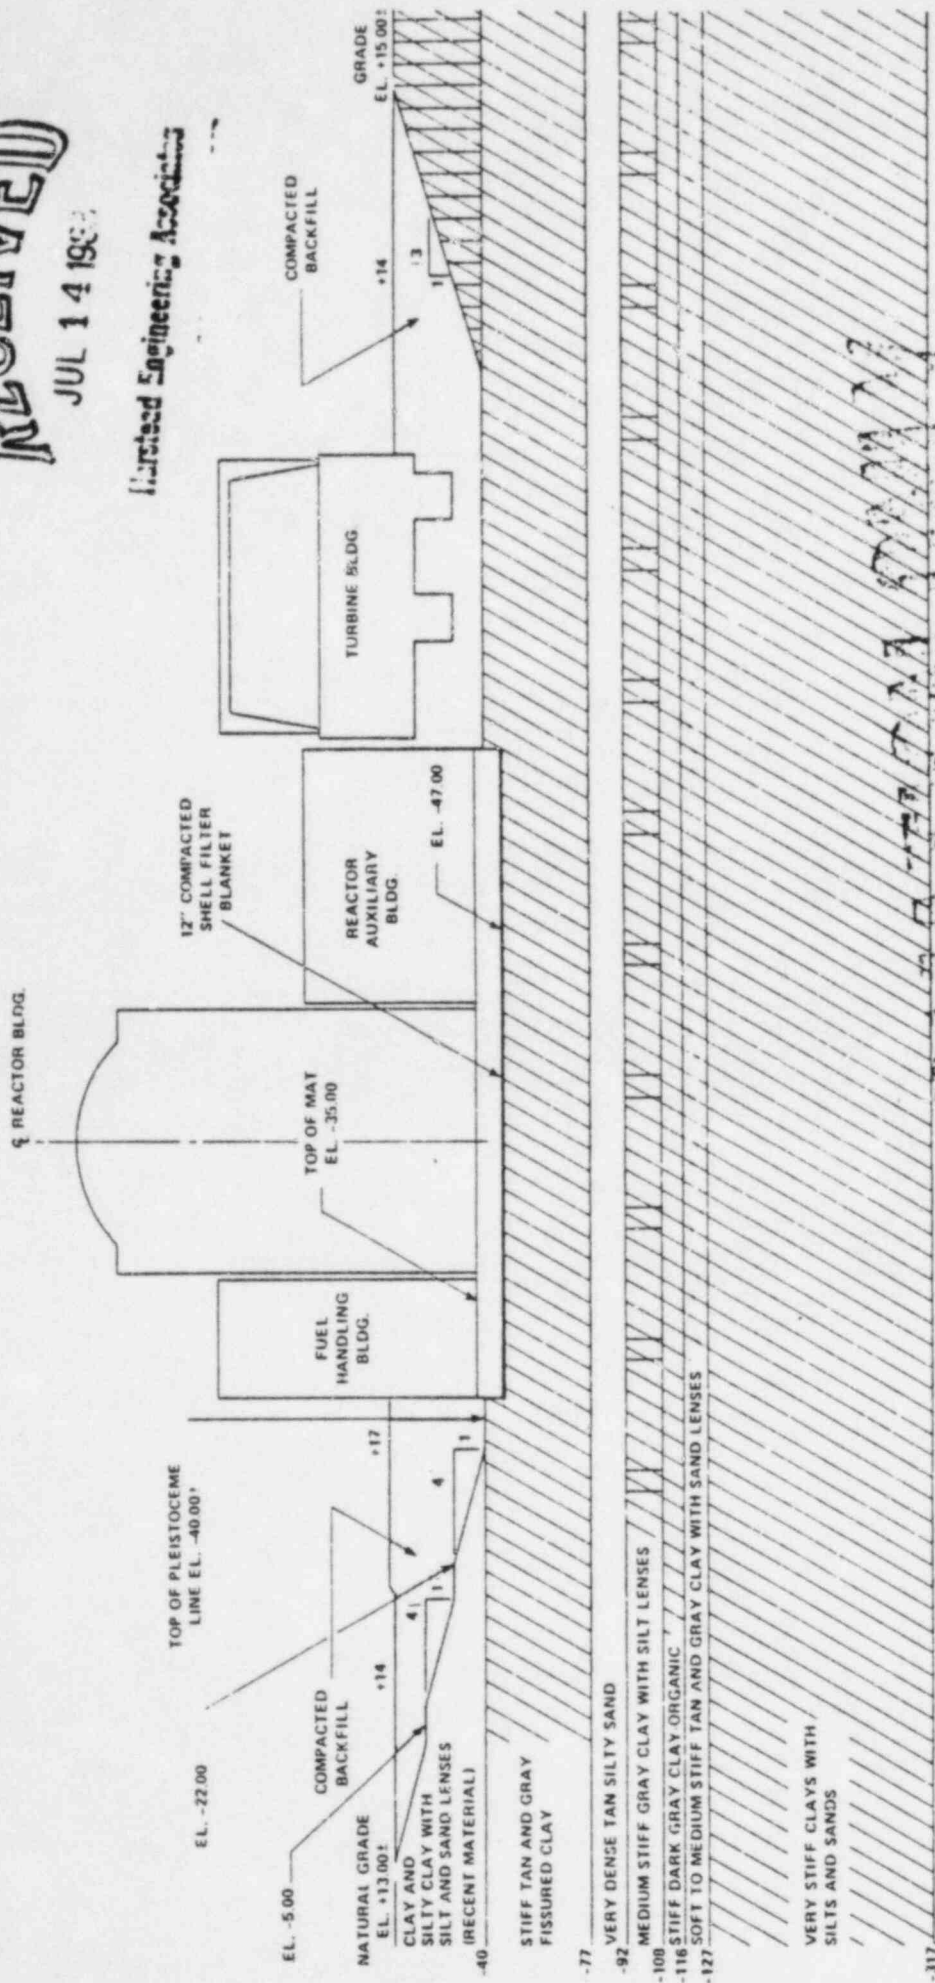
LOUISIANA POWER & LIGHT CO.
Waterford Steam Electric Station
GENERALIZED SITE CROSS SECTION
FIG 2.5-80

A generalized site cross-section showing the Nuclear Island structures and adjacent non-Category I Turbine Building is outlined in Appendix D (FSAR Fig. 2.5-80).

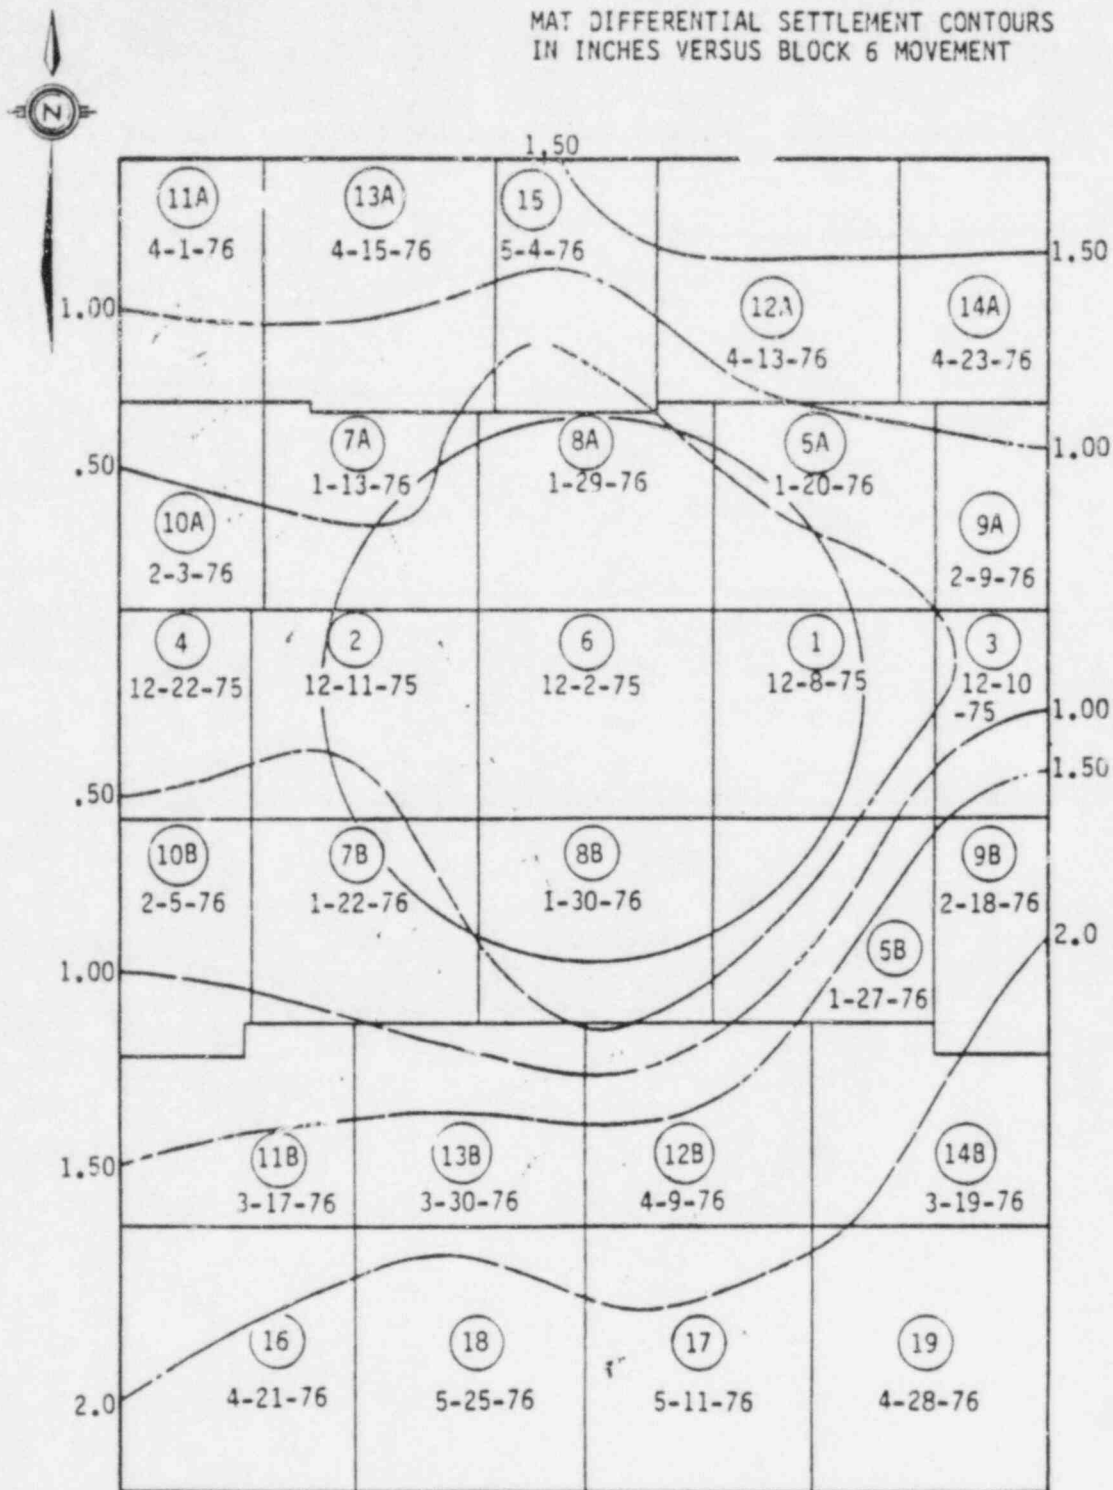
MAT DIFFERENTIAL SETTLEMENT CONTOURS
IN INCHES VERSUS BLOCK 6 MOVEMENT

Composite Foundation Mat
Differential Settlement Contours

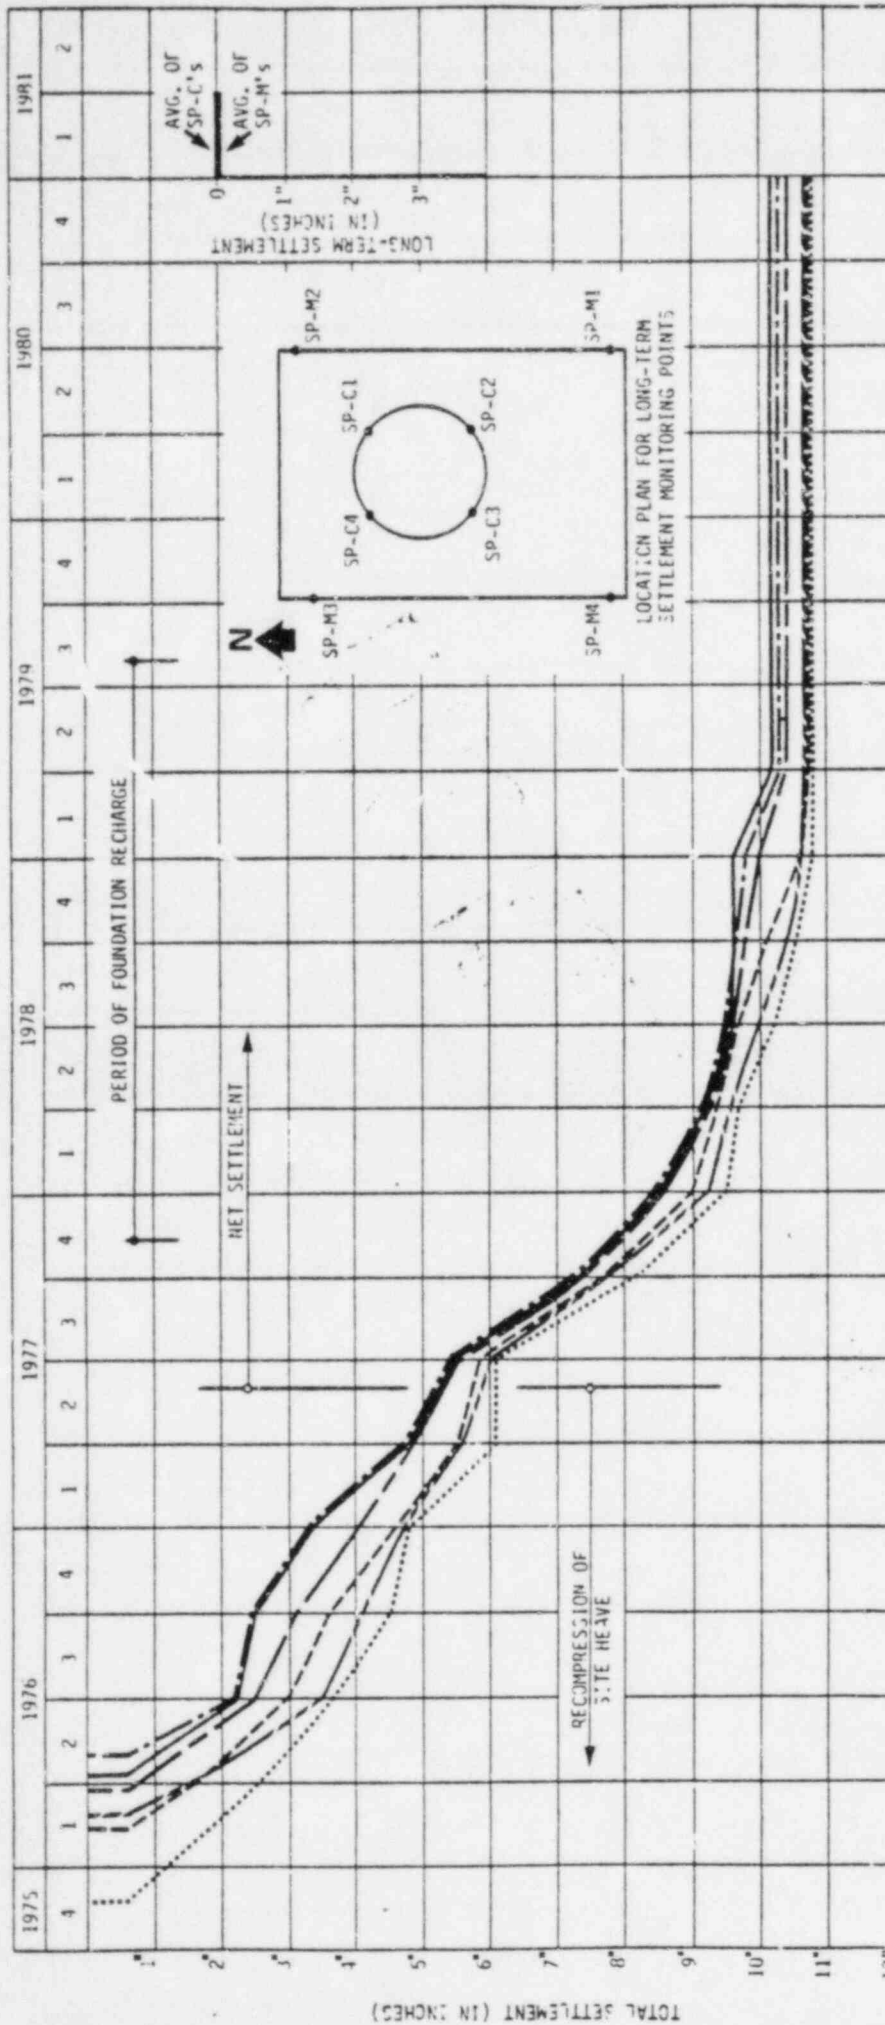
Composite Foundation Mat
Settlement

To compensate for the additional heave, the permissible overload of 700 psf was increased to 1,200 psf in order to accomplish most of the recompression during construction. This increase permitted the load from the structures and backfill to be increased to 4,500 psf prior to commencing the Recharge Program to achieve buoyancy. By July, 1977 recompression of the heave had occurred due to loading from structures and backfill, assisted by larger and more efficient dewatering pumps. The dewatering system was continued until October, 1977 when the average net settlement was approximately 2 inches. During the period October, 1977 to July, 1979 the rate of movement was controlled by releasing the dewatering system in stages, permitting construction of the plant to continue. The average net settlement increased to approximately 5 inches during this period. Readings have stabilized at that level for the past four years with only minor fluctuations noted due to change in river level. The composite foundation mat settlement is shown in Appendix J (FSAR Fig. 2.5-117).
