In the Matter of)	ASLBP Nos. 78-389-03 OL
)	80-429-02 SP
CONSUMERS POWER COMPANY)	Docket Nos. 50-329 OL
)	50-330 OL
(Midland Plant, Units 1 and 2))	Docket Nos. 50-329 OM
)	50-330 OM

SECOND SUPPLEMENTAL MEMORANDUM IN SUPPORT OF INTERVENOR
BARBARA STAMIRIS' MOTION TO LITIGATE DOW ISSUES

FOUNDATION SETTLEMENTS

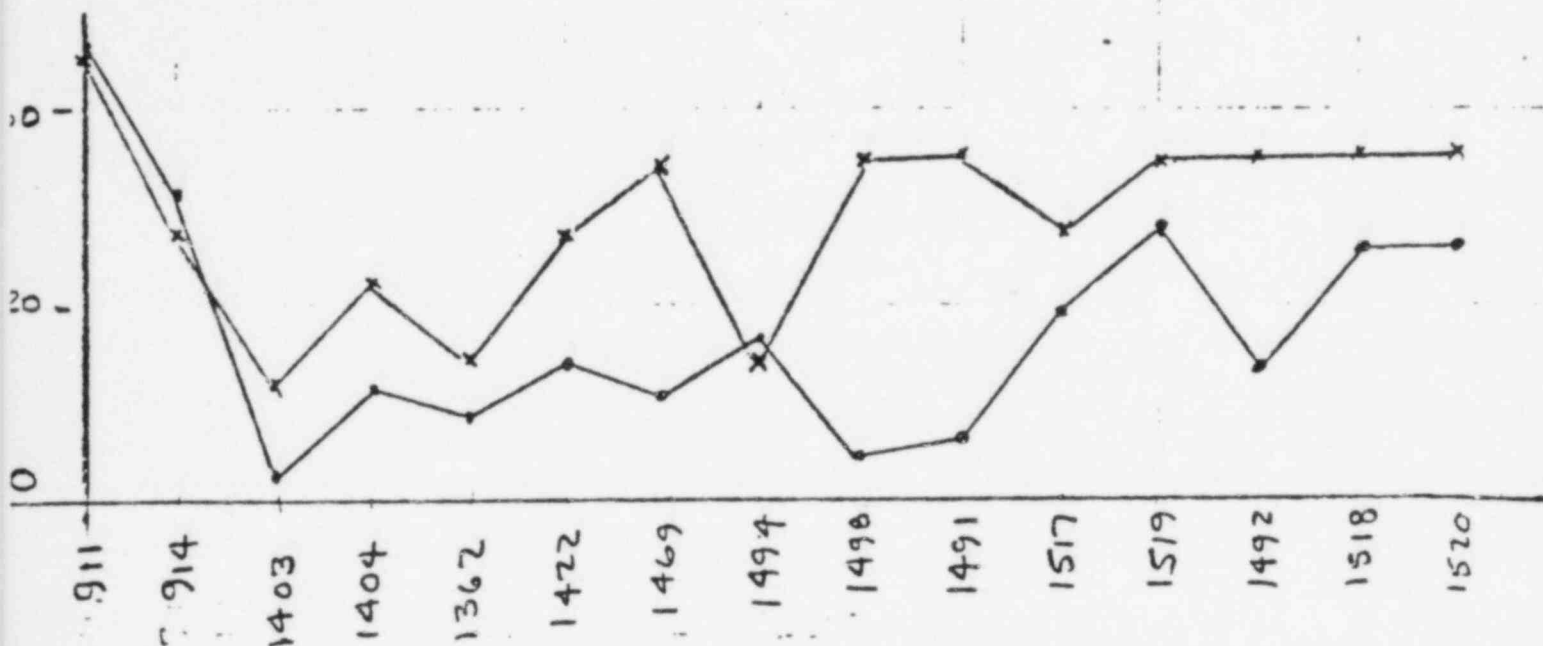
FIGURE # 2

x ——— x MAX. LAB. (PROCTOR) DRY DENSITY SELECTED BY THE US. TESTING TECHNICIAN DURING ORIGINAL TESTING OF COMPACTED FILL

3. The value of maximum laboratory dry density selected for comparison of the in-place dry densities in the subject fill varies between 132.9 lb./ft.³ and 116.0 lb./ft.³. This variation includes most of the full range of maximum laboratory density standards which represent significantly differing soil characteristics of the clay soils in use on this project. A graph of the maximum laboratory dry density plotted with the corresponding in-place dry density for each test is given in Figure #2. Note that for three compacted fill density tests (1469, 1494 and 1493) taken within a few feet of each other and at the same elevation, two significantly different maximum laboratory densities were used as the compaction standard by the same U. S. Testing technician.

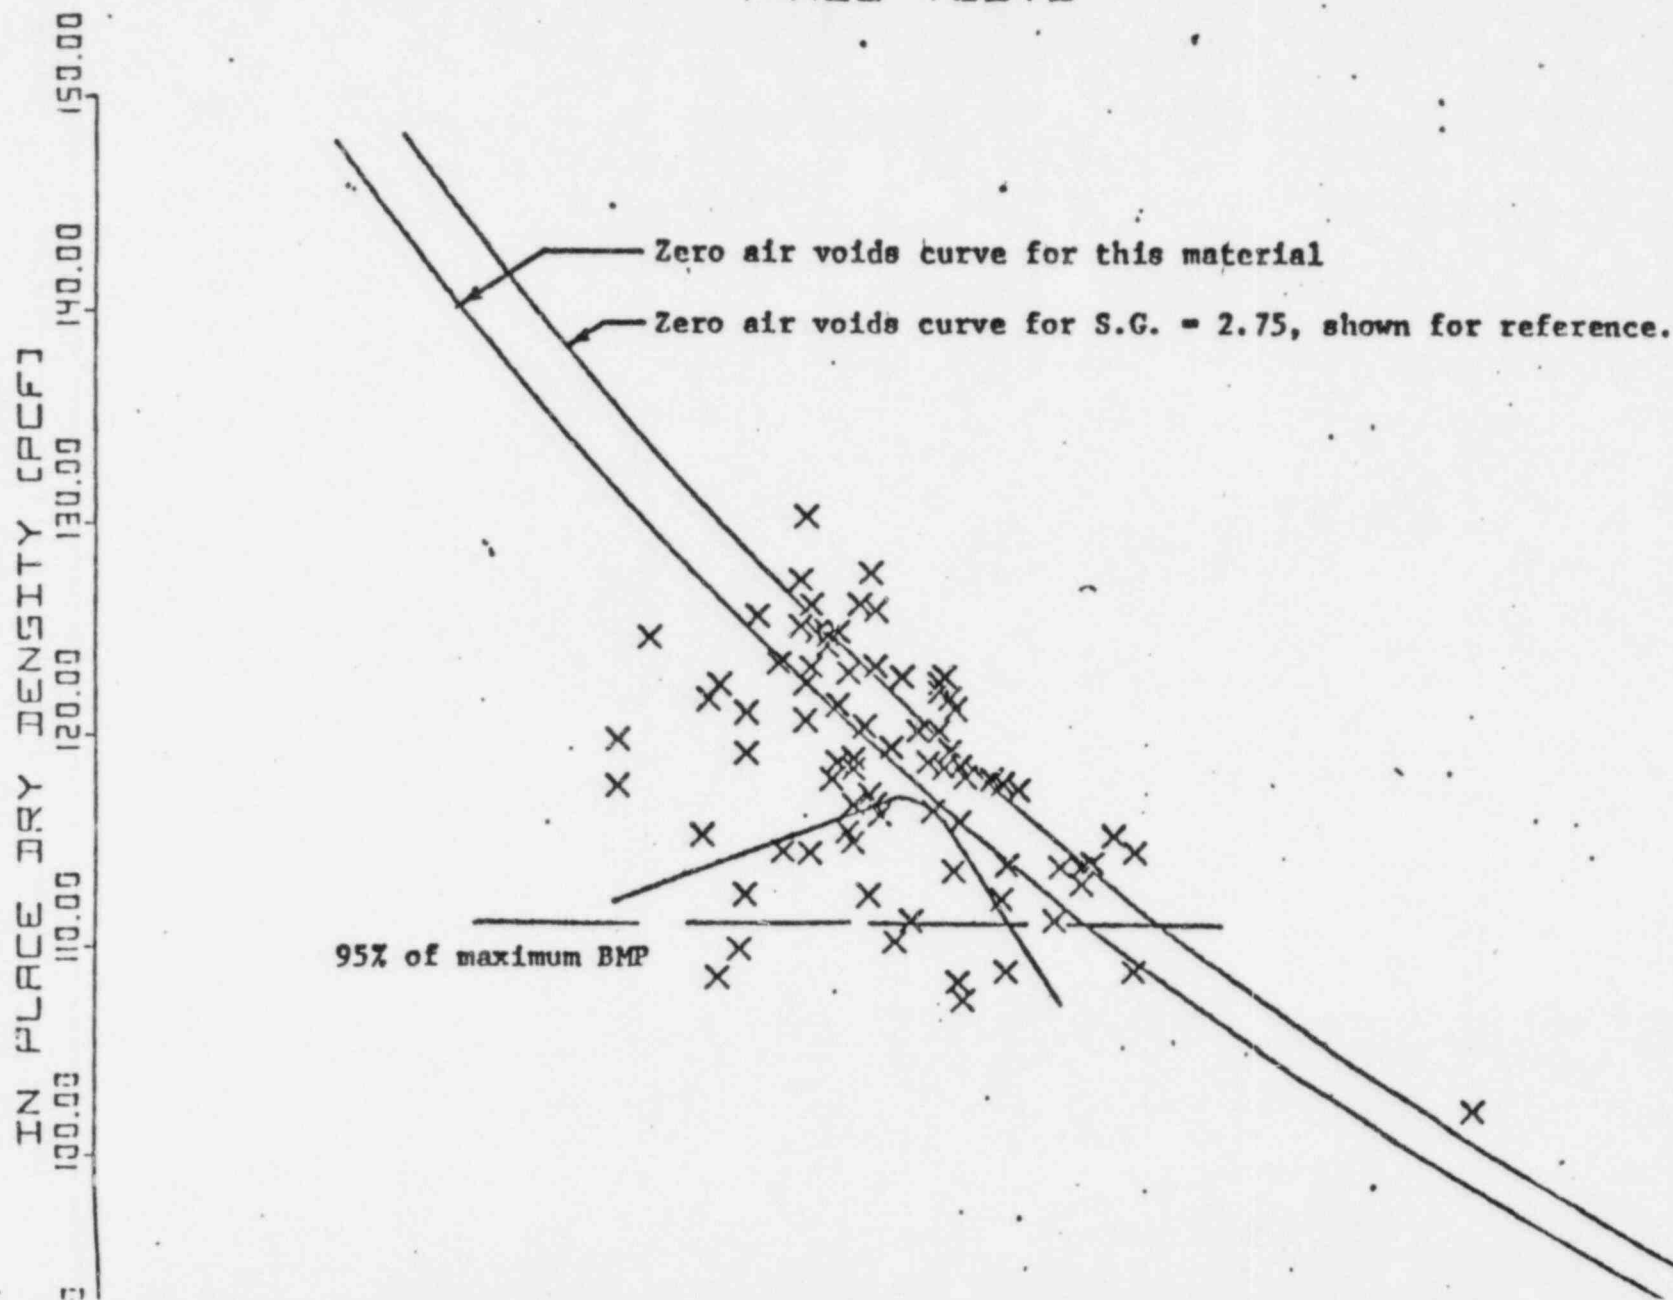
FIGURE 1

Also, referring to Figure 1 it would appear that soil density varied widely. Specifications called for compactive effort results as defined by ASTM D 1557 which is 56,255 ft-lb/ft³ energy. This was modified to laboratory test compactive effort of about 20,000 ft-lb/ft³ energy, or referred to as Bechtel Modified Proctor (BMP). Laboratory compaction test curves should be related to the same effort as that called for in the field for use in comparing with field density tests to determine percent compaction. According to plots of field data shown on Figure 1 density varied from about 108 lb/ft³ to about 130 lb/ft³. It is doubtful that the soil classification or other properties would be similar for a wide variation in density. It is noted that 100 percent of modified Proctor (ASTM D 1557) which is difficult to obtain, is rated at 56,255 ft-lb/ft³ energy. The curve plotted on Figure 1 is at about 20,000 ft-lb/ft³ energy. For comparative purposes it was determined by U. S. Testing that 100 percent of specified effort (20,000 ft-lb/ft³) is approximately equal to 95 percent of the maximum density as determined by ASTM D 1557 (ft-lb/ft³) Reference Figure 8.

In a letter from U. S. Testing to Bechtel (dated May 30, 1974), the average deviation of the nuclear device from oven-dry moistures was +.12% for a set of 30 tests. However, the standard error of estimate was 1.8% for the data with the range of differences being from - 3.2% to +3.9%. Thus, accuracy of the nuclear device is questionable, and could translate into errors of about ± 4 pcf in the dry density calculation (It should be noted that errors in the moisture content tend to shift the position of test results on a moisture density plot approximately parallel to the zero air voids curve, assuming the in-place wet density is correct, and thus do not explain the large number of points which plot outside the zero air voids. Compare Figures 1 and 9).

ALL TESTS

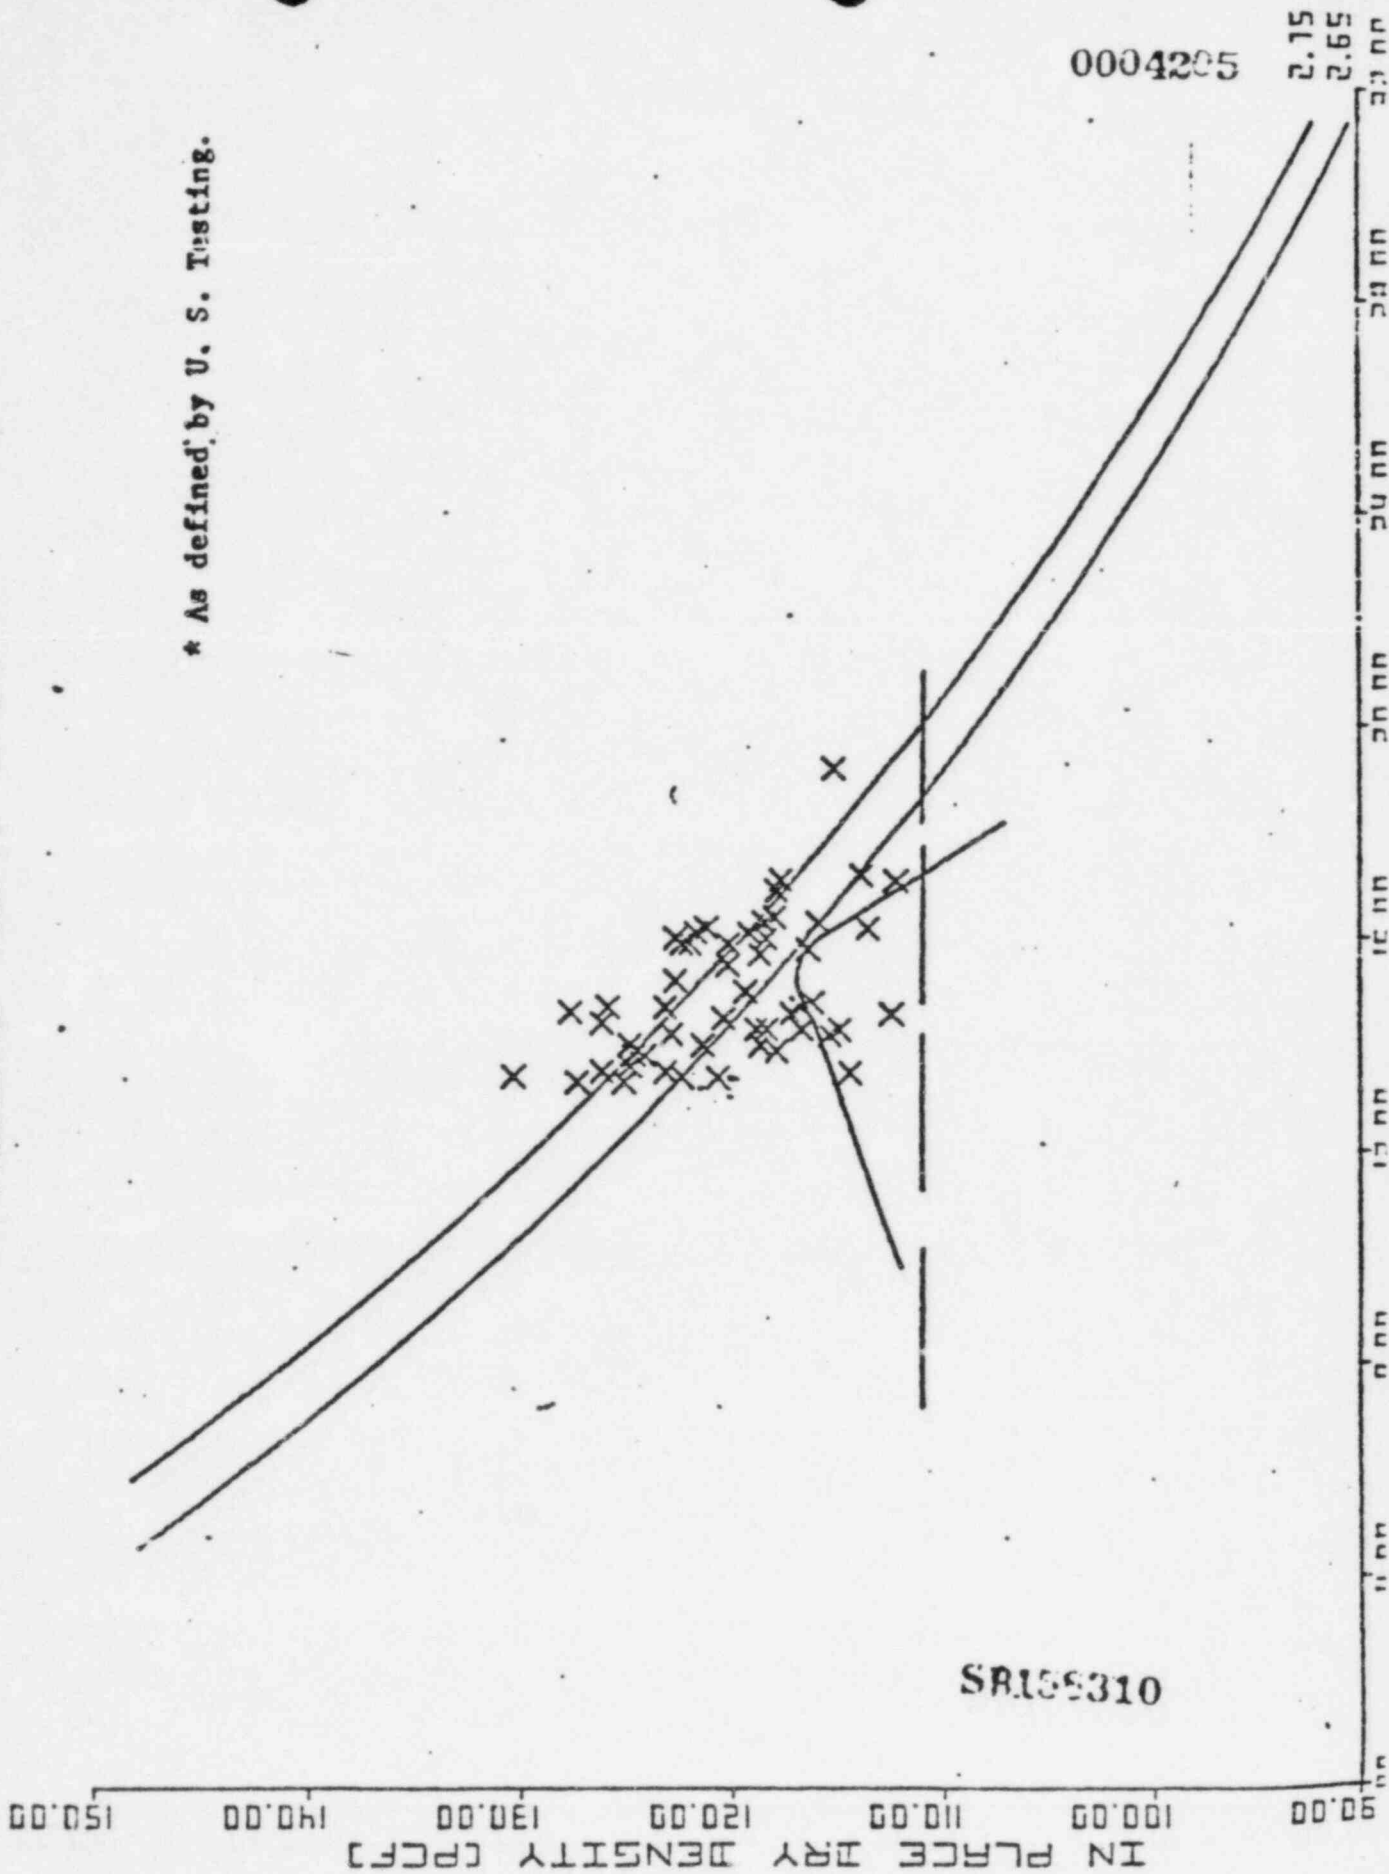
FIGURE 2

MOISTURE-DENSITY FOR BMP 278 SPECIFIC GRAVITY = 2.65 PASSING TESTS ONLY*

* As defined by U. S. Testing.

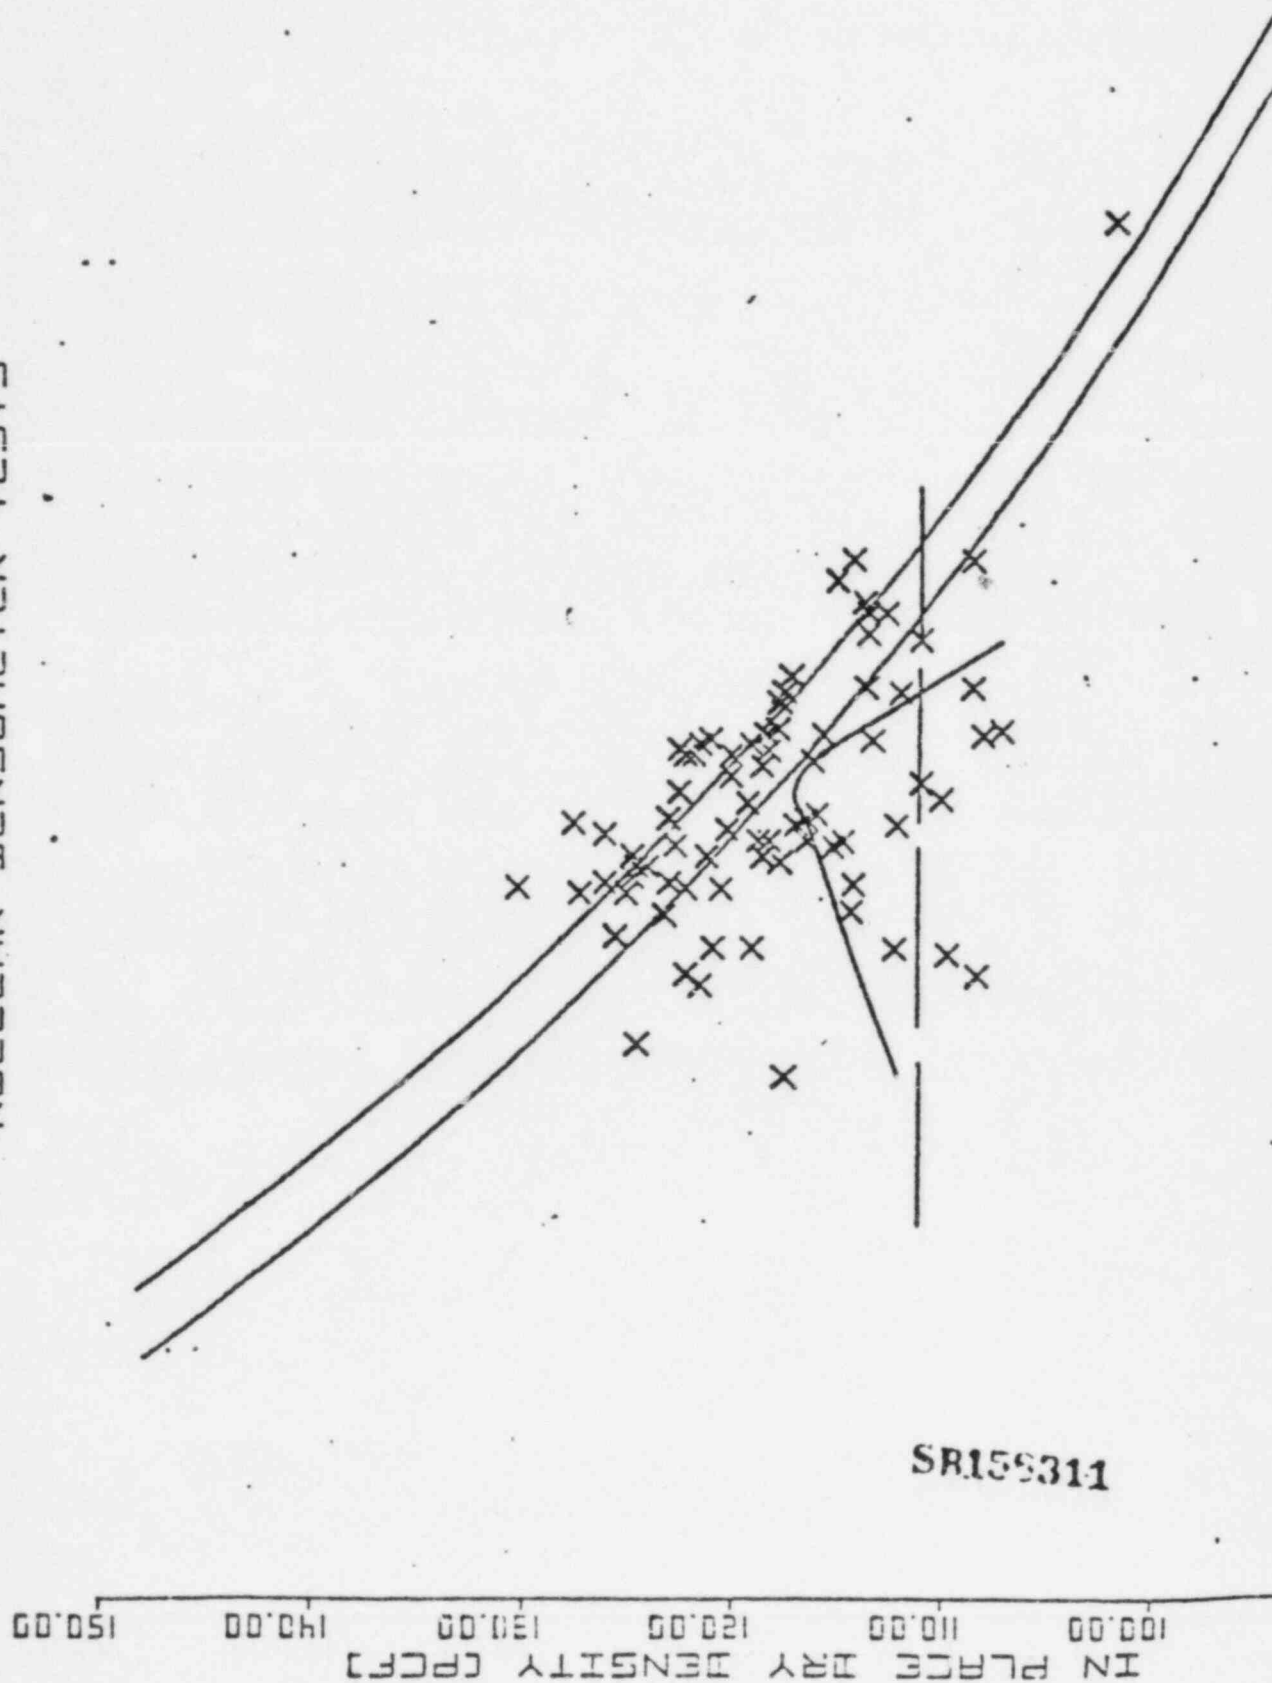
FIGURE 3

Plots of field data for compaction test BNP 278 are shown on Figures 1 through 6. The title of each figure gives the assumptions made in plotting data for the figure. In comparing figures 3 and 4 it is seen that a majority of field tests were made using the nuclear device. The two test results shown on Figure 4 for the sand cone method indicates one test result on each side of the zero air voids curve. The one falling above the zero air voids curve (shown on Figure 4) is designated by U. S. Testing Company as the only passing sand cone test (shown on Figure

SPECIFIC GRAVITY = 2.65
NUCLEAR DENSOMETER TESTS

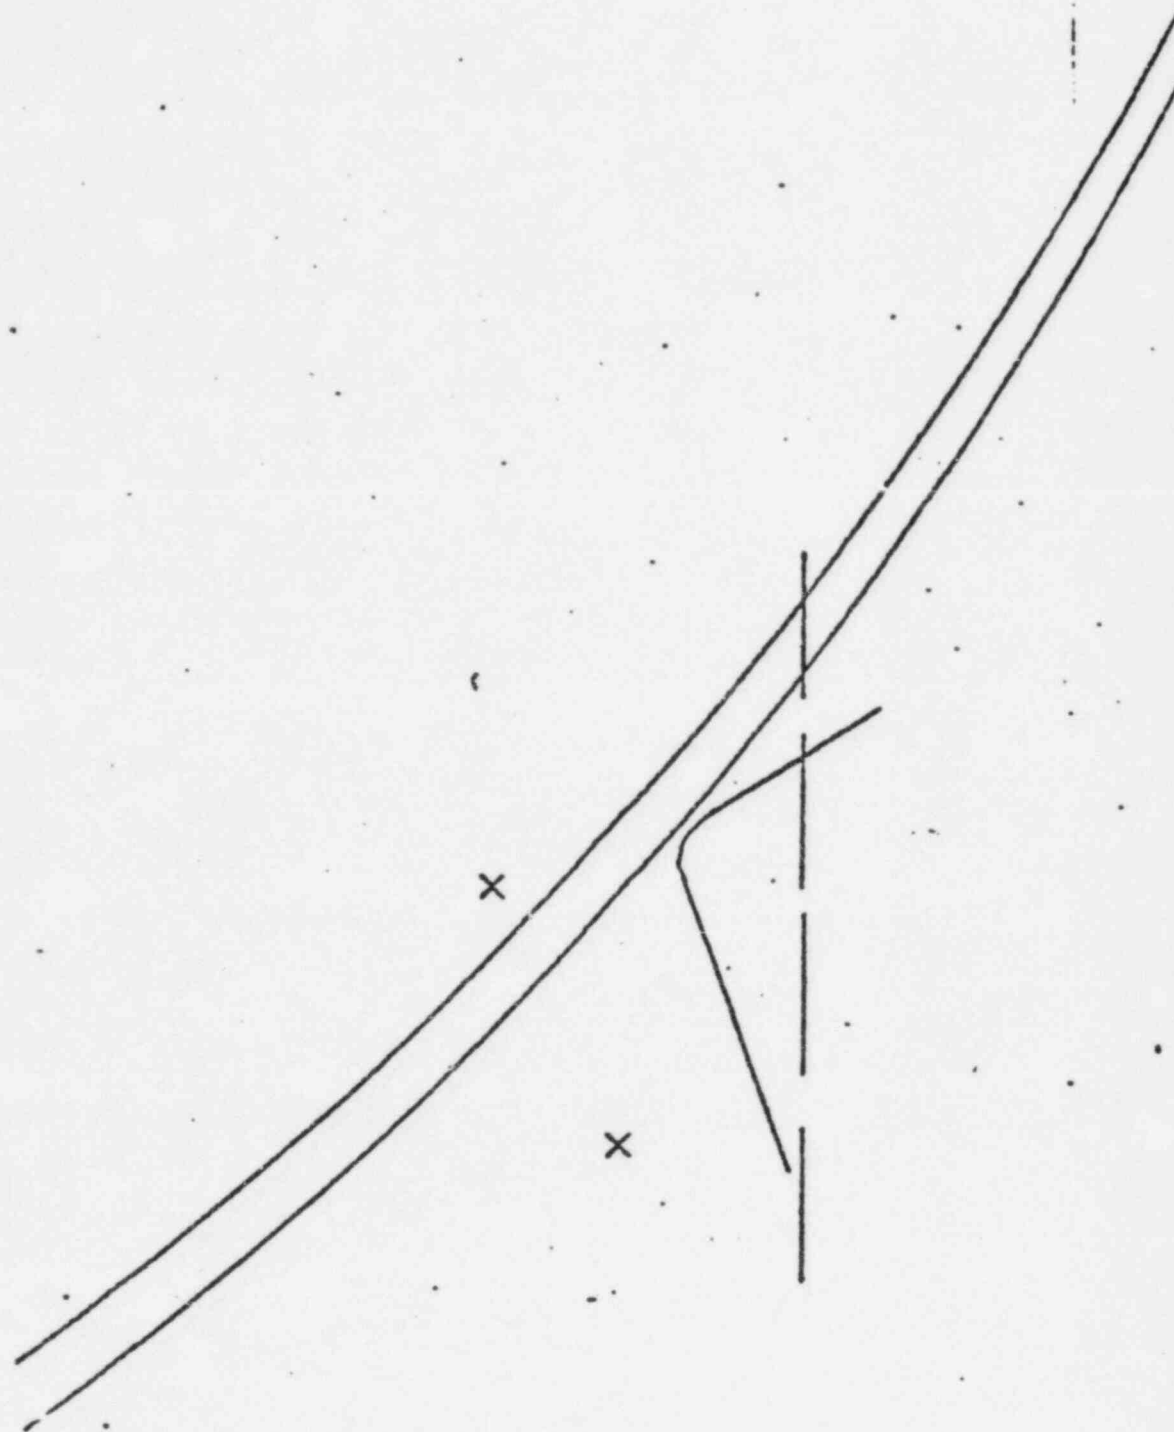
FIGURE 4

MOISTURE-DENSITY FOR BMP 278 SPECIFIC GRAVITY = 2.65 SAND-CONE TESTS

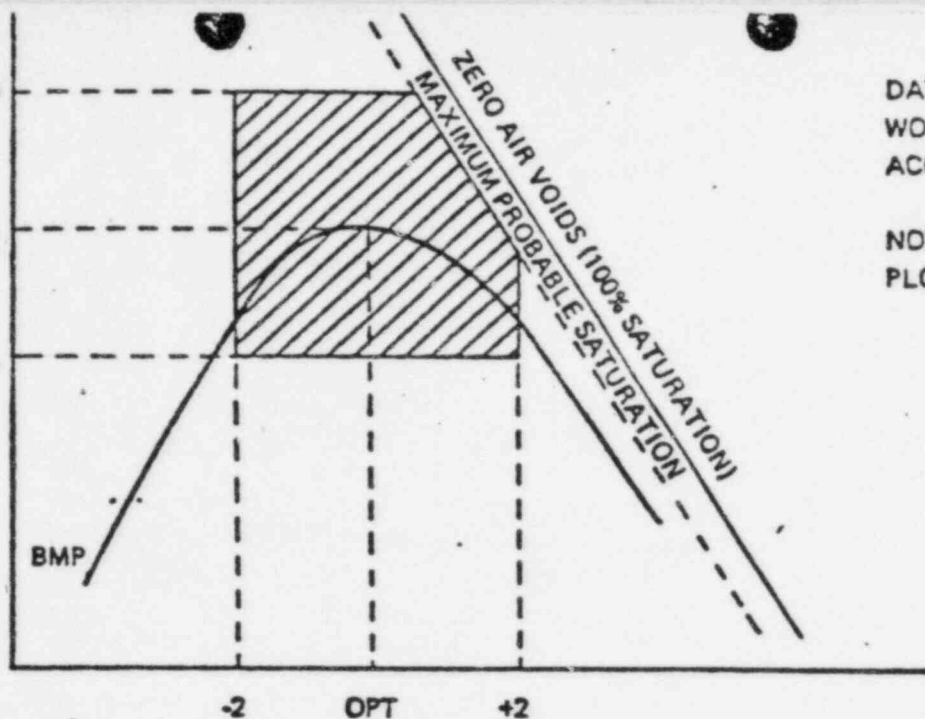
FIGURE 7-A-

For a field test result to be valid as well as "Passing" it must fall within a well defined area on the plot containing the laboratory compaction curve. This area or window of acceptability is shown for a hypothetical compaction curve on Figure 7a that would meet requirements of Specification 7220-C-210. It is defined by horizontal lines at 95 percent and 105 percent of specified density, vertical lines through ± 2 percent of optimum moisture content, and a line parallel to the zero voids line indicating saturation about half way between the compaction curve and 100 percent saturation (zero air voids curve). The practical upper limit of 105 percent of specified density is not defined in the specifications. It was arbitrarily chosen as numbers greater than this give increasingly invalid comparisons between field test results and the specified laboratory compaction test curve. Therefore, if all data points fall within the defined window there would be no reason to assume that they are wrong. However, when many data points fall outside the designated area there is something wrong with the information and then all data points become suspect. A review of all data indicates that about 25 percent of the cohesive soil test results fall within this area.

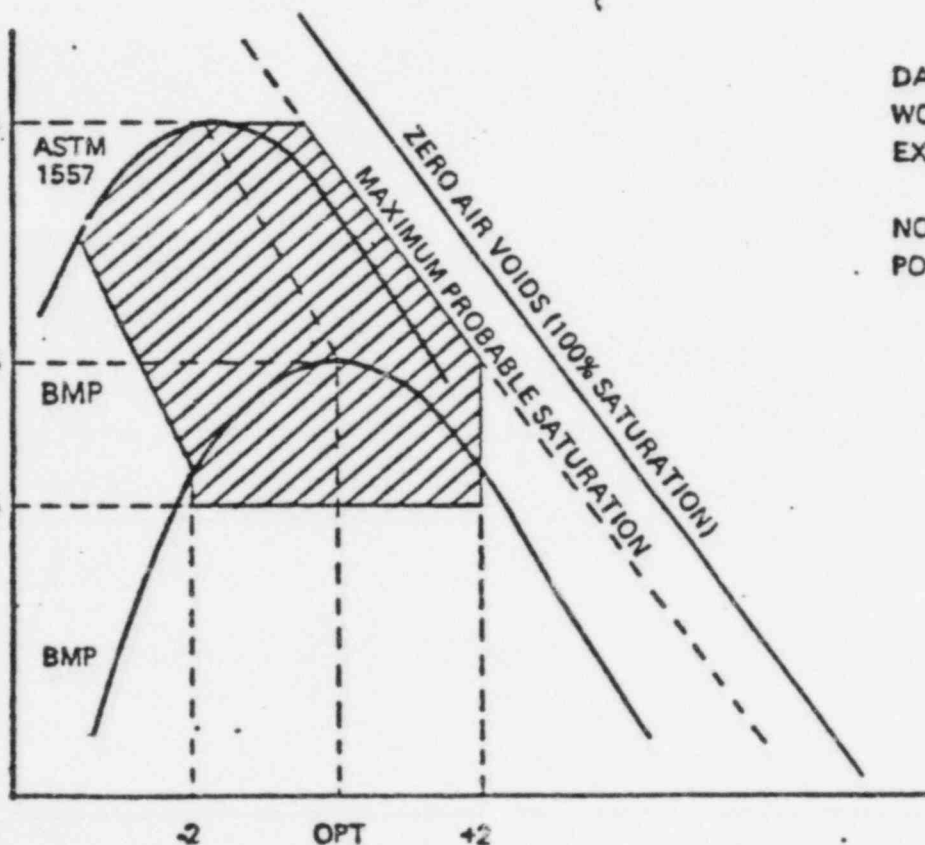
FIGURE 7-B-

Figure 7B shows an area where field test results would be acceptable, in theory even though not in strict accordance with the specifications. Figure 7B was arrived at by expanding Figure 7a to include test results up to a compactive effort related to ASTM D 1557 (56,255 ft-lb/ft³) which is considered to be a practical upper limit. About 40 percent of all cohesive soil test results would plot in this area.

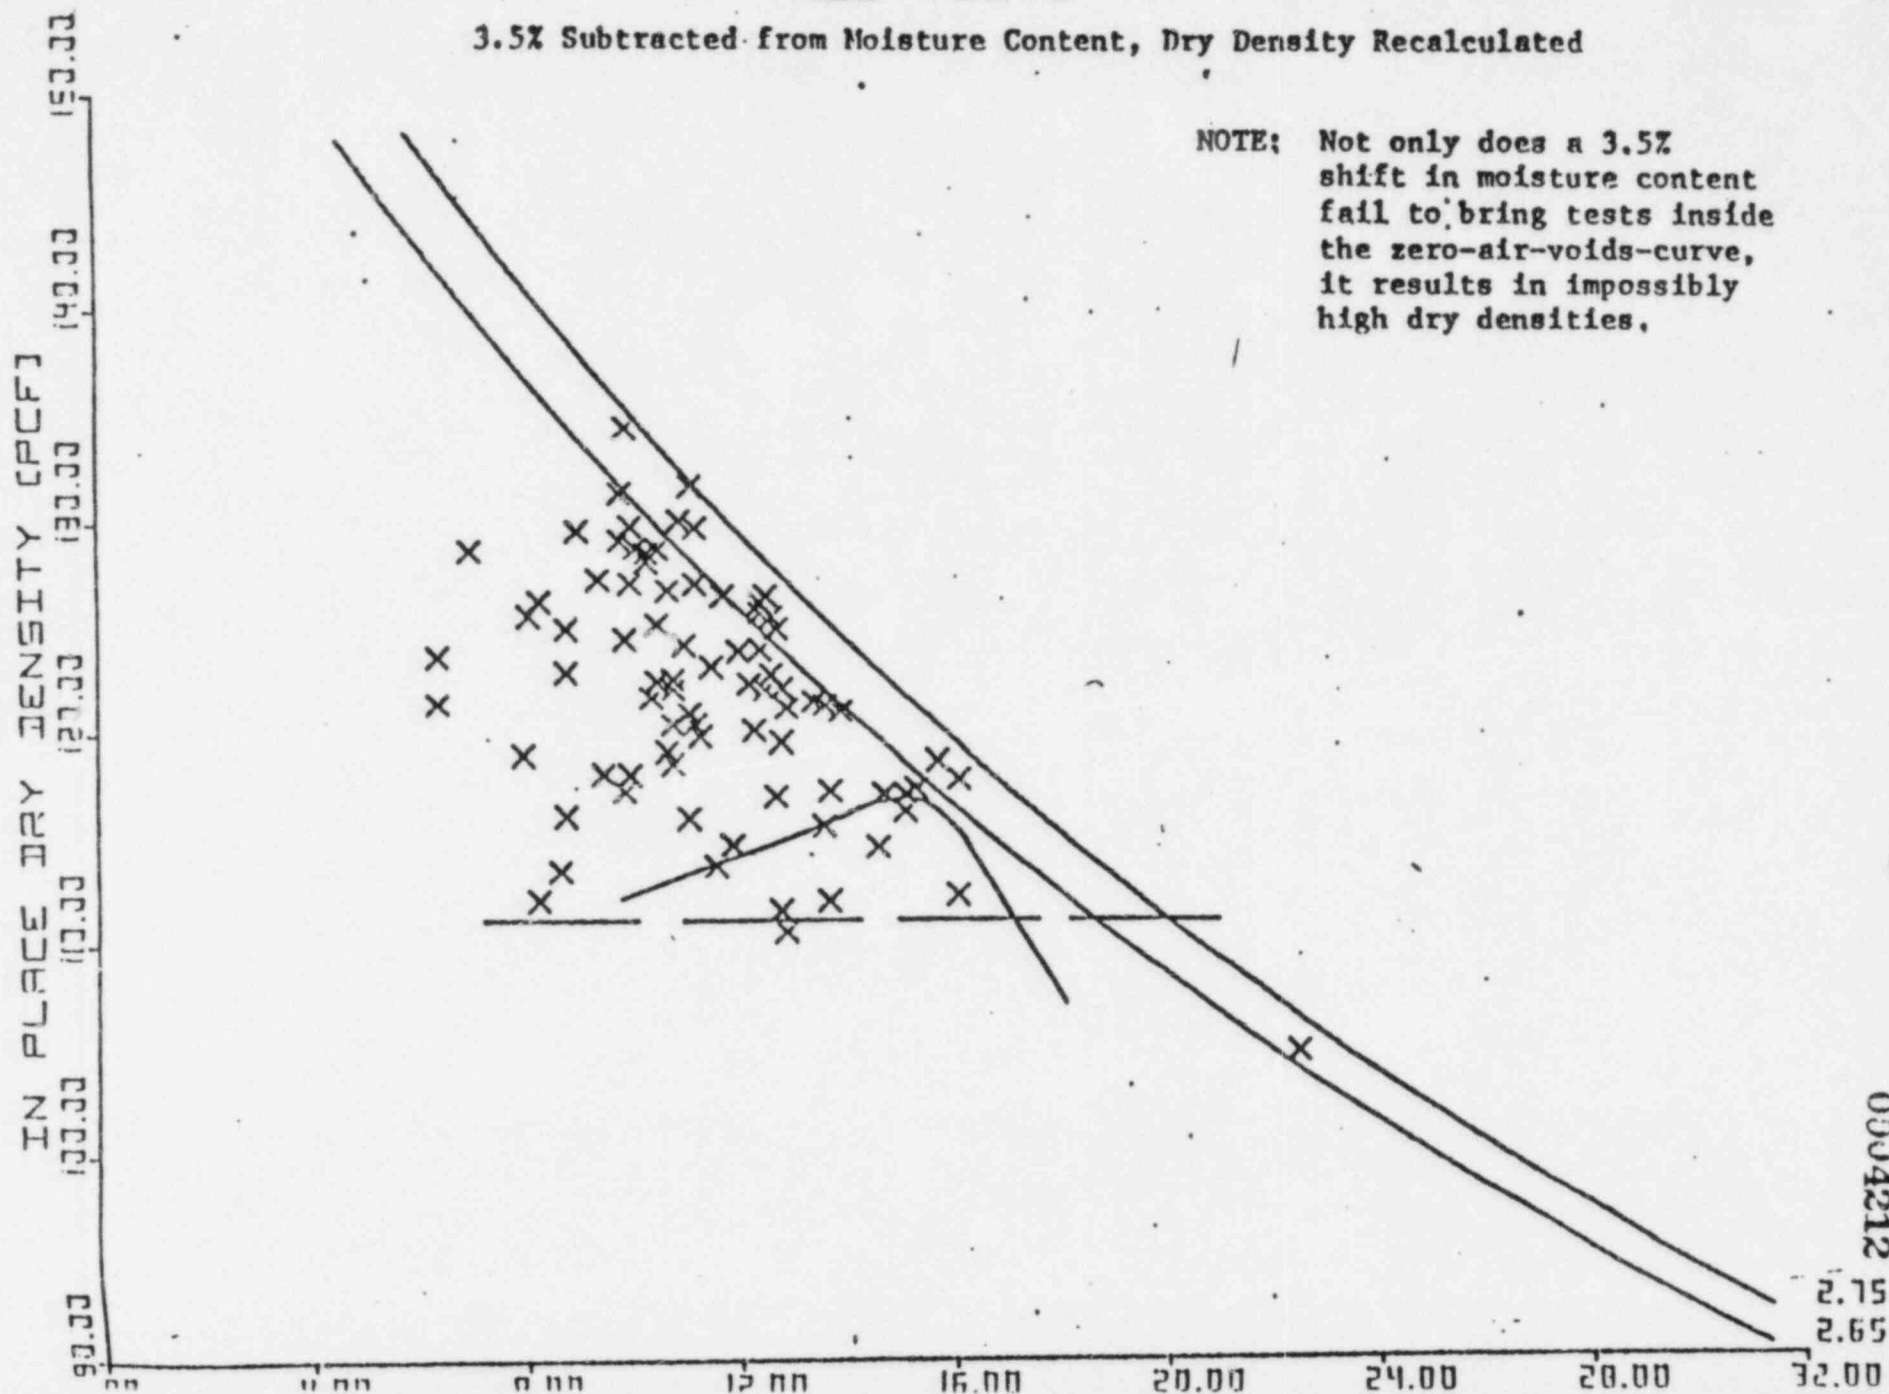
FIGURE 9

3.5% Subtracted from Moisture Content, Dry Density Recalculated

NOTE: Not only does a 3.5% shift in moisture content fail to bring tests inside the zero-air-voids-curve, it results in impossibly high dry densities.
