Washington Public Power Supply System

Subject: NUCLEAR PROJECT 2
NRC INSPECTION REPORT 50-397/83-38 NOTICE OF VIOLATION

RESPONSE TO INSPECTION REPORT 83-38
NOTICE OF VIOLATION

BURNS AND ROE, INC.
PROCEDURE FOR EVALUATION OF CONCRETE
FOR
WASHINGTON PUBLIC POWER SUPPLY SYSTEM
UNIT 2
AUGUST 24, 1983

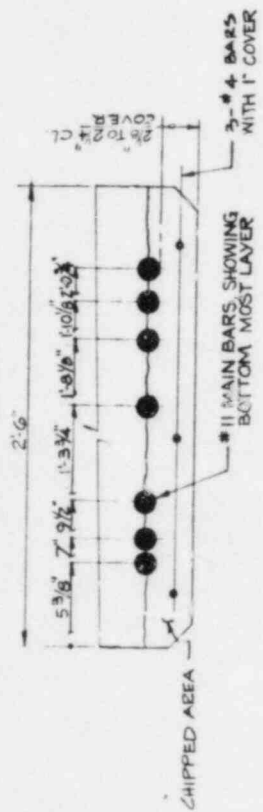
REINFORCEMENT REQUIRED BY ORIGINAL DESIGN AND SHOWN ON DESIGN DRAWINGS	REINFORCEMENT REQUIRED BY ANALYSIS FOR MOST CRITICAL OPERATING/SSE LOAD CONDITION	AS-BUILT CONDITIONS (SEE SKETCH NOTED)			DISCREPANCIES
		LOCATION OF EXCAVATION	BOTTOM BARS EXPOSED	DOWELS EXPOSED	
<u>SECTION A-A</u>	<u>SECTION A-A</u>				<u>ALL EXCAVATIONS</u>
Bottom Bars: 14-#11 in 2 layers	Bottom Bars: 7-#11	2'-0" East of column line 7.7	7-#11	None - Not required	1) Rebar spacing deviation partly to accommodate installation of 2 rows of Richmond inserts parallel to axis of beam.
Bottom Bar Dowels: Not required	Bottom Bar Dowels: Not required				
Top Bars: 7-#11	Top Bars: 5-#11				
RESOLUTION OF DISCREPANCIES:				COMMENT:

1) Excavation demonstrated that concrete is fully consolidated and is tightly bonded to rebars. The rebar spacing deviation has not ad- versely affected placement of concrete and is acceptable.				1) Beam 2B3 has been reanalyzed and checked and found to be structurally adequate. Reanalysis indicates a large design margin.

2) Dimensions and bar sizes shown on as-built sketch SK-1 have been verified.	
				3) Honeycomb, which was originally identified in Nonconformance Report 1851, was repaired prior to the NRC CAT inspection.

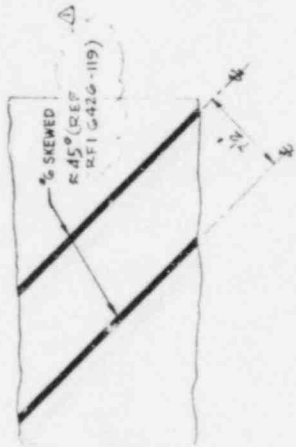
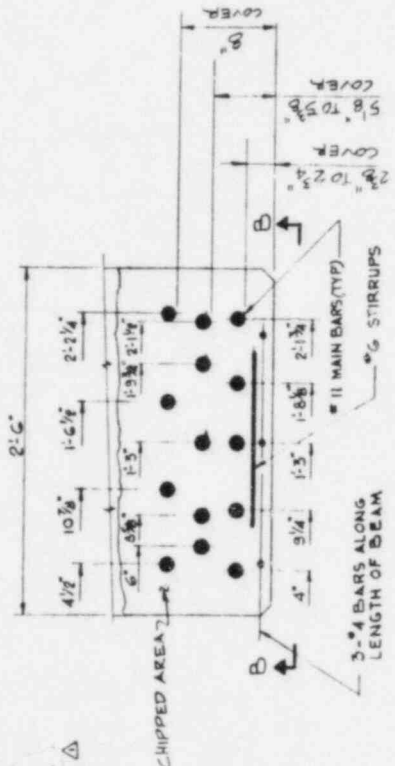
AS-BUILT

1) Further excavation after NRC CAT inspection found 5 bars in bottom-most layer, 5 in middle layer, and 4 in top layer as shown on SK-2. The deviation in bar and layer spacing would be acceptable provided the concrete was adequately consolidated. Beam 2B5 was found to have fully consolidated concrete tightly bonded to the rebars with no honeycomb. Placement of the rebar in 3 layers did not change the conservative effective depth used in the original calculations.				1) Beam 2B5 has been reanalyzed and checked and found to be structurally adequate.

2) a) See 1) All bars have been found; none are missing.				2) Dimensions and bar sizes shown on as-built sketch SK-2 have been verified.

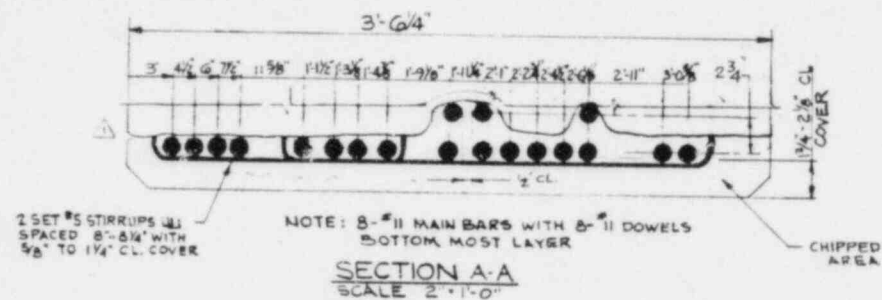
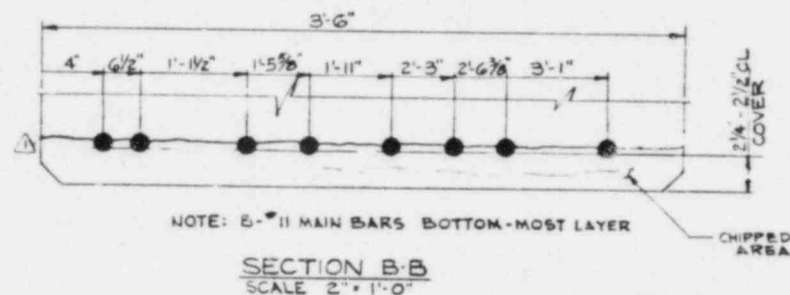
BEAM 2B25

REINFORCEMENT REQUIRED BY ORIGINAL DESIGN AND SHOWN ON DESIGN DRAWINGS	REINFORCEMENT REQUIRED BY ANALYSIS FOR MOST CRITICAL OPERATING/SSE LOAD CONDITION	AS-BUILT CONDITIONS (SEE SKETCH NOTED)			DISCREPANCIES
		LOCATION OF EXCAVATION	BOTTOM BARS EXPOSED	DOWELS EXPOSED	
<u>SECTION A-A</u>	<u>SECTION A-A</u>				<u>ALL EXCAVATIONS</u>
Bottom Bars: 24-#11 in 3 layers	Bottom Bars: 9-#11	9'-0" East of column line 8.3	8-#11	8-#11	1) Deviations in rebar and layer spacing partly due to relocation of bars to accommodate installation of 2 rows of Richmond inserts parallel to the axis of the beam. 2) Bars in second layer were not directly above bars in the first layer. 3) Honeycomb visible in local area concentrated between bars; local void visible above bars. 4) Defective patching. 5) Richmond inserts were not tagged to derate capacity.
Bottom Bar Dowels: 24-#11 in 3 layers	Bottom Bar Dowels: 3-#11				
Top Bars: 12-#11 in 2 layers	Top Bars: 9-#11

1) The deviations in rebar and layer spacing would be acceptable provided the concrete was adequately consolidated around the bars.				1) Beam 2B25 has been reanalyzed and checked and found to be structurally adequate.

4) The patch has been removed completely and will be replaced.					
5) Derating tags will be reattached permanently to pertinent inserts upon completion of patching.

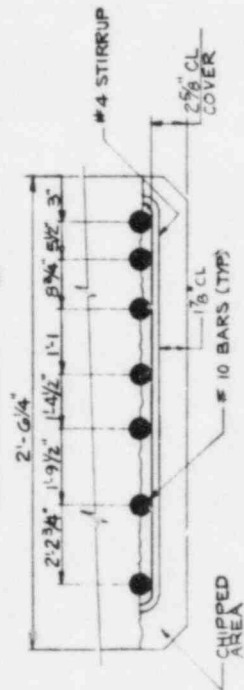
AS-BUILT A

REINFORCEMENT REQUIRED BY ORIGINAL DESIGN AND SHOWN ON DESIGN DRAWINGS	REINFORCEMENT REQUIRED BY ANALYSIS FOR MOST CRITICAL OPERATING/SSE LOAD CONDITION	AS-BUILT CONDITIONS (SEE SKETCH NOTED)			DISCREPANCIES
		LOCATION OF EXCAVATION	BOTTOM BARS EXPOSED	DOWELS EXPOSED	
<u>SECTION A-A</u>	<u>SECTION A-A</u>				<u>ALL EXCAVATIONS</u>
Bottom Bars: 7-#10	Bottom Bars: 4-#10	4'-9" West of column line 8.3	7'-#10	None - Main bars extend dir- ectly into supports.	1) One bar spacing deviation.
Top Bars: 4-#9	Top Bars: 3-#9				
RESOLUTION OF DISCREPANCIES:				COMMENT:	
1) Excavation demonstrated that concrete is fully consolidated and tightly bonded to rebars, indicating that the deviation has not adversely affected concrete placement.				1) Beam 3B10 has been reanalyzed and checked and found to be structurally adequate. 2) Dimensions and bar sizes shown on as-built sketch SK-5 have been verified.

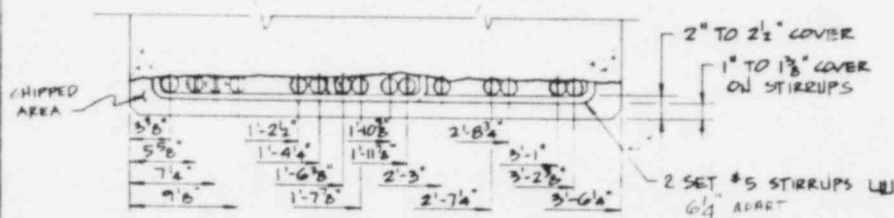
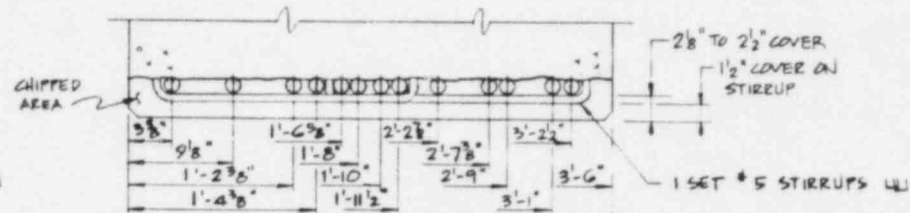
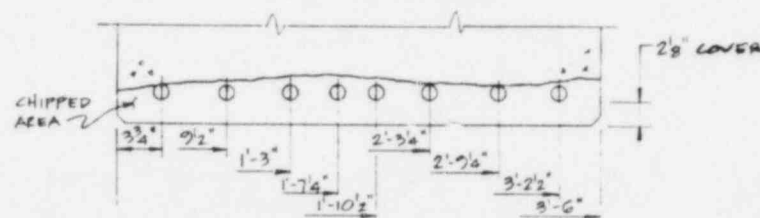
Top Bars: 8-#10	Top Bars: 8-#10				
RESOLUTION OF DISCREPANCIES:				COMMENT:	
1) The deviation in spacing would be acceptable if the concrete were adequately consolidated. The concrete is fully consolidated and the concrete is tightly bonded to the rebar. The deviations are acceptable.				1) Beam 3B-18 has been reanalyzed and checked and found to be structurally adequate.

2) ACI 318-71 requires that only one-fourth of the positive moment reinforcement (bottom bars) extend into the support. The number of dowels observed exceeds the number required by code. Therefore, even if the bar is assumed to be missing the beam would be acceptable.				2) Dimensions and bar sizes shown on as-built sketch SK-6 have been verified.

3) The orientation of lap splices was not clearly defined on the placement drawings and was left to the contractor. Lap splices can be in either plane. This does not represent a discrepancy.

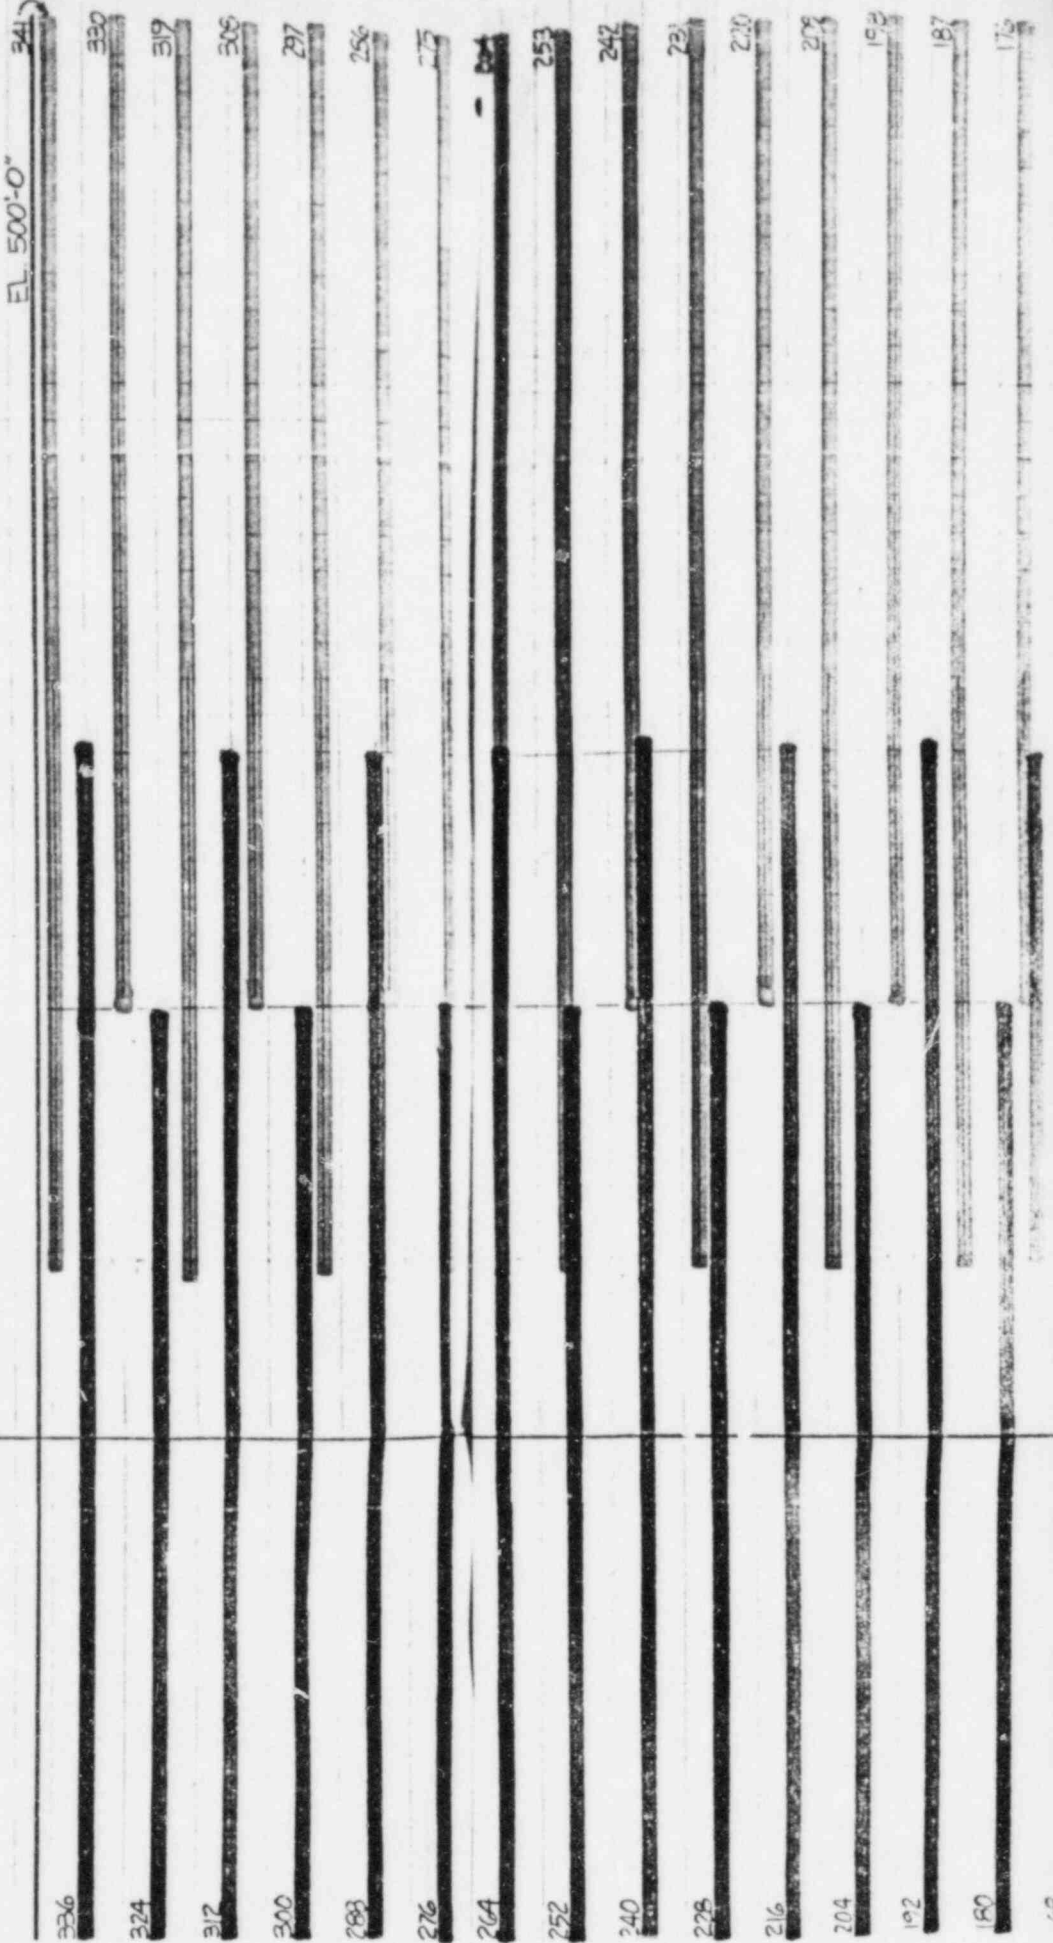
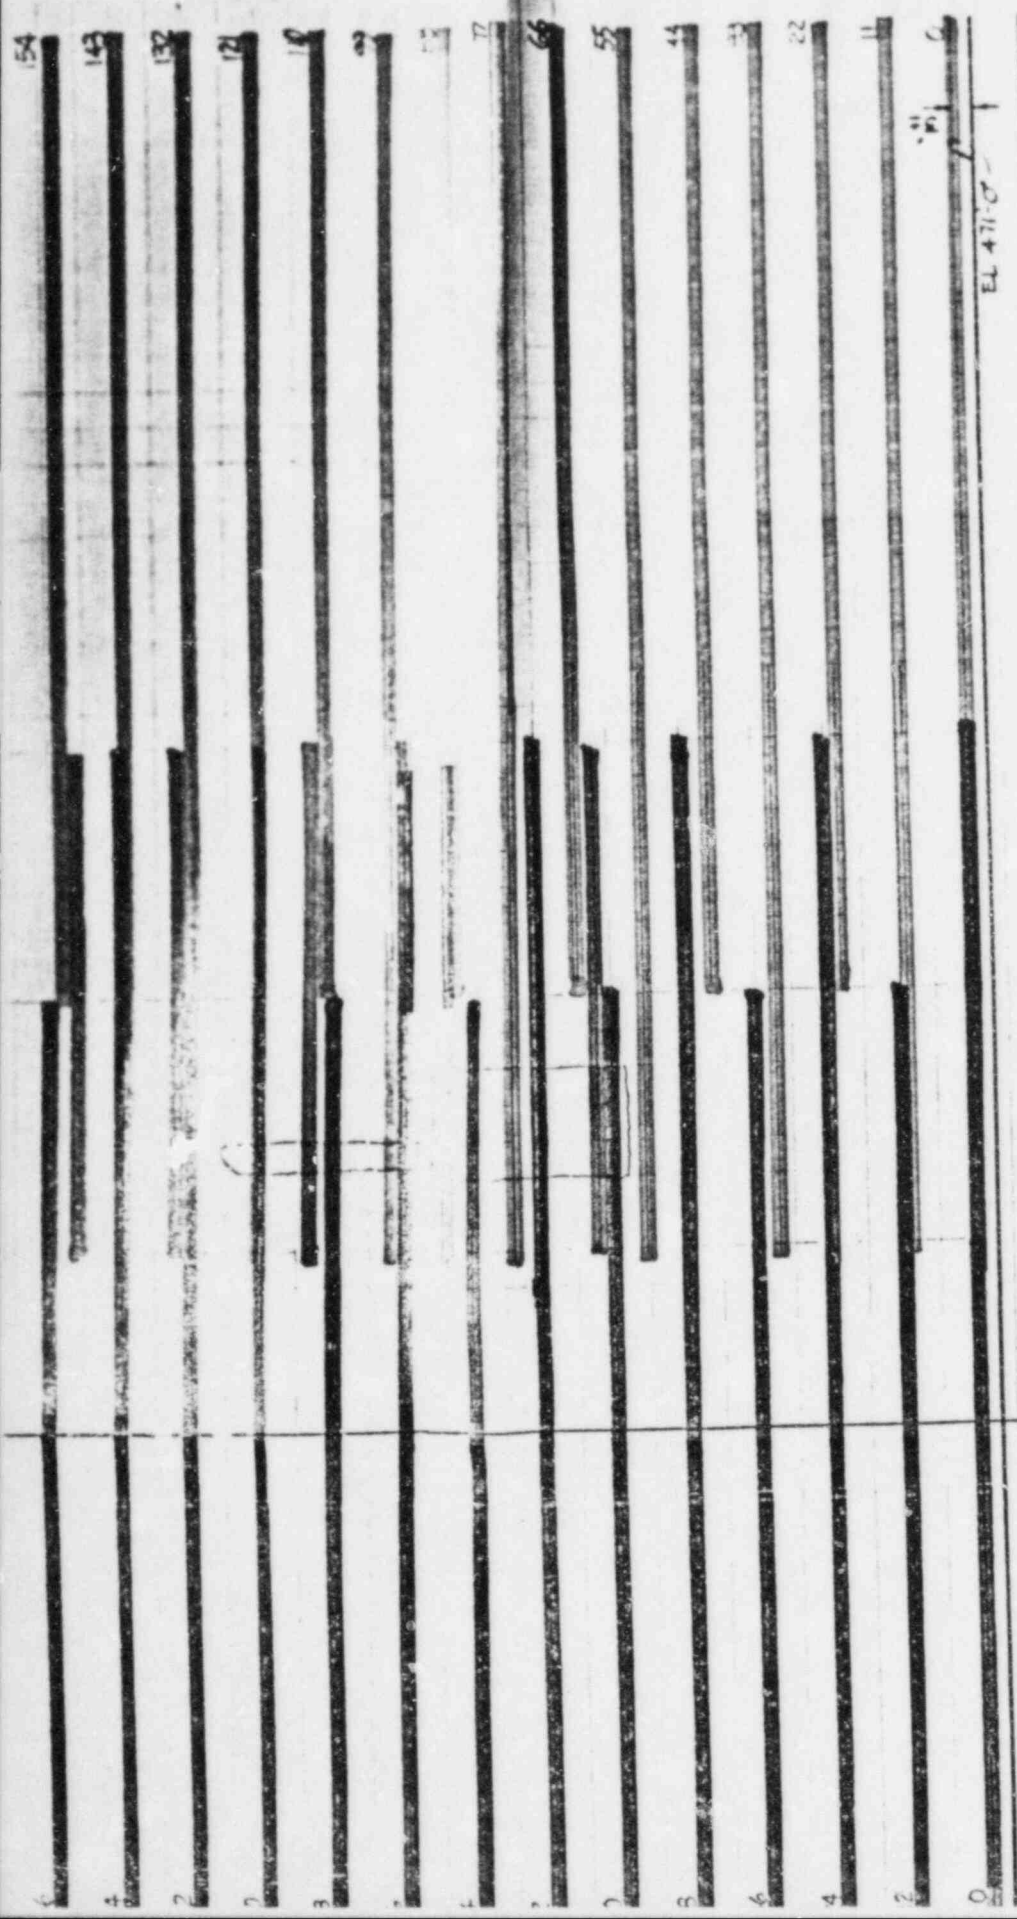
PART ELEVATION OF EAST WALL

LOOKING WEST
REBARS SHOWN PER BETH-STL DNG (APPD) AND PER RFI.
