# MEMORANDUM

FROM J.M. McONAGHY, DPE DESIGN ENGR'S SUBJECT NCI 9092 - DOME PITTING

# TECHNICAL EVALUATION-INDIVIDUAL CONCERN

FIGURE 9092.1  
DOME PLATE SURFACE  
FLAW ACCEPTANCE  
CRITERIA

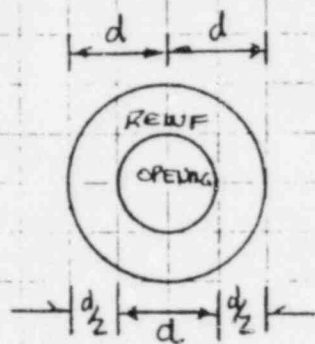
NE-3334.1a

ELEV. OF OPENING

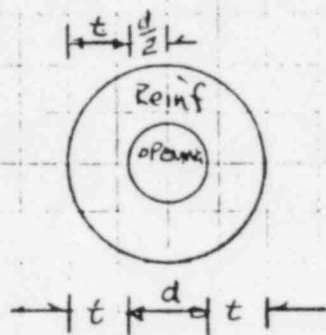
NE-3334.1b ( $t_{nozzle} = 0$ )  $t$  = wall thickness

GREATER OF TWO AREAS IS TO BE COUNTED AS REINFORCEMENT.

NOTE THAT IF  $t > d/2$  [ie  $d < 2t$ ], NE3334.1b ALWAYS GIVES GREATER REINFORCING AREA.

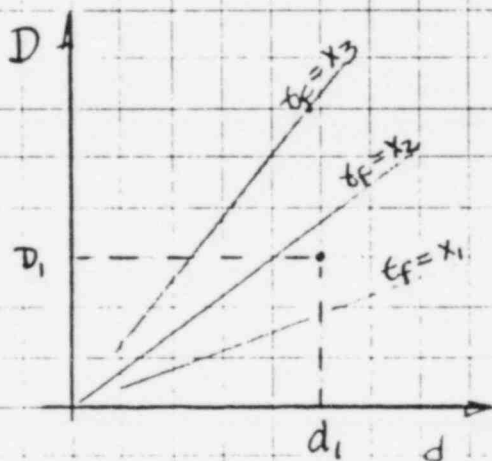
$$D \geq k_e d \quad \text{where} \quad k_e = \frac{t_f}{t - t_{re}} - \frac{1}{2}$$

THIS IS A FAMILY OF STRAIGHT LINES ON  $D$  vs  $d$  plot for different flaw depths  $t_f$

EXAMPLE: flaw w/ diameter  $d_1$  and spacing  $D_1$  is acceptable if it is  $x_1$  deep and unacceptable if it is  $x_2$  deep.

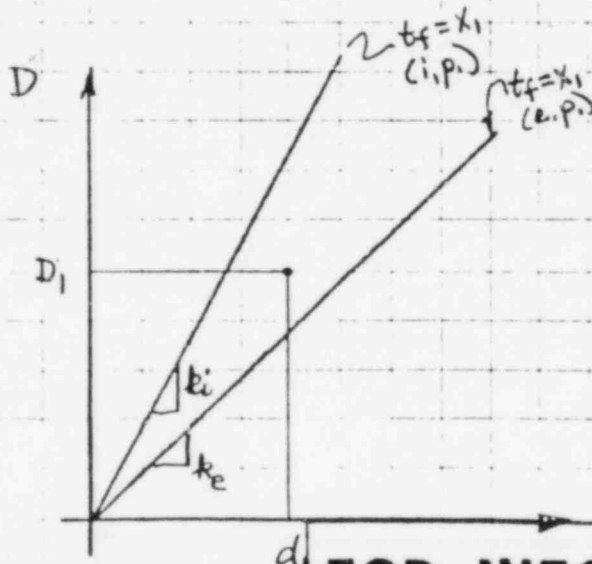
$\therefore$  For  $\left. \begin{array}{l} P_{ext} = 1.5 \text{ psi} \\ P_{int} = 15 \text{ psi} \\ t = .699'' \end{array} \right\}$ , external pressure always controls the acceptability of surface flaws.

Flaw  $\phi d_1$ , spacing  $D_1$ ,  
depth  $t_f = x_1$ , is OK FOR  
internal pressure, NOT FOR  
external pressure as  
long as  $k_i > k_e$ .
