GRAND GULF NUCLEAR STATION
COMPREHENSIVE REPORT ON STANDBY DIESEL GENERATORS -
SIGNIFICANT ACTIVITIES TO ENHANCE AND
VERIFY RELIABILITY

February, 1984

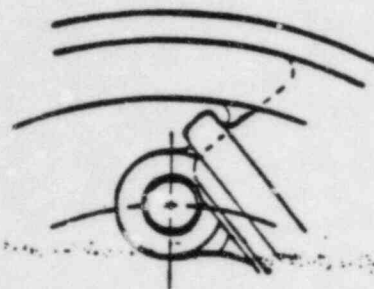
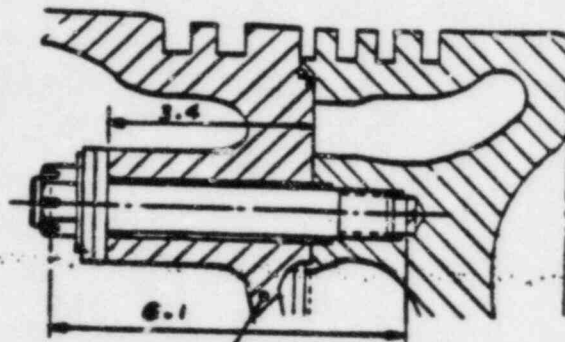
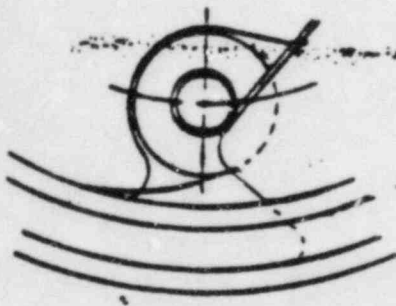
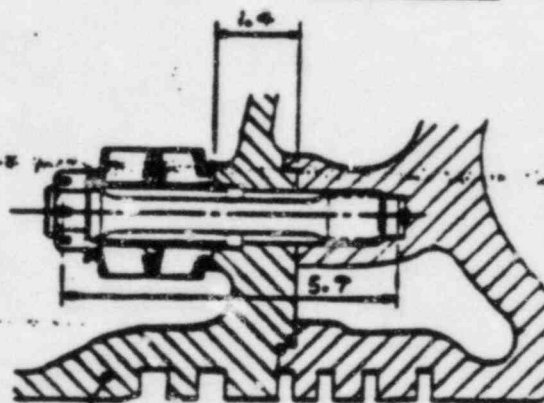
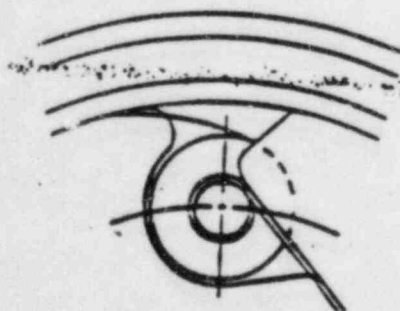
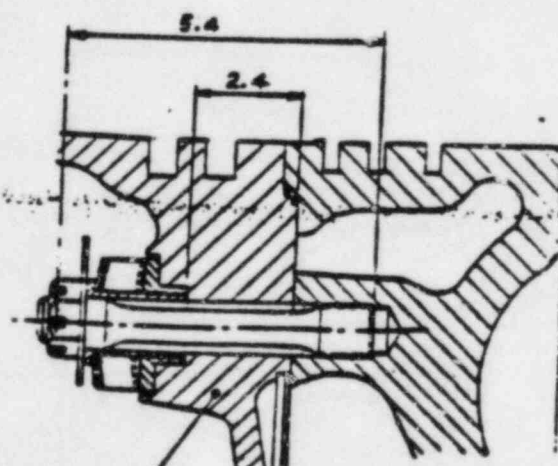
FIGURE A2-1: PISTON COMPARISONS

The "AE" design utilizes a "half stack" Belleville washer arrangement. All "AE" skirts are heat treated to produce stress relieved 100,000 psi tensile strength nodular iron. All piston skirts in the TDI units at GGNS Unit 1 have been replaced with this design. The "AE" style skirt is interchangeable with existing R-4 piston crowns and requires only minor hardware changes.
