SNUPPS

SLNRC 83-0063 FILE: 0671.1
SUBJ: NUREG-0737, Item I.D.1 "Control
Room Design Reviews"

HUMAN ENGINEERING FINDINGS AND RESPONSES

SNUPPS CONTROL ROOM

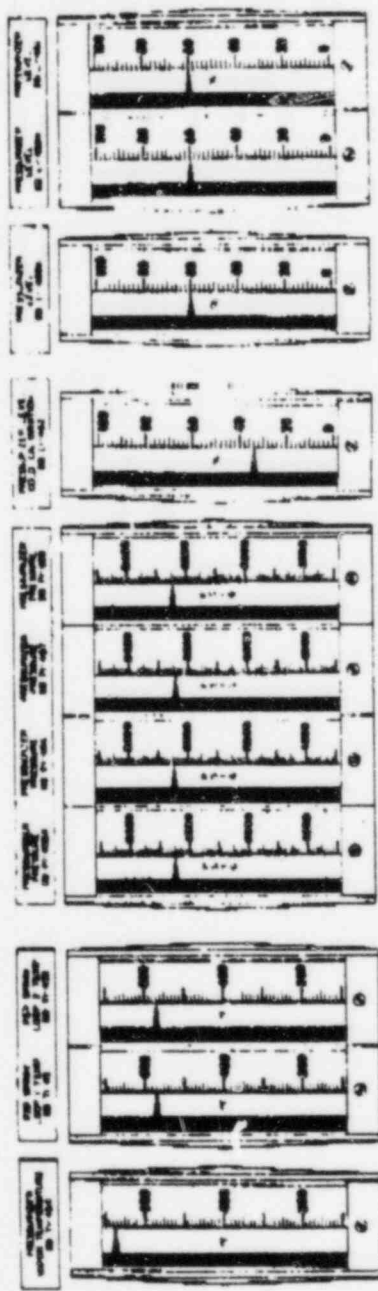
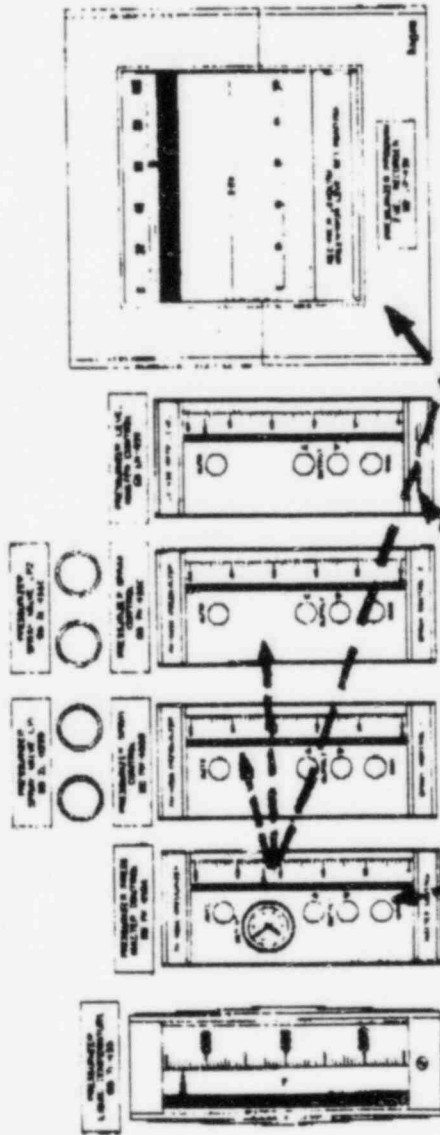
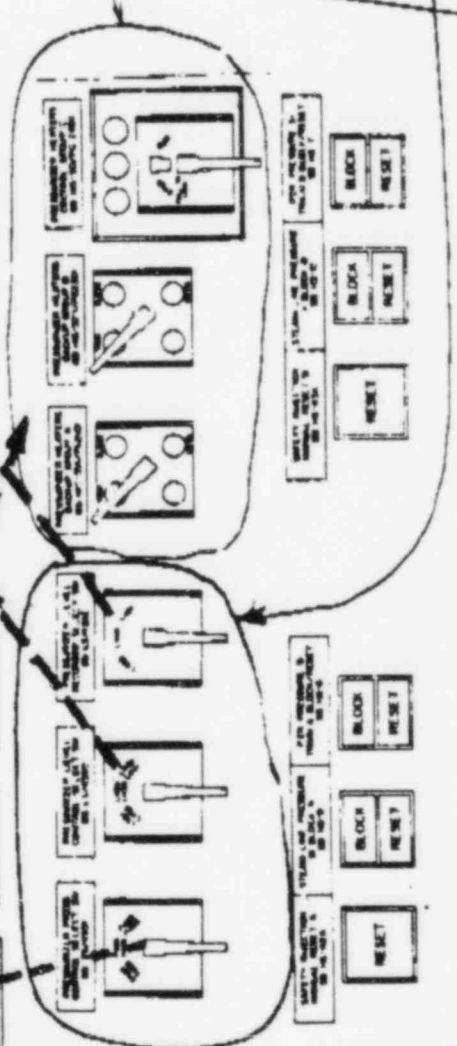
Pressure heater controls

4. The channel select switches are logically located with respect to the Process Controllers that they affect. See the drawing for signal relationships.

5. Normal operation of the Pressure Control System is completely automatic, and does not involve any Operator manipulation of these switches. Manual operation uses the push buttons on the Process Controllers, and again, does not involve these switches.

Heated select switches
(refer to as pressure and level
controls in HEP 9.14)
