TITLE METALLOGRAPHIC EXAMINATION OF A FUEL ROD FROM  
SEGMENT 2 FSV FUEL ELEMENT 1-2415

906968

TITLE: METALLOGRAPHIC EXAMINATION OF A FUEL ROD FROM SEGMENT 2 FSV FUEL  
ELEMENT 1-2415

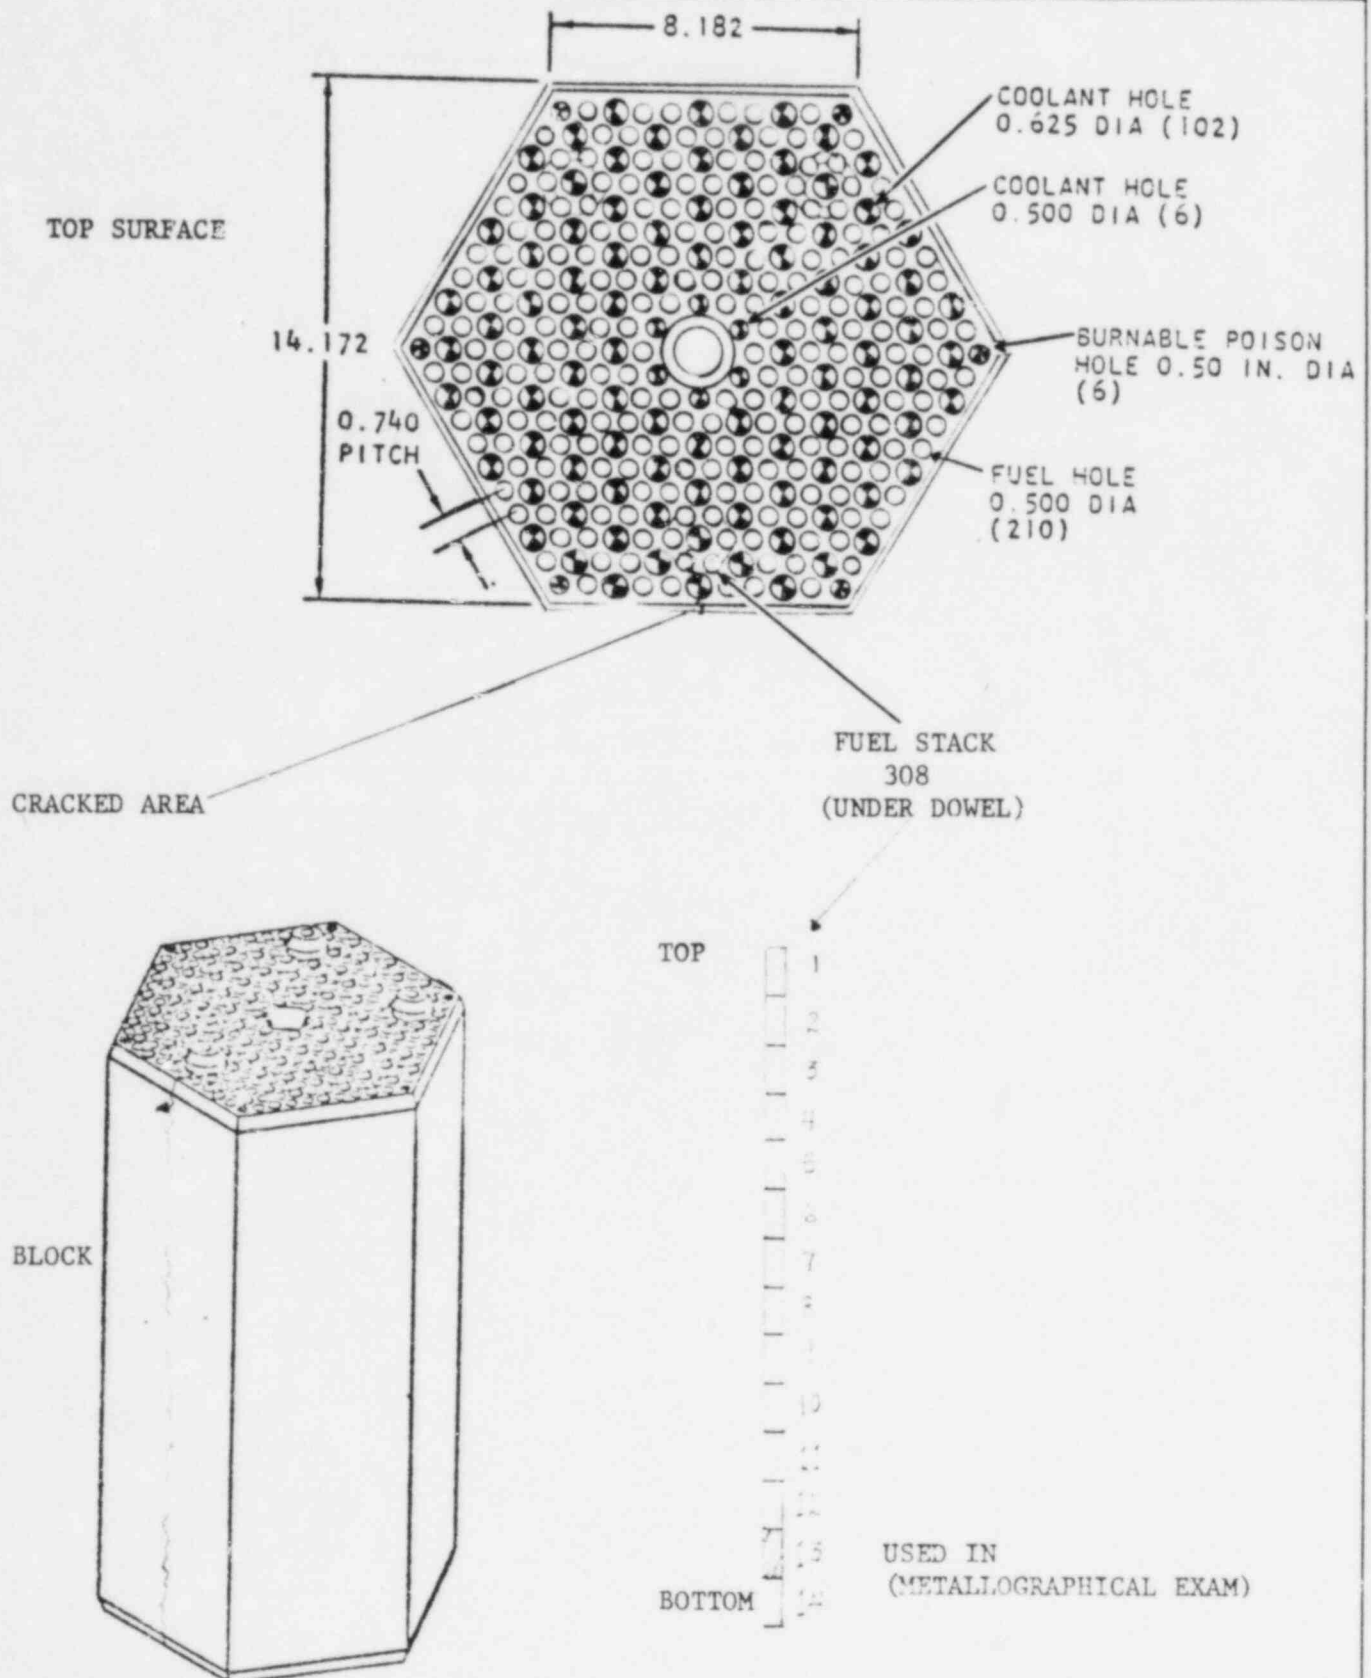
Fig. 4 Location of fuel rod used in metallography

The metallographic examination was performed in accordance with the procedure outlined in Reference 5. Irradiated fuel rod 13 from fuel stack 308 was subjected to metallographic examination because it was expected to have a high temperature history relative to the fuel elsewhere in the element and, thus, would provide an indication of thermal effects in the fuel earlier than fuel rods from lower temperature portions of the element. This fuel rod, which was one rod length above the bottom of the fuel hole, came from the axial location in the block where the power peaked (Ref. 6). Fuel stack 308 was chosen because it was located under the dowel pin of face B adjacent to the cracked web. Figure 4 shows the location of fuel stack 308 in reference to the cracked web. In general, the appearance of the fuel rods from stack 308 was good, with no evidence of fuel rod-block interaction. A little chipping at the ends of the rods and some debonding of particles from the rod were observed (see Fig. 5). Rods which were chipped and slightly debonded on the ends appeared similar to the preirradiated rods and are not believed to have been damaged during operation or by the extraction of the stack from the fuel block. This conclusion is further supported by the low pushout force ( $\leq 7$  lbs) required to remove the stack from the fuel element. Also, the small amount of debris collected from the emptied block is indicative of a lack of fuel rod-block interaction.
