Public Service Company of Colorado

SUBJECT: Fort St. Vrain Unit No. 1
Fuel Element Meeting

FORT ST. VRAIN
FUEL ELEMENT INFORMATIONAL MEETING
APRIL 4, 1984

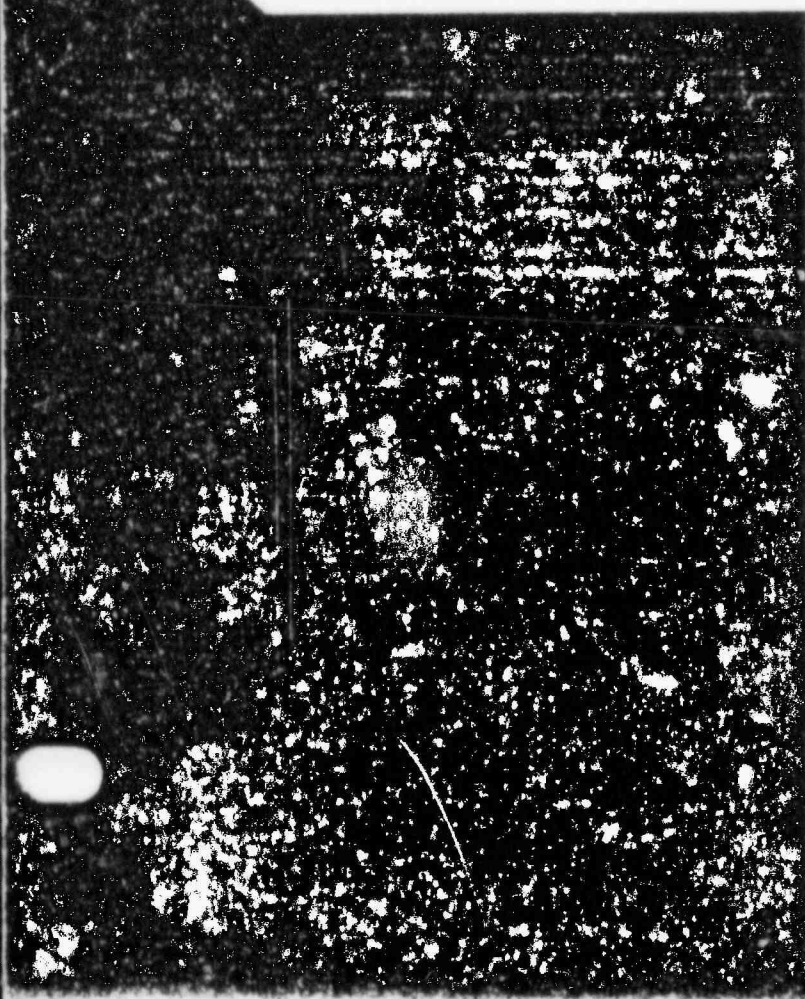
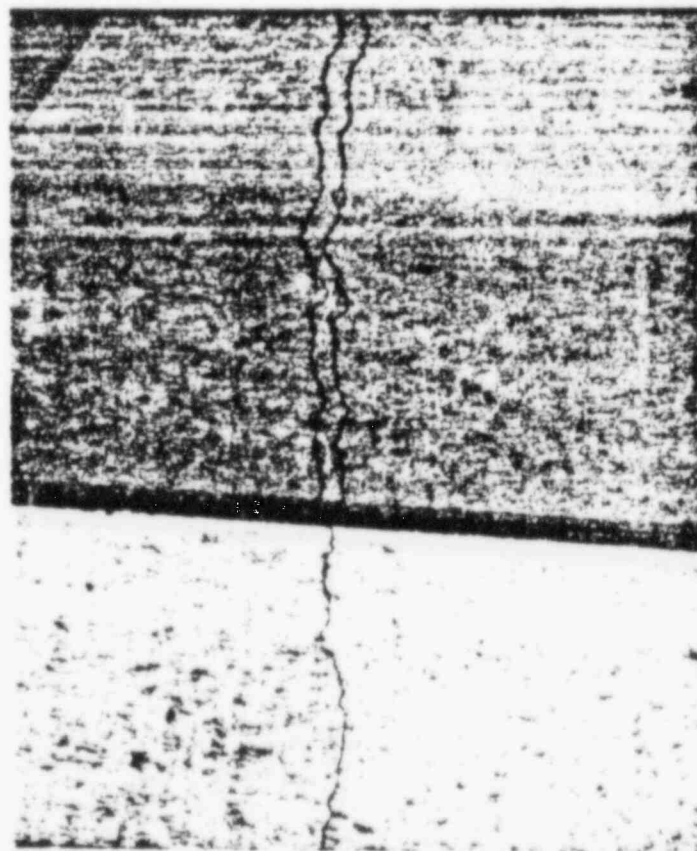
A detailed description of the probable causes for two cracked elements from Segment 2 was presented. The probable cause was defined as a high tensile stress experienced on the "B" face of the elements induced by high thermal gradients and shrinkage induced by neutron flux.

- A. There have been two (2) fuel elements (1-2415 and 1-0172) that have hairline cracks vertically along the "B" face.
- B. A program to investigate these two (2) elements to determine probable cause as well as any detrimental effects has been set forth.

Crack Appearance
Enhanced

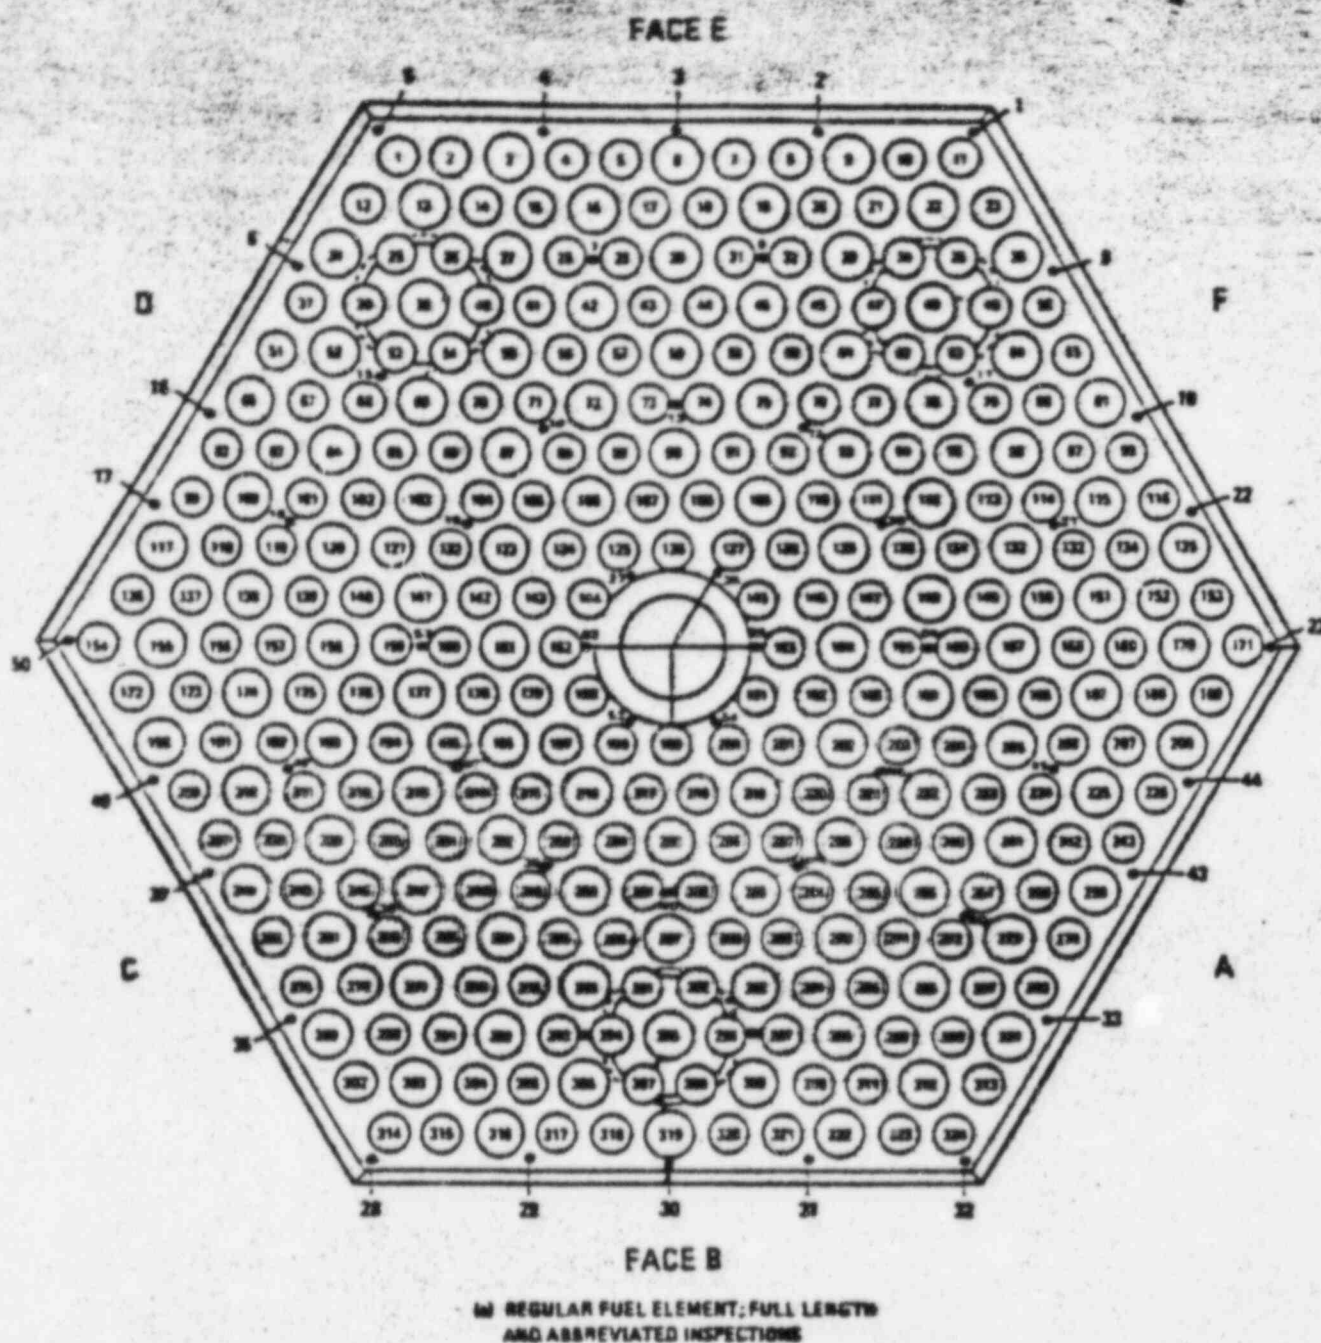
**CRACK PATTERN IN FORT ST. VRAIN
FUEL ELEMENT NO. 1-2416**

SKEWED POWER/FLUX DISTRIBUTION + INCREASED THERMAL
GRADIENT

RESULT - GREATER IRRADIATION INDUCED CONTRACTION +
TENSILE STRESSES

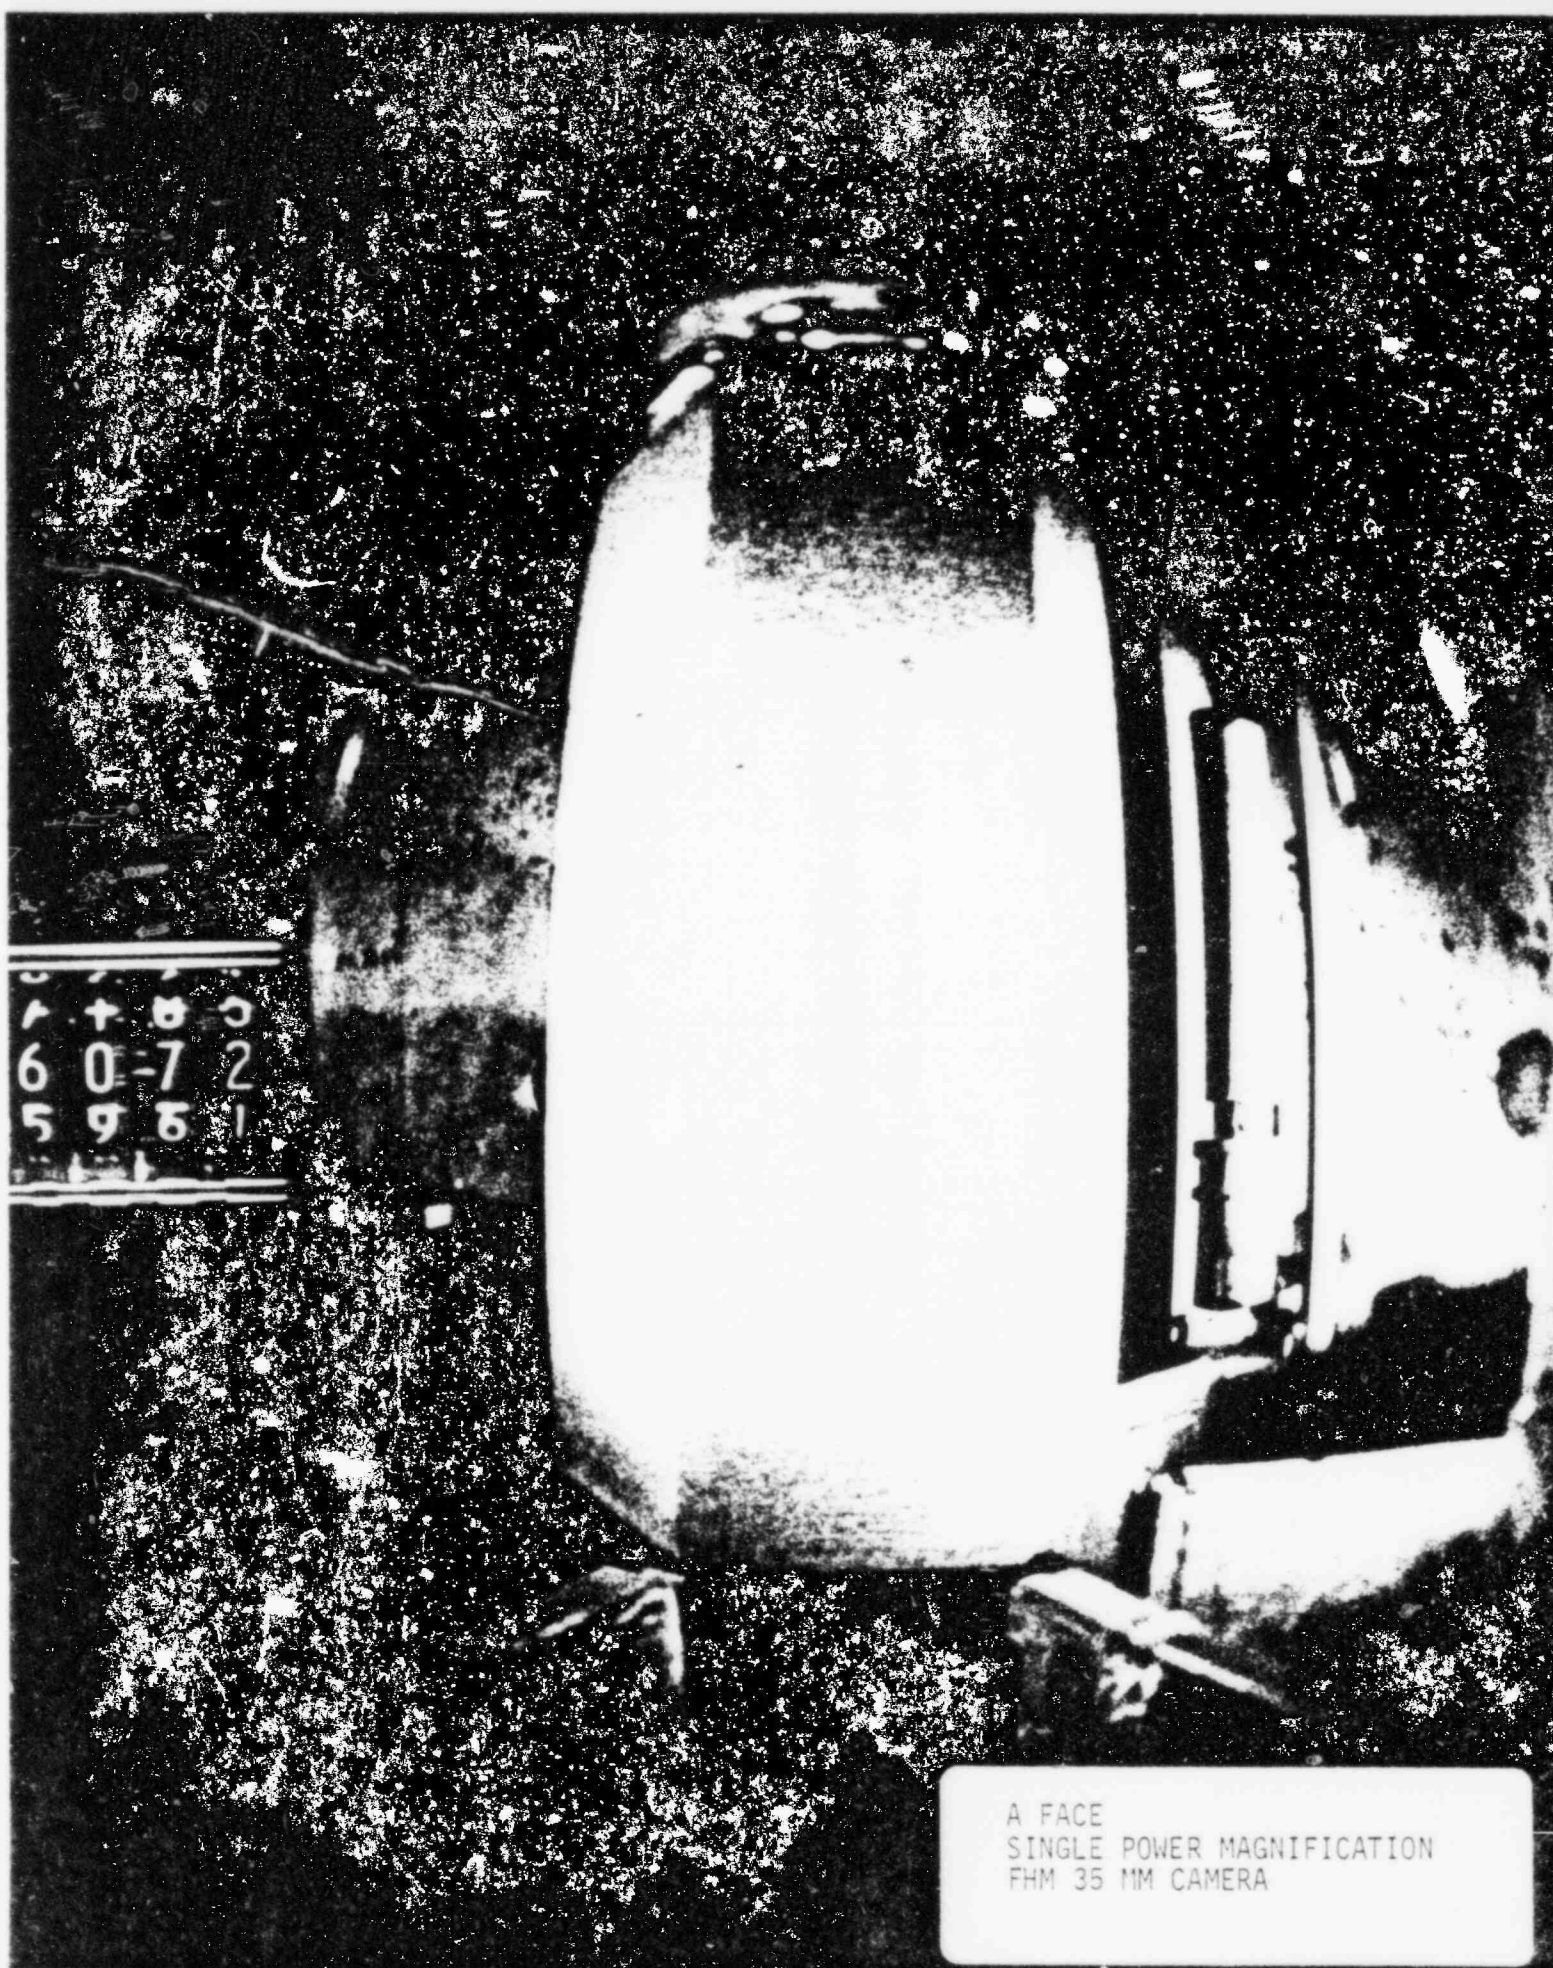
- A. No significant fuel damage was found for those elements inspected. The elements had stains, scratches, abrasions, minor gouges, all of which were typical of previous segment inspection results. No fuel element cracking was identified.

A FACE
SINGLE POWER MAGNIFICATION
FHM 35 MM CAMERA

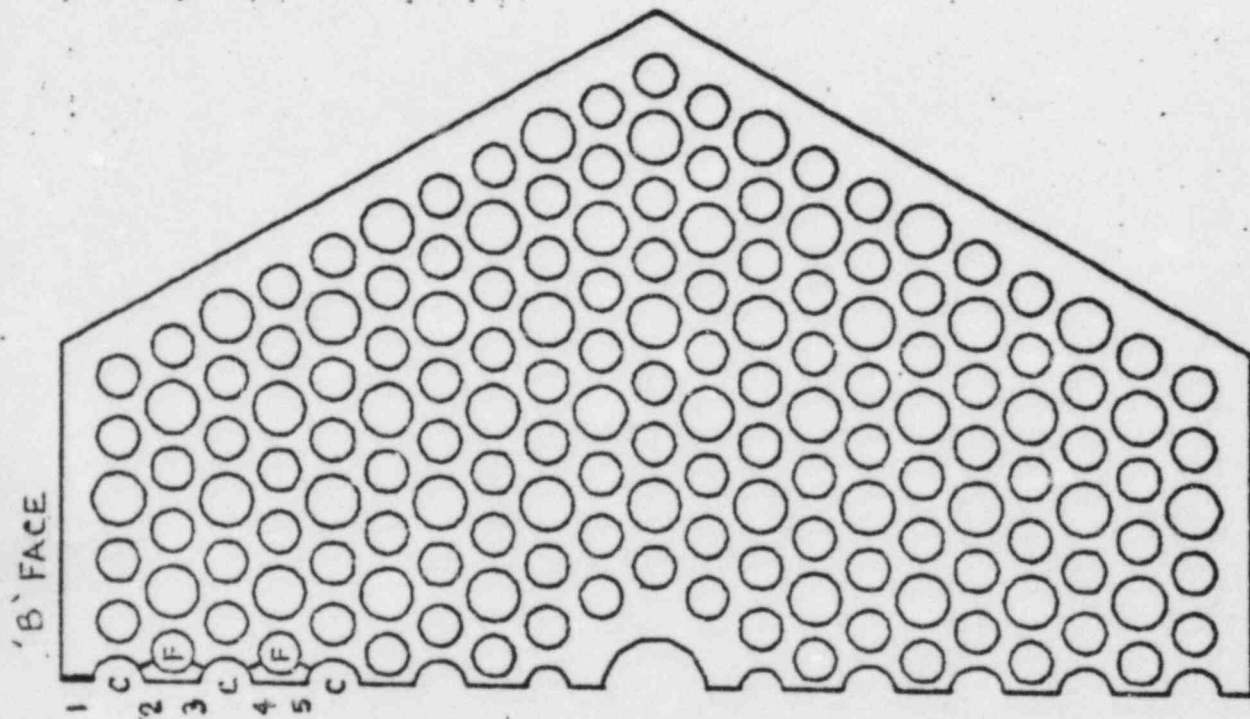
FSV FUEL ELEMENT WITH SIMULATED CRACKS

Loading tests of typical H-327 unirradiated fuel elements were conducted with fuel element web cracks being simulated by physically cutting the webs with a hack saw. The results of various loading combinations along with combinations of fuel element web failures (from 0 to 3) were presented.

- D. Given the possibility of fuel element cracking actual load testing was performed on elements with various combinations of cracked webs. The end result of the testing indicates that with various combinations of cracked coolant hole/fuel hole webs from 0 to 3, the strength of the fuel element is essentially unaffected. Even with cracked webs it would take in excess of 100,000 lbs. of compressive load to fail a fuel element.

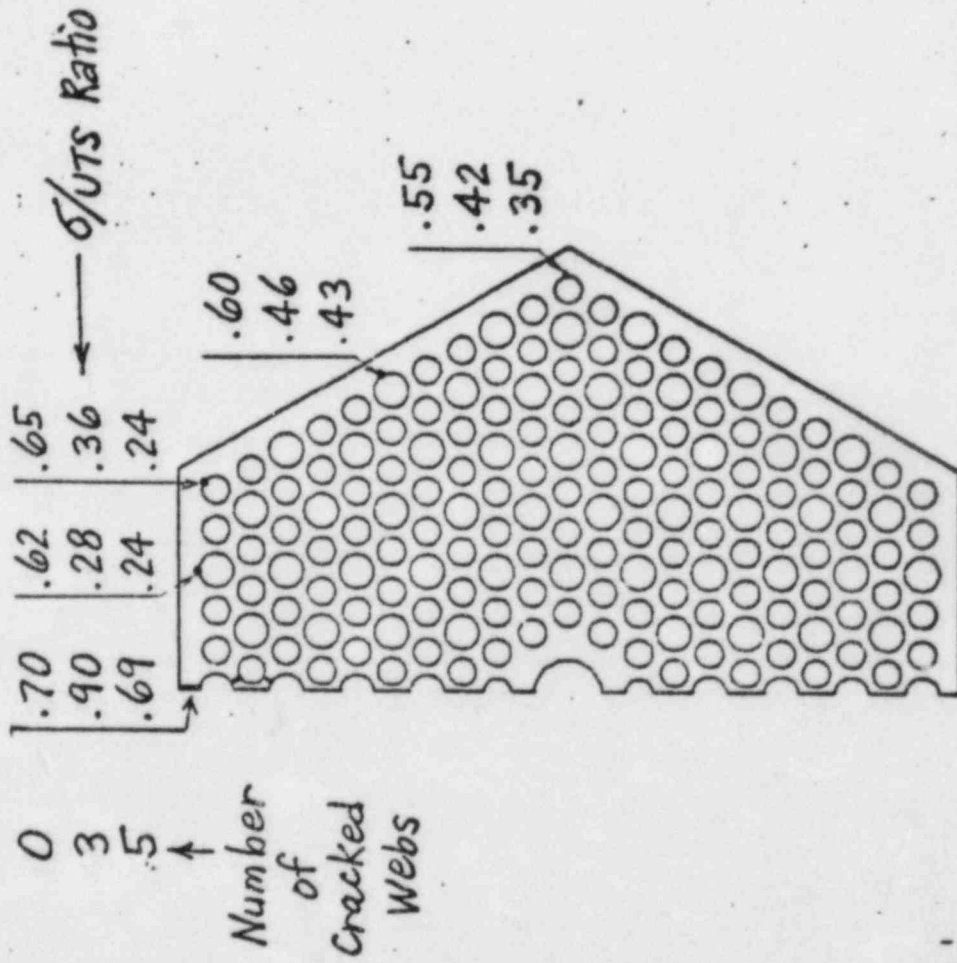
STRESS REDUCTION AFTER CRACKING

- C. Detailed stress analysis of the Fort Saint Vrain elements indicates that crack progression in the element is limited. As coolant hole/fuel hole webs are progressively cracked the tensile stress is reduced. The result of progressive cracking of five (5) webs from the fuel element face inward indicates that tensile stresses are reduced to acceptable values within the strength of the graphite. Cracking in one area also significantly reduces tensile stress of the other inter-regional faces of the fuel element resulting in a low probability that cracking would occur in any more than one area of a fuel element.
