Subject: James A. FitzPatrick Nuclear Power Plant
Docket No. 50-333
Core Spray "A" Metallurgical Analysis

A METALLOGRAPHIC INVESTIGATION OF A
TYPE 304 STAINLESS STEEL SCHEDULE 80 PIPE

AN INVESTIGATION OF FLAWS ON THE
INSIDE SURFACE OF A TYPE 304 STAINLESS
STEEL SCHEDULE 80 PIPE

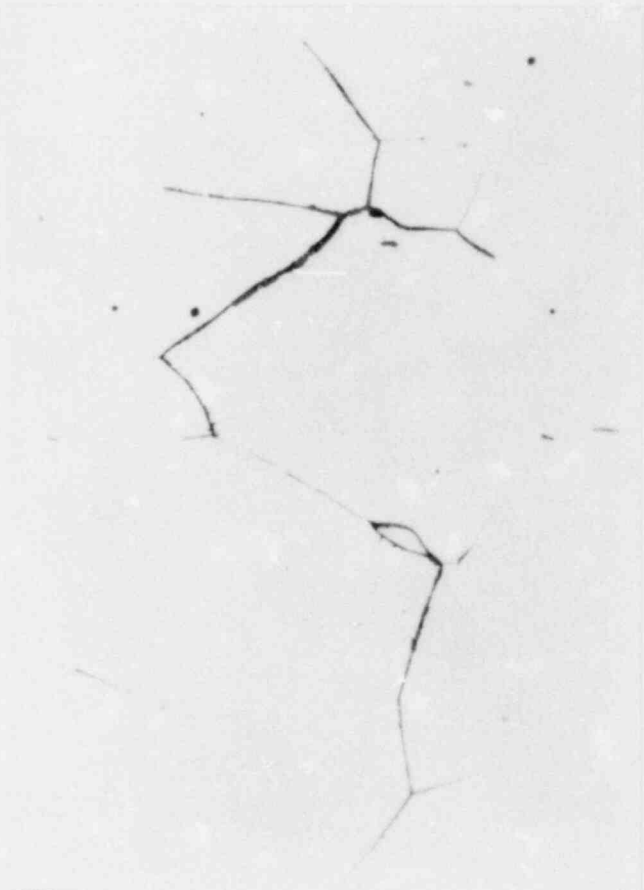
d. IGSCC at the 0.517-Inch Position
