Metallurgical Examination  
Cracked Field Weld No. 212  
Feed Water Pipe to Nozzle; Steam Generator 1-2.

Pacific Gas & Electric Co.  
Diablo Canyon Nuclear Project

Pullman Power Products Co.  
Williamsport, Pennsylvania

Date: 6/23/77

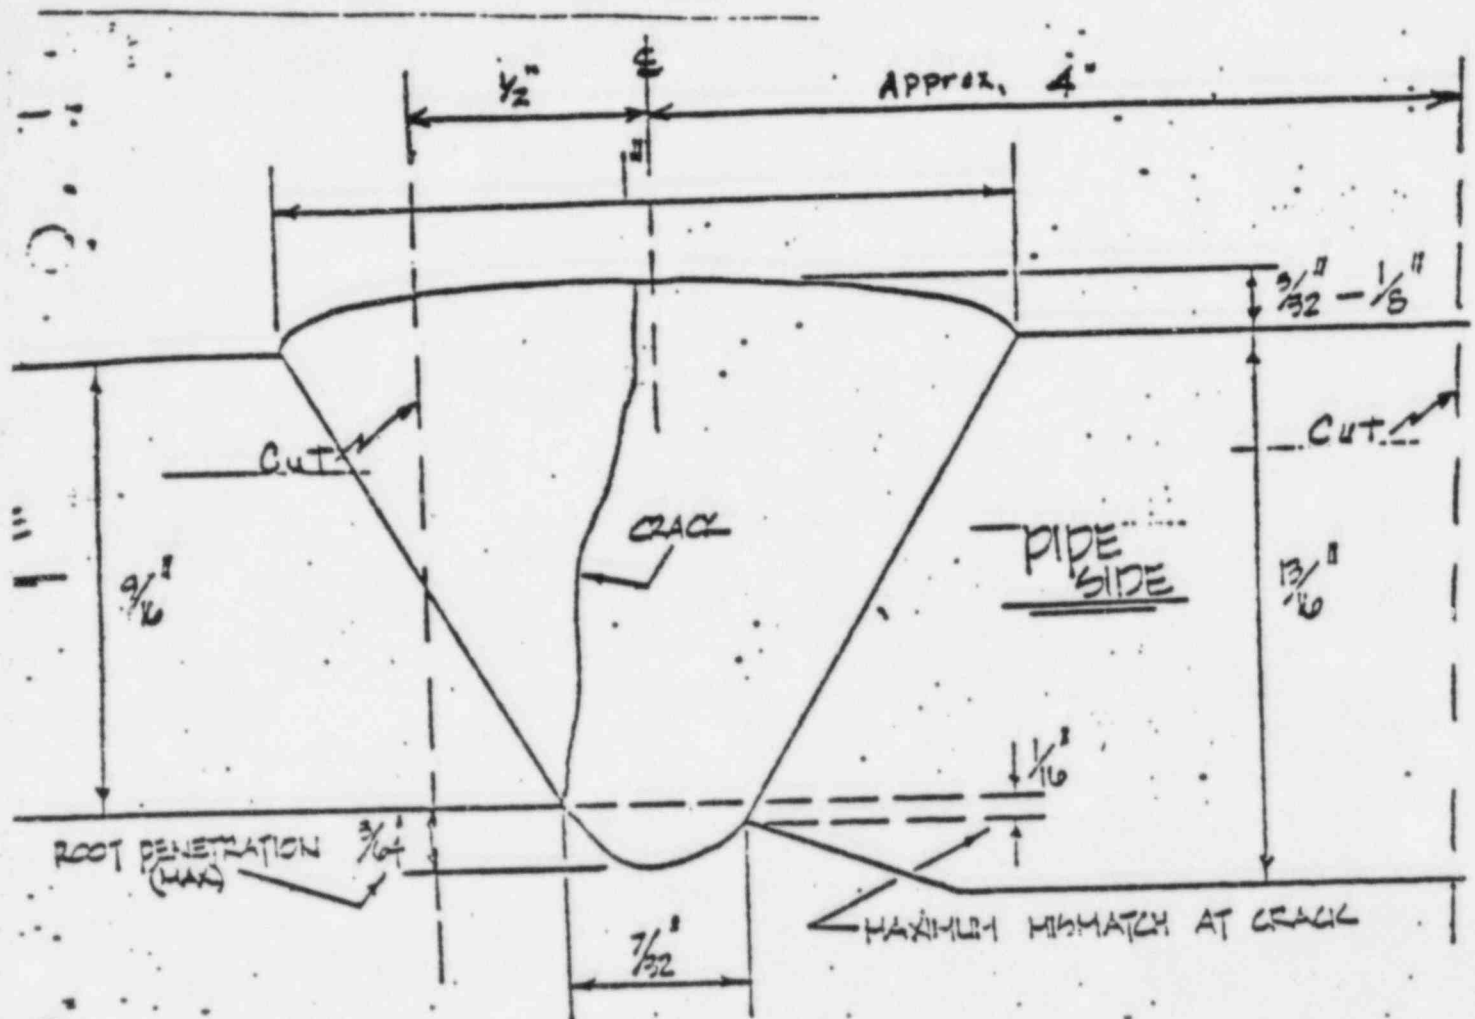
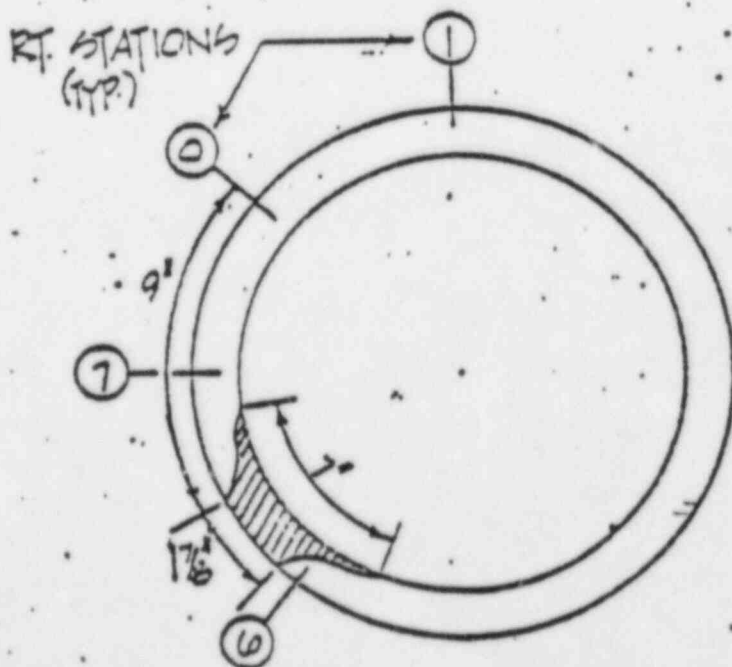
1. WALL THICKNESS MEASR. ARE APPROXIMATE
2. REF. TO DR. 3366 REV A
3. STEAM GENERATOR 1-2  
FW. #212  
NO. 500140  
LINE # KU-555-10 II

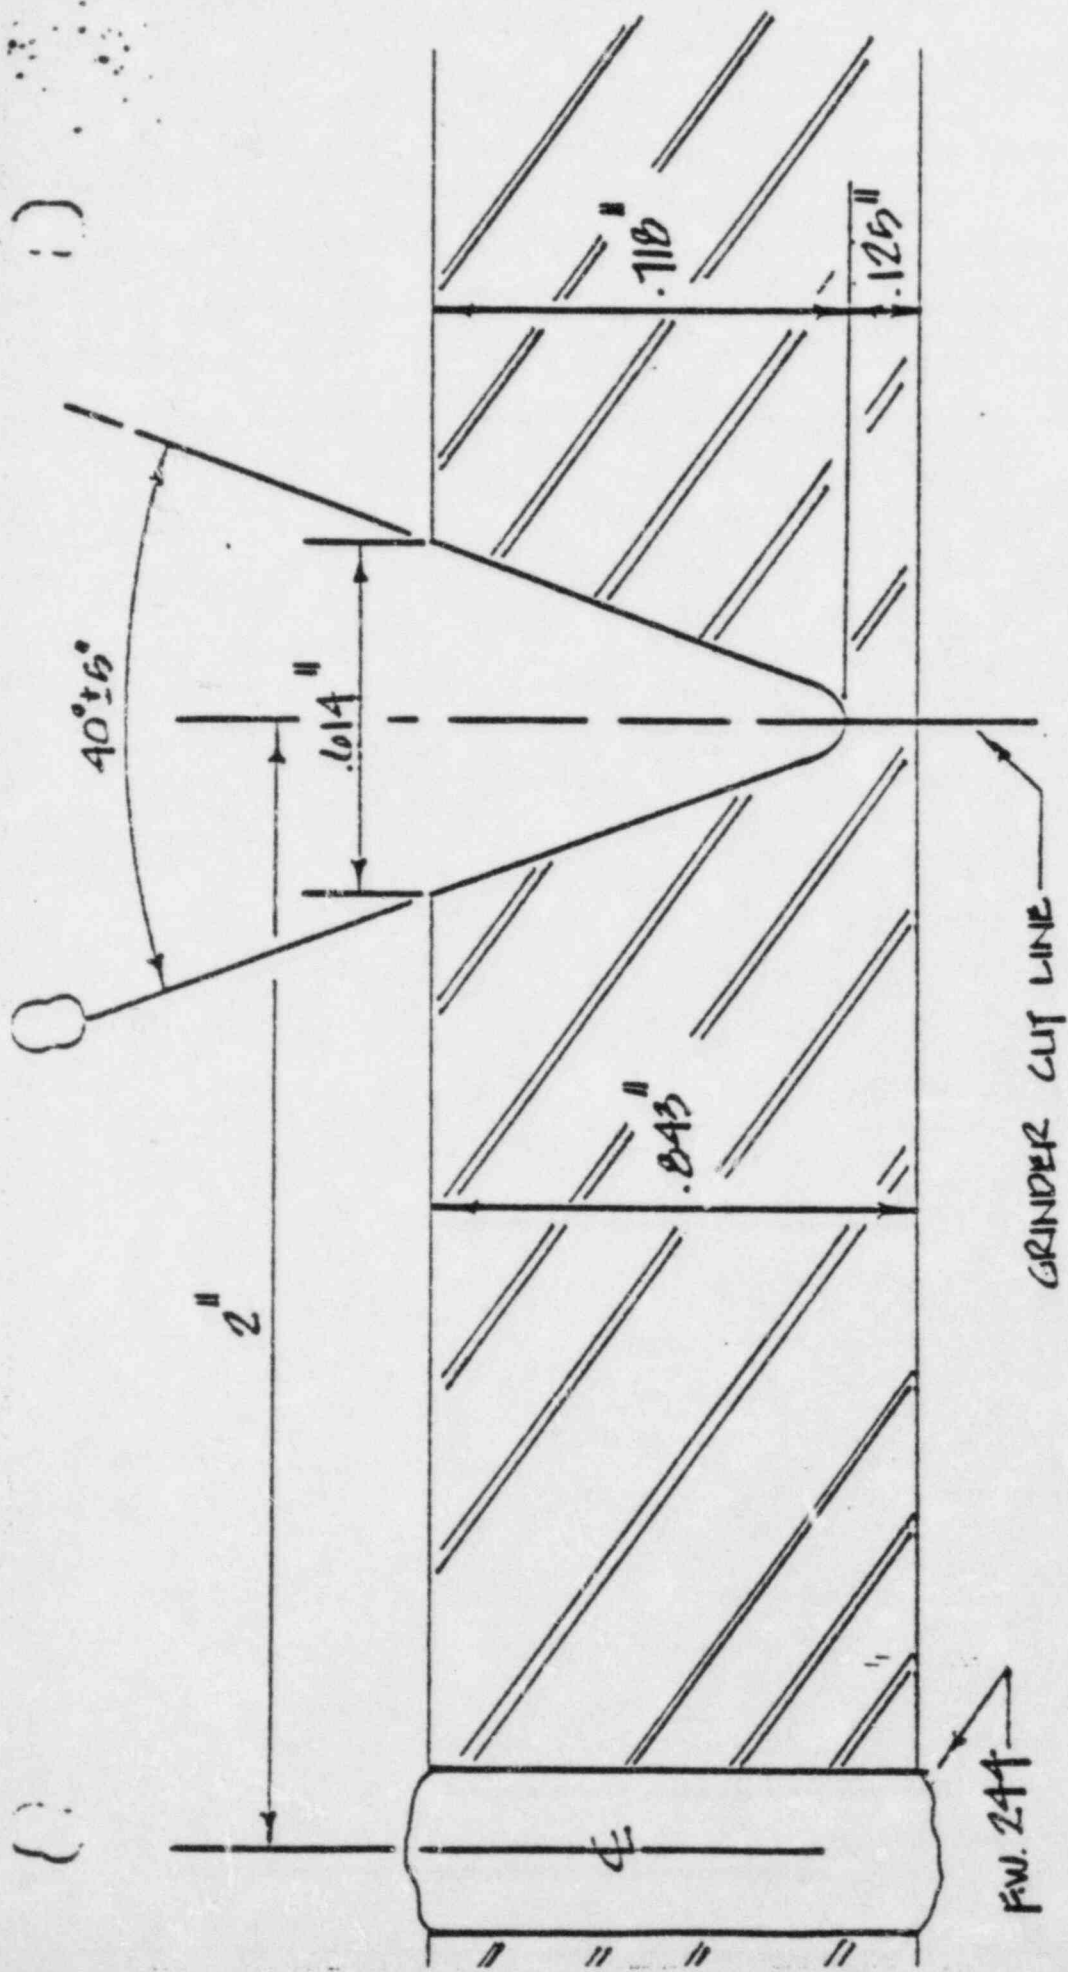
#  
DR-3453  
SKETCH #1

The following indications were noted:

- Stress relieve at F.W. 244 R1 and F.W. 549 1100°F to 1150°F per ESD-218.
- NDE F.W. 244 R1 and F.W. 549 to ESD-207.
- " " " " to ESD-211 PGSE 9/30/77
- Add information to process sheets.

We recommend that the root pass be ground and polished to blend with base metal surfaces. Particular care should be taken to avoid the removal of base material. Then re-examine the I.D. with liquid penetrant, if acceptable, proceed to "Recommended Disposition", Step 7 of D.R. 3453, Revision 1.

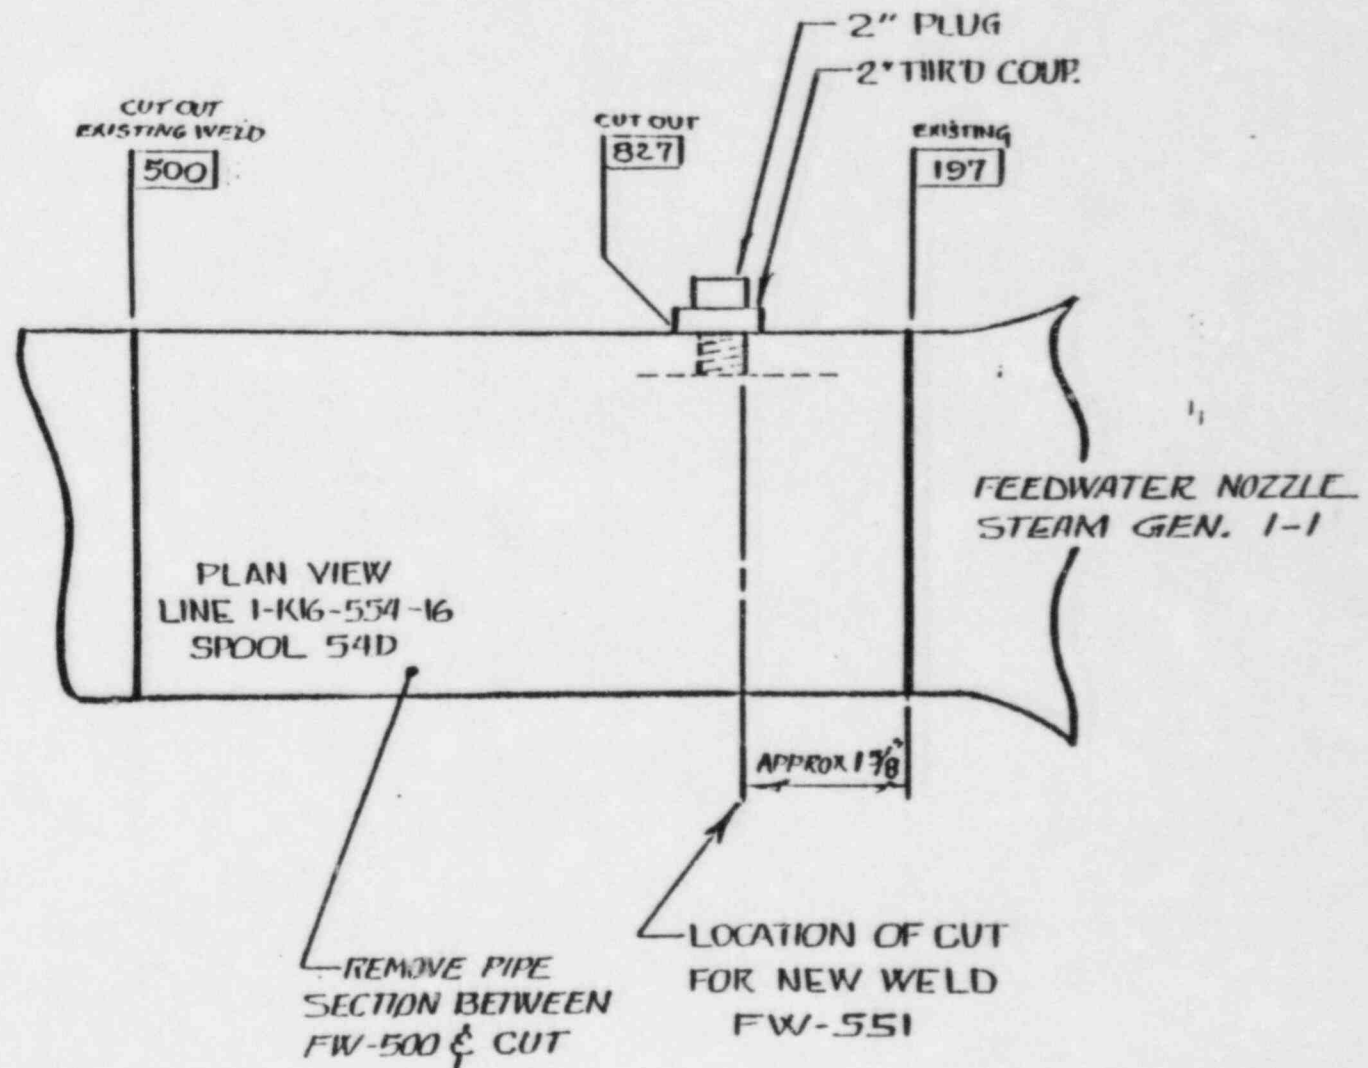
NEW PUP BETWEEN  
FW-500 & FW-551  
WITH GAMMA PLUG  
ON SIDE OF PIPE.

REWELD  
[500]

- Weld the 5 3/8" Grindout to original I.D. configuration using Procedure 200.
- Grind 5 3/8" repair for R.T. while maintaining pre-heat.
- M.T. to ESD 207 or Hot P.T. by P. G. & E. D.E.R. *207*

- Grind inclusion repair, if Step 3 is used, for R.T. while maintaining pre-heat.
- Perform Hot R.T. of repair area per ESD 207.
- Proceed with Step 10 of the original D.R. 3484 Recommended Disposition.
