GRAND GULF NUCLEAR STATION

UNIT 1

UPDATE REPORT ON TDI STANDBY

DIESEL GENERATORS

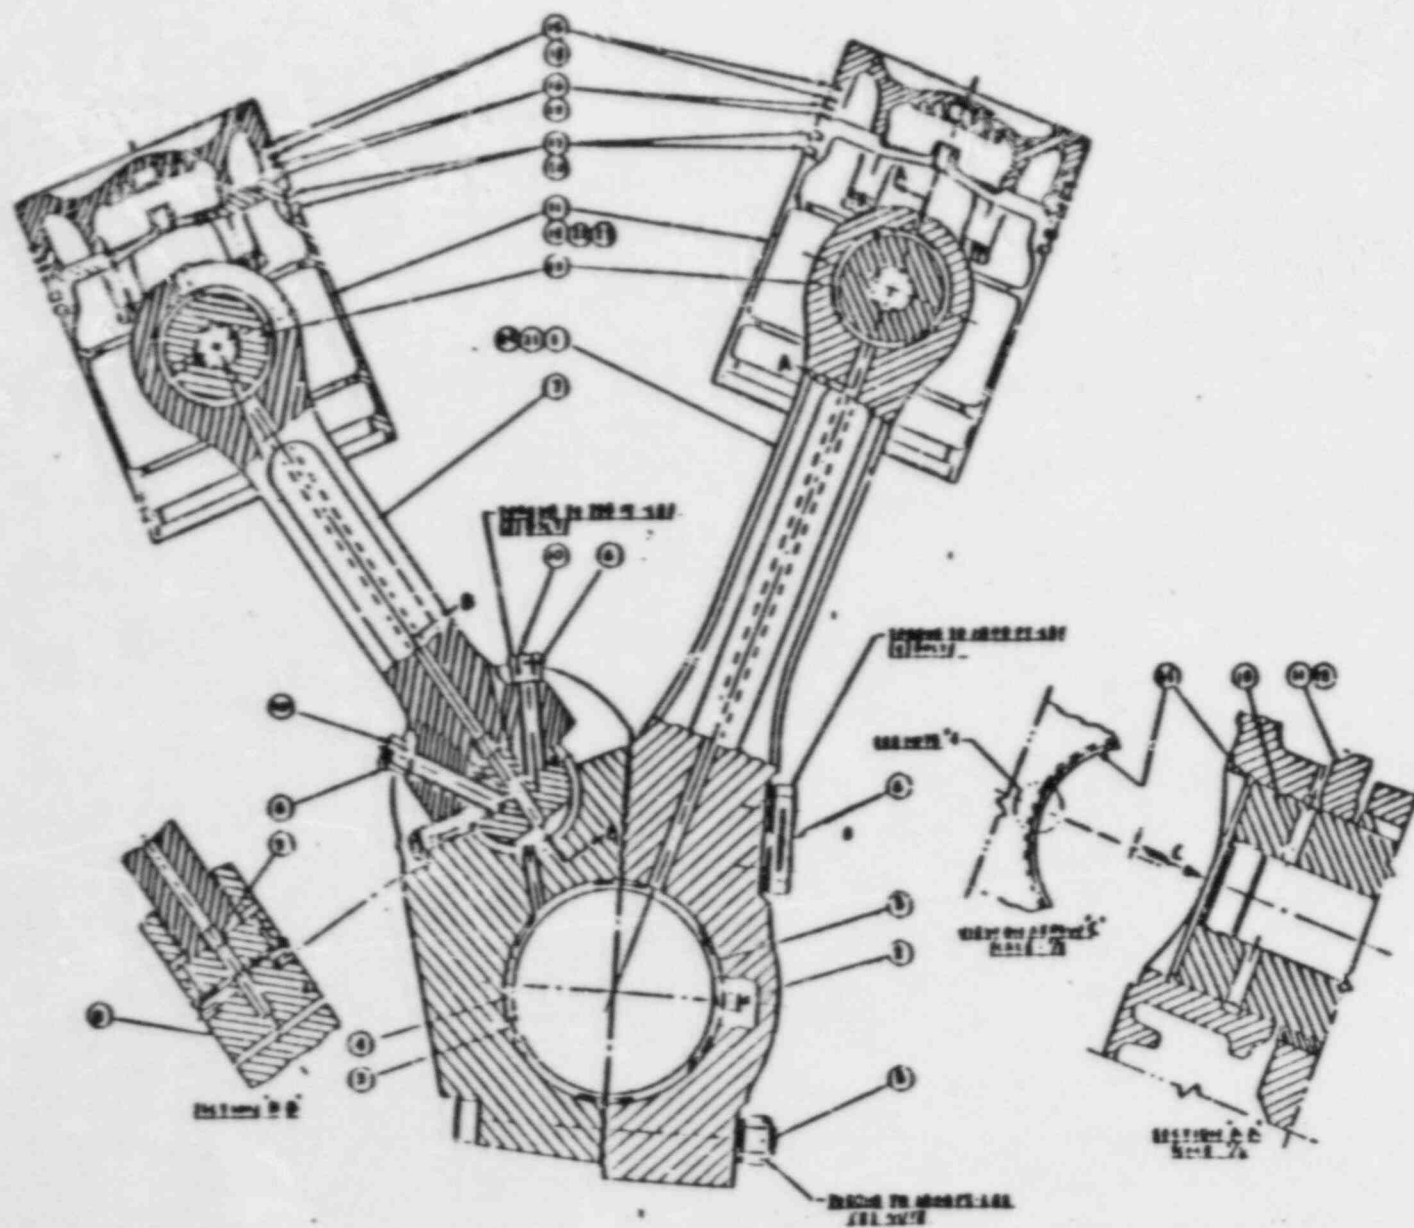
FIGURE A12-1: Articulated Connecting Rod Assembly

Based on low probable propagation rate of incipient cracks, relatively low run hours on Division I and II at pre-SIM 64 torques, and the expected low future run times, (estimated 200 hours/year) deleterious cracking of the GGNS connecting rods is not expected.

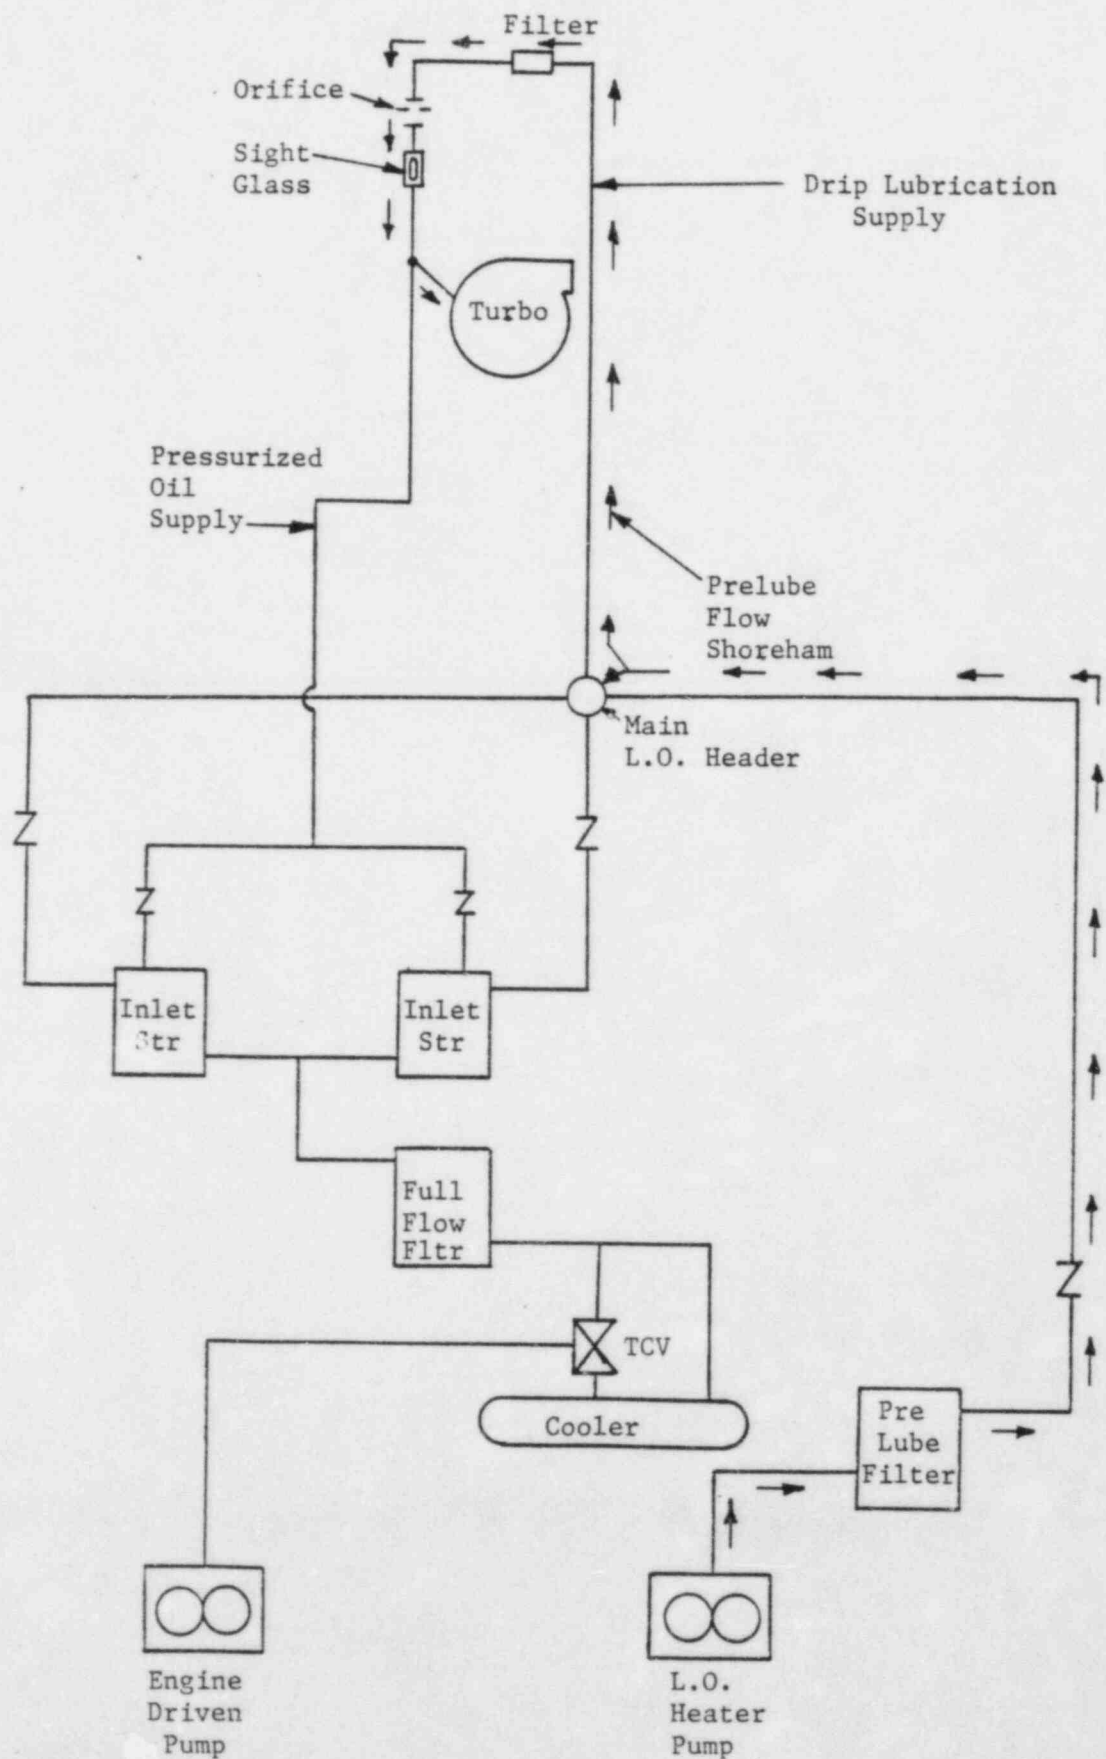
FIGURE 15-1: Illustration of Shoreham TDI Diesel
Generator Lube Oil System
(Reference Telecon Shoreham)

Shoreham's TDI D/Gs lube oil systems utilize two pumps, one an engine driven pump and the other an electric driven heater pump (See Figure 15-1). The GGNS D/Gs lube oil system utilizes three pumps, one an engine driven pump, one an electric driven heater pump and the other an electric driven auxiliary pump (See Figure 15-2).

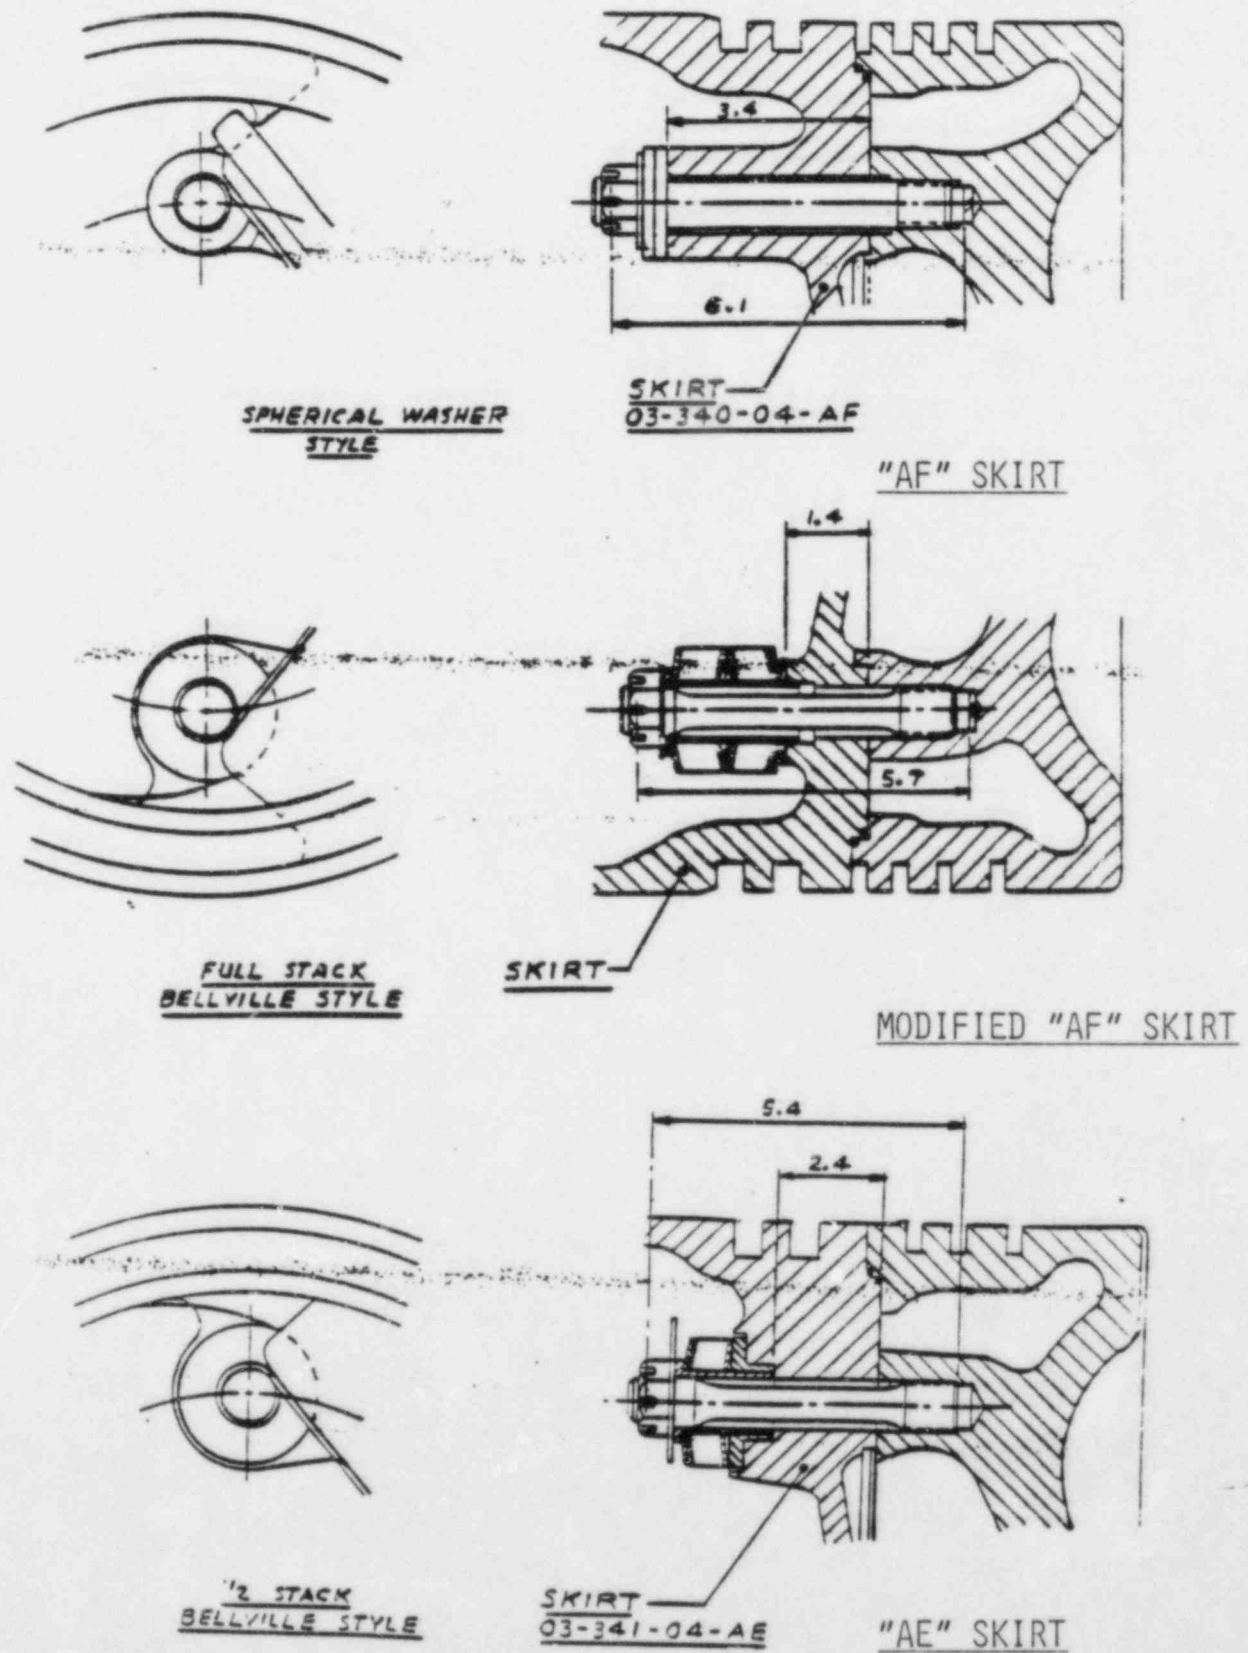
FIGURE A2-1: PISTON COMPARISONS

The "AE" design utilizes a "half stack" Belleville washer arrangement. All "AE" skirts are heat treated to produce stress relieved 100,000 psi tensile strength nodular iron. All piston skirts in the TDI units at GGNS Unit 1 have been replaced with this design. The "AE" style skirt is interchangeable with existing R-4 piston crowns and requires only minor hardware changes.
