Subject: Oyster Creek Station
Docket No. 50-219
Safety Valve Seat Bushing Cracks

OYSTER CREEK NUCLEAR GENERATING STATION

Safety Valve Seat Bushing Cracks

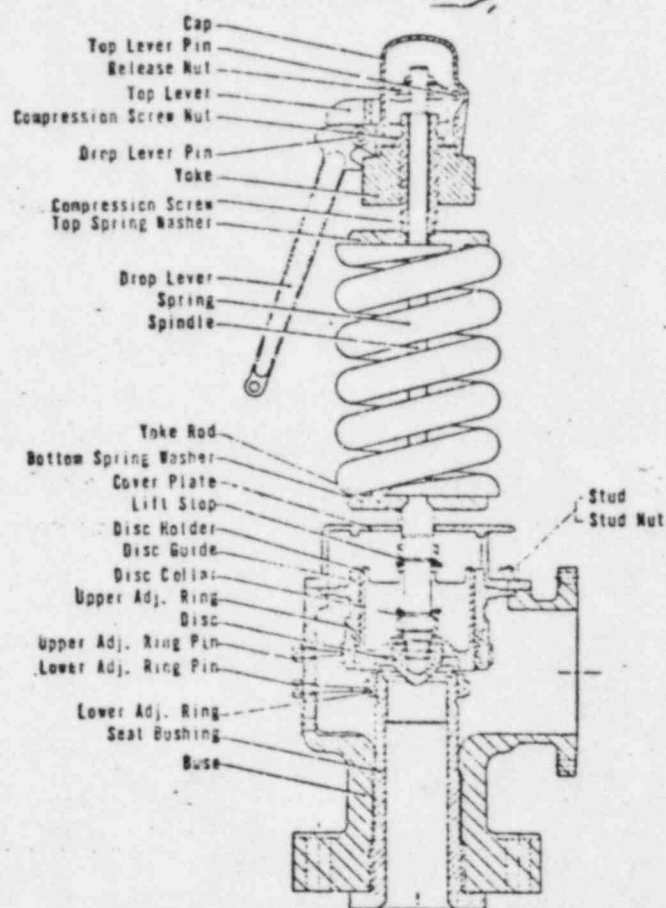
FIGURE I - MAXIFLOW SAFETY VALVE

With the exception of the cracks across the seating surfaces, the longitudinal and circumferential cracks on the outside of the seat bushings were located below the water level mark.

In summary, the environment at the seat bushing during plant operation was hot steam and water, free oxygen, chloride contamination and stress in the seat bushing from the reactor pressure of 1020 psi. Under these conditions, stress corrosion cracking of 304 stainless steel could occur.

Based on the above information and the experience at other plants, the cracks in the seat bushings at the Oyster Creek Nuclear Plant are the result of chloride contamination.

To eliminate the possibility of water standing in the lower part of the valves where cracking occurred, a drain hole was added just above the inlet flange.

All cracked seat bushings were replaced with new ~~316~~ 304 stainless steel bushings of the same design as originally provided.
