Jersey Central Power & Light Company

Subject: Oyster Creek Station
Docket No. 50-219
Reactor Coolant System Leakage

Subject: Abnormal Occurrence Report 73-14

Report No. 73-14

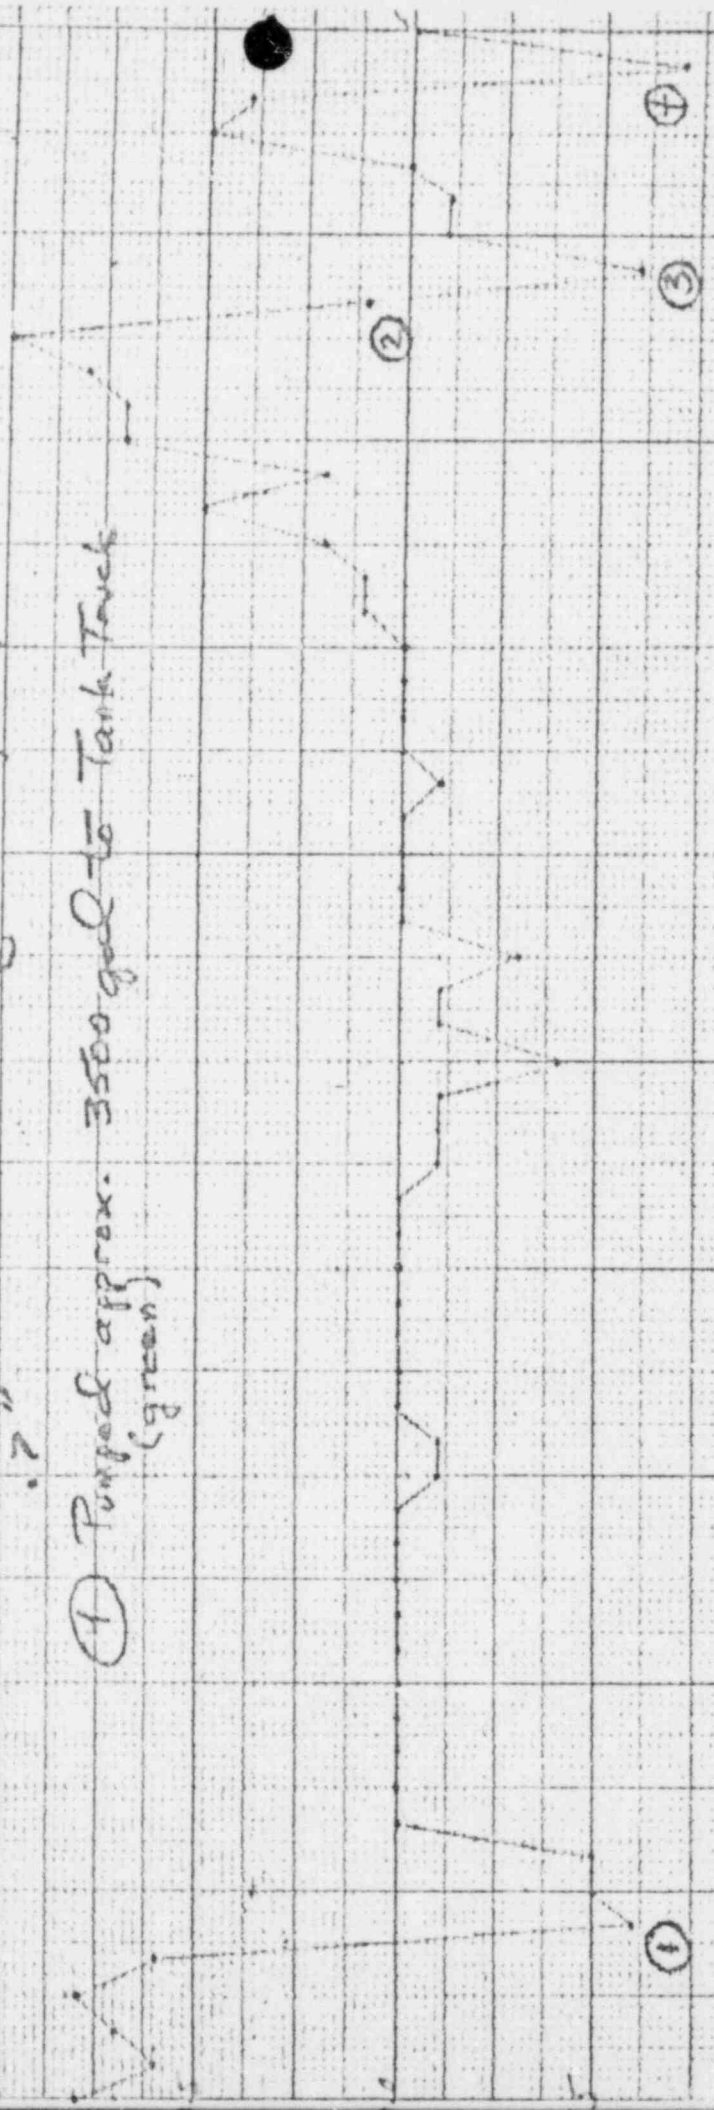
③ Recalibrated Torus level indicator transmitter. Was found indicating too high by about .7"

④ Pumped approx. 3500 gal to Tank Truck (green)
