**EXAMINATION OF
CRYSTAL RIVER-3 PULLED
STEAM GENERATOR TUBES
FINAL REPORT**

**Submitted by:
Florida Power Corporation**

May 31, 1995

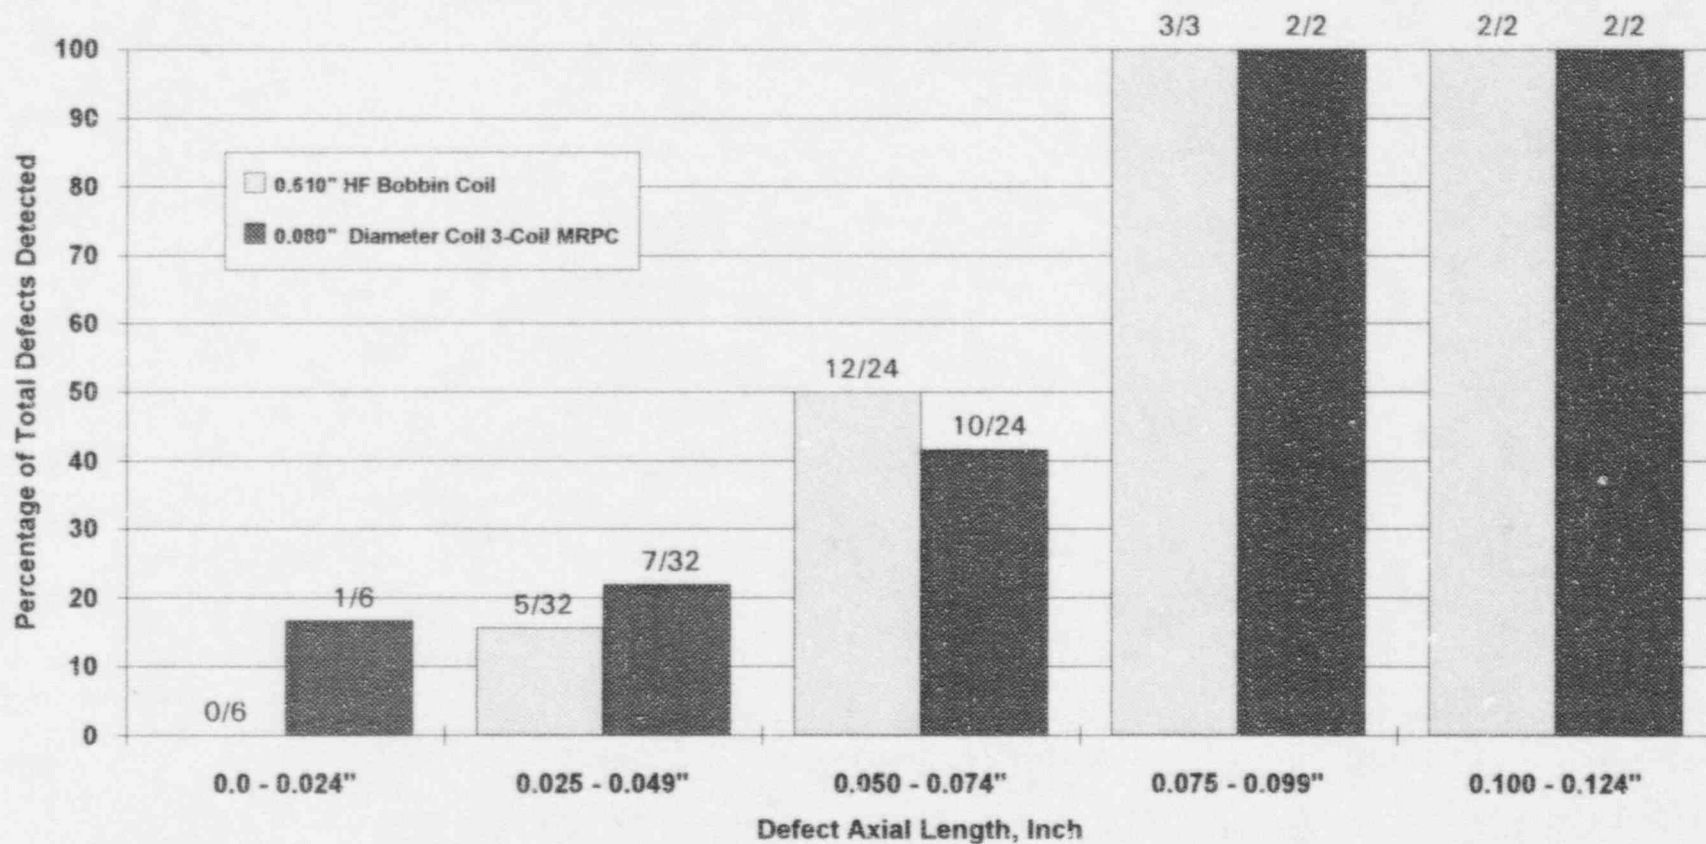
The findings of Figures 2-8 and 2-9 are consistent with the expectation that the probability of detection increases as the degradation increases in size. Figure 2-8 and 2-9 also show that both the 0.510" bobbin coil and the 0.080" diameter coil 3-coil MRPC have generally about the same detection probability.

Figure 2-8. Crystal River-3 Field Eddy Current Detectability vs. Axial Length for Non-Tubsheet Defects in the 1992 & 1994 Pulled Tubes

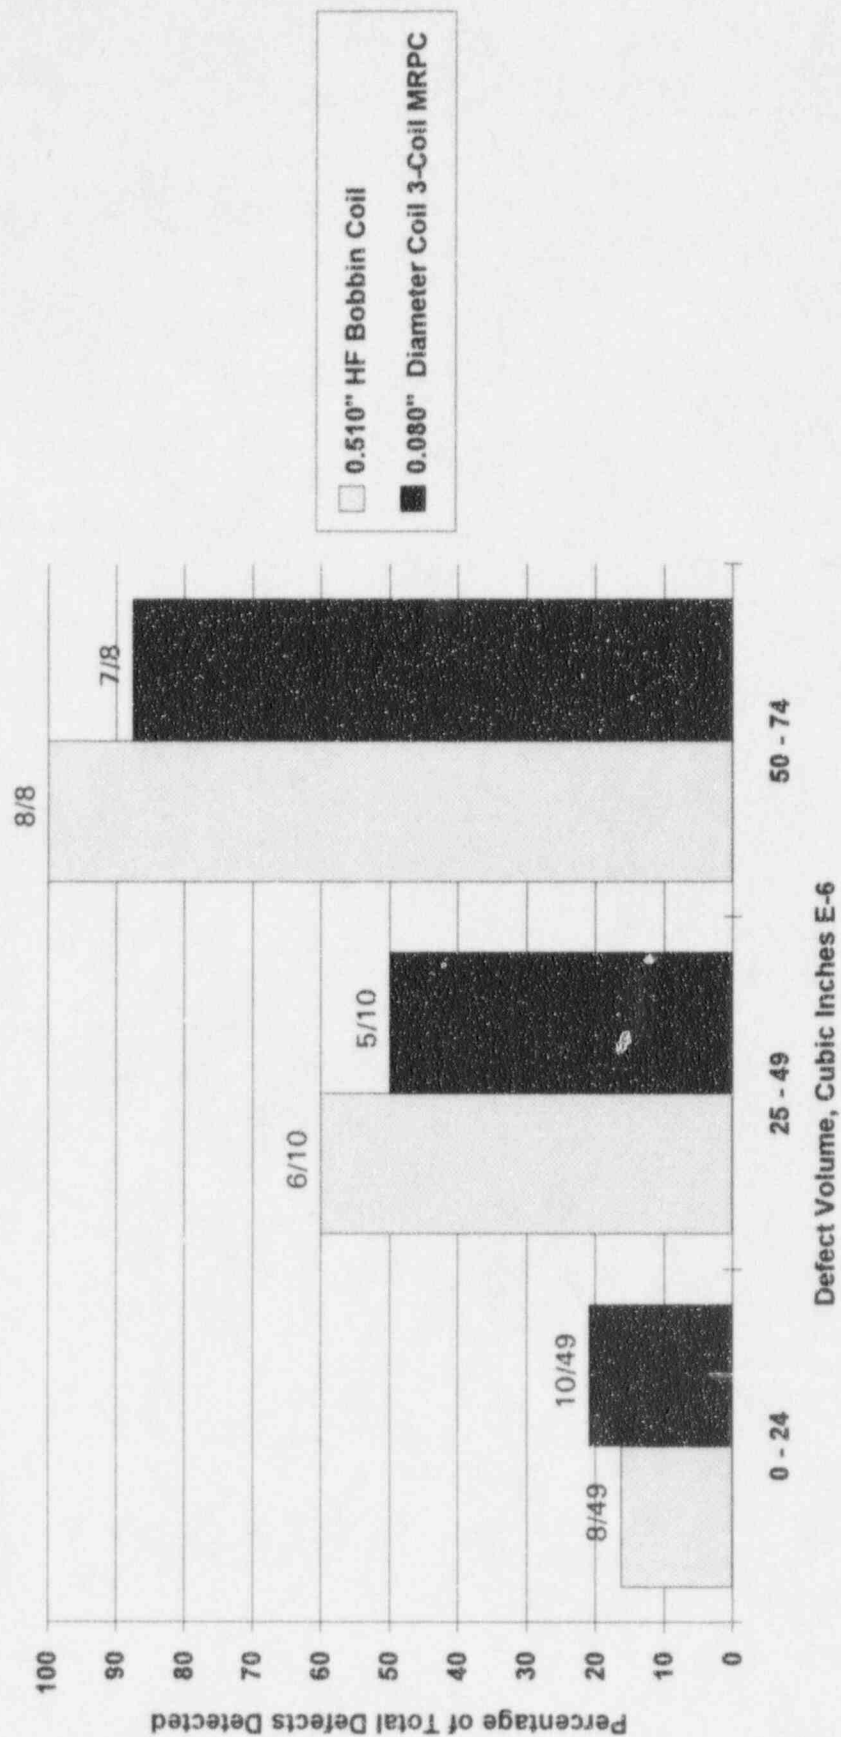
Figure 2-9. Crystal River-3 Field Eddy Current Detectability vs. Volume for Non-Tubesheet Volumetric Indications in the 1992 and 1994 Pulled Tubes

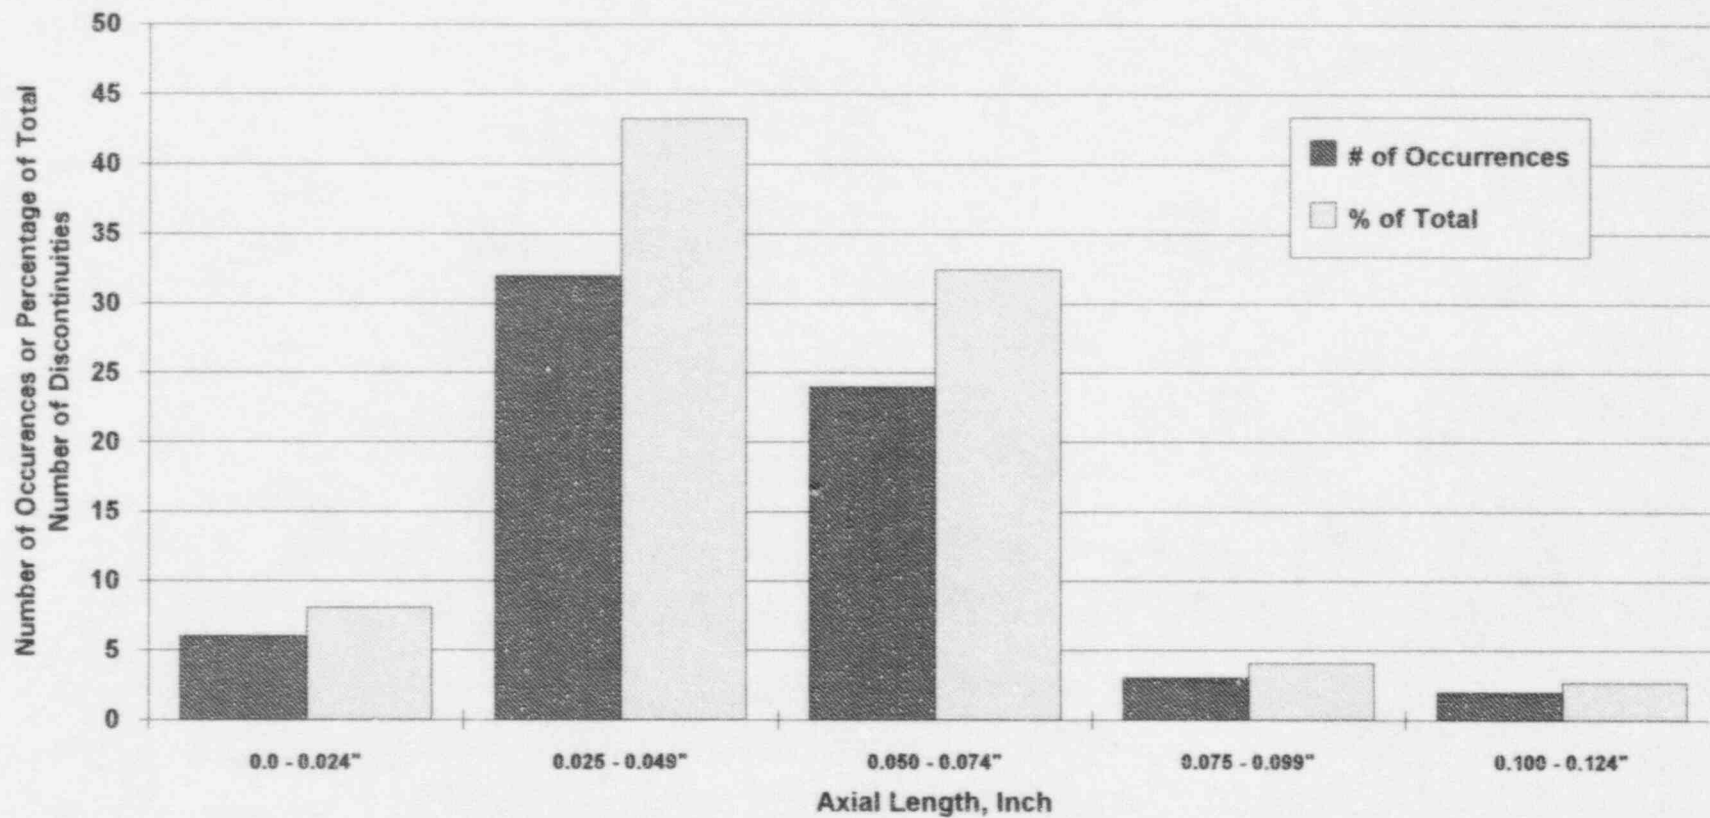
Sixty-seven (67) eddy current distinguishable non-tubesheet, volumetric discontinuities (i.e., greater than 0.200 inch apart) were subjected to metallurgical examination. These discontinuities consisted of five (5) circular wear scars, and 62 pit-like IGA patches. All five (5) circular wear scars were from the 1994 pulled tubes. Nine (9) of the IGA patches were from the 1992 archived tube that was destructively examined in 1994. The probability of detection was found to increase as the axial length and/or volume of the discontinuity increases as shown in Figures 2-8 and 2-9, respectively. The distribution of axial lengths observed in the 1992 and 1994 pulled tubes is shown in Figure 2-10. All of the IGA patches had lengths of 0.074 inch or less. All of the discontinuities with axial extents longer than 0.074 inch were circular wear.

Figure 2-10. Axial Length Distribution of the Non-Tubesheet Discontinuities from the 1992 & 1994 Crystal River-3 Pulled Tubes

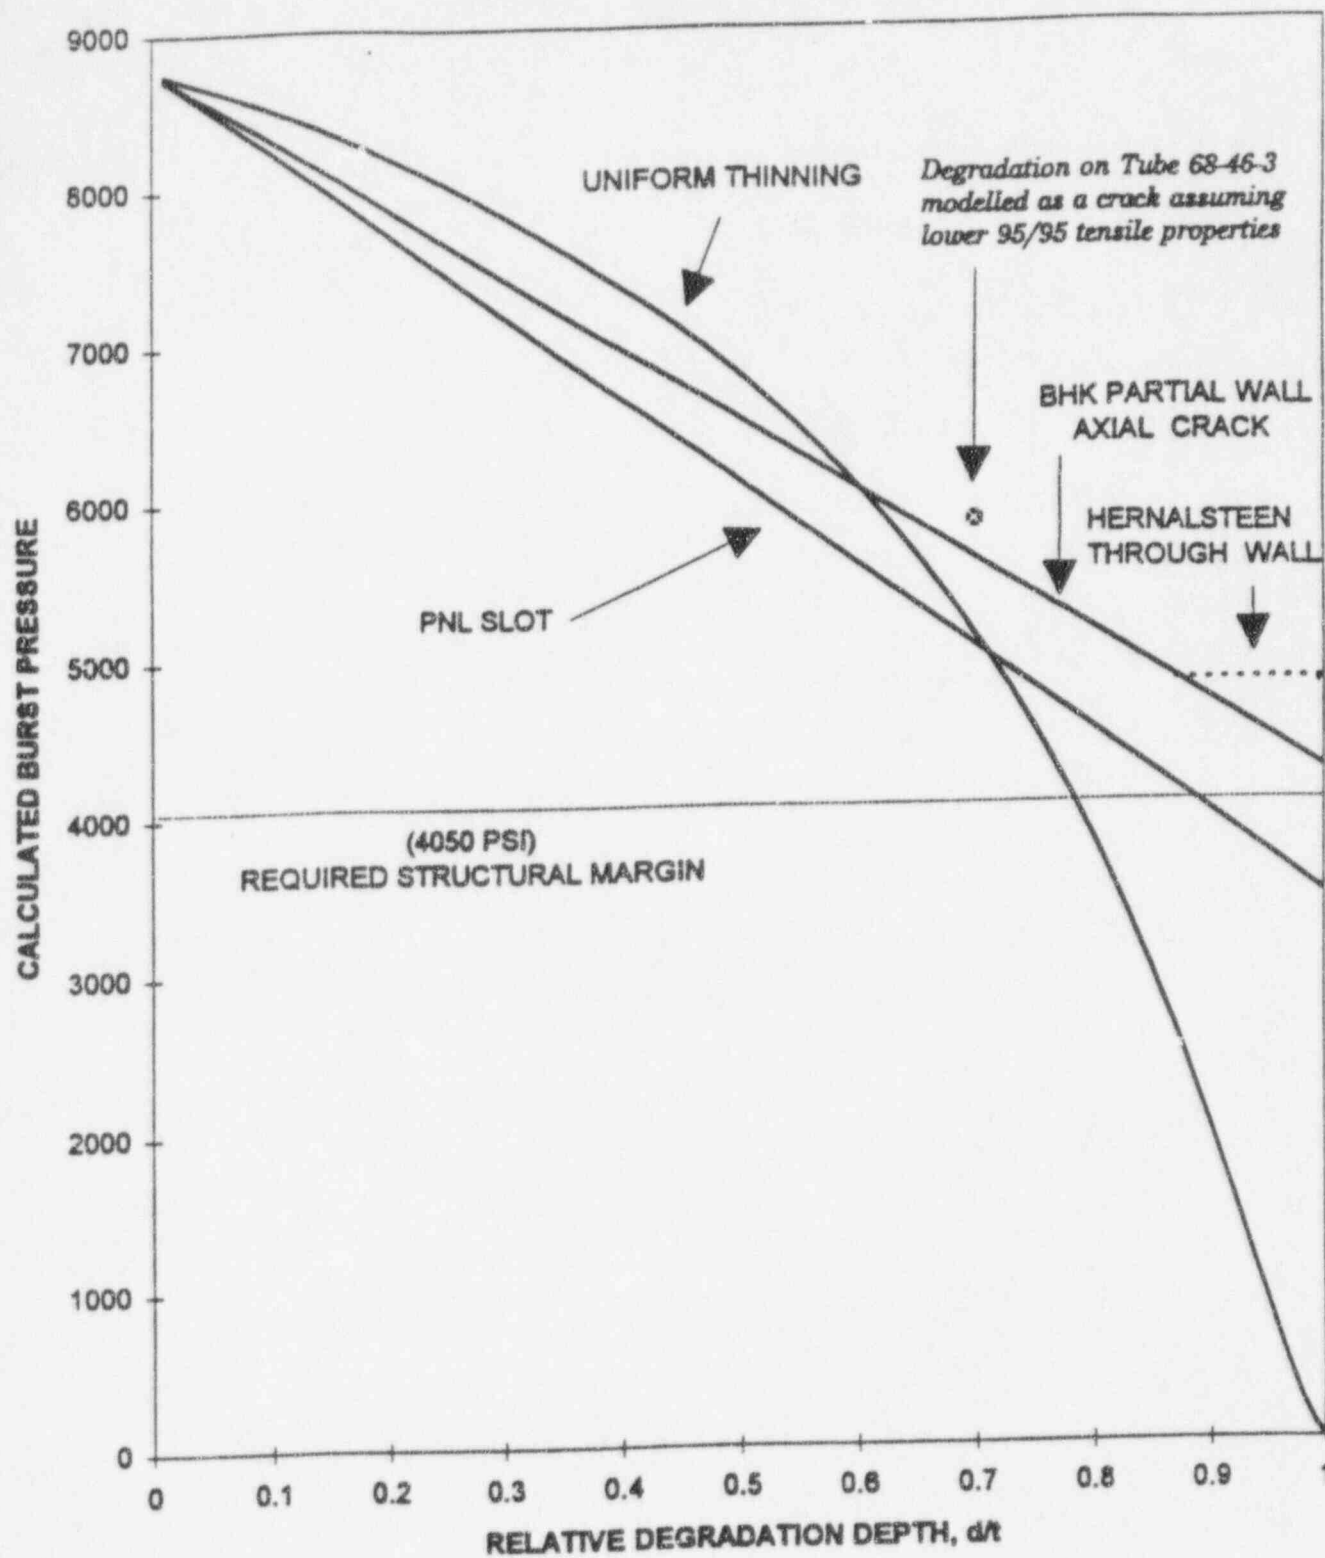
Figure 3-1 illustrates a comparison of burst pressure predictions from these equations for a degradation length of 0.25 inches. The degradation depth is expressed as a fraction of the tube wall thickness. For conservatism, lower 95/95 tensile properties are assumed. At shallow degradation depths, burst pressure predictions are very similar. At large depths of degradation, the uniform thinning model must extrapolate to zero burst pressure at through wall penetration. The partial through wall axial crack models extrapolate to the through wall crack burst pressure limit.

discussion) is also plotted on Figure 3-1. For conservatism, the measured burst pressure was reduced to match the assumption of lower limit tensile properties. When burst strength is computed on the basis of the maximum depth of degradation (a value of 70% was assumed), the measured burst pressure lies above predictions from all models, but is closest to the BHK model. The same statement is true for all of the test results in Table 3-2. Pulled tube burst test results are consistent with expectations of structural evaluations and behave in a consistent, predictable fashion.

CALCULATED BURST PRESSURE VERSUS RELATIVE DEGRADATION DEPTH FOR A CRACK LENGTH OF 0.25 INCH

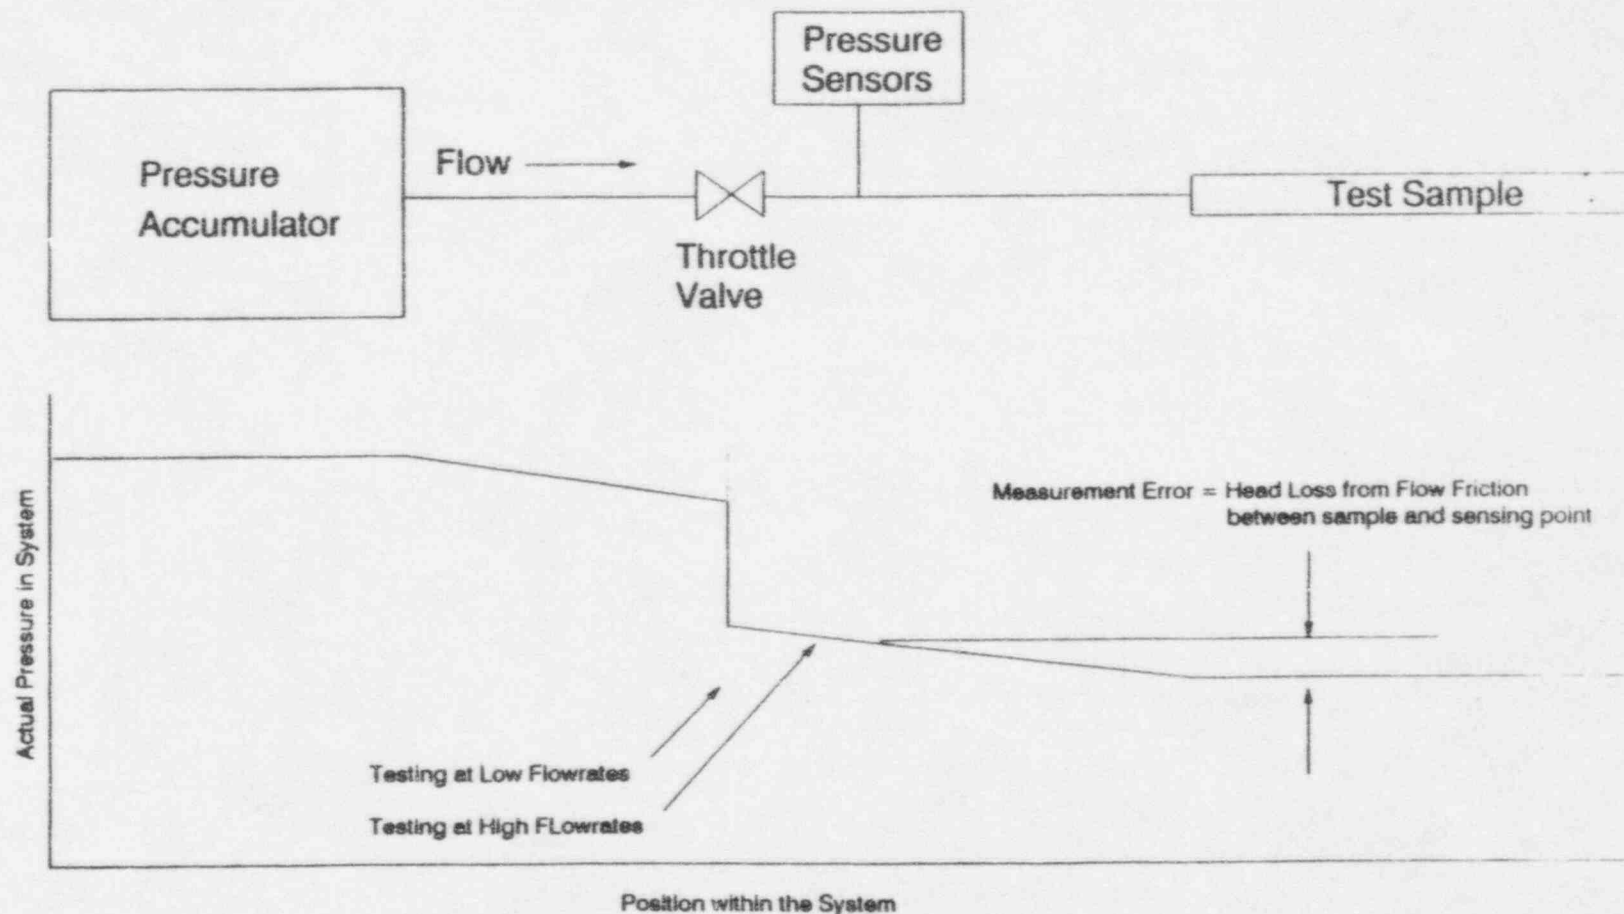
velocities of only about 0.4 feet/second. The high fluid velocities in the 1992 testing are believed to be capable of giving rise to frictional head loss errors. This is illustrated in Figure 1.

Figure 1: Schematic of the burst test apparatus, below which is a graph of pressure versus position within the system. At high flow rates, flow friction gives rise to a measurable pressure drop (head loss) in the small diameter, high pressure tubing that transfers the hydraulic fluid from the accumulator to the test sample.

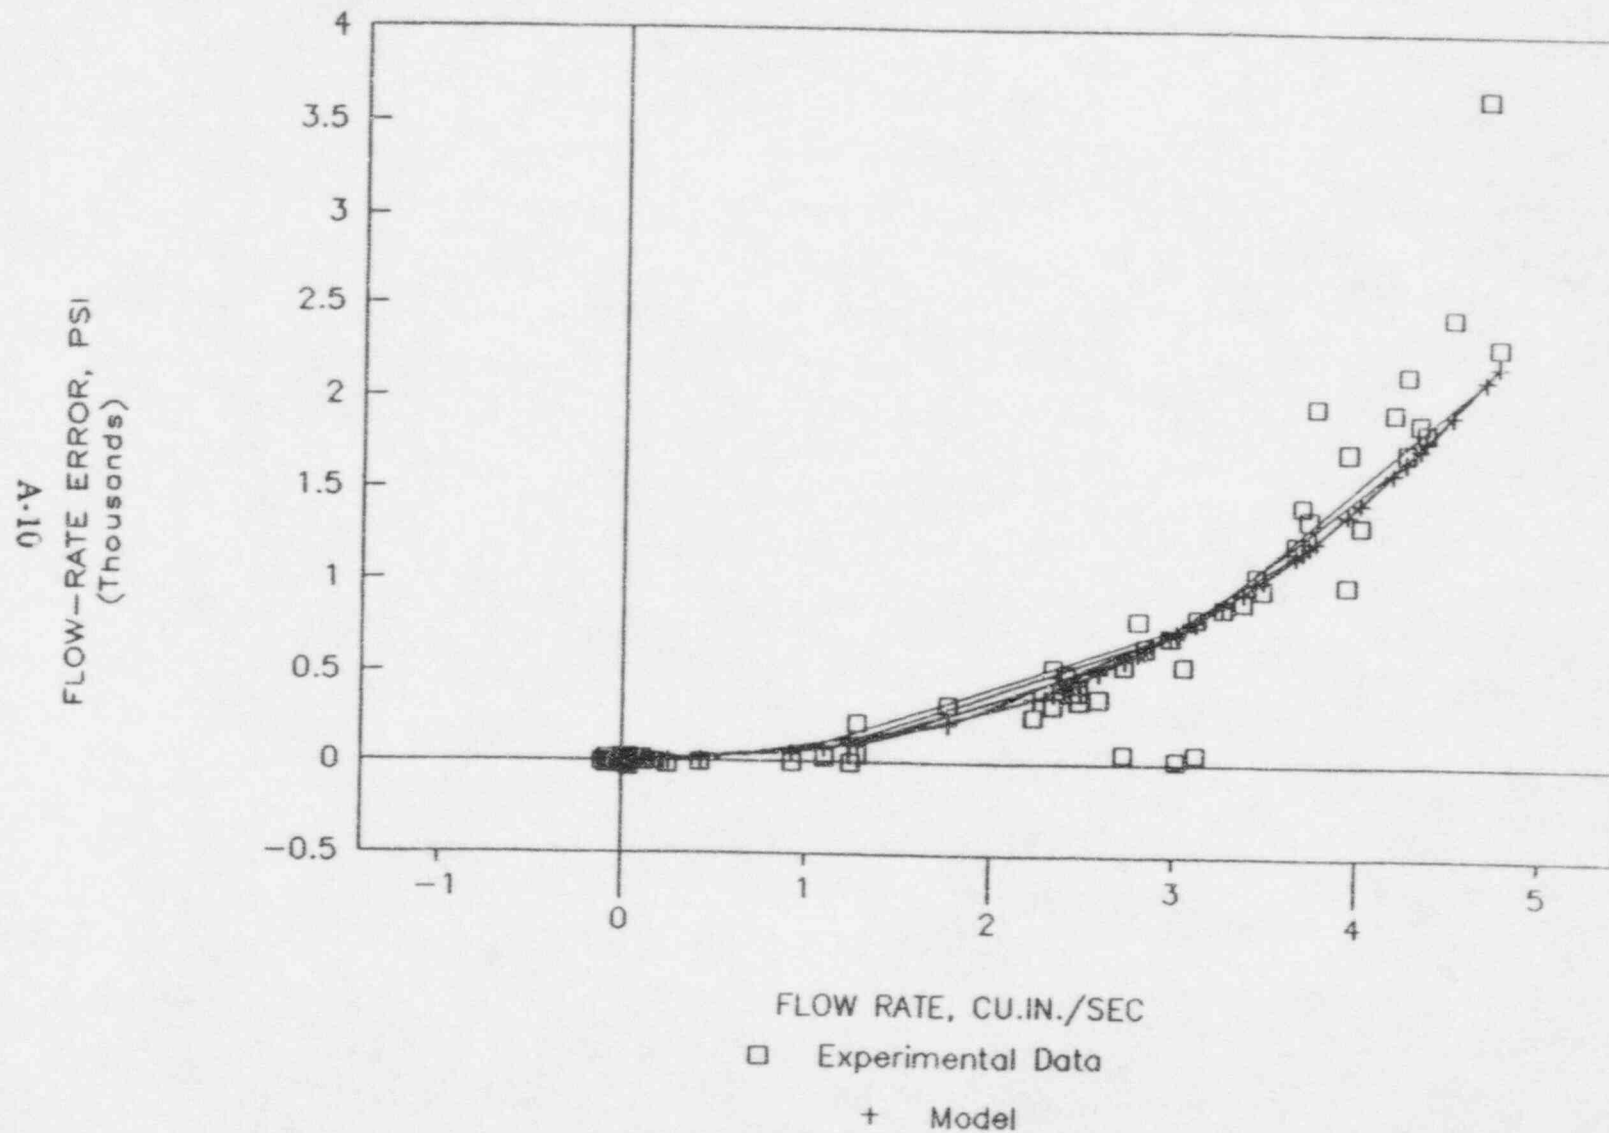
To demonstrate the existence of such a friction loss error, de-ionized water was vented to atmosphere at high flow rates using the 1994 burst test apparatus. The water was vented from the accumulator through the tubing normally used in testing and through the fitting where a S/G tube sample would normally be. Although the "sample pressure" was zero by definition, pressures of several thousand psi were recorded by the pressure transducer. The 1994 burst test apparatus is instrumented to allow the delivered volume to be monitored and recorded, and from this, the pressure as a function of volume flow rate could be graphed and modelled, (see Figure 2). It can be seen that virtually no error is expected at the low volume rates used in the 1994 testing, but that errors can be expected at volume rates above about 1 cubic inch per second.

Figure 2: Graph of experimentally determined error in pressure caused by flow friction as a function of flow rate. The equations used to model the behavior is also shown.

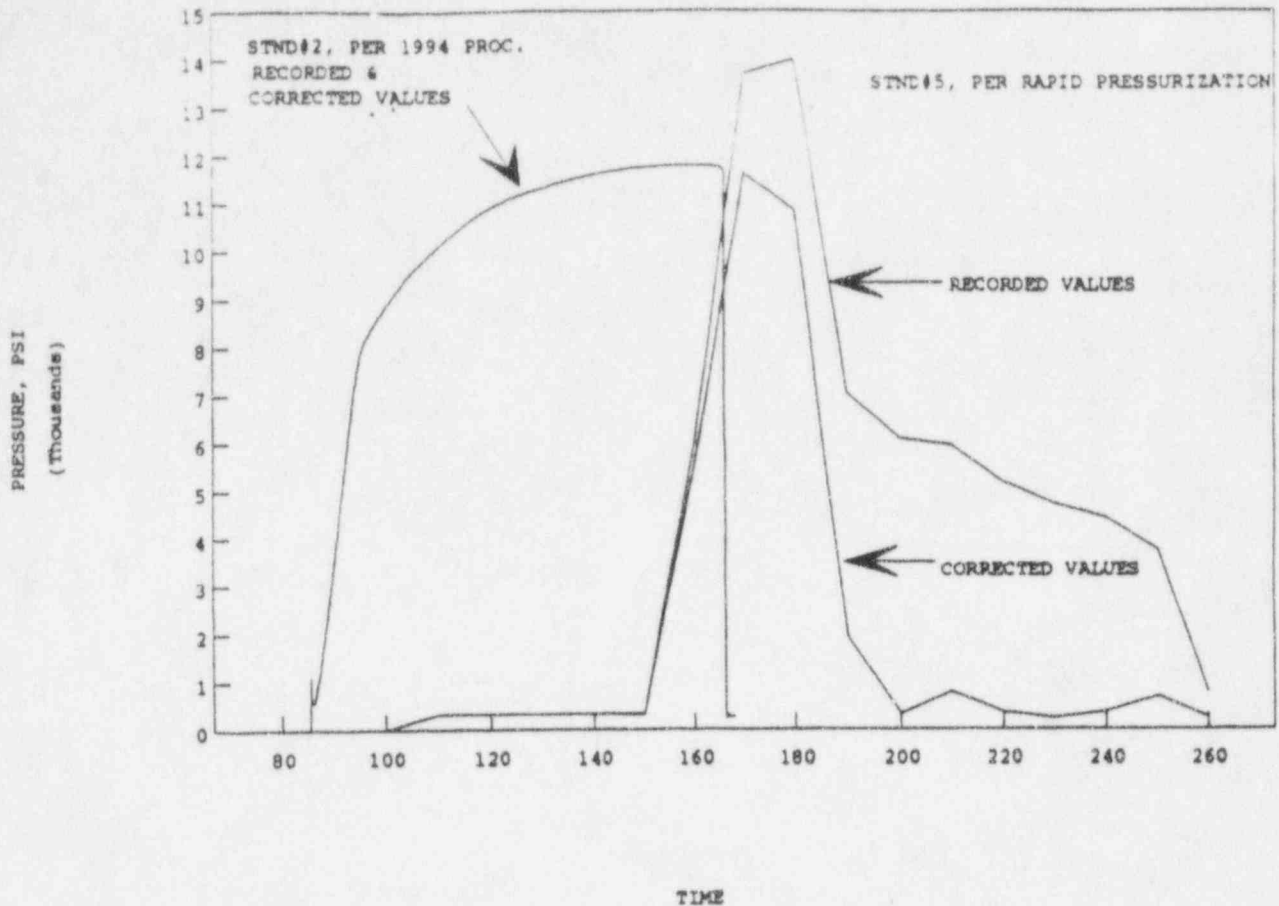
Using this model of the flow error versus volume delivery rate, the data of tests on virgin steam generator tubing carried out at high pressurization rate were corrected to remove the error; this is shown in Figure 3. The instantaneous volume delivery rate during each test was calculated, converted via the model to a flow rate error, and the error subtracted from the recorded pressure to yield corrected pressures. The results validate the concept of the flow rate error.

Figure 3: Application of the flow rate error model to pressure versus time data of burst testing of virgin S/G tubing. The curve on the left (time units = seconds) is from testing per 1994 procedures. Because of the low flow rates, no significant flow rate error is predicted, and the curve on the left is actually the overlapping uncorrected and corrected data. The curves on the right (time units = 1/100's of seconds) is from testing at high flow rates. The model predicts several thousand psi of error at the flow rates used, and corrects the pressures downward into agreement with the data from testing per 1994 procedures. Note that the uncorrected data show 3 to 7 thousand psi of flow rate error after sample burst has occurred (from time units 200 to 240), which is corrected to nearly zero by the corrected curve.

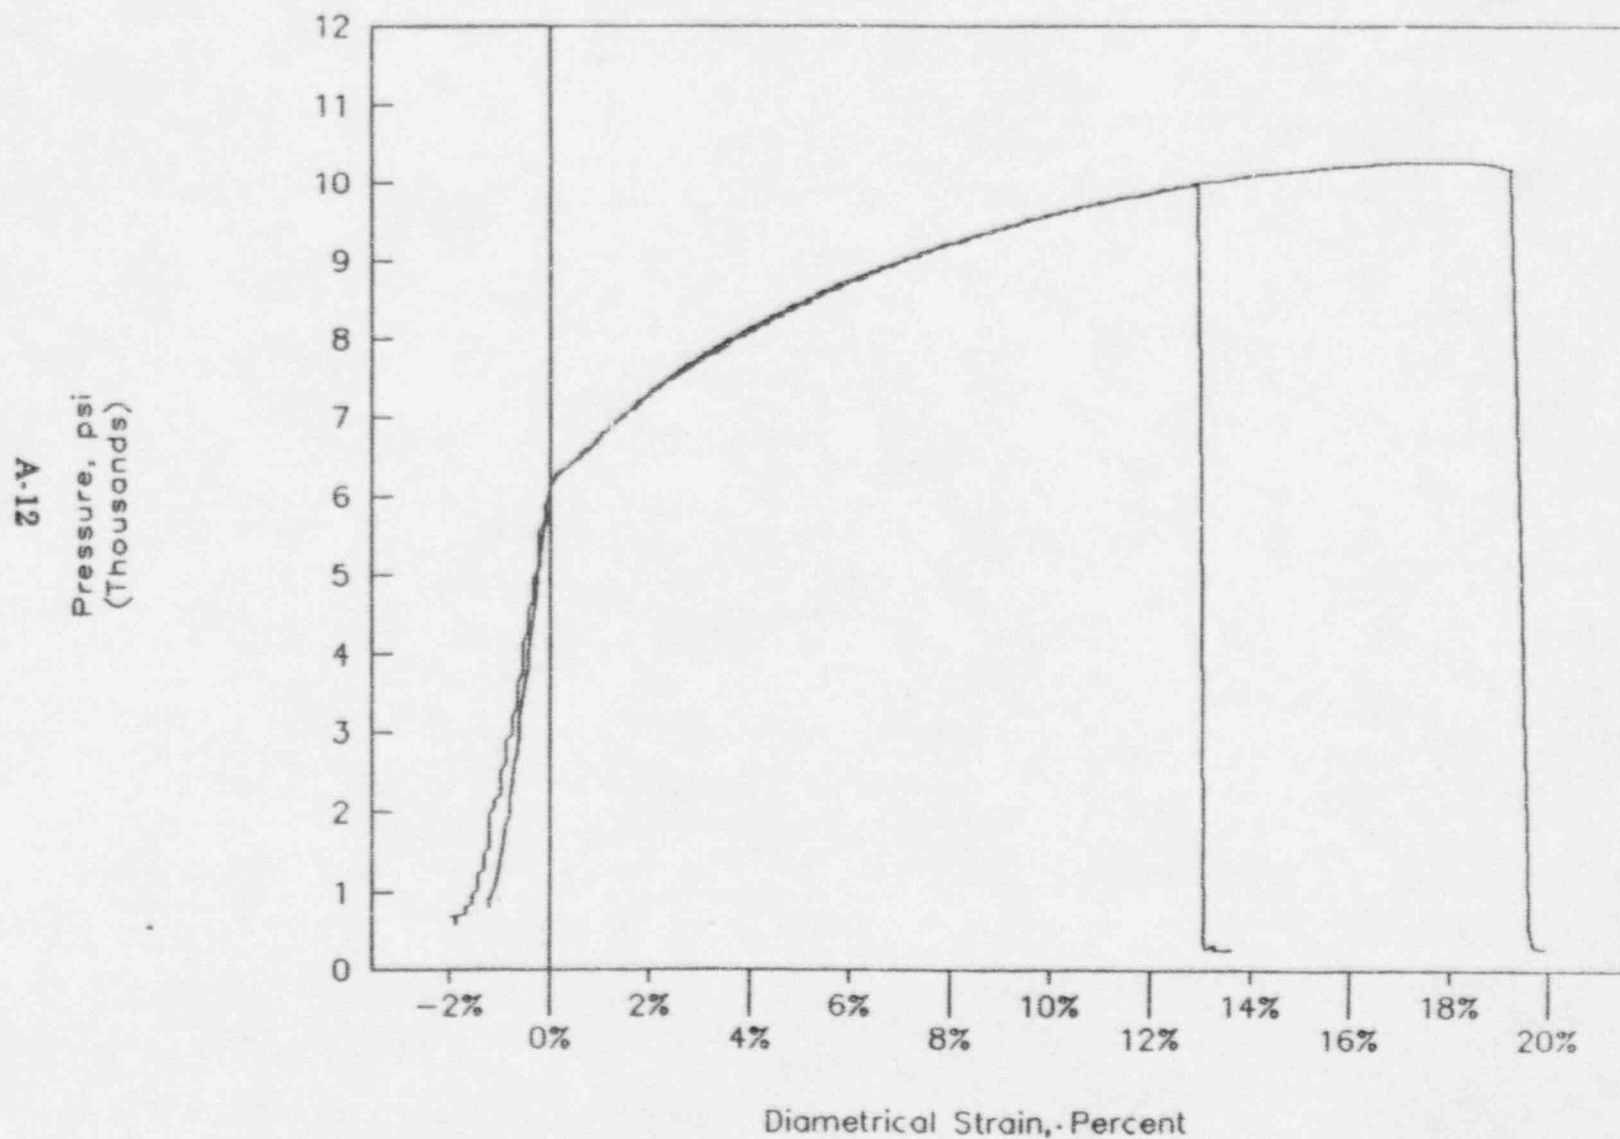
Figure 4 shows the 1994 burst test data for tube sections 41-44-5 (defect free) and 41-44-2 (IGA patches), both converted to pressure versus diametrical strain. To convert to diametrical strain, the delivered hydraulic volume data recorded during testing (only recently made available by new instrumentation added to the test apparatus) were scaled and offset such that the resulting value at burst agreed with the diametrical strain determined from post test diameter measurements. It can be seen that the small IGA patches had virtually no effect on pressure versus strain behavior up to the point of burst. This behavior is consistent with the behavior of load versus strain data for the tensile testing of notched ductile materials.

Figure 4: Pressure versus Diametrical Strain graph of burst test data for samples 41-44-2 (small IGA patches) and 41-44-5 (defect free).

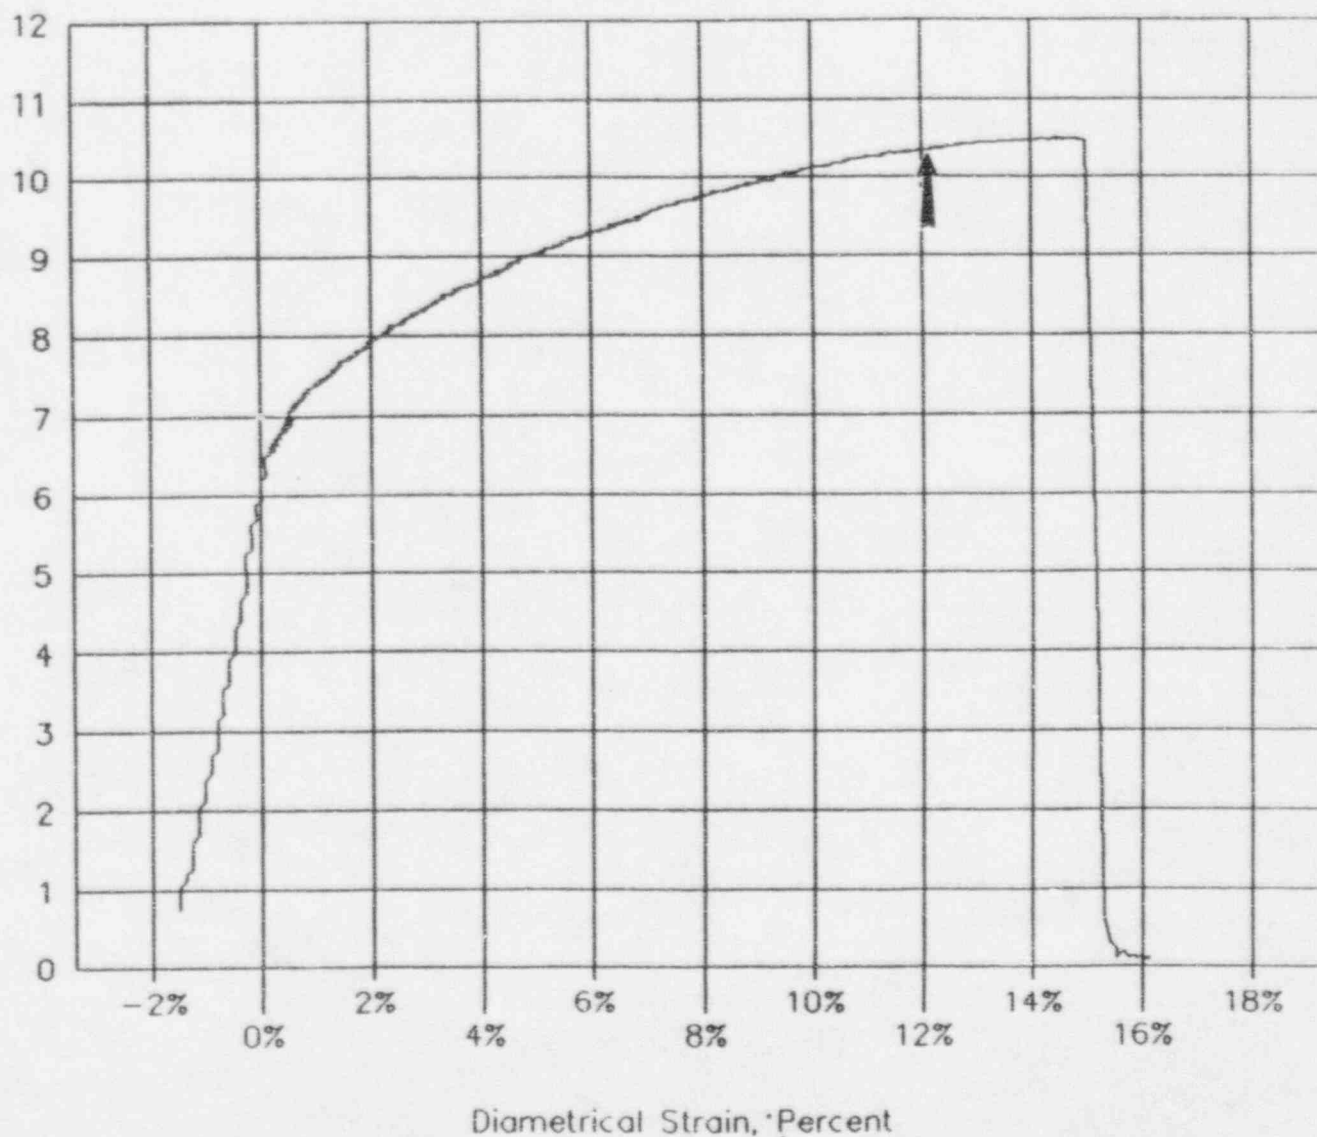
Figures 5 and 6 show the 1994 burst test data for tube sections 97-91-5 and 106-32-5 (both defect free), similarly converted to pressure versus diametrical strain curves. (Both of these curves have been corrected for volume lost to a fitting leak that occurred during the tests. The curve for section 106-32-5 is a composite of three

Figure 5: Pressure versus Diametrical Strain graph of burst test data for sample 97-91-5 (defect free). The arrow indicates the 12.1% strain at which sample 97-91-2 burst in 1992 testing. This corresponds to a burst pressure of 10,300 psi.

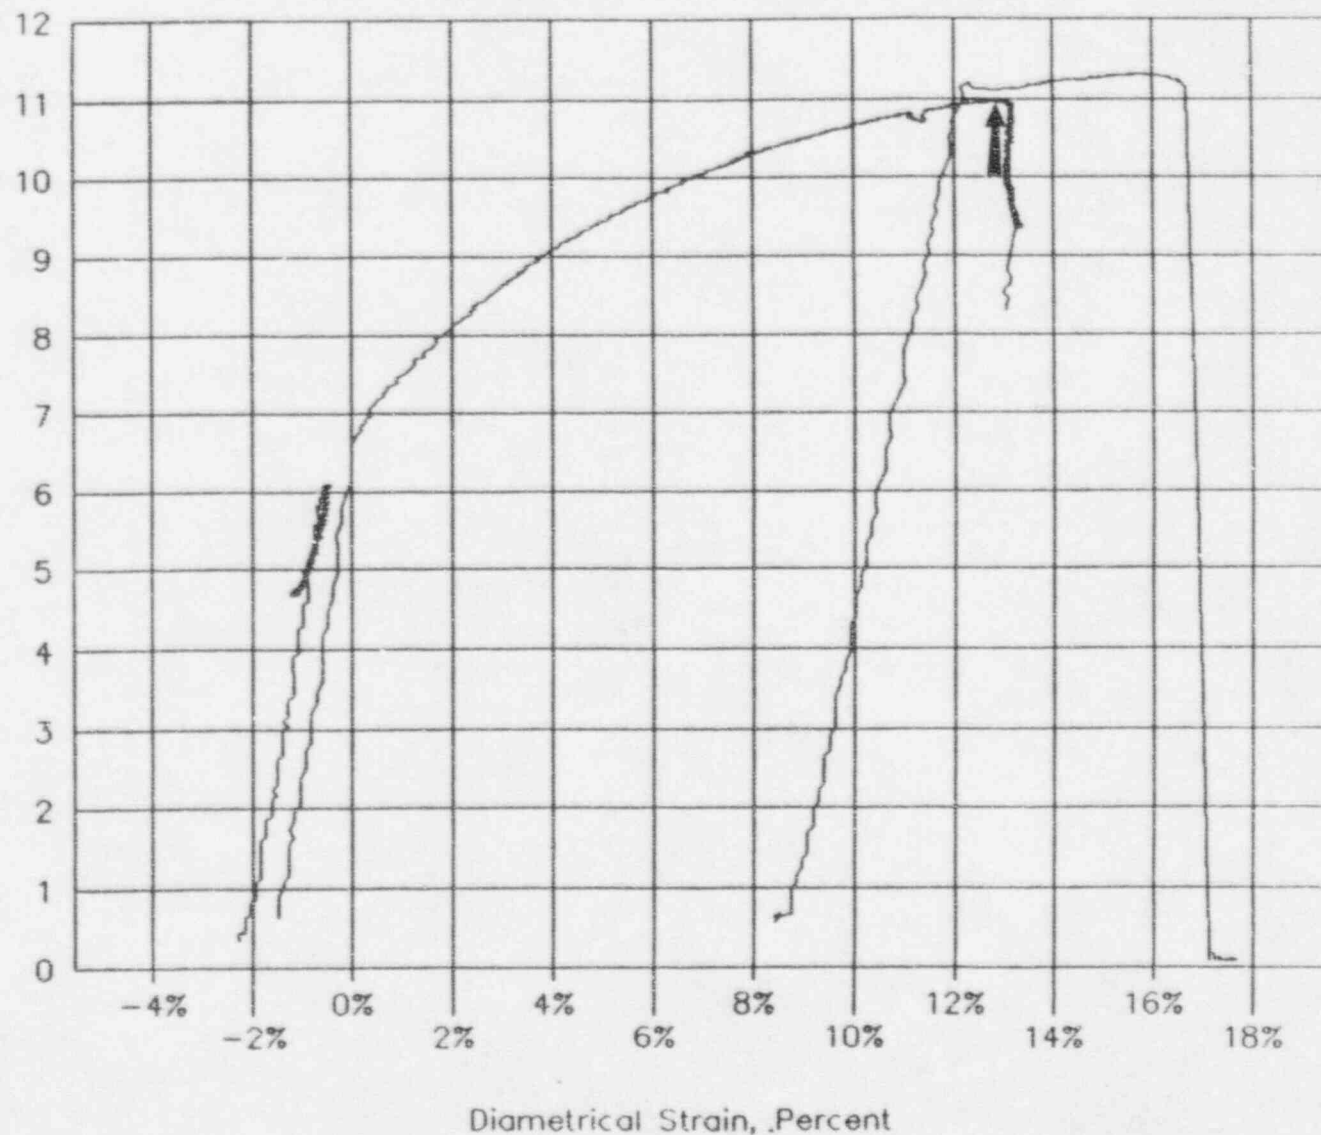
Figure 6: Pressure versus Diametrical Strain graph of burst test data for sample 106-32-5 (defect free). The arrow indicates the 12.9% strain at which sample 106-32-2 burst in 1992 testing. This corresponds to a burst pressure of 10,915 psi.
