Examination and Evaluation of
Safe End From Nozzle N6B on
Nine Mile Point Reactor

DC-65

5 March, 1970

Prepared for: Division of Compliance
United States Atomic Energy Commission

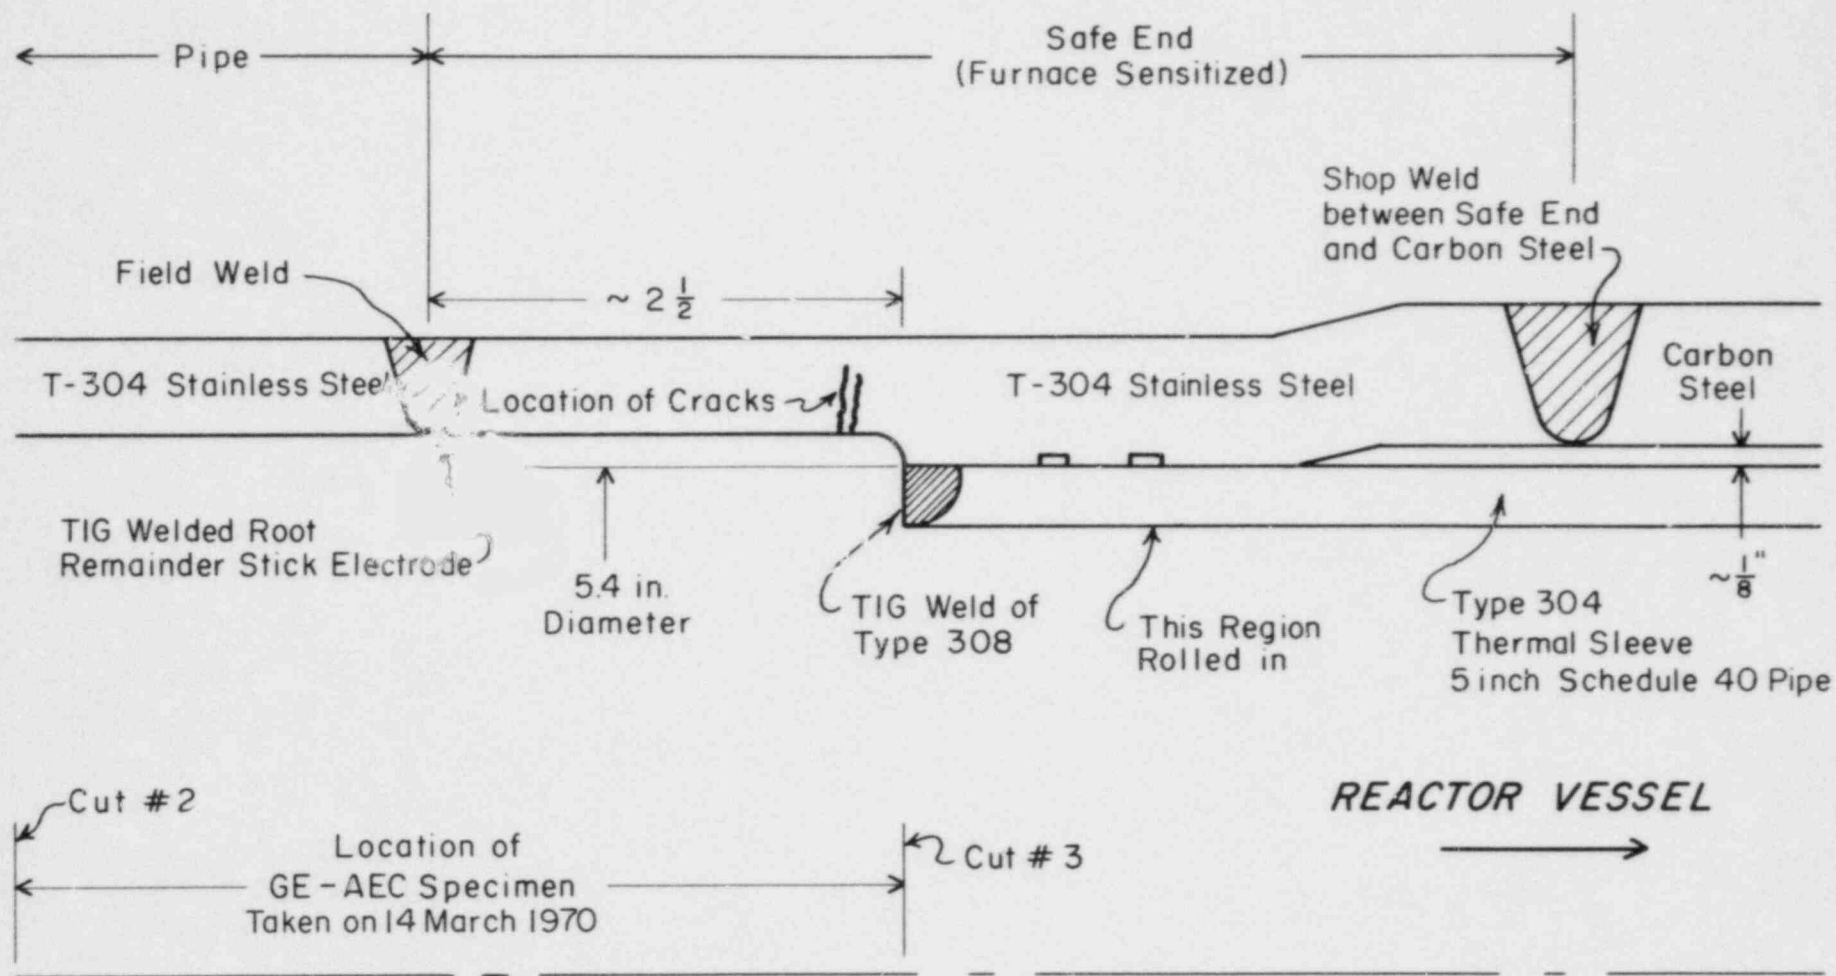
Figure 1. Schematic diagram showing safe end configuration.

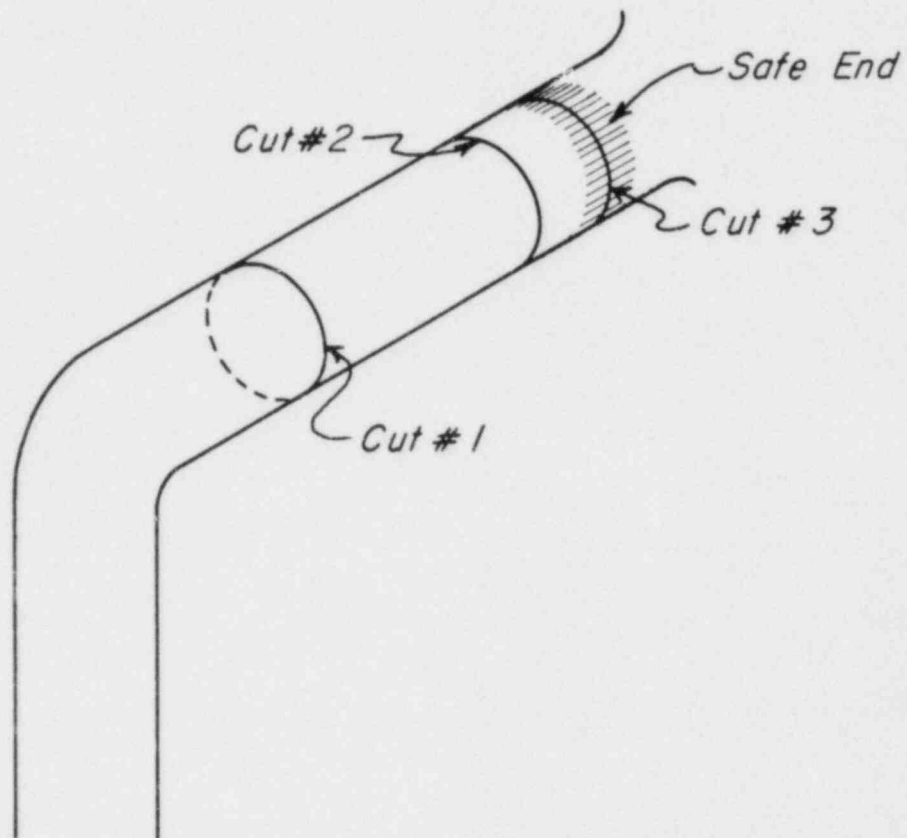
The specimen was removed from its installed location using a power hacksaw. No coolant was used during the operation. A schematic arrangement of the location from which the specimen was removed together with the cuts is shown in figure 3. The first cut was made approximately at position #1.

Figure 3. Schematic location of cuts made in the core spray line for removing the AEC-GE specimen. Cut numbers refer to same numbers of figure 1.

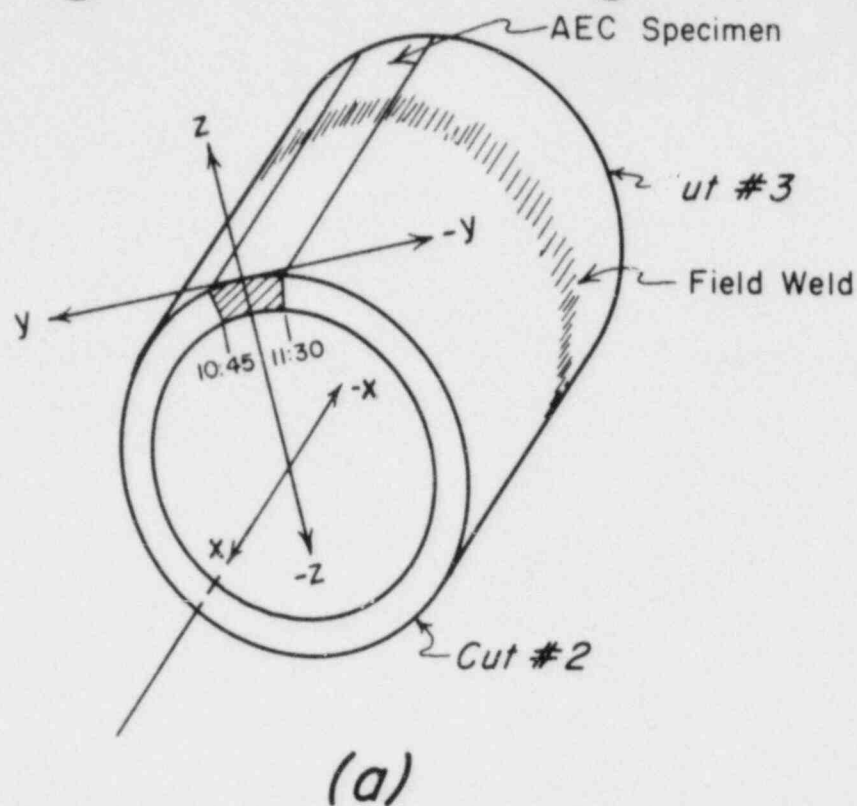
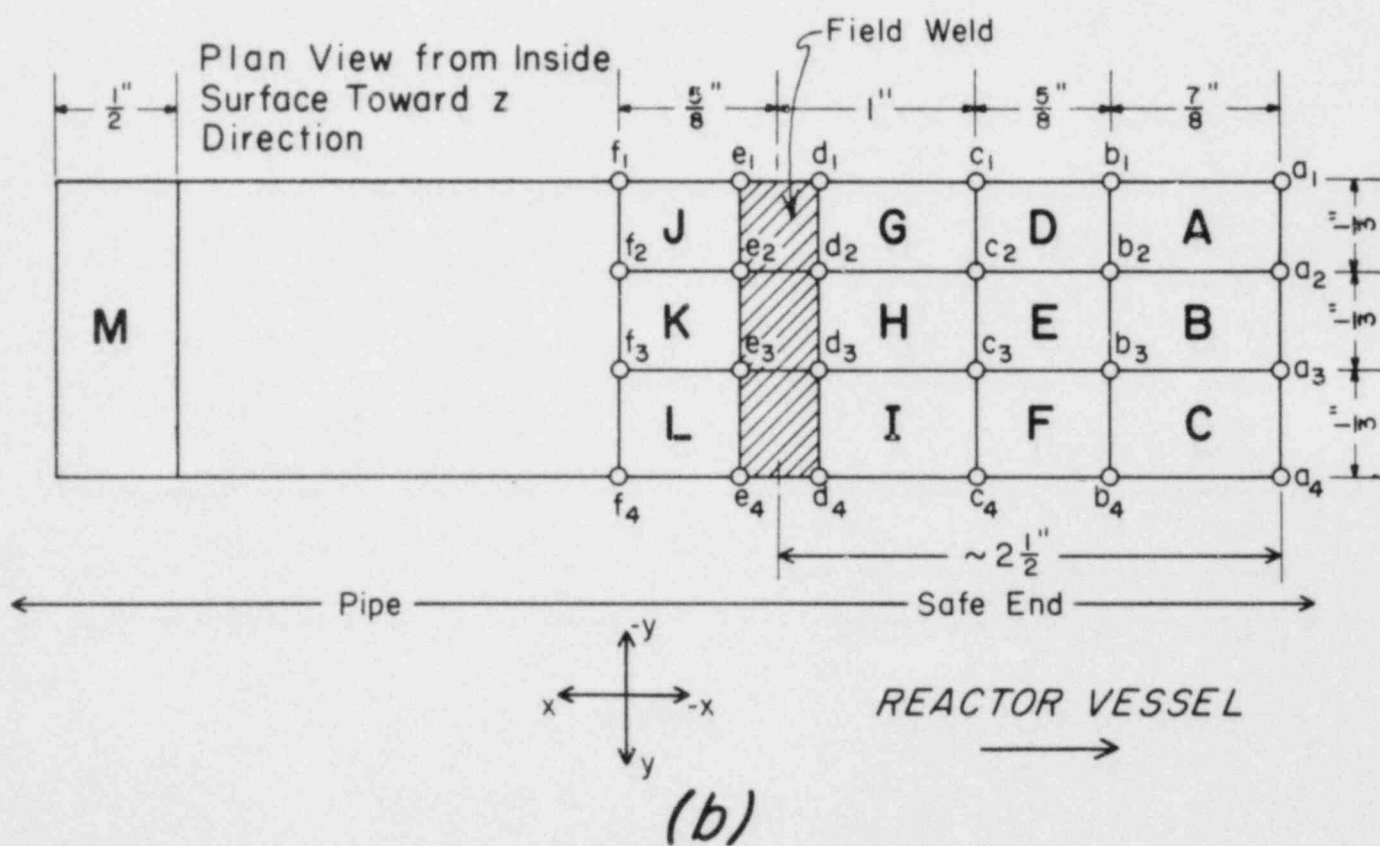
The GE-AEC specimen is shown in figure 4 with respect to orientations and specimen designations. X-y-z coordinates are applied for convenience in describing the specimen. In addition to these directions a series of letter designations (a₁-b₂ etc.) outline specific interfaces.

Figure 4. Schematic arrangement showing orientation and description of AEC specimen. (a) Orientation of specimen with respect to tube and coordinate axes. (b) Letter designations describing specimens taken from AEC specimen, together with coordinate axes.

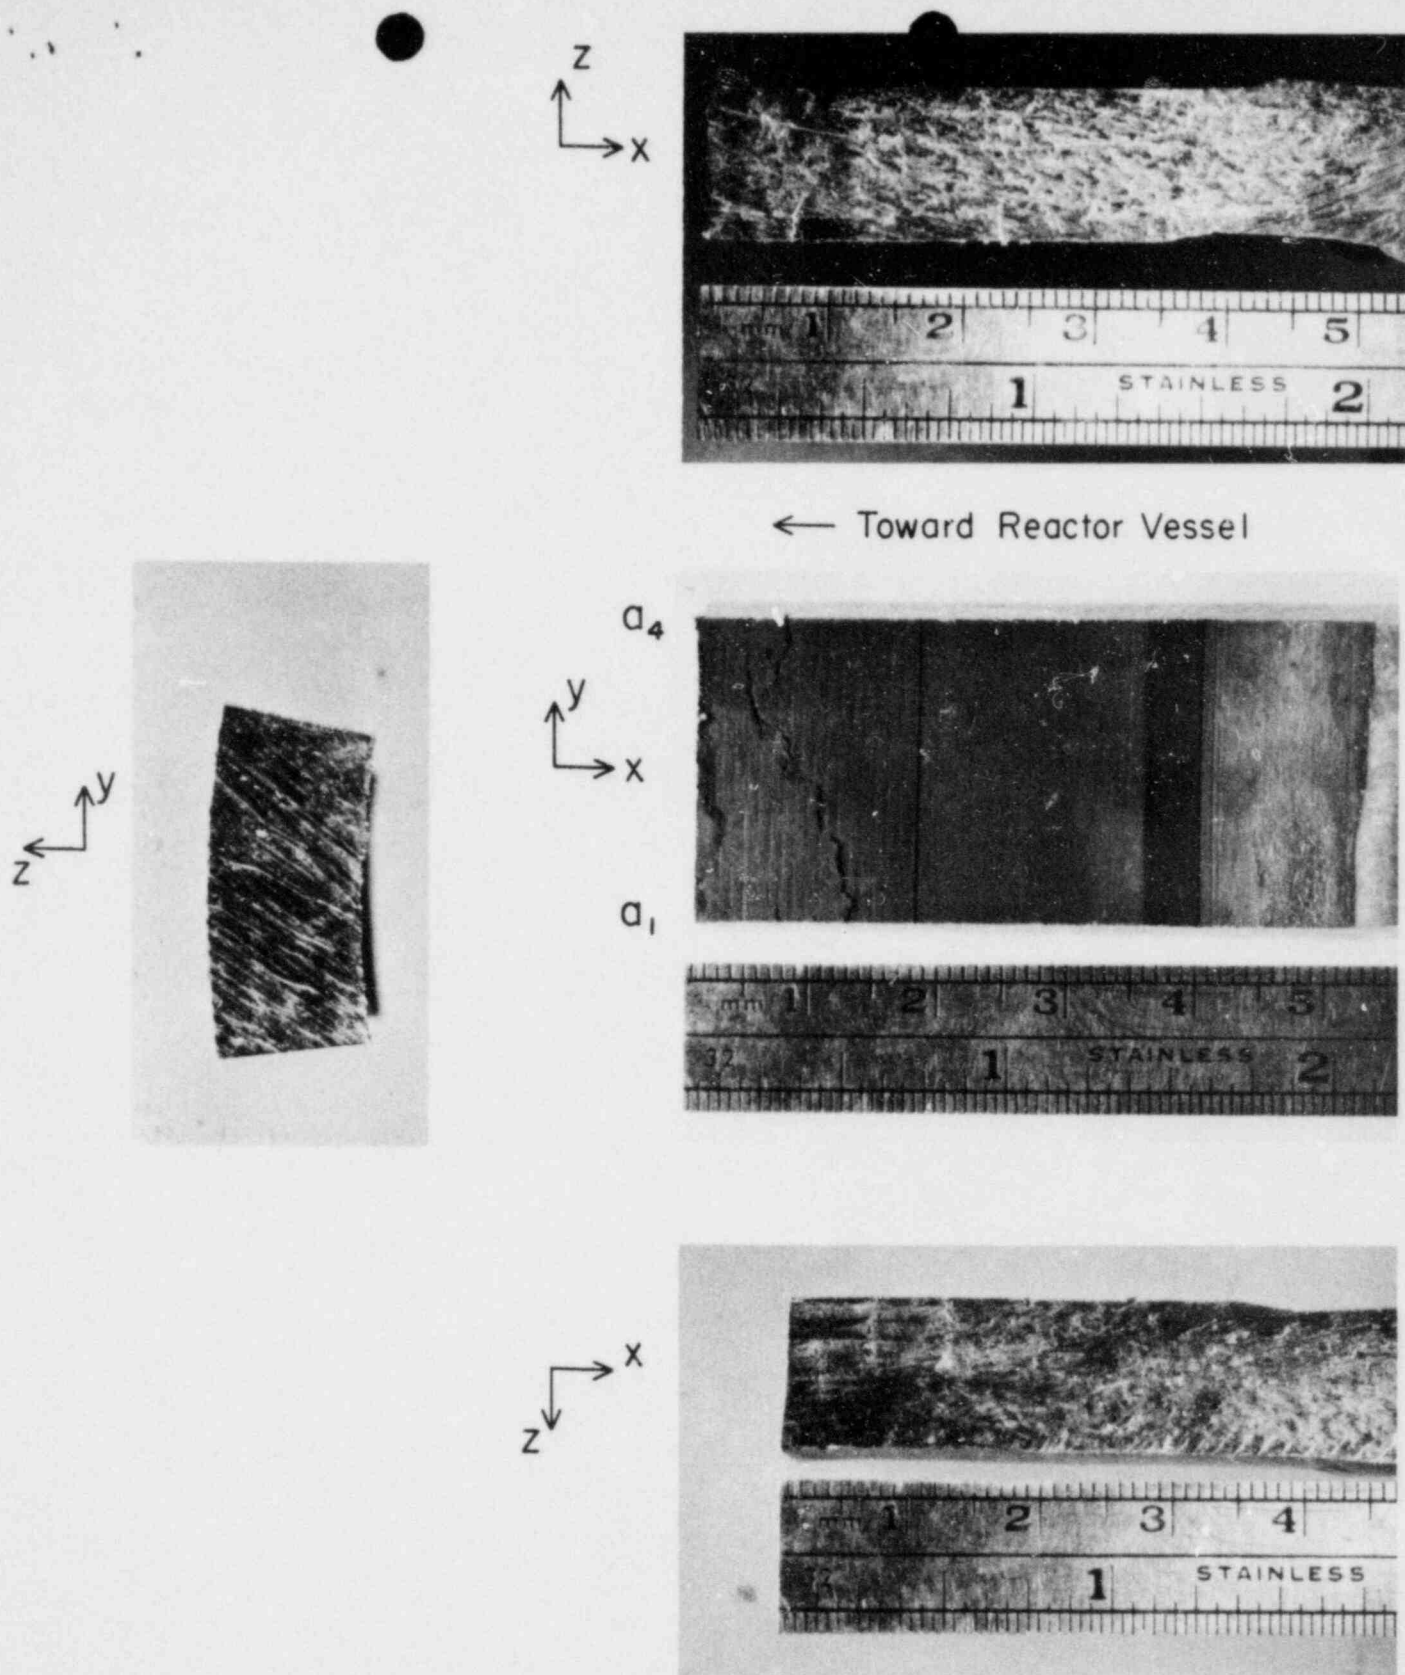
The AEC specimen was cut by manual hacksaw into the specimens shown in figure 4b. Figure 4c shows the part of the AEC specimen before it was cut into smaller specimens for subsequent evaluation.

Figure 4. (c) Optical macrographs showing views of inside surface, edges, and end of AEC specimen. Only that portion shown in the $-x$ direction from the field weld.

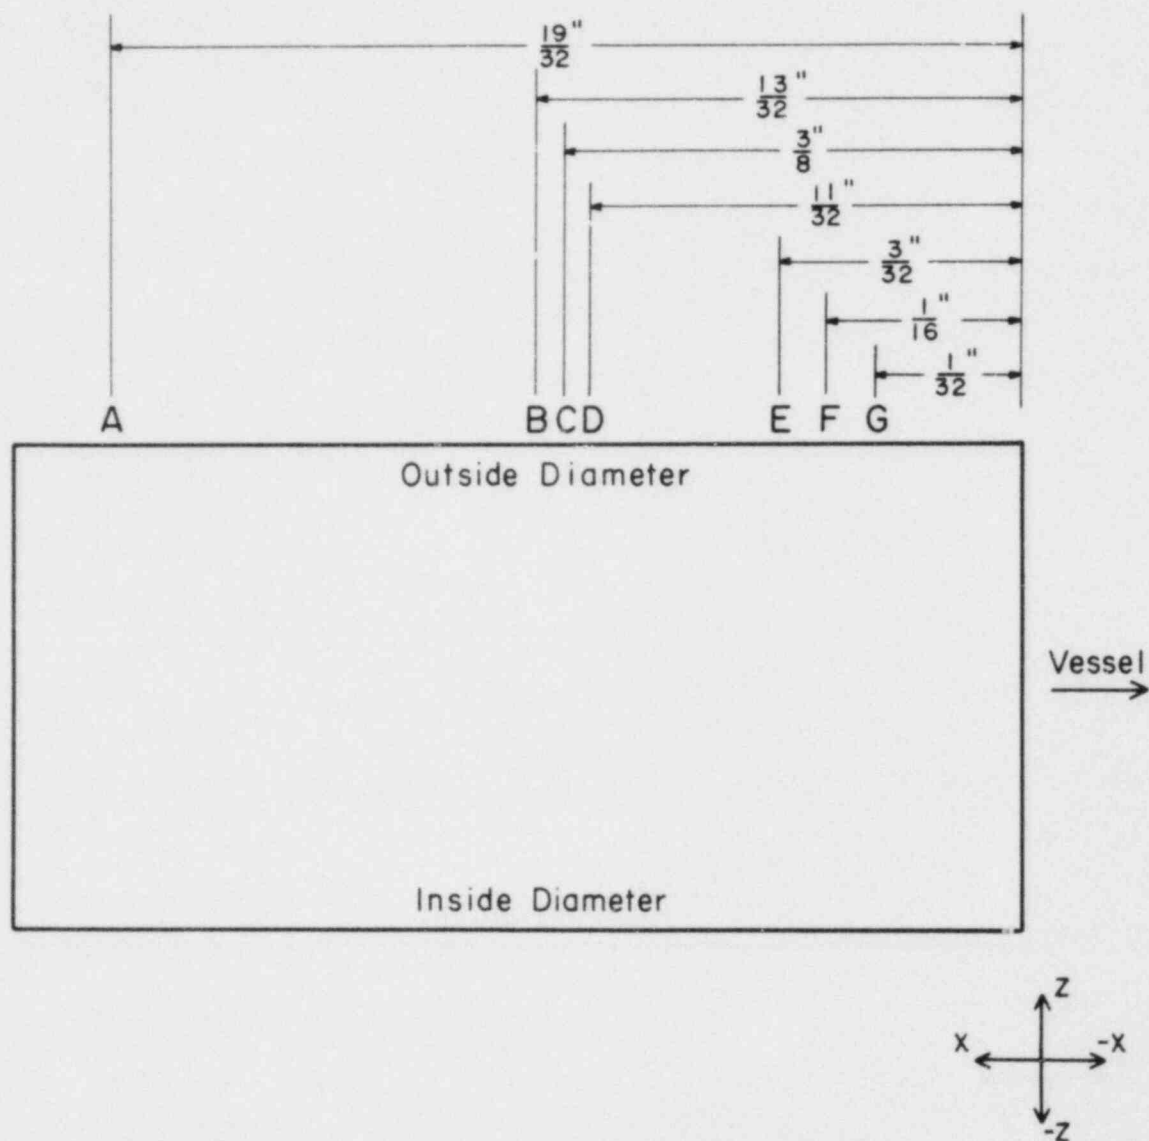
The outside surface of the AEC specimen was also examined metallographically. Figure 10 shows schematically where a specific set of specimens was taken from specimen B. These specimens were taken from the a_2 - b_2 face of specimen B and looking in the +y direction. The capital letters (A,B,C ...) indicate approximate locations where micrographs were taken. These micrographs are shown in figure 11 and have letter designations corresponding to those of figure 10. Figure 11 shows that transgranular cracks had initiated from the outside surface. Some of the specimens show extensive evidence of strain markings near the surface. These should be compared with the edge of the crack in figures 8 and 9 where no such strain markings are evident. This comparison is again significant with respect to establishing whether the intergranular cracking from the inside surface was due to stress corrosion or to a purely mechanical type of failure. The strain markings of figure 11 are no doubt the result of rough handling of the piping during construction. This amount of cold work, in itself, at this location is probably not significant. The point to be made here is simply that the evidence of strain markings on the surface is not associated with the intergranular cracks.

Figure 10. Schematic arrangement showing location of specimens taken from outside surface of specimen B. Surface viewed is in the x-z plane.

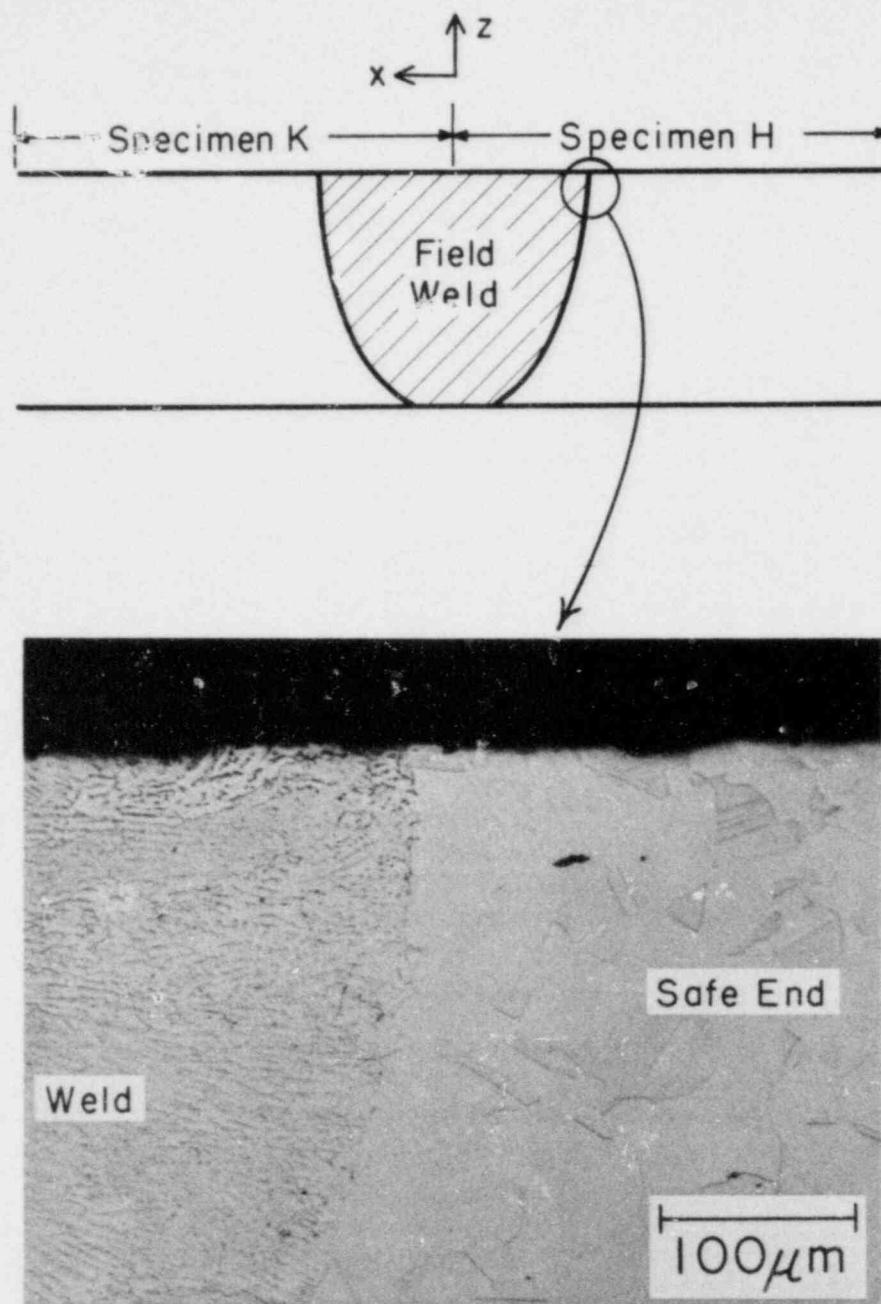
Figure 19 shows the weld region on the outside diameter of specimen H along the line d_2-d_3 . No gross attack is evident here.

Figure 19. Optical micrograph from specimen H along the outside surface along d_2 - d_3 . Plane viewed is x-z.

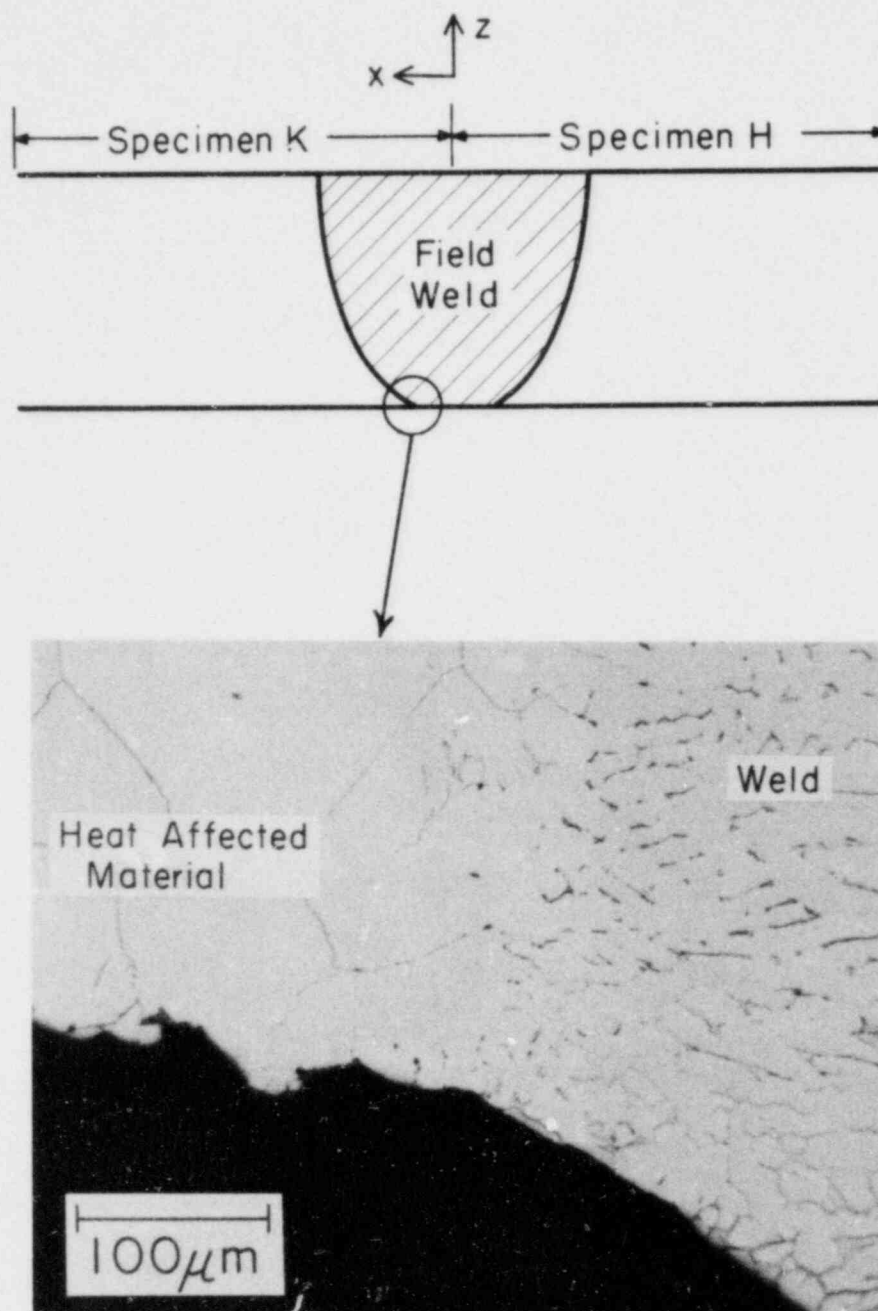
Figure 20 shows the inside diameter from specimen K along the line e_2-e_3 . Some intergranular penetration is evident here although it appears to have extended inward only a relatively small fraction of a grain diameter.

Figure 20. Optical micrograph from specimen K showing inside surface along e_2 - e_3 . Plane viewed is x-z.

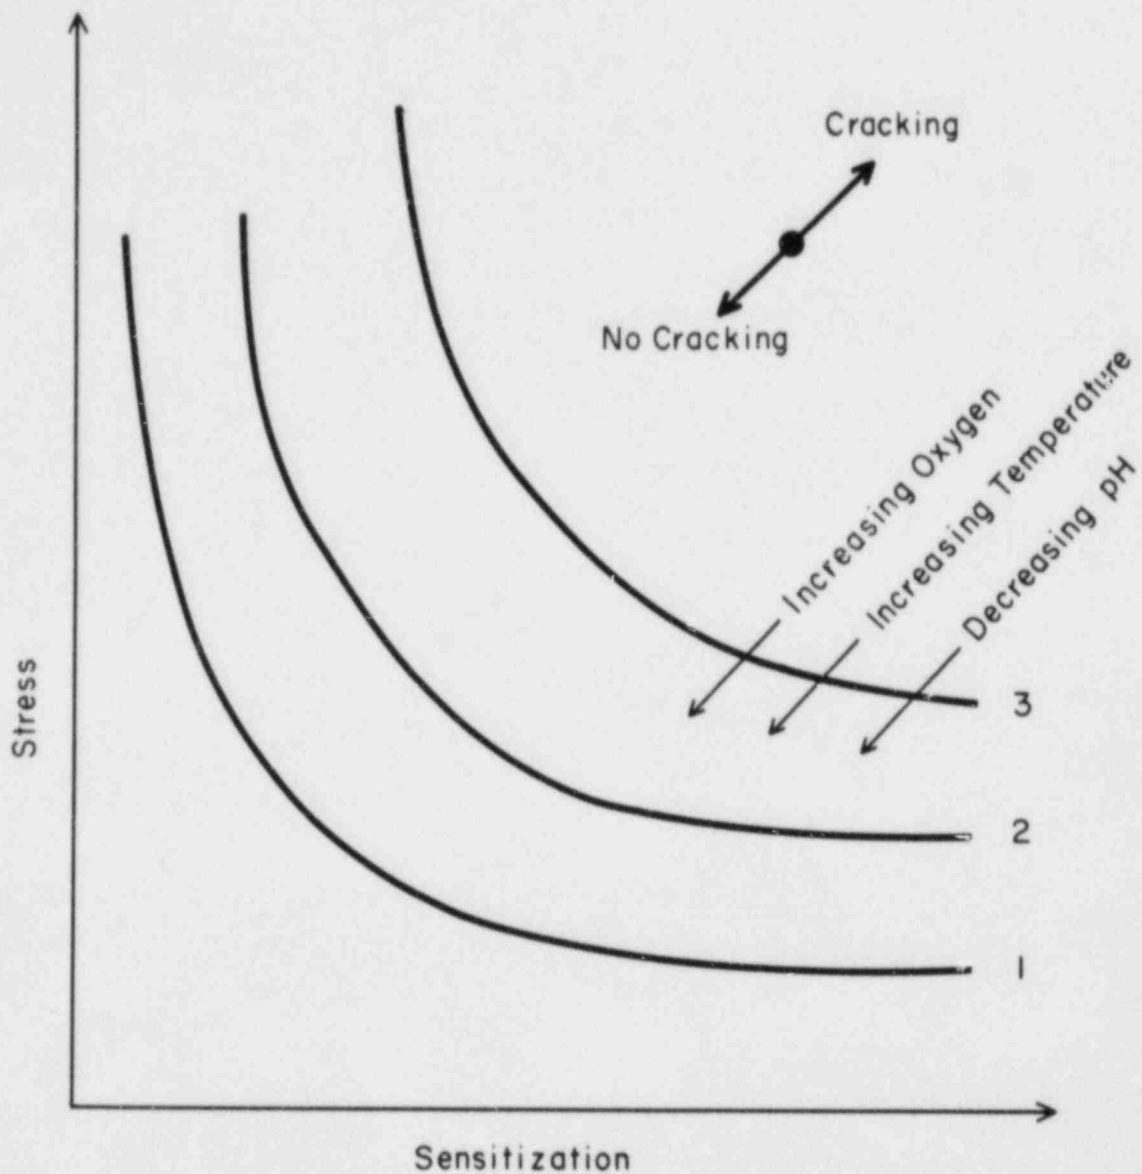
One can conclude from this equation that SCC will not occur when any of these quantities is 0 (except for some obvious difficulties of interpretation associated with too low pH). Further, an approach to eliminating the SCC problem is to minimize all the factors. Graphically this SCC problem might be considered as having the dependancies shown in figure 26. This figure suggests that the two most critical parameters are stress and degree of sensitization. Below the hyperbolic lines SCC will not occur but will above; the increase of oxygen and temperature, and decreasing pH may cause these lines to shift to a broader range of cracking by going progressively from lines 3 to 2 and 1. Increasing the concentration of contaminants (like fluoride) would presumably act to move from line 3 to 1.

1. There is no clear evidence that the applied plus residual stress patterns presently existing and during reactor life can be specified with the necessary confidence.
2. The complexity of interaction suggested by equation 1 and figure 26 produce an additional degree of uncertainty that makes clear conclusions difficult.

Figure 26. Schematic relationship showing possible pattern of interaction of stress, sensitization, dissolved oxygen, temperature and pH in the stress corrosion cracking of sensitized stainless steels.
