SAN ONOFRE NUCLEAR GENERATING STATION

Subject: Docket No. 50-361  
Voluntary Report  
Licensee Event Report No. 91-014  
San Onofre Nuclear Generating Station, Unit 2

# LICENSEE EVENT REPORT (LER) TEXT CONTINUATION

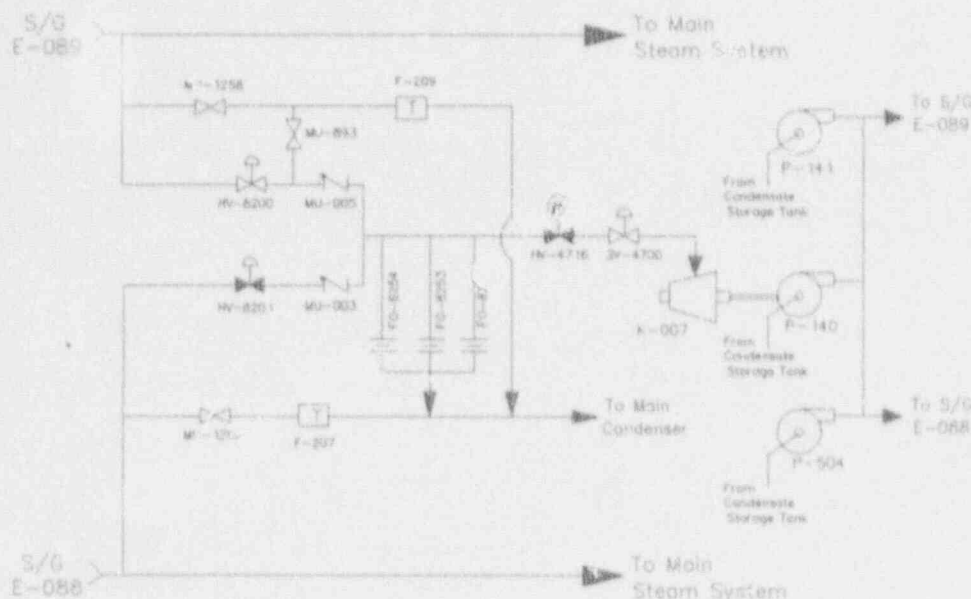
Figure 1: AFWPT Steam Supply & Drain System

AFWPT P-140 can be supplied steam from either E-088 via isolation valve HV-8201 [ISV] and check valve MU-003 [V] or from E-089 via isolation valve HV-8200 and check valve MU-005. The steam lines from these two sources are combined into a common line downstream of the check valves. Steam is then directed to the AFWPT via trip/throttle valve HV-4716 and governor valve SV-4700. HV-8201 is normally maintained closed when P-140 is in the standby mode of operation, and HV-8200 is left open to minimize wear damage from flow induced pressure oscillations to check valves MU-003 and MU-005. During surveillance and normal starts, both HV-8200 and HV-8201 are opened.

The AFWPT steam supply lines are provided with traps and orifices which are intended to provide a means for continuously extracting condensed steam and to keep the piping hot (refer to Figure 1 for details).
