SAXTON NUCLEAR EXPERIMENTAL CORPORATION

DOCKET NO. 50-146
LICENSE DPR-4

SAXTON COOLANT SYSTEM

INSPECTION REPORT

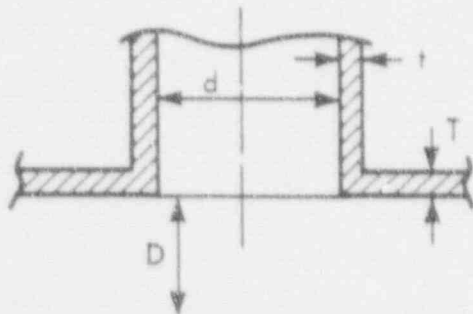
From "Seal Shell 2" Printout by inspection, the stress field across the penetration at mid-plane is effectively uniaxial and constant at 350 psi (Figure D-5).

Points of interest are at 90° and 135° as noted (discontinuity lies in this region) i.e., a nozzle type reinforcement in uniaxial stress. (Figure D-6)
