Florida Power

CORPORATION
Crystal River Unit 3
Docket No. 50-302

Subject: Response to Generic Letter 95-03, "Circumferential Cracking of Steam Generator Tubes"

Generic Response to GL 95-03 for B&W OTSG
Relative to Circumferential Cracking of Steam Generator Tubes

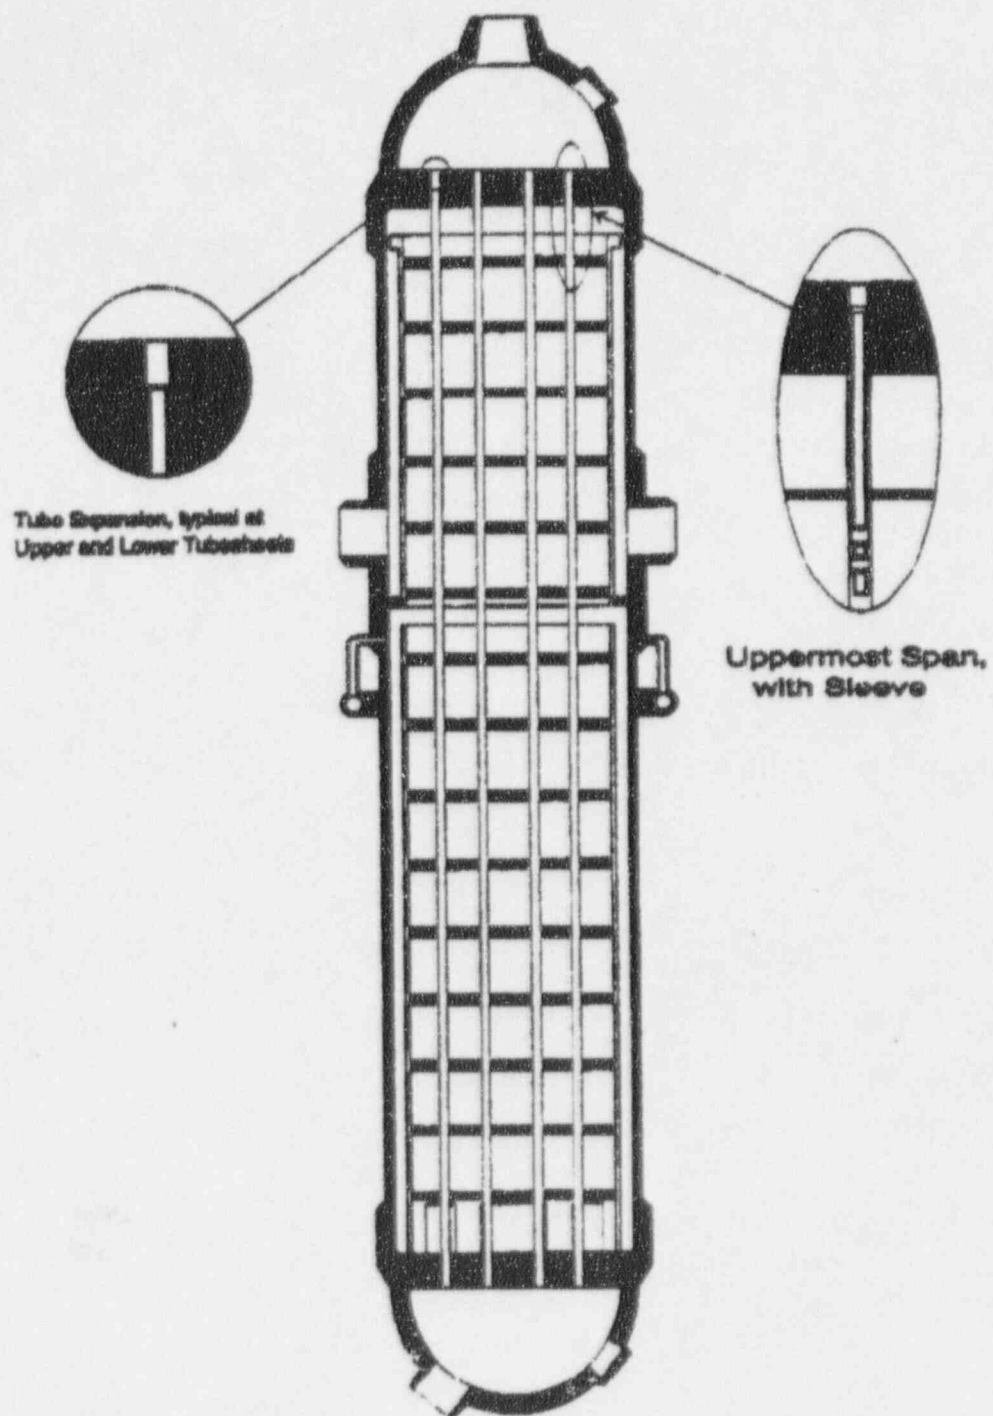
Figure 1
OTSG Section

The OTSG is a vertical once-through steam generator containing typically 15,531 5/8-inch diameter Alloy 600 straight tubes, each over 56-feet long (see attached Figure 1). The tubes are aligned and supported by 15 carbon steel tube support plates (TSP) which have broached holes to provide three-point support and a space for axial flow around each tube. During manufacture each tube was roller expanded 1-inch deep at each primary face of the 24-inch thick tubesheets for tube-to-tubesheet welding. Each fully assembled steam generator underwent a furnace stress relief heat treatment process at 1100 to 1150 degrees for 12 hours.
