UNUSUAL EVENT

FORT ST. VRAIN NUCLEAR GENERATING STATION
PUBLIC SERVICE COMPANY OF COLORADO
P. O. BOX 361
PLATTEVILLE, COLORADO 80651

REPORT NO. 50-267/75/5

FAILURE OF PV21105-1

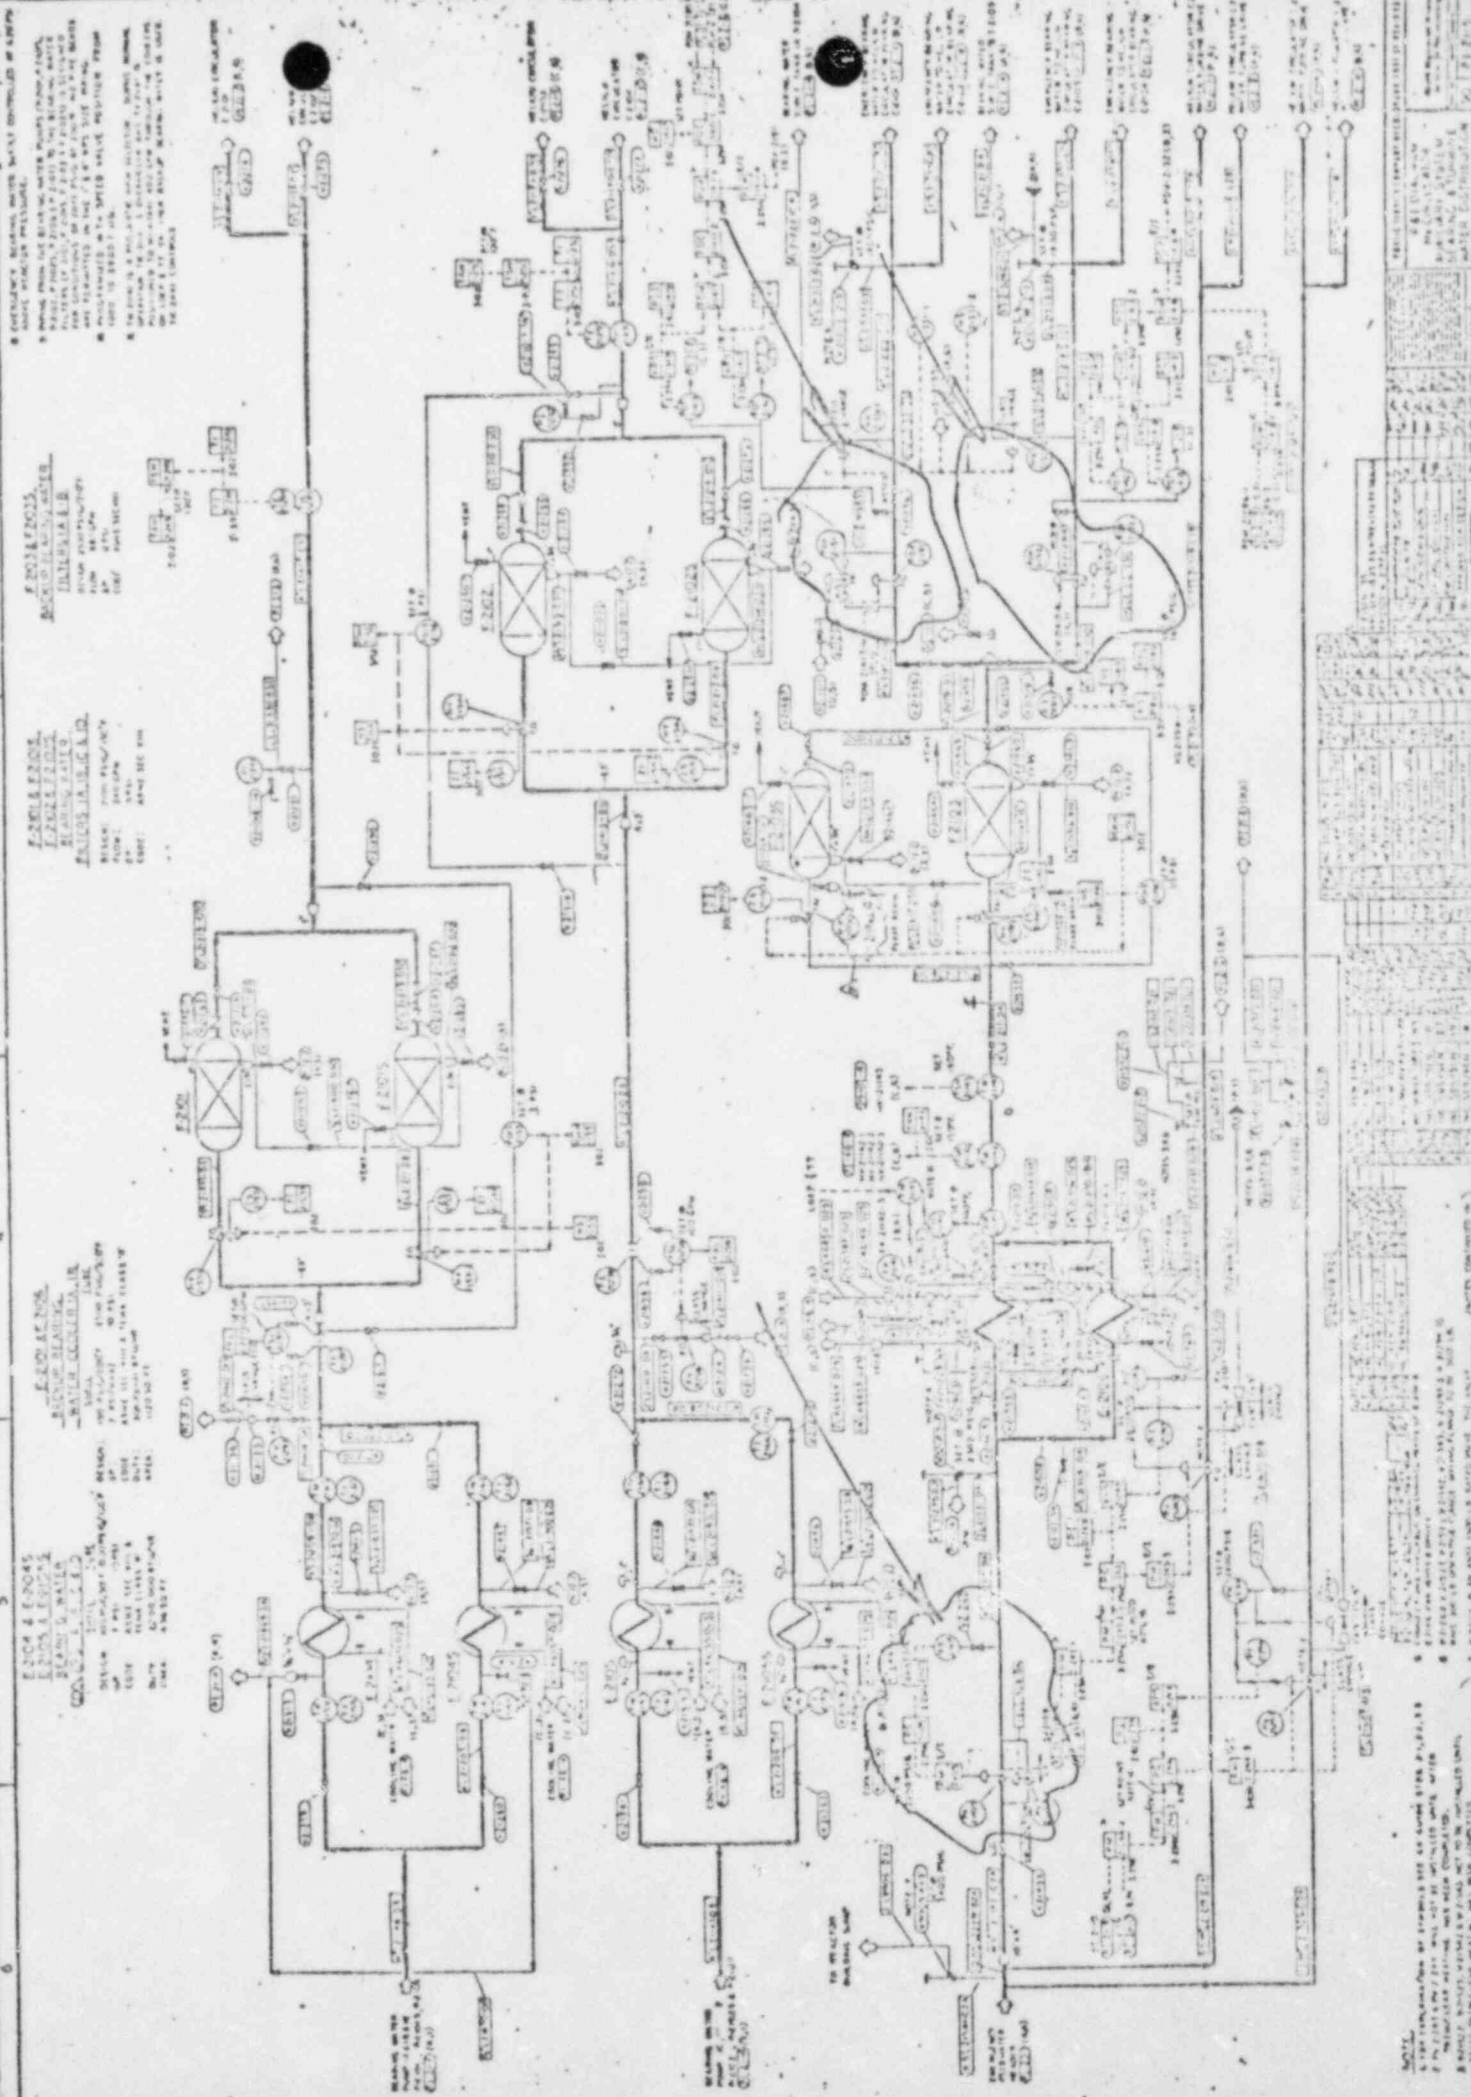
On April 10, 1975, while testing the helium circulator backup bearing water system a pressure control valve (PV21105-1) experienced a mechanical failure requiring shutdown of the emergency feedwater header and loss of the backup bearing water system.

Emergency Feedwater Header pressure pushing up against the valve plug was approximately 4,000 psig. The yoke clamp failed, causing the plug assembly to push upward lifting the operator assembly, packing spacers and packing retainer (not shown in attached drawing). This allowed high pressure water to blow out of the stem guide area.

Examination of the yoke clamp revealed a fractured area. This fractured area appeared to have existed for a considerable time, as evidenced by discolored surfaces in the fracture.

A manufacturer's representative investigated the failure on April 11, 1975. Damaged parts were replaced and this valve (PV-21105-1) along with two other Valtek valves (PDV-2191-1, 2192-1) were disassembled and inspected. All yoke clamps were dye penetrant checked. The pressure containing components on PV-21105-1 were also radiographed or dye penetrant checked.
