LICENSEE EVENT REPORT (LER)

FACILITY NAME (1) Point Beach, Unit 1										DOCKET NUMBER (2) 0 5 0 0 0 2 6 6				PAGE (3) 1 OF 1 3										
TITLE (4) Cracked & Missing Control Rod Guide Tube Split Pins																								
EVENT DATE (5)			LER NUMBER (6)				REPORT DATE (7)			OTHER FACILITIES INVOLVED (8)														
MONTH	DAY	YEAR	YEAR	SEQUENTIAL NUMBER	REVISION NUMBER	MONTH	DAY	YEAR	FACILITY NAMES				DOCKET NUMBER(S)											
0	2	5	8	4	8	4	0	0	1	0	0	0	3	2	8	8	4	0	5	0	0	0	0	0
OPERATING MODE (9)		THIS REPORT IS SUBMITTED PURSUANT TO THE REQUIREMENTS OF 10 CFR 5: (Check one or more of the following) (11)																						
N		20.402(b)				20.406(e)				80.73(a)(2)(iv)				73.71(b)										
POWER LEVEL (10)		0 0 0				20.406(a)(1)(i)				80.73(a)(2)(v)				73.71(c)

DOCKET NO. 50-266
LICENSEE EVENT REPORT NO. 84-001-00
CONTROL ROD GUIDE TUBE SPLIT PINS
POINT BEACH NUCLEAR PLANT, UNIT 1

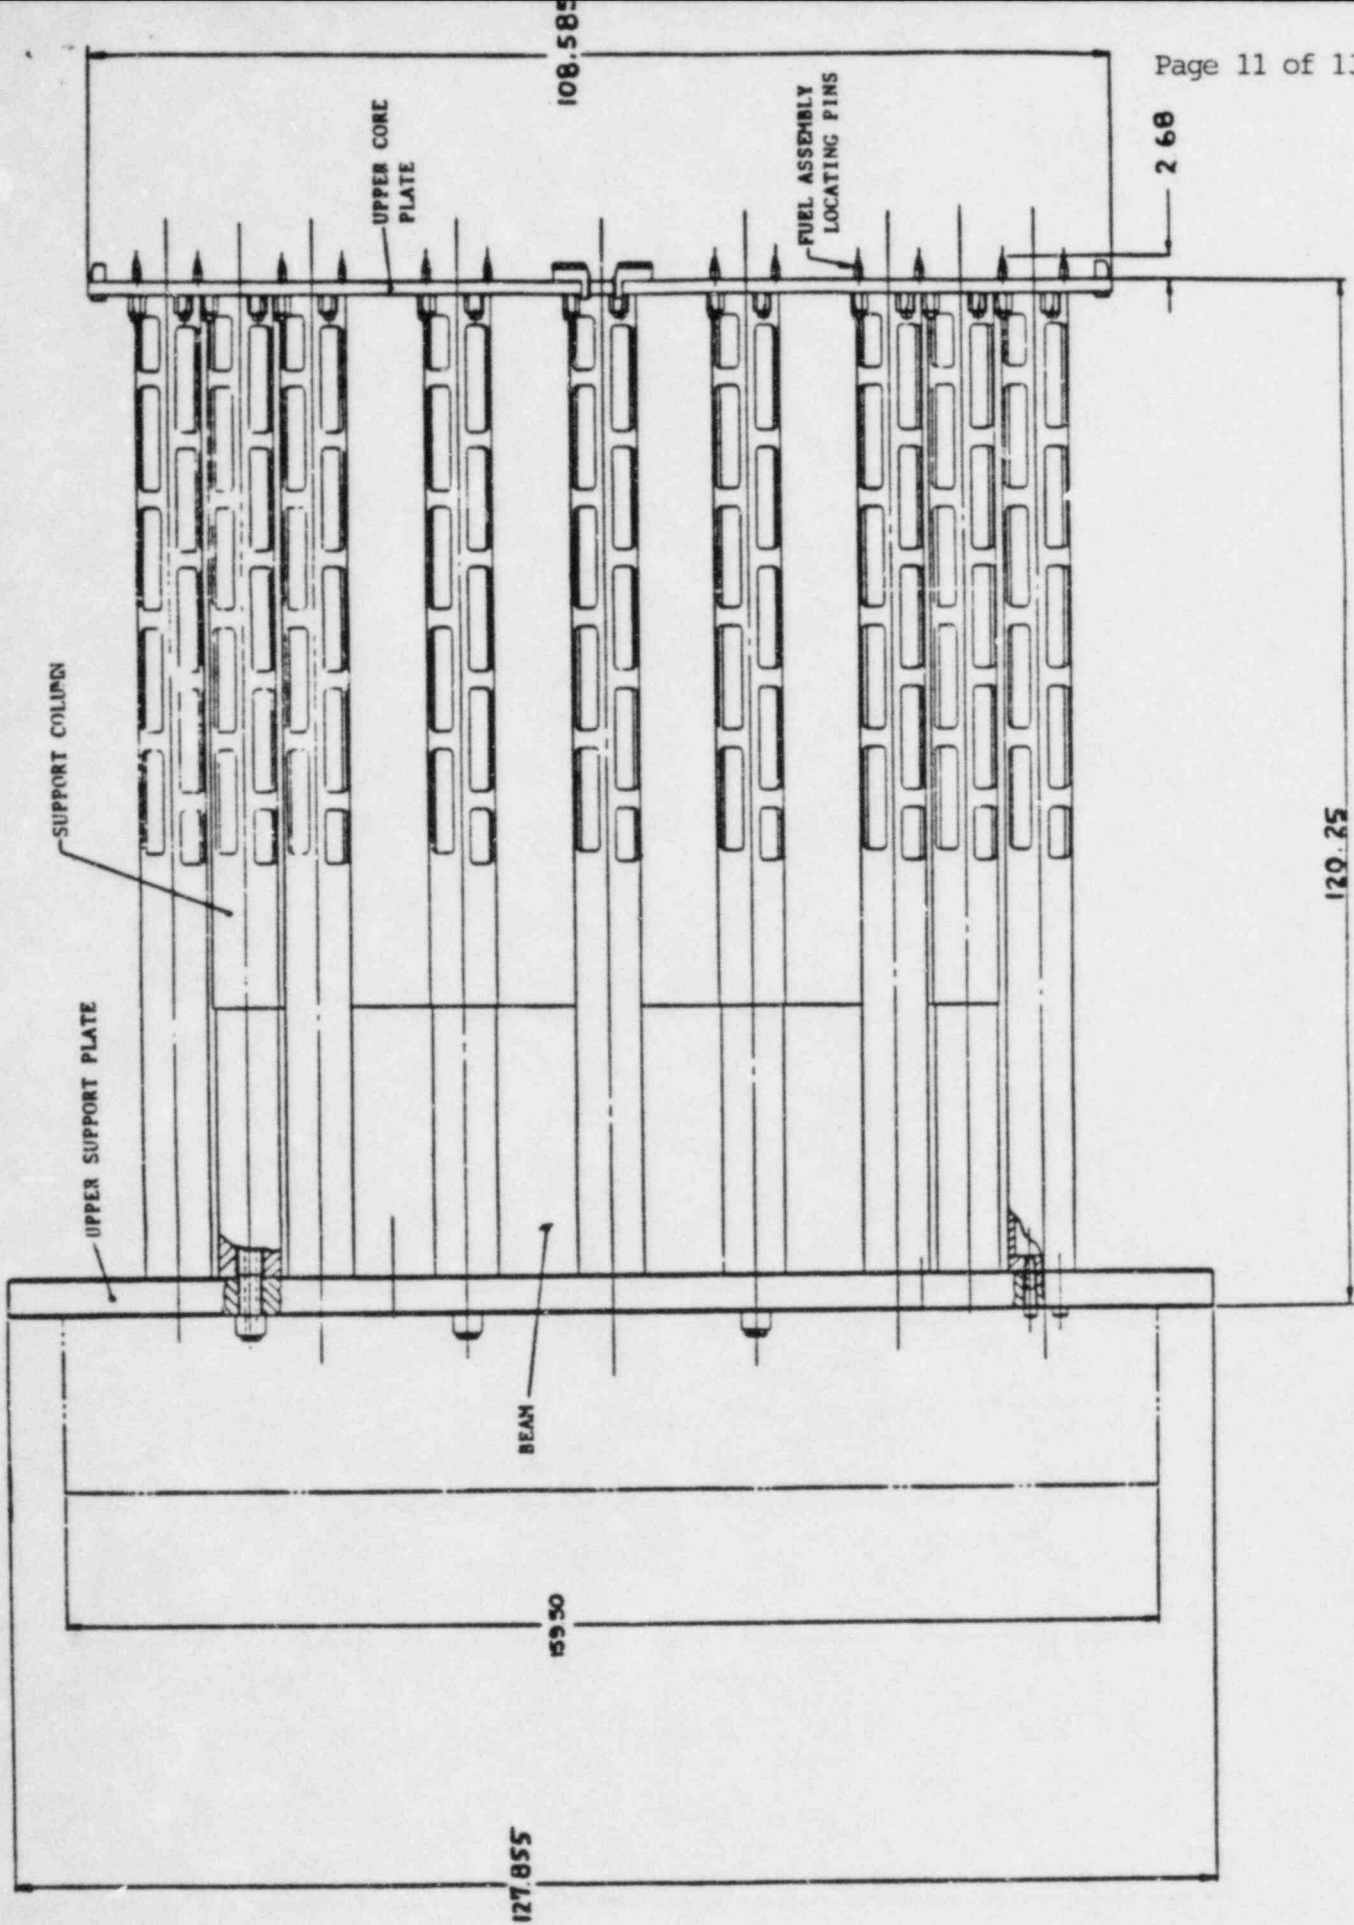
FIGURE 7

An ultrasonic inspection of the CRGT support pins at PBNP, Unit 1, was recently completed. The inspection revealed UT indications in the shank-to-collar region of 67 of 74 support pins (i.e., approximately 90%) (see Figure 7). No indications were found in the support pin leaves. A subsequent visual inspection of the sleeve nuts and threaded shank portion of the support pin assembly revealed 3 missing nuts and shanks (one each on the CRGT's above core positions G3, I5 & K7) (see Figure 8). Visual inspection of the peripheral portion of the upper core support plate (the inner portions are essentially inaccessible), the core former plate just below the upper core support plate, the lower core plate, the lower portion of the reactor vessel, and all upper nozzles of fuel

The long-range solution to this problem is to replace the pins at a future outage when the tooling and parts are available. An inspection of the PBNP Unit 2 pins is also planned during the next refueling outage. Cracking of the split pins in Unit 2 is not considered as likely, however, since they were heat treated at a temperature much closer to the recommended ideal.
