AFFIDAVIT

Response to PG&E Report 411-77.55

Subject: Failure Analysis of Cracked Field Weld No. 212, Diablo Canyon Unit 1, Steam Generator 1-2, Nozzle-To-Pipe Weld.

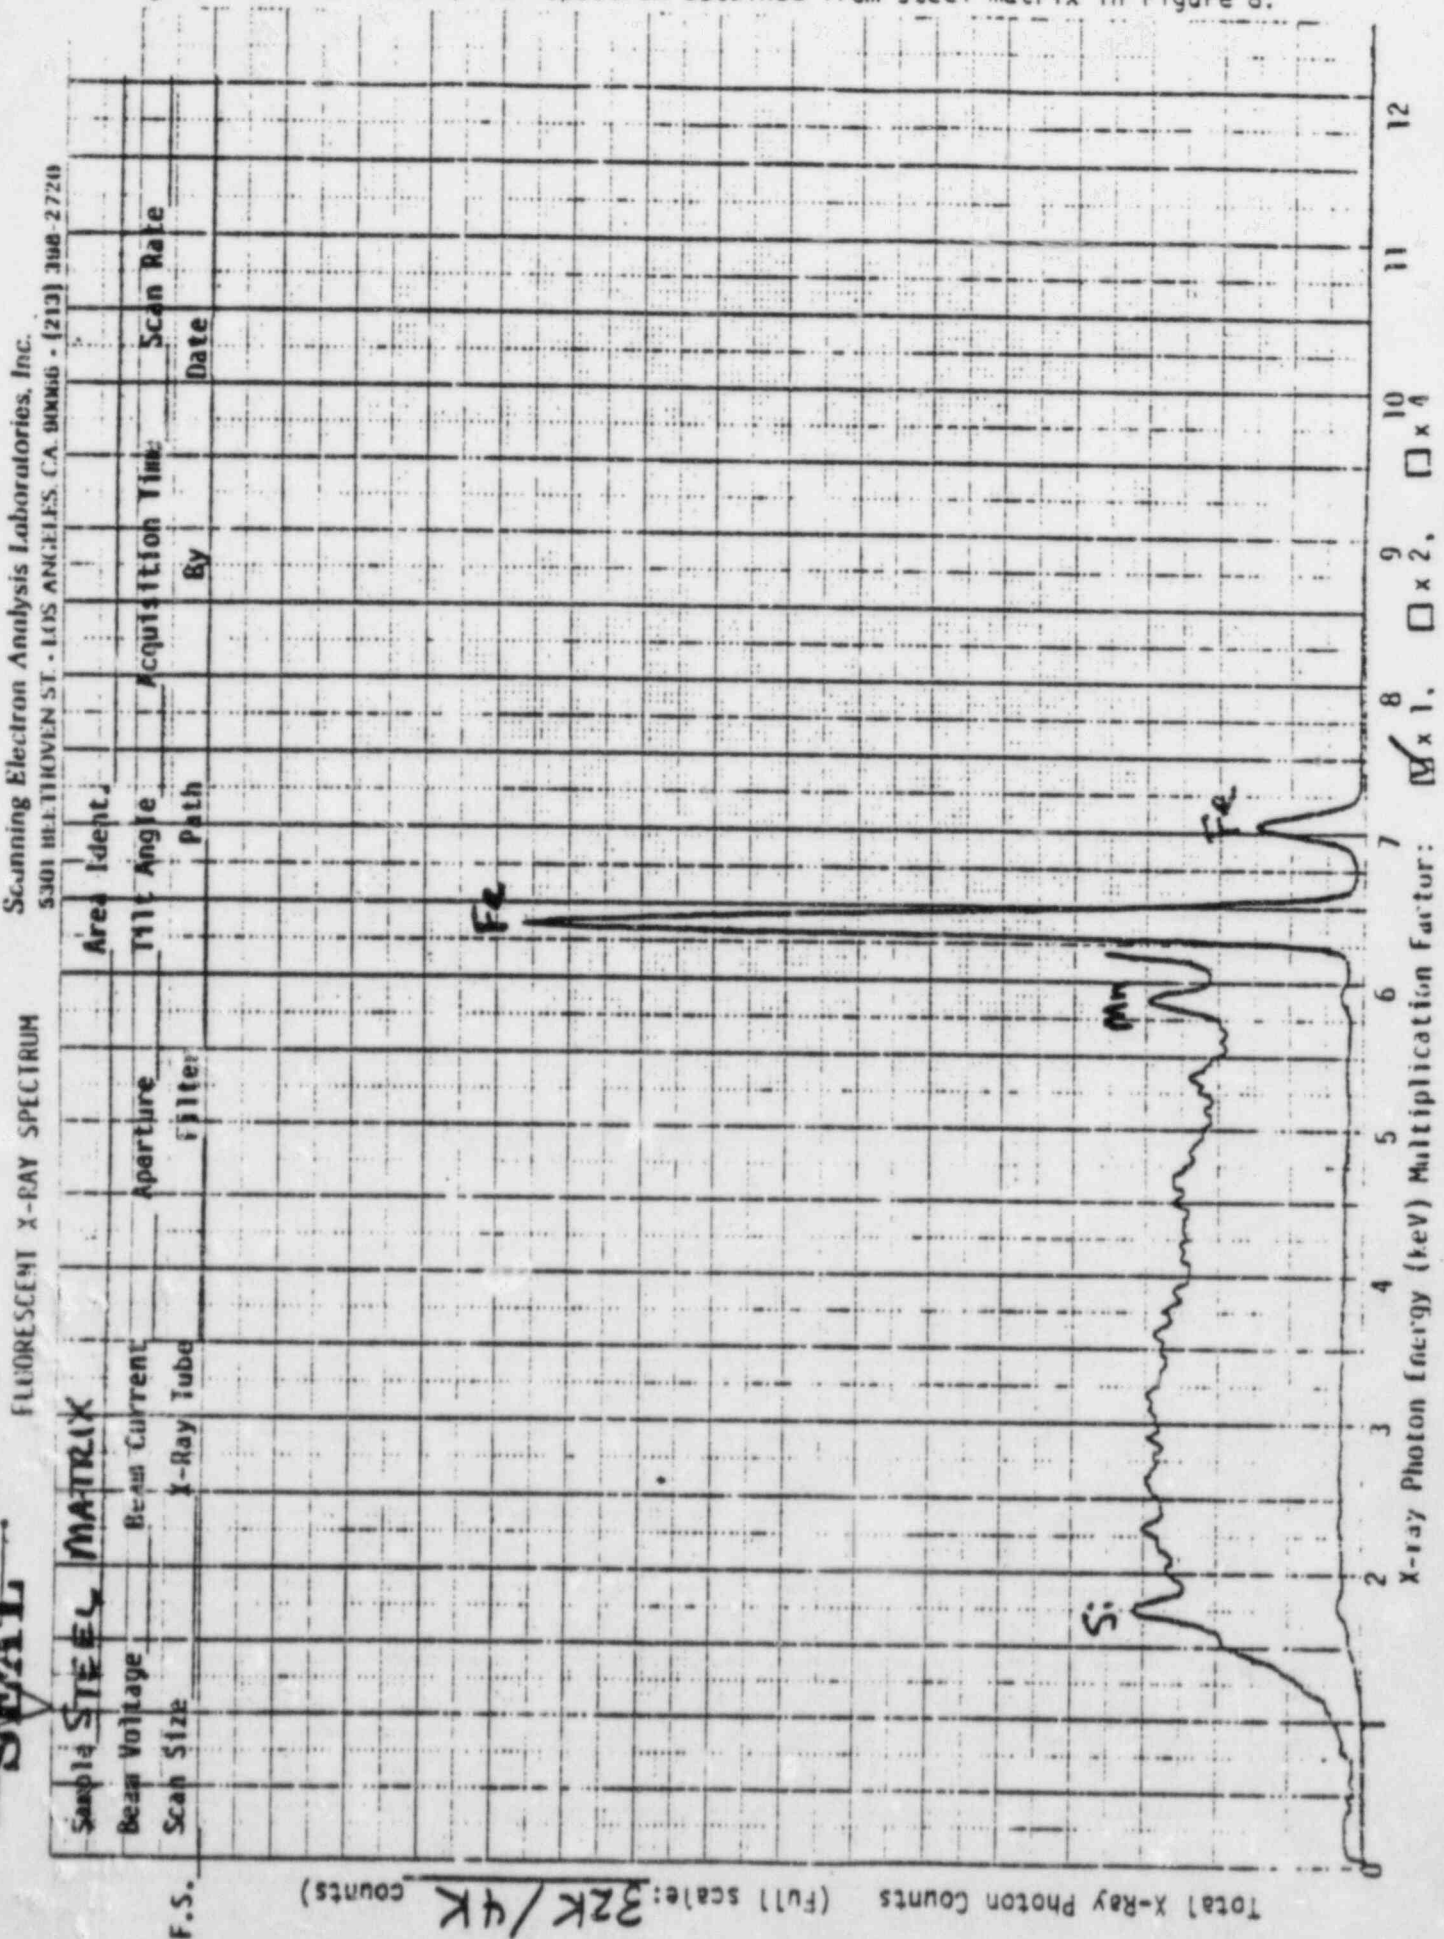
Figure 10. EDXA microprobe spectrum obtained from steel matrix in Figure 8.

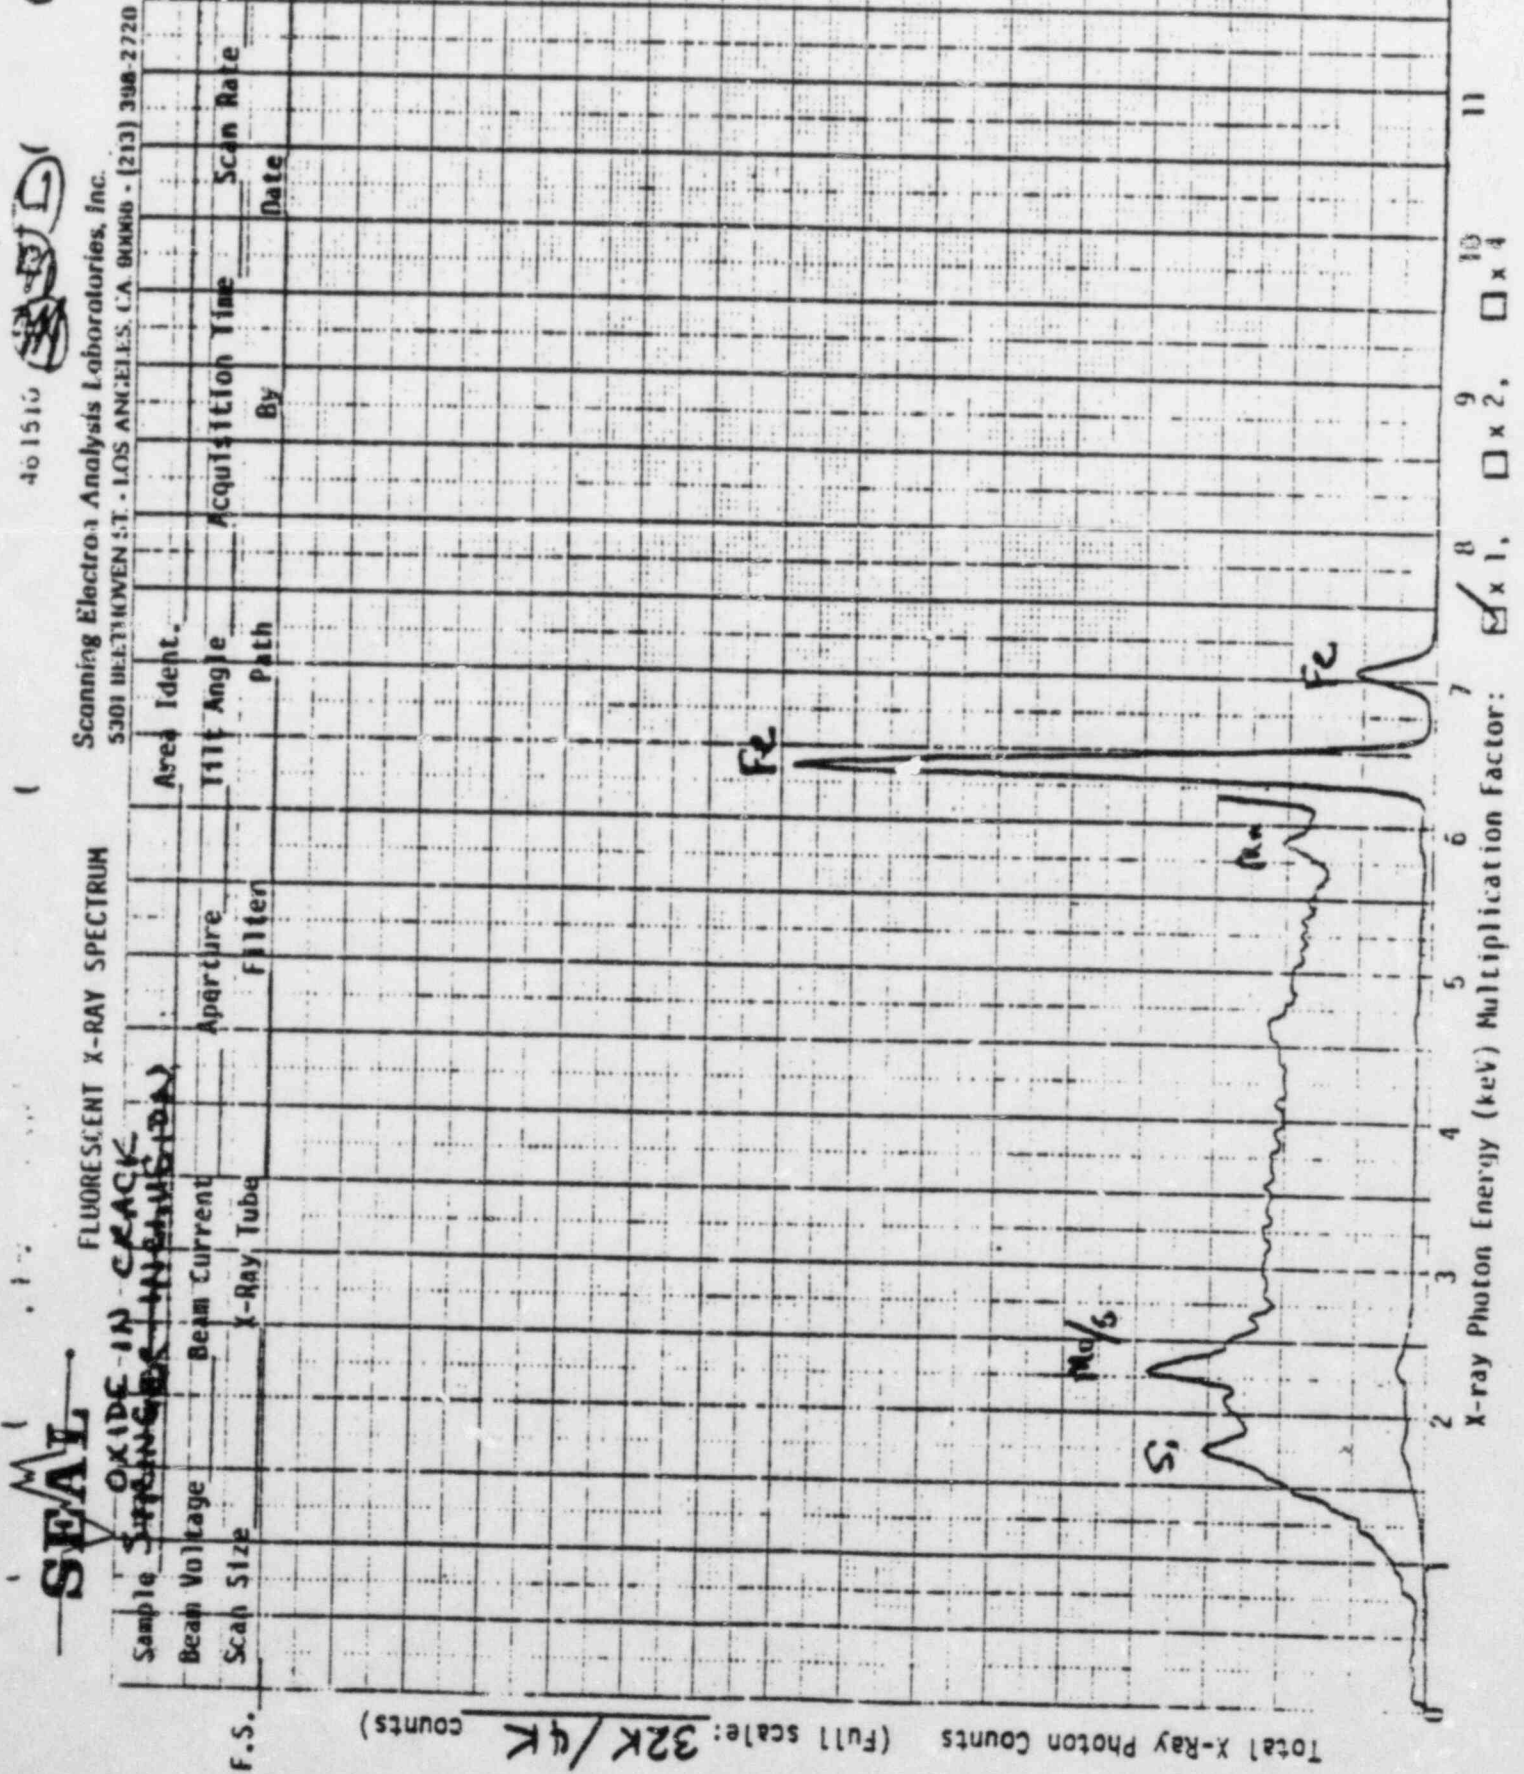
Two small cracks were opened up for examination by impacting them at liquid nitrogen temperatures (Specimens 2 and 3). The fracture surfaces had a dark layer of oxide patches along the outer edge, Figure 9, and were in close proximity to weld beads. Each crack was actually the result of the coalescence of many cracks each having its own origin. The origin edges of the fracture surfaces were covered with a relatively uniform oxide layer. The oxide layer was present all the way to the tip of the prior existing crack.

Figure 11. EDXA microprobe spectrum obtained from oxide in crack in Figure 8.

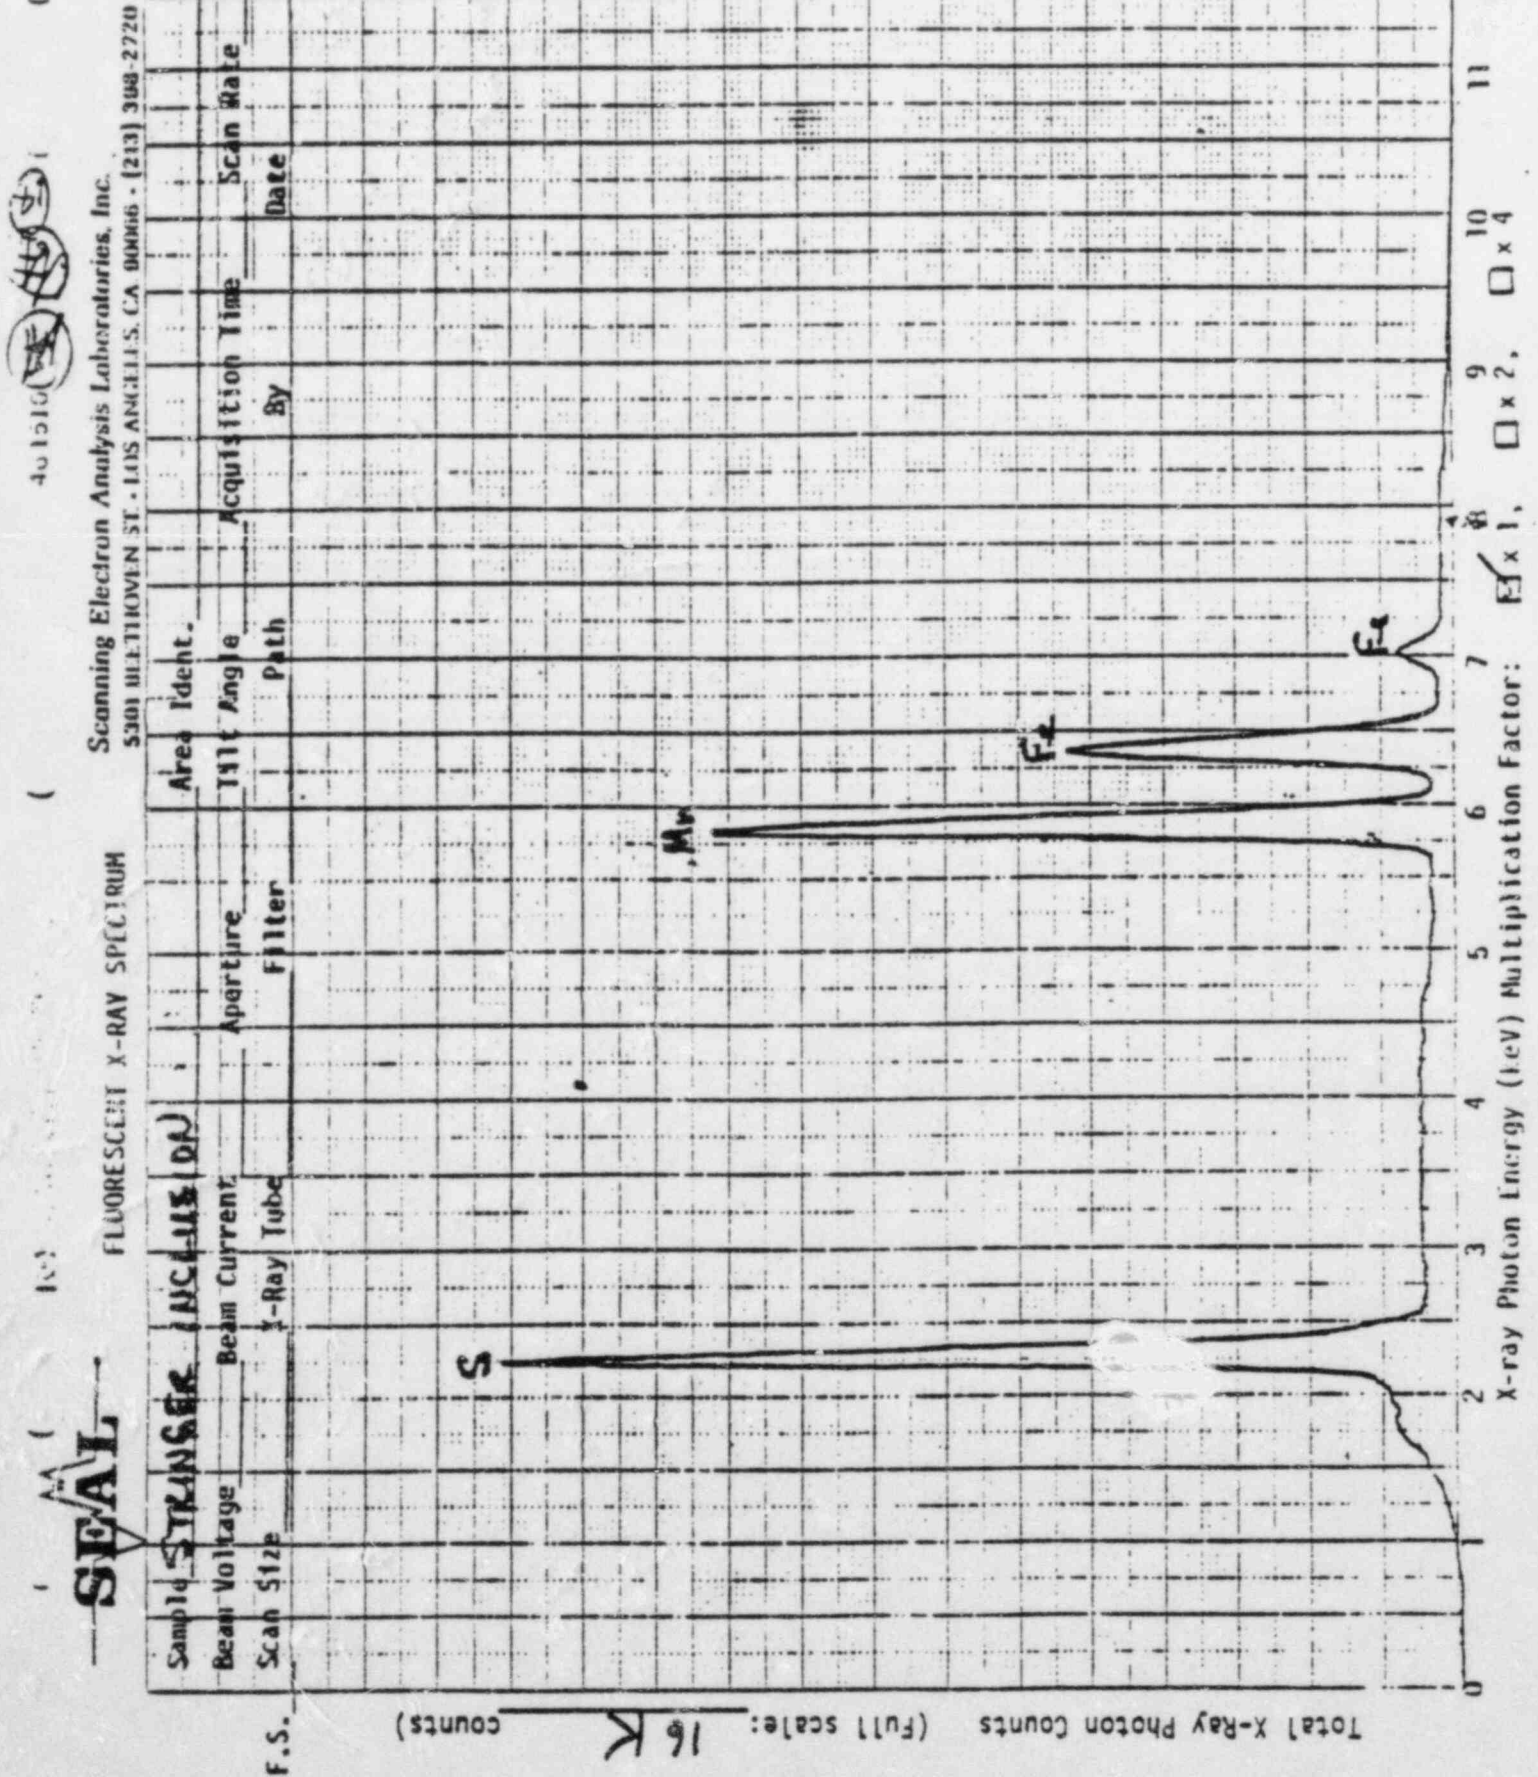
Figure 12. EDXA microprobe spectrum obtained from inclusion stringer Figure 8.

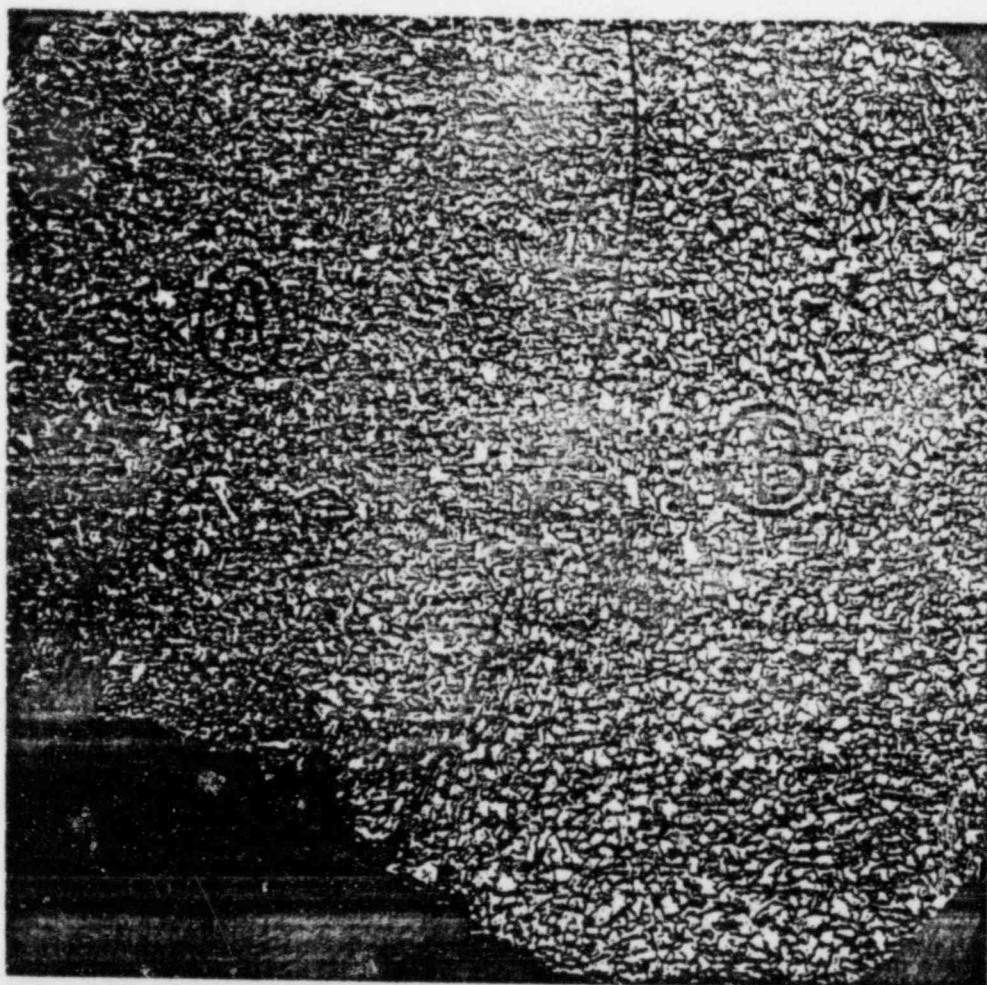
Photomicrograph  
Crack Evidence in Initial Weld Bevel Land

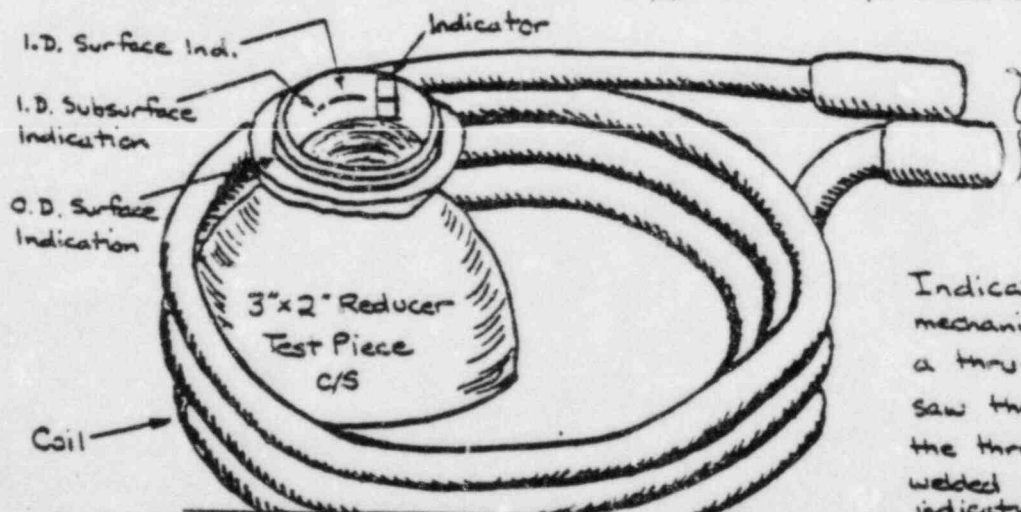
Indications are induced  
mechanical defects made by  
a thru-wall cut of a band  
saw then compressed. Part of  
the thru wall cut was back-  
welded to produce sub-surface  
indications.

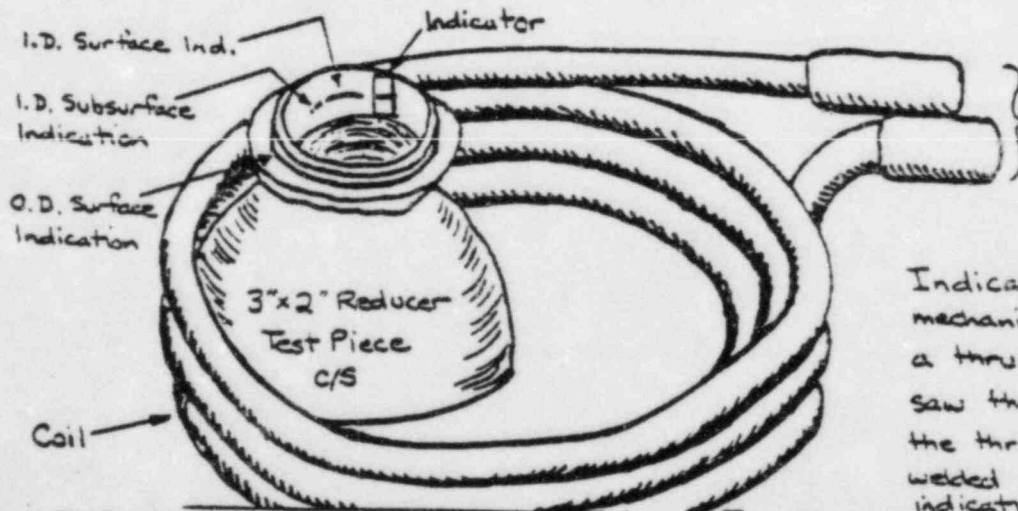
Indications are induced  
mechanical defects made by  
a thru-wall cut of a band  
saw then compressed. Part of  
the thru wall cut was back-  
welded to produce sub-surface  
indications.
