VERMONT YANKEE NUCLEAR POWER CORPORATION

Subject: **Proposed Alternative for Compliance with
10CFR50.55a Regarding RPV Cladding Indications**

ENGINEERING EVALUATION
OF VERMONT YANKEE REACTOR PRESSURE
VESSEL CLAD INDICATIONS
1992 REFUELING OUTAGE

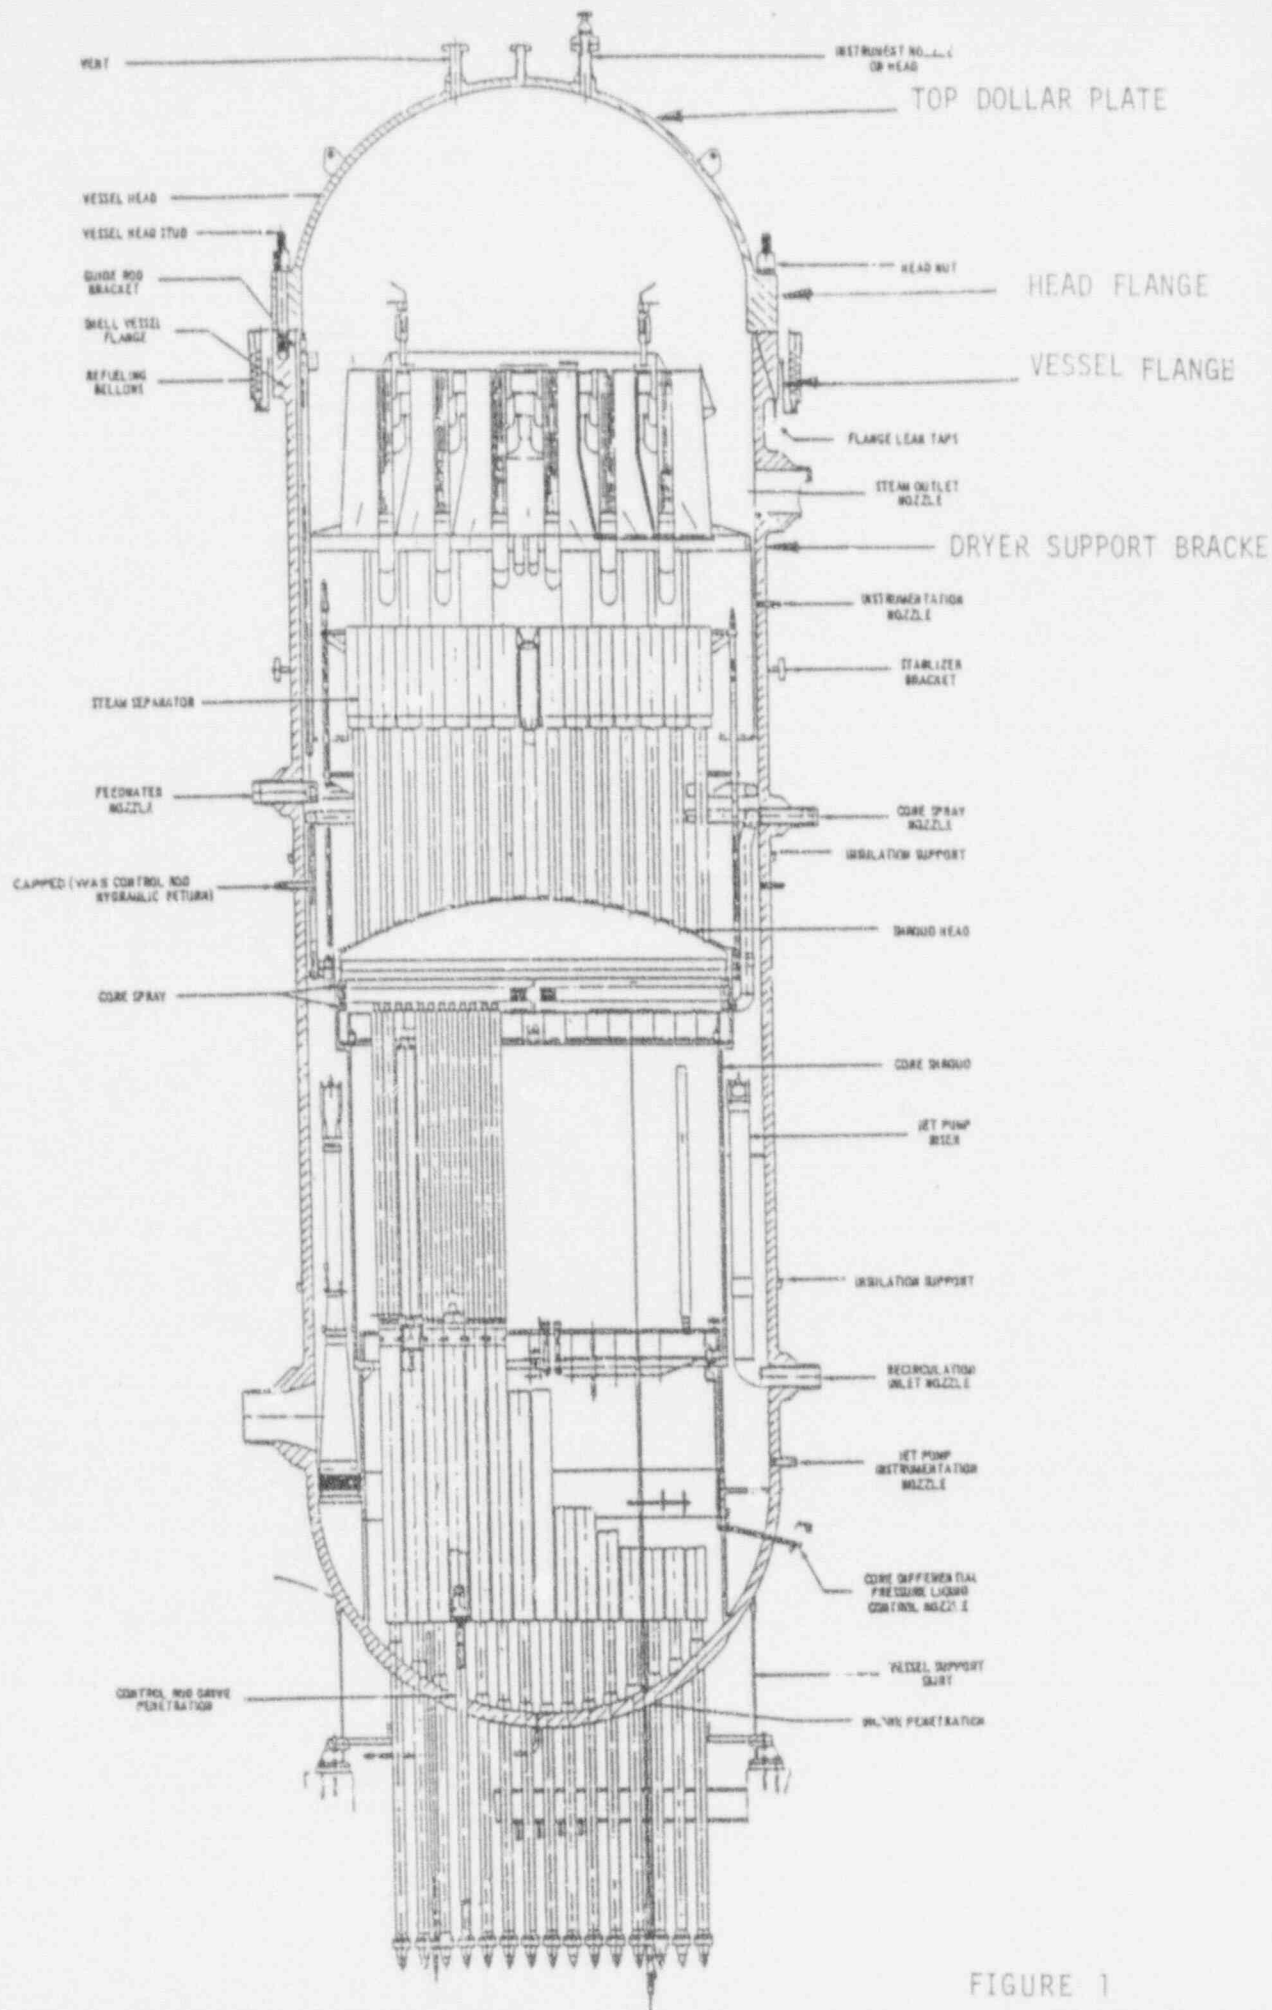
FIGURE 1

A visual inspection of the internal surfaces of the Vermont Yankee reactor pressure vessel head was performed on March 17, 1992 in accordance with the recommendations of the GE SIL No. 539. Numerous areas of rust on the stainless steel cladding were noted. This would be indicative of clad penetration down to the alloy steel basemetal. The rust areas were seen at the area of the flange to head butt weld and on the manual cladding on the flange forging [see Figure 1]. Additional rusting was observed on the manual cladding of the dollar plate section of the head. These areas were mostly limited to locations of manually applied cladding; however, some rusting was also visible in the area of automatically applied cladding. Some of the areas of rust were associated with visual linear indications. The majority of the rust marks are on the flange area with a long indication at the manual-to-automatic clad weld interface. Approximately 2/3 of the circumference at that interface shows some rust. There are also some indications on the manually clad area of the dollar plate. This area is about five feet in diameter at the top of the head. Most of the rust marks follow the circumferential clad weld beads.
