Donald C. Shelton
Vice President - Nuclear
Davis-Besse

Docket Number 50-346

October 15, 1991

Subject: License Amendment Request to Revise Technical Specification
5.3.1, Fuel Assemblies: Additional Information

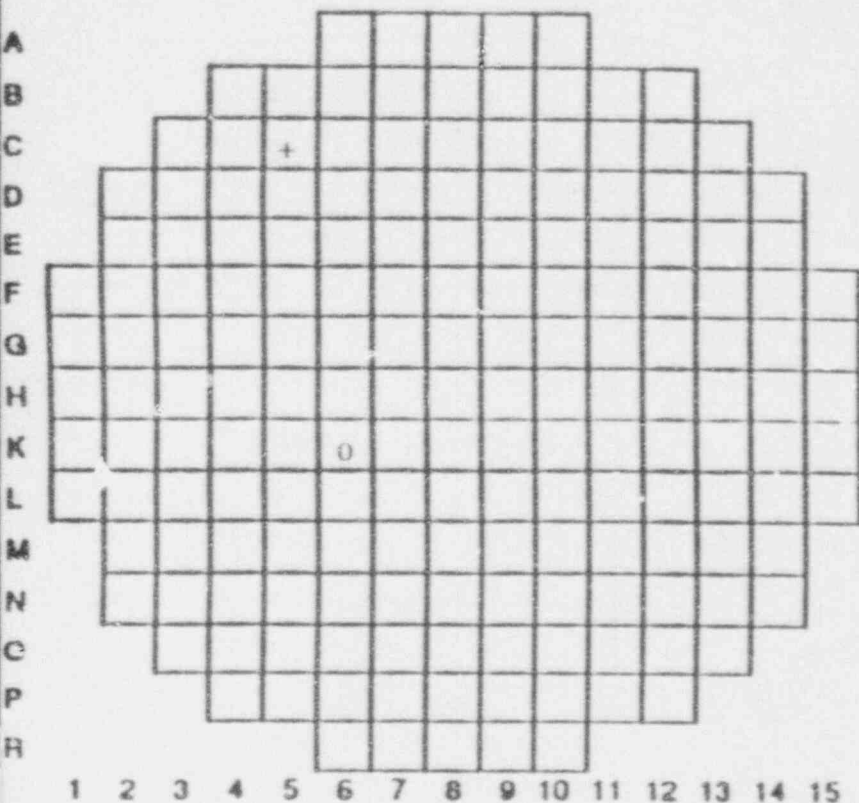
Core Map

The remaining Batch 9 FA had a defective fuel pin in a location adjacent to a control rod guide tube. This FA was reconstituted by removing the upper end fitting, extracting the defective fuel pin, moving an adjacent fuel pin into the location vacated by the defective fuel pin, inserting a solid stainless steel (SS) filler rod into the location vacated by the good pin, and then replacing the upper end fitting. The attached Figure 1 shows the location of the SS filler rod in the FA and the location of the FA in Cycle 8. The resulting configuration has the SS pin surrounded by heated rods (i.e., there are no adjacent cold walls). As discussed in the above-mentioned previous meetings with the NRC Staff, this FA configuration does not require any critical heat flux (CHF) penalties. The channels with the SS pin and surrounding fuel pins are not the lead channels for power generation in this FA. The minimum thermal margin for this FA will be greater than 5 percent relative to the lead power generation FAs in the core.

ASSEMBLY NJ0542
 BATCH 9
 RECONSTITUTABLE
