**SG Structural Inspection Plan
In Support
of Braidwood-1 and Byron-1
3.0 Volt IPC**

**COMMONWEALTH EDISON COMPANY
SEPTEMBER 1995
REV.0**

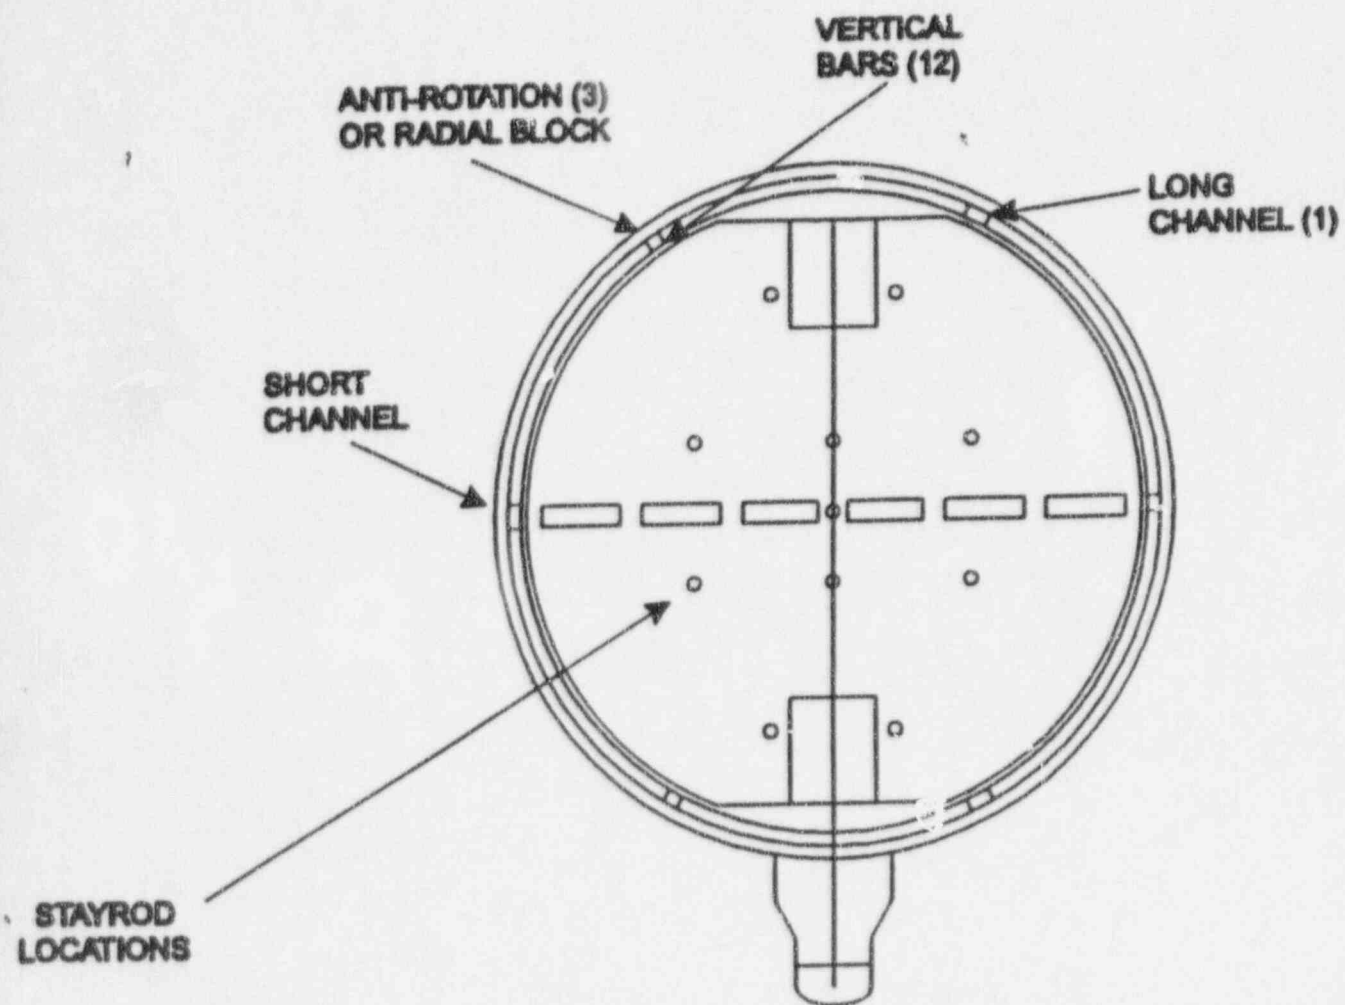
FIGURE 1

The TSPs are supported by stayrods with spacers, and by vertical support bars welded to the wrapper, which is supported by the SG shell. Figures 1 and 2 give an outline of the location of these components.

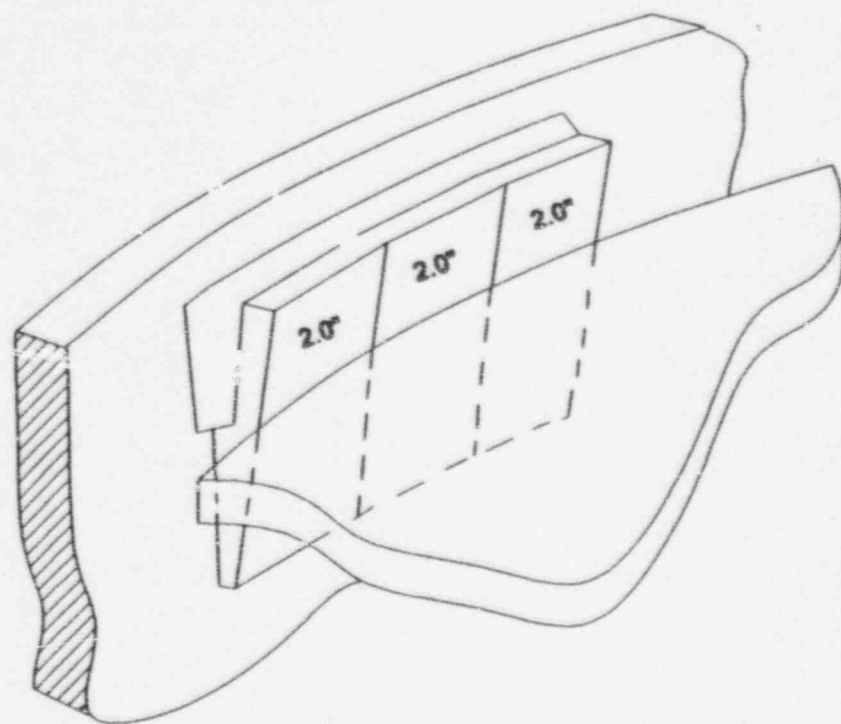
THREE WEDGE
LOCATION

The wedges are inserted between the TSP and wrapper at specified locations at each TSP elevation. They occur in groups of 2 or 3 and are held in place by welding between the wedge and wrapper (see figure 5). The wedges are designed to allow minor movement of the TSP due to thermal expansion while keeping the TSP approximately centered within the wrapper.

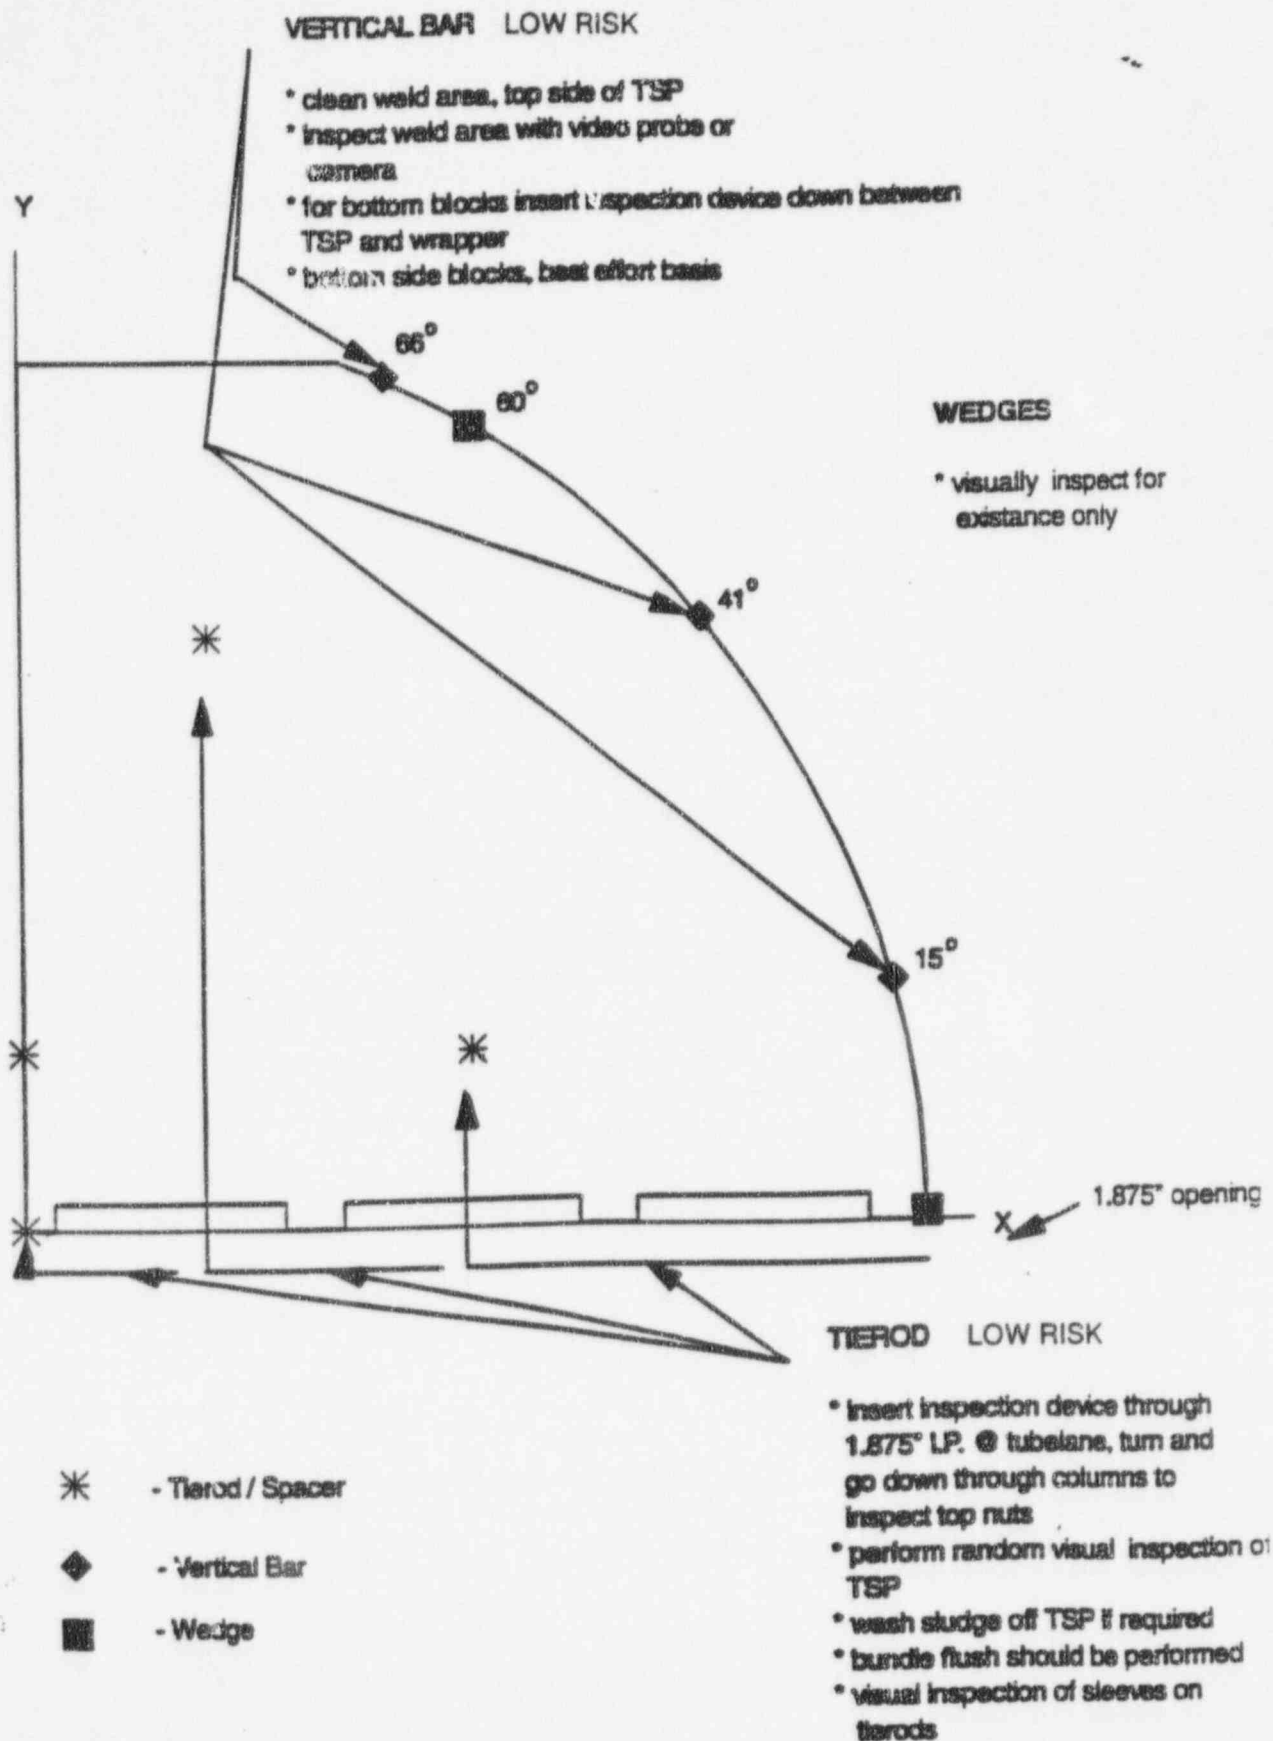
Plate P (11H) Support Locations

TSP	DESCRIPTION OF DRAWING
11 H	Drawing represents 1/2 of the hot leg TSP. Inspections can be performed on hot and cold legs equally for the vertical block welds. Inspections can be performed on hot and cold legs closest to handhole for stayrods.
10 H	Drawing represents 1/2 of the hot leg TSP. Inspections can be performed on hot and cold legs equally for the vertical block welds.
09 H	Drawing represents 1/2 of the hot leg TSP. Inspections can be performed on hot and cold legs equally for the vertical block welds.
08 H	Drawing represents 1/2 of the hot leg TSP. Inspections for the vertical block spaced at 78 degrees can be performed on hot and cold legs equally. However, those vertical blocks spaced at 15 and 41 degrees can only be performed on the hot and cold leg side closest to the handhole. Inspections can be performed on hot and cold legs closest to handhole for stayrod spacers.
07 H	Drawing represents 1/2 of the hot leg TSP. Inspections for the vertical blocks spaced at 78 degrees can be performed on hot and cold legs equally. However, only those vertical blocks down the tube lane closest to the handhole can be inspected.

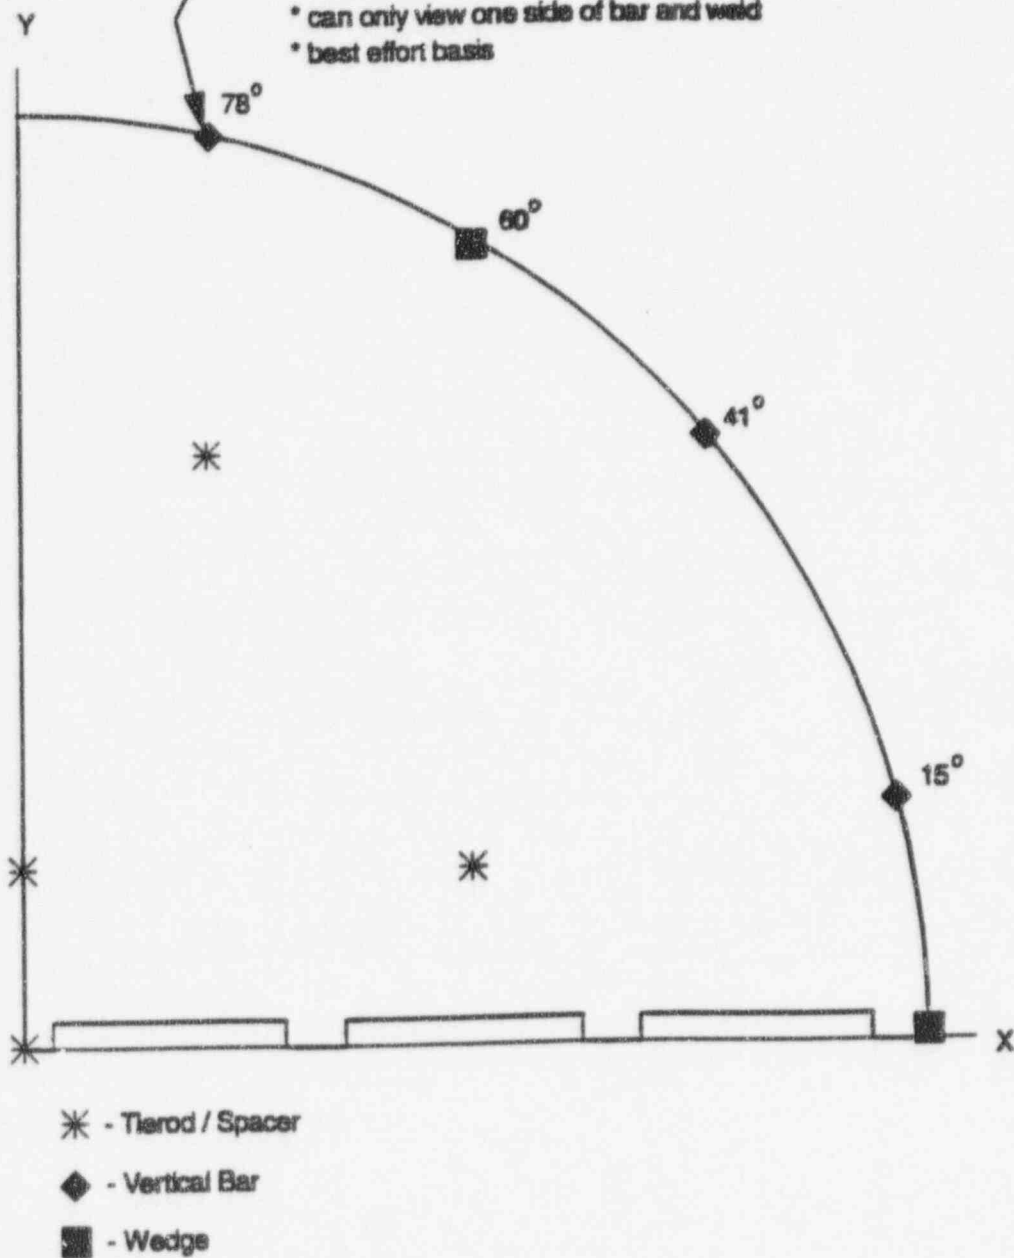
Plate M (9H) Support Locations

VERTICAL BAR HIGH RISK
