METALLURGICAL EVALUATION
OF
DIESEL GENERATOR TURBOCHARGER
GUIDE VANE HOLD DOWN BOLTS
AT
GRAND GULF NUCLEAR STATION - UNIT 1

PREPARED FOR: NUCLEAR PLANT ENGINEERING
MISSISSIPPI POWER & LIGHT COMPANY
PORT GIBSON, MISSISSIPPI 39150

PREPARED BY: J. S. BRIHMADESAM
NUCLEAR ENGINEERING DEPARTMENT
MIDDLE SOUTH SERVICE, INC.
NEW ORLEANS, LOUISIANA 70112

JULY, 1984

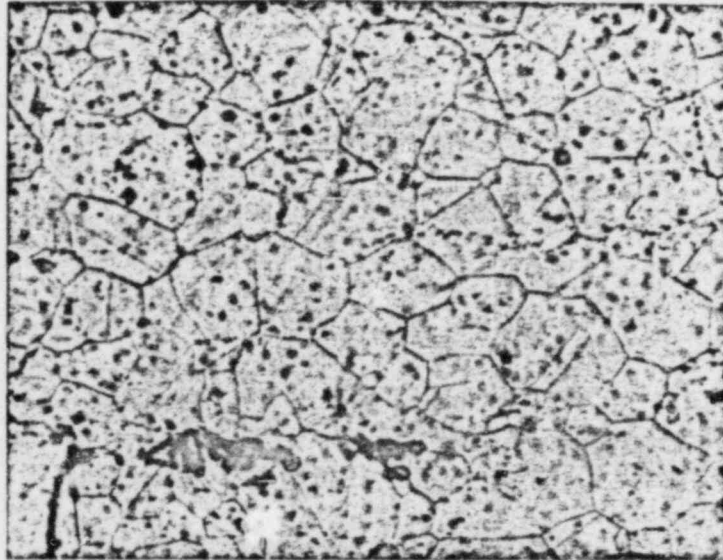
Figure 14 Photomicrograph of Turbocharger Bolt From Division II
L-1 Bolt

Note smaller grain size than the Division I bolts. Micro-structure shows some evidence of stepping, indicating absence of sensitization.

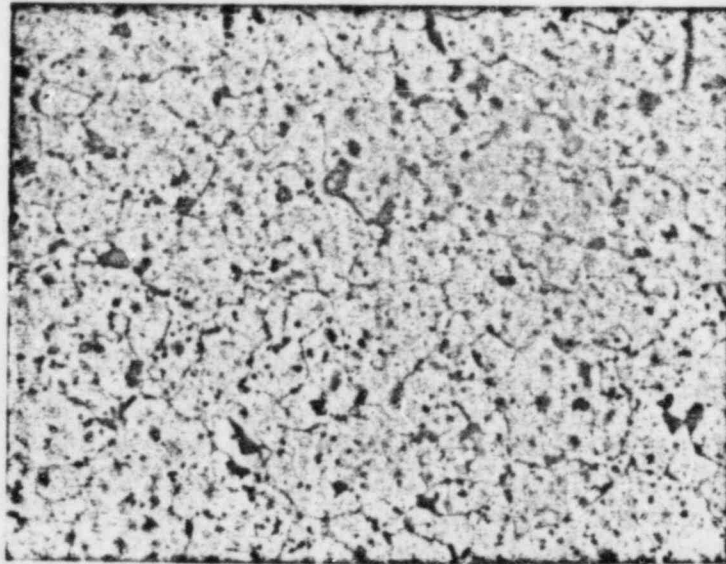
Figure 19 Photomicrograph of Turbocharger Bolt From Division II
Very slight evidence grain boundary precipitation. Material
is not sensitized.
