TMI-1 REACTOR COOLANT PUMP SHAFT FAILURE ANALYSIS

TMI-1 REACTOR COOLANT PUMP SHAFT
FAILURE ANALYSIS

Lynchburg Research Center Report
RDD:84:5183-06:01

August 1984

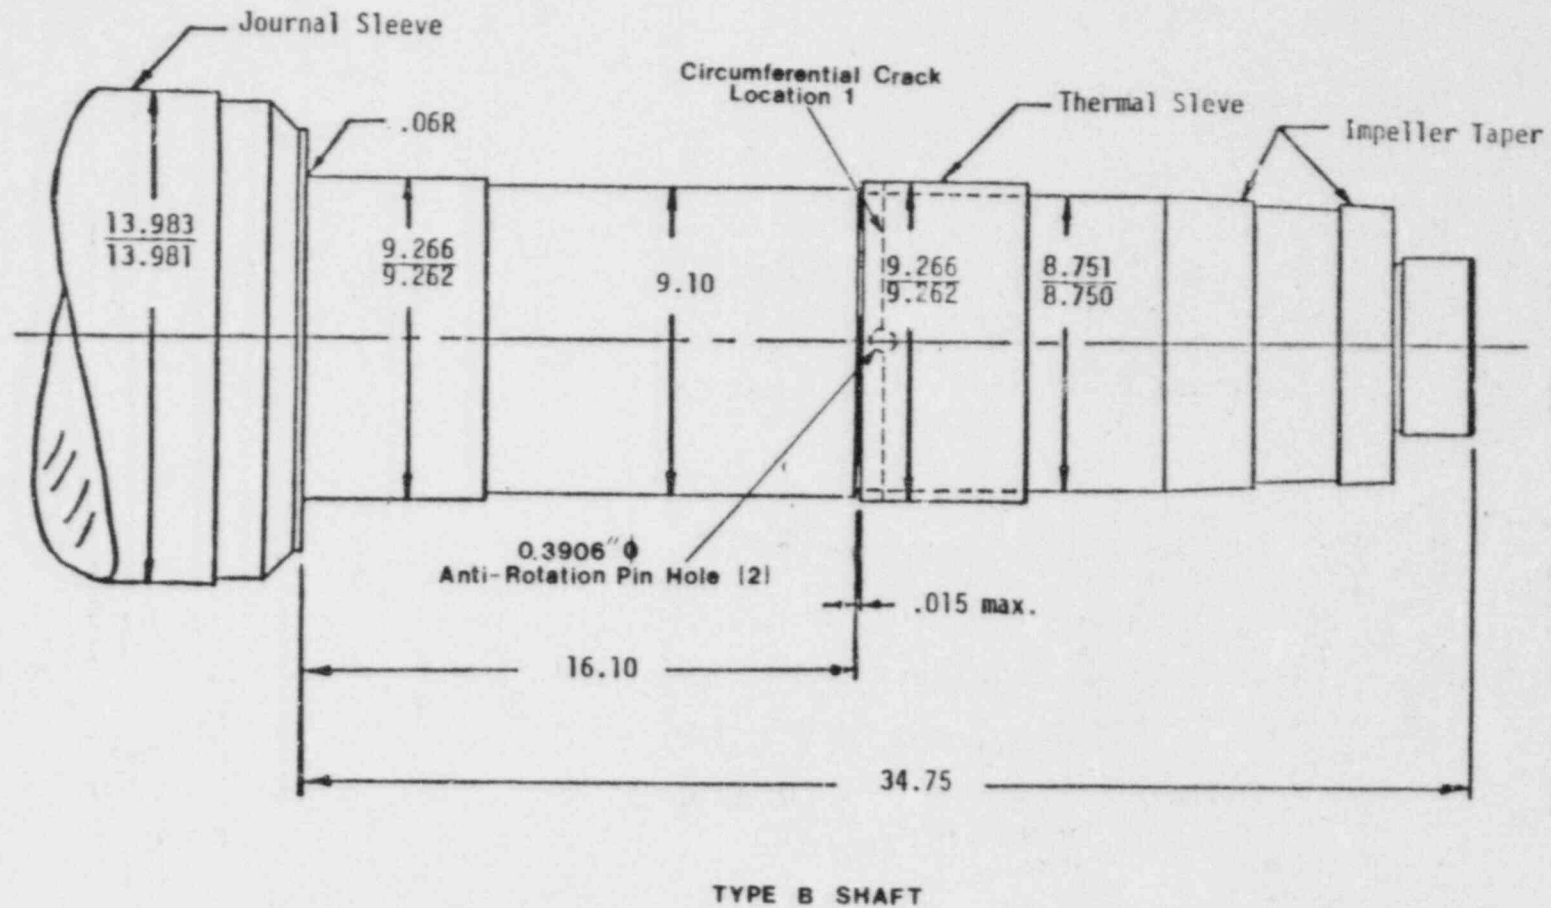
Figure 1.2-4. Geometry of Type B Shaft in Failure Area

The geometry of the lower end of type B shaft used in TMI-1 RCP-1B is shown in Figure 1.2-4. The majority of the crack in RCP-1B was found by GPU to exist under the thermal sleeve near the shaft diameter step change from 8.750 inches to 9.10 inches. Near this diameter change are two blind holes 180° apart on the shaft. Each of these holes are 0.3906 inches in diameter and extend to a maximum depth of 0.455 inch. Figure 1.2-5 shows the design detail of these holes, the thermal sleeve, and shaft in this area. The holes position the anti-rotation pins which are welded to the thermal sleeve.

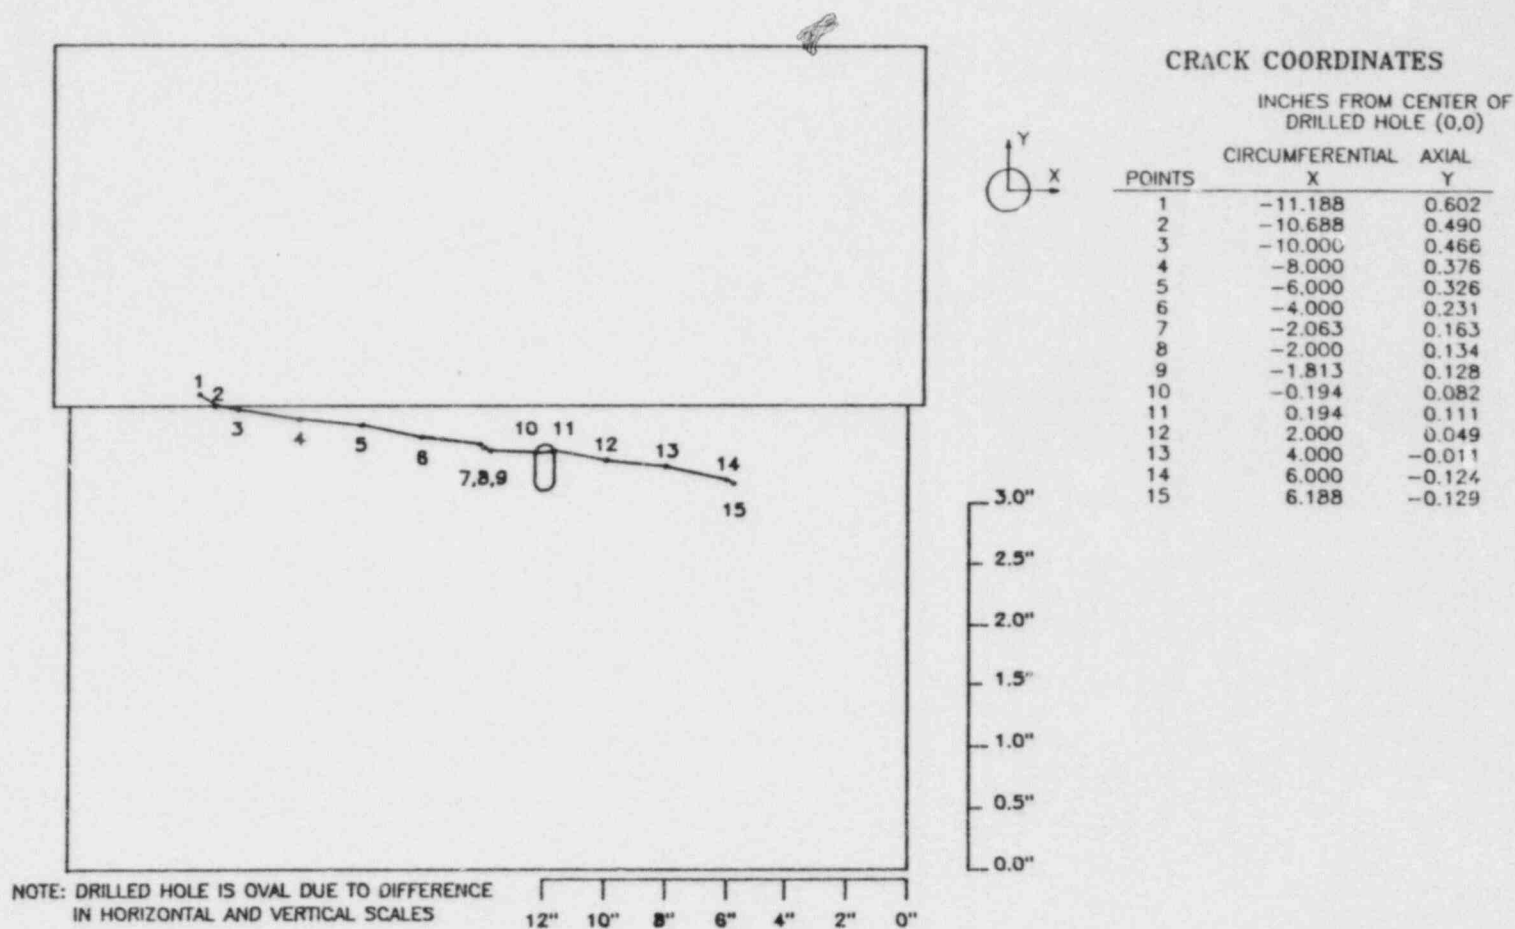
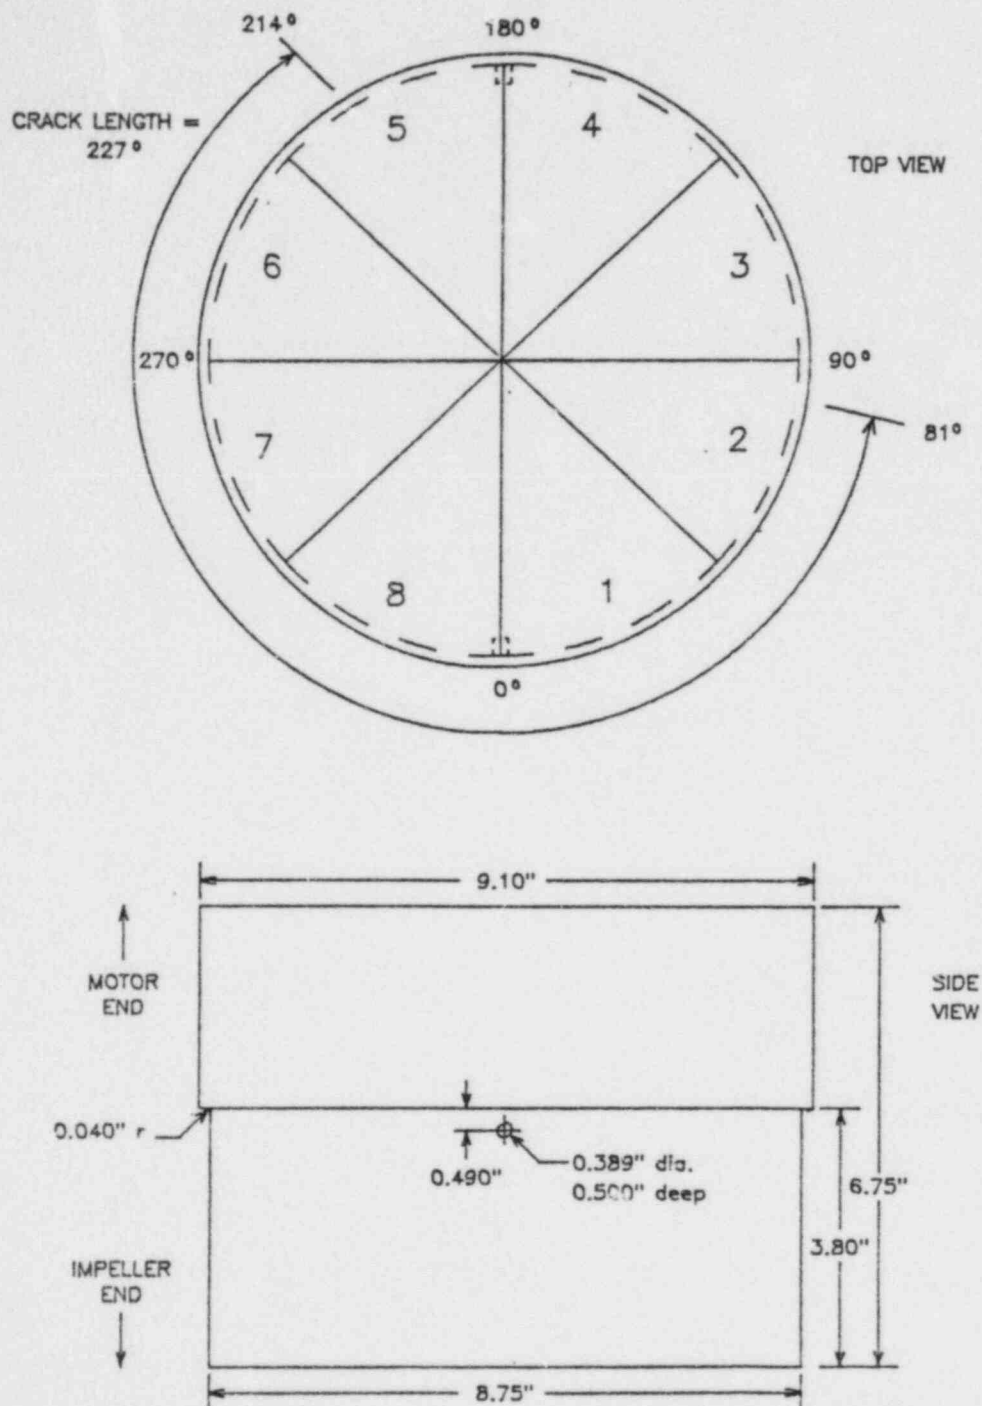
Figure 3.1-13. Pump Shaft Dimensions and Crack Location

Figure 3.1-13, continued; Pump Shaft Crack Location and Coordinates

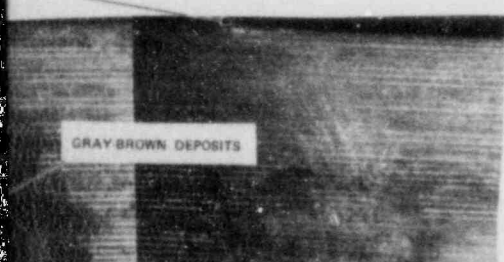
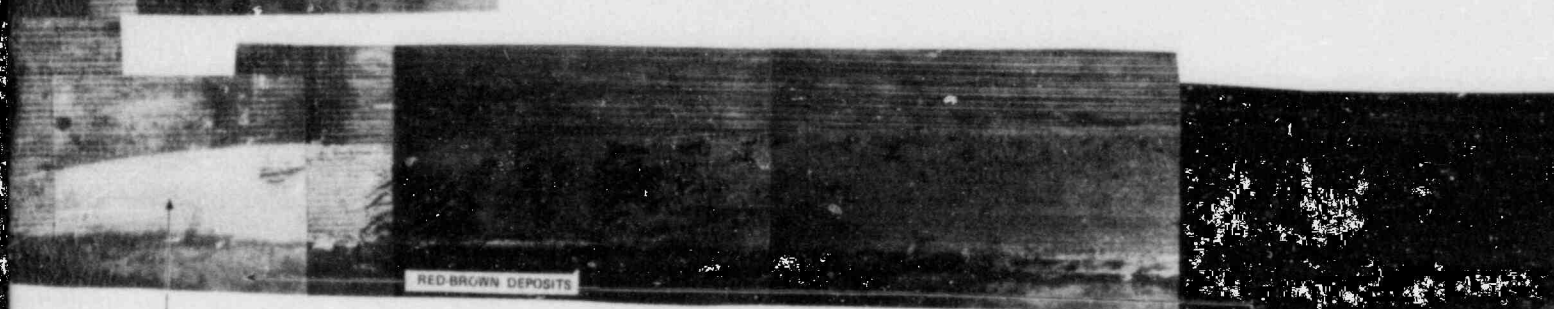
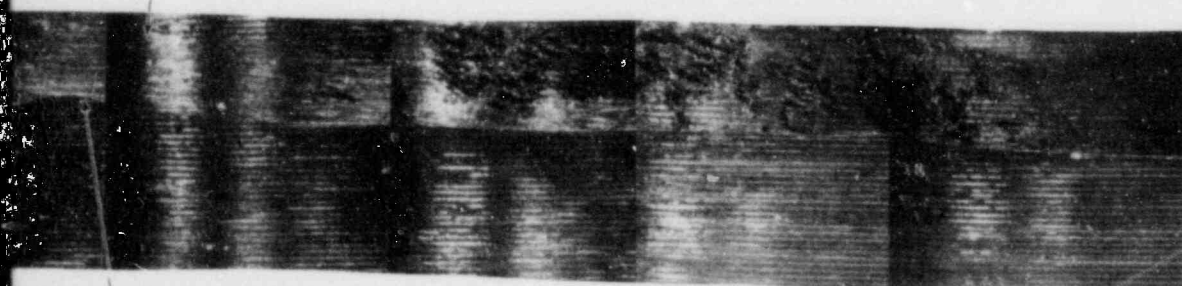
GRAY-BROWN DEPOSITS

RED-BROWN DEPOSITS

MATCHING WEAR

CRACK

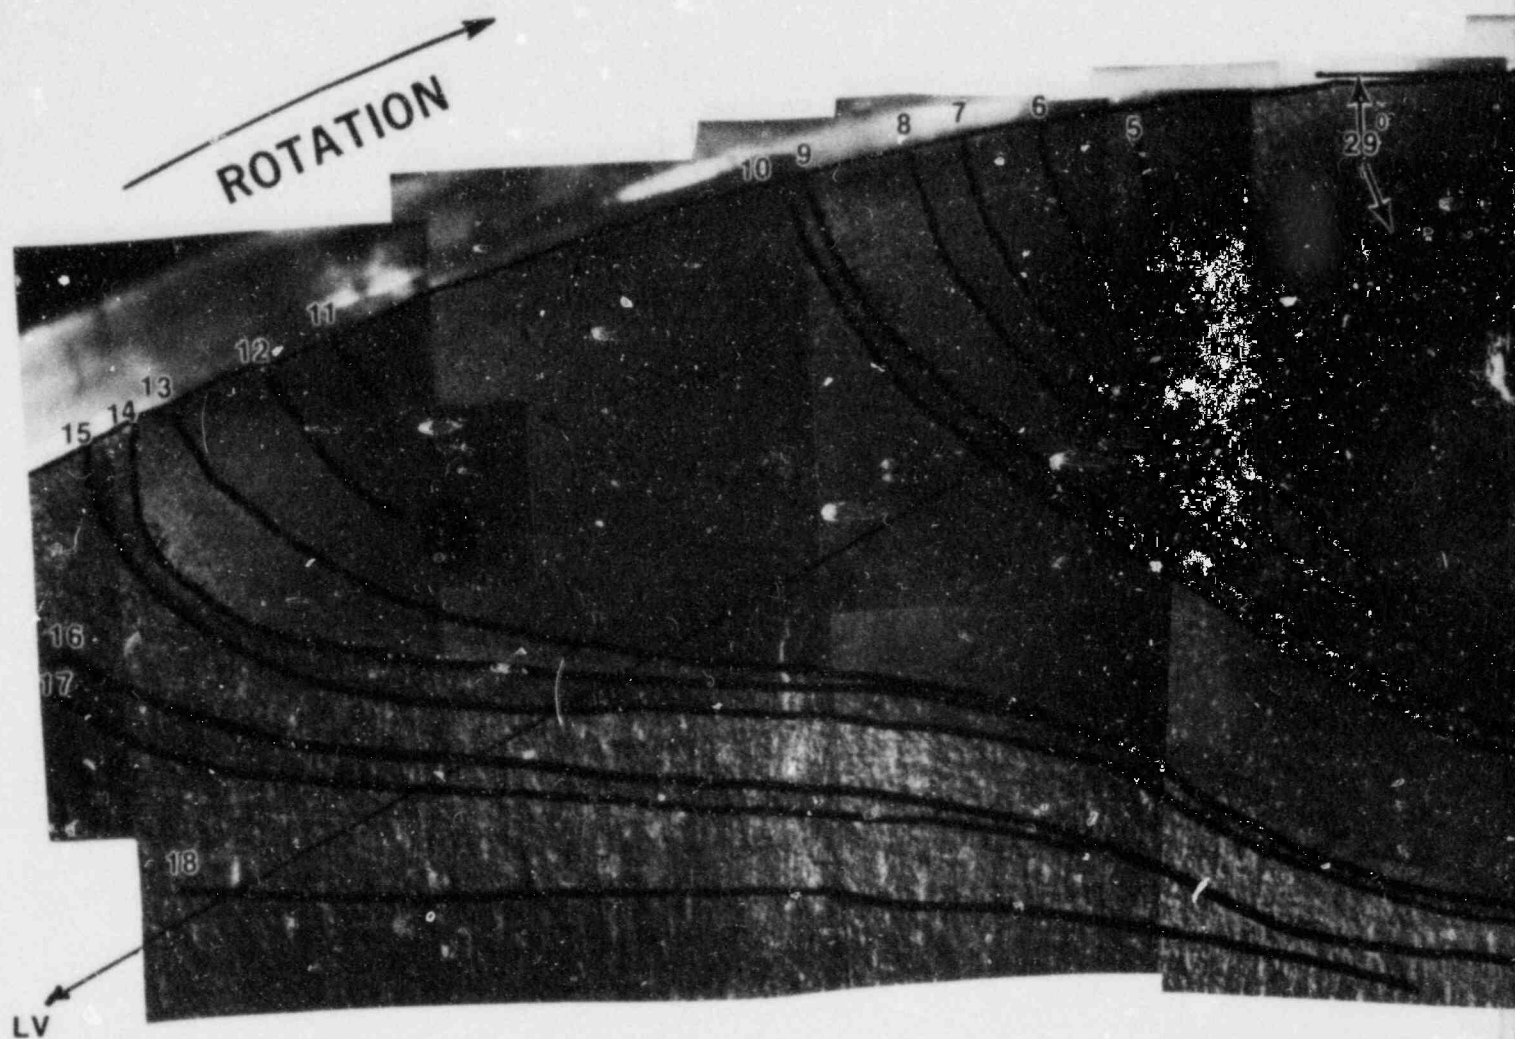
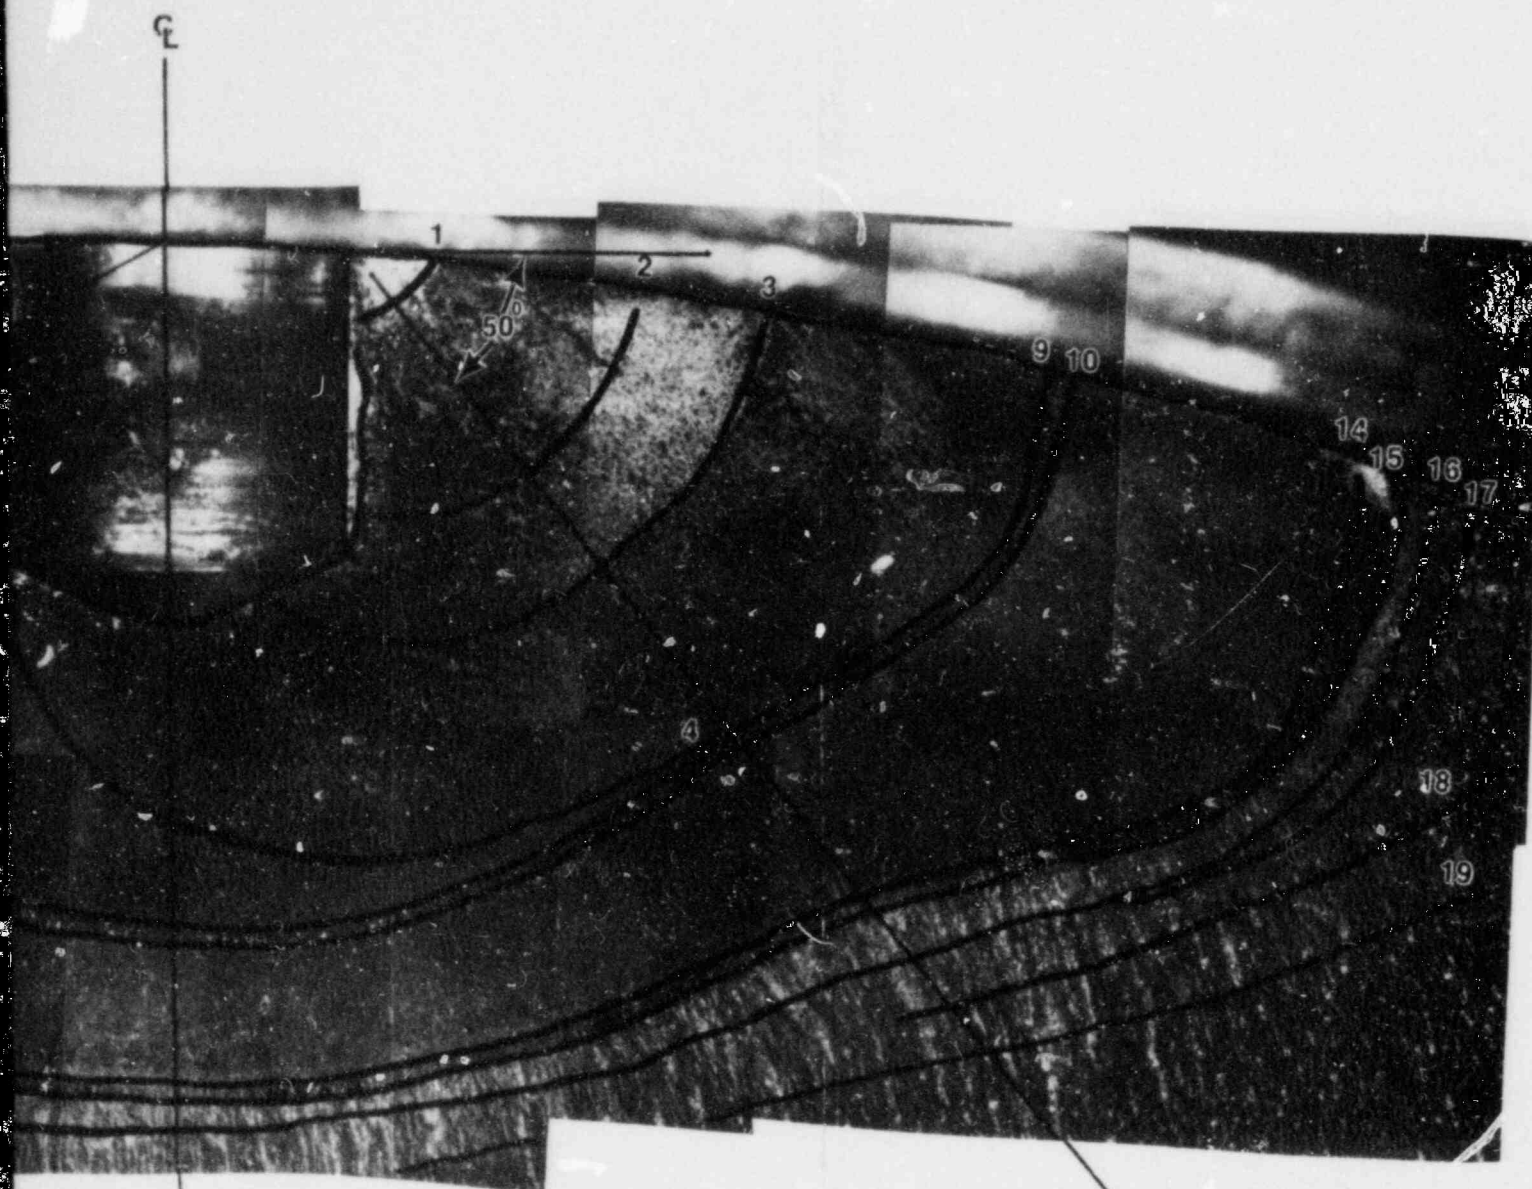
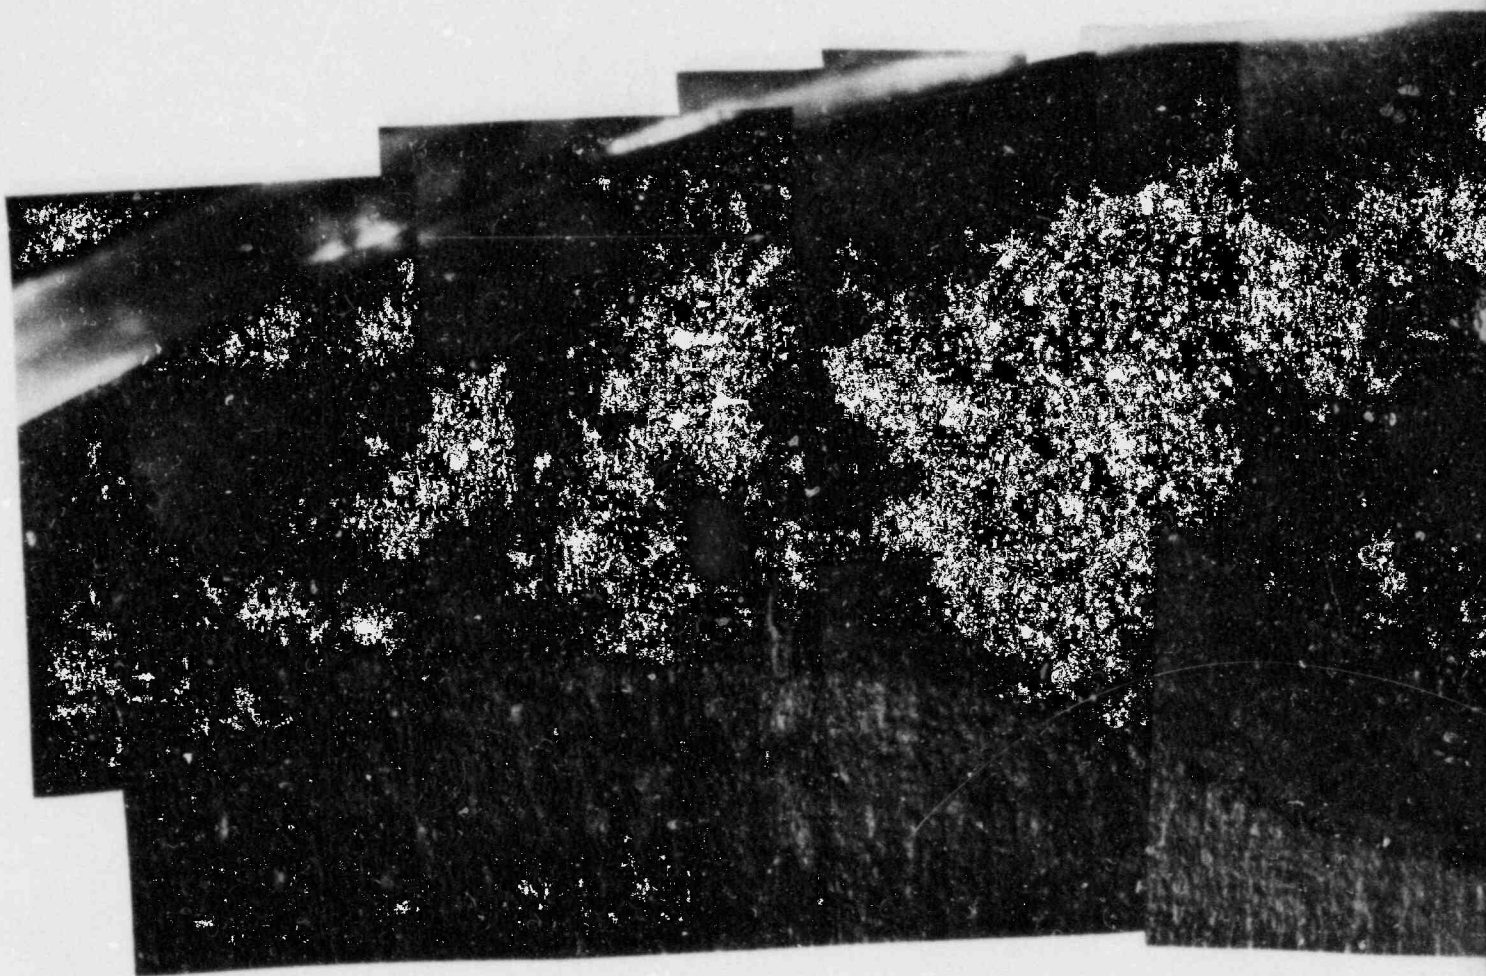
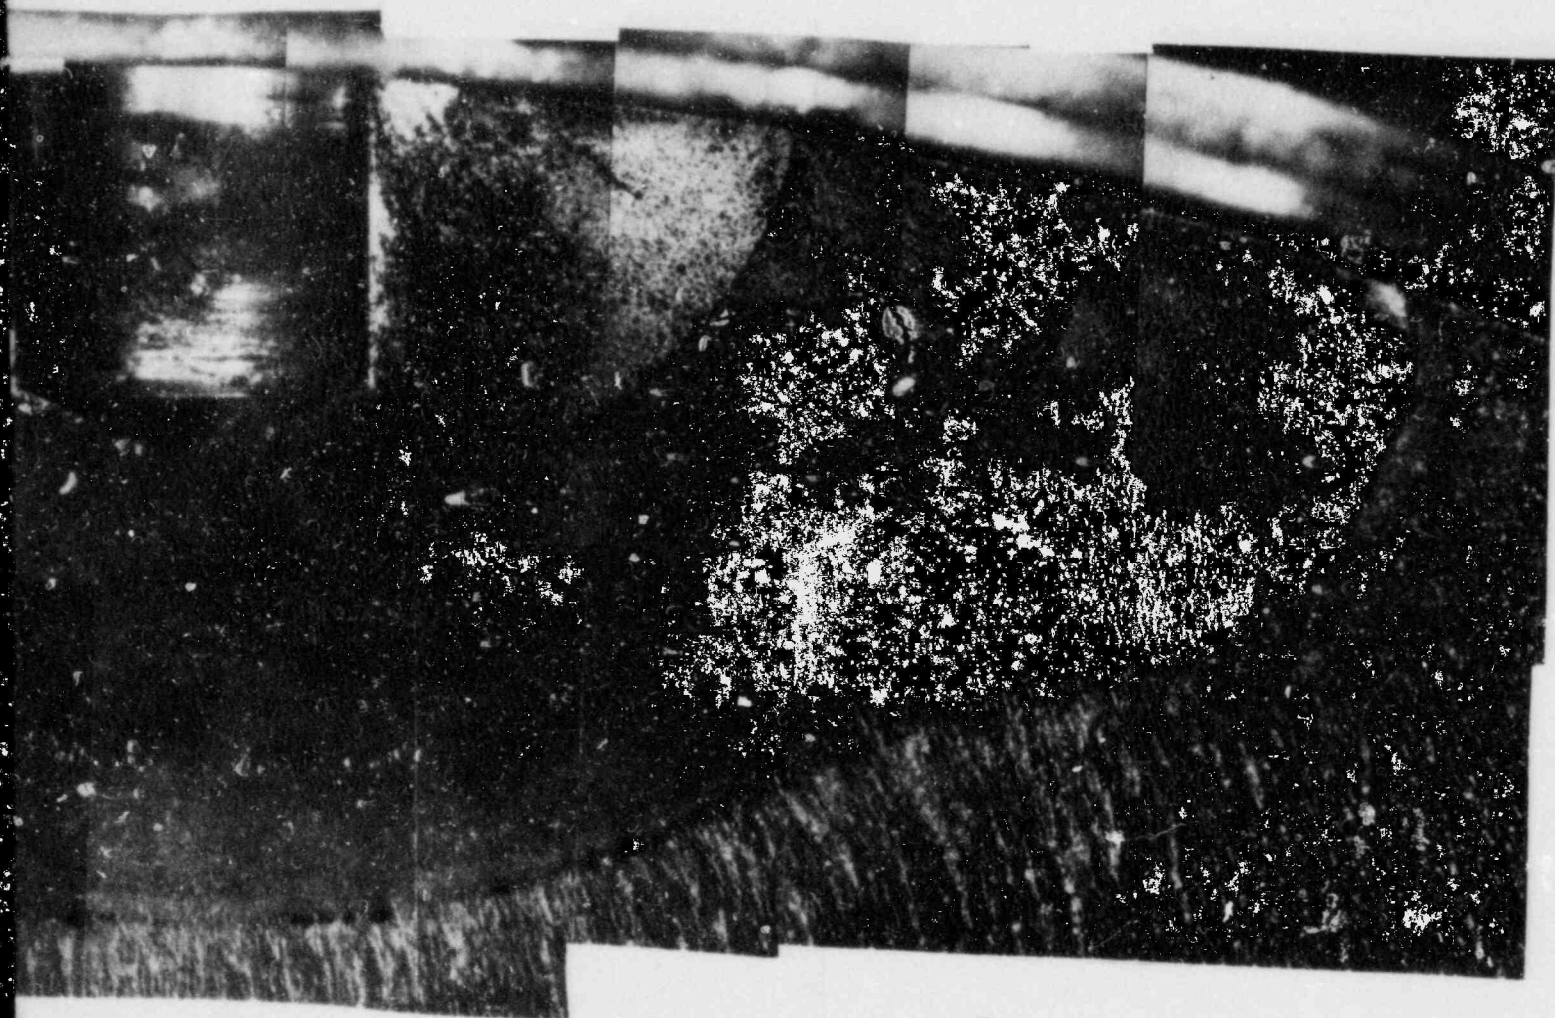
Figure 3.3-2. Initiation
A. As-
B. Overia

Region on Shaft Fracture Surface
Captured
by With Beachmarks Emphasized

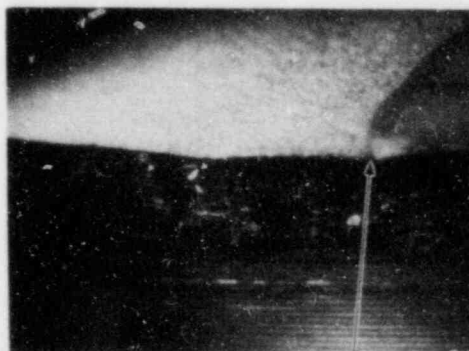
Figure 3.3-4. Views of Crack Path Changes Relative to Fracture Surface Beachmarks

A
BEACHMARK 3 INITIATION SITE

B
BEACHMARK 3 INITIATION SITE

C
BEACHMARK 15 OCTANT

PIN HOLE OCTANT 8

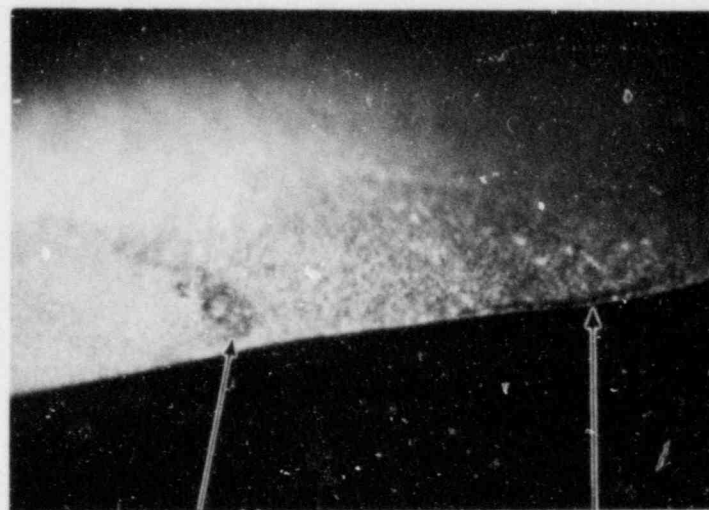
D

BEACHMARK 15 OCTANT 8

BEACHMARK 18 19

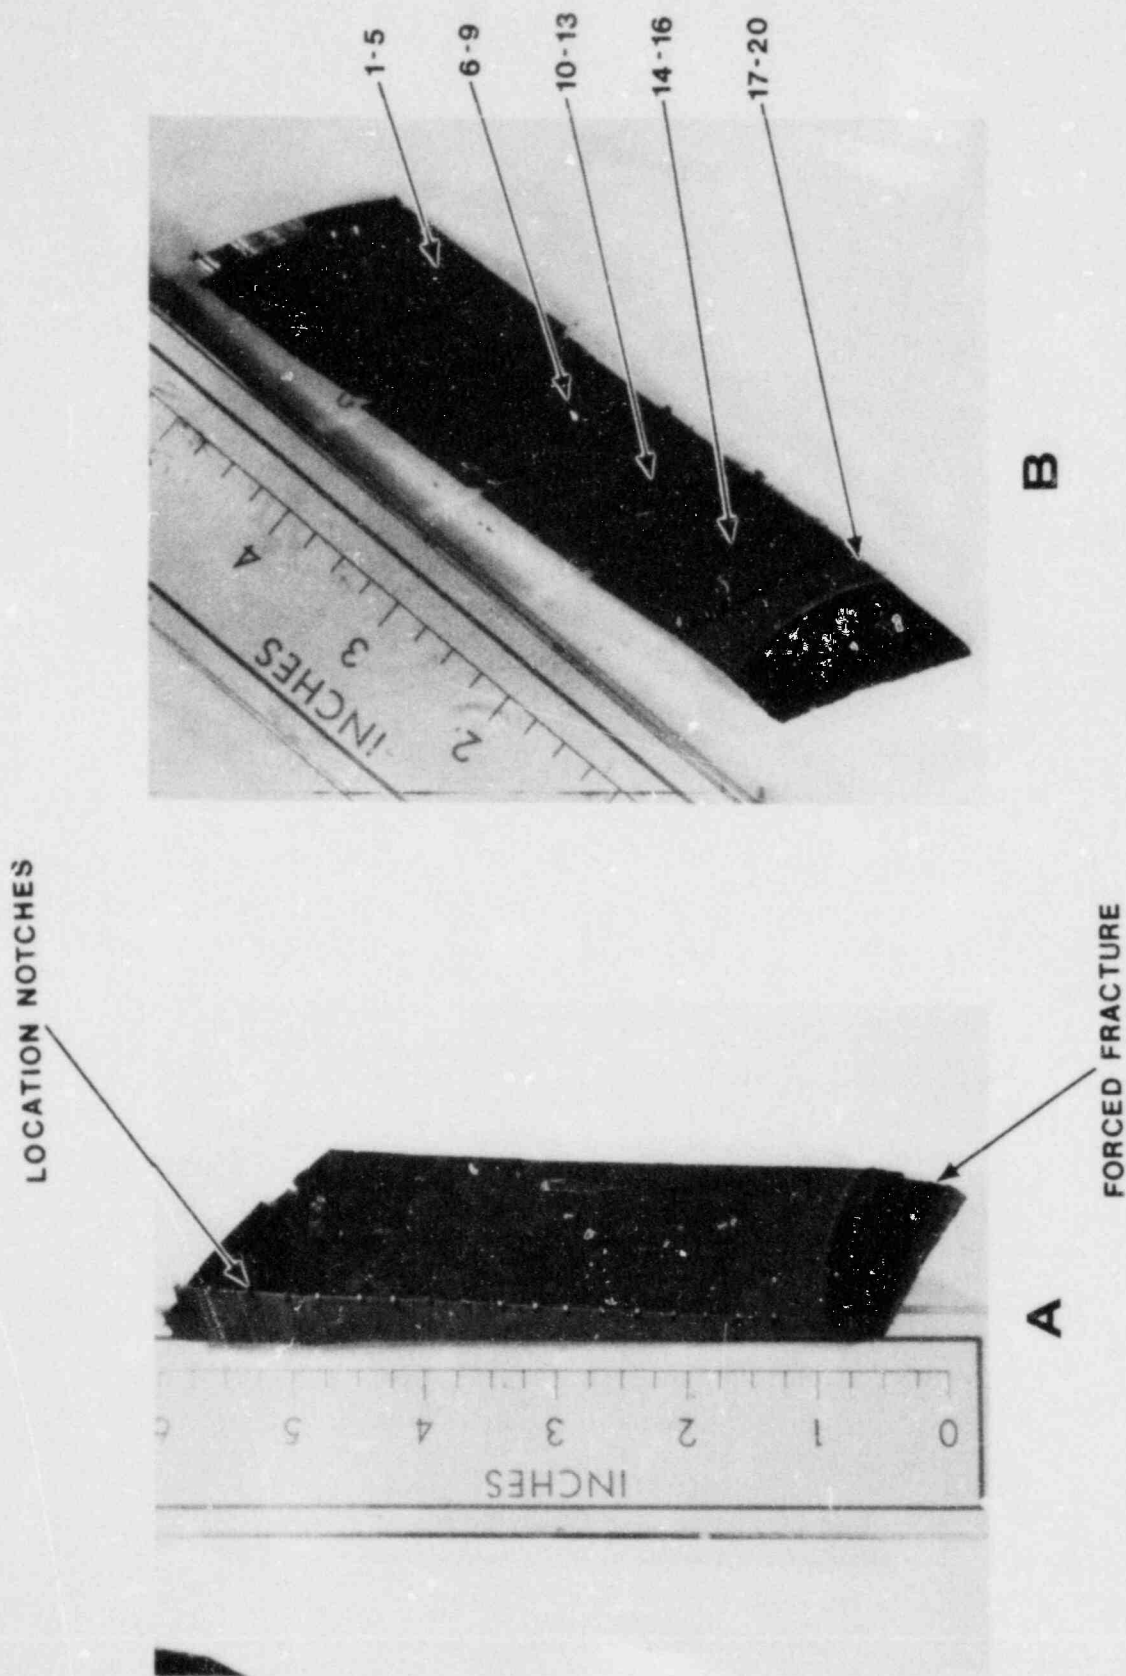
Figure 3.3-5. Specimen B1A1 Preparation for Examination
A. Notches Placed Every $\frac{1}{4}$ " at Edge
B. Subdivision Into Fractography Specimens

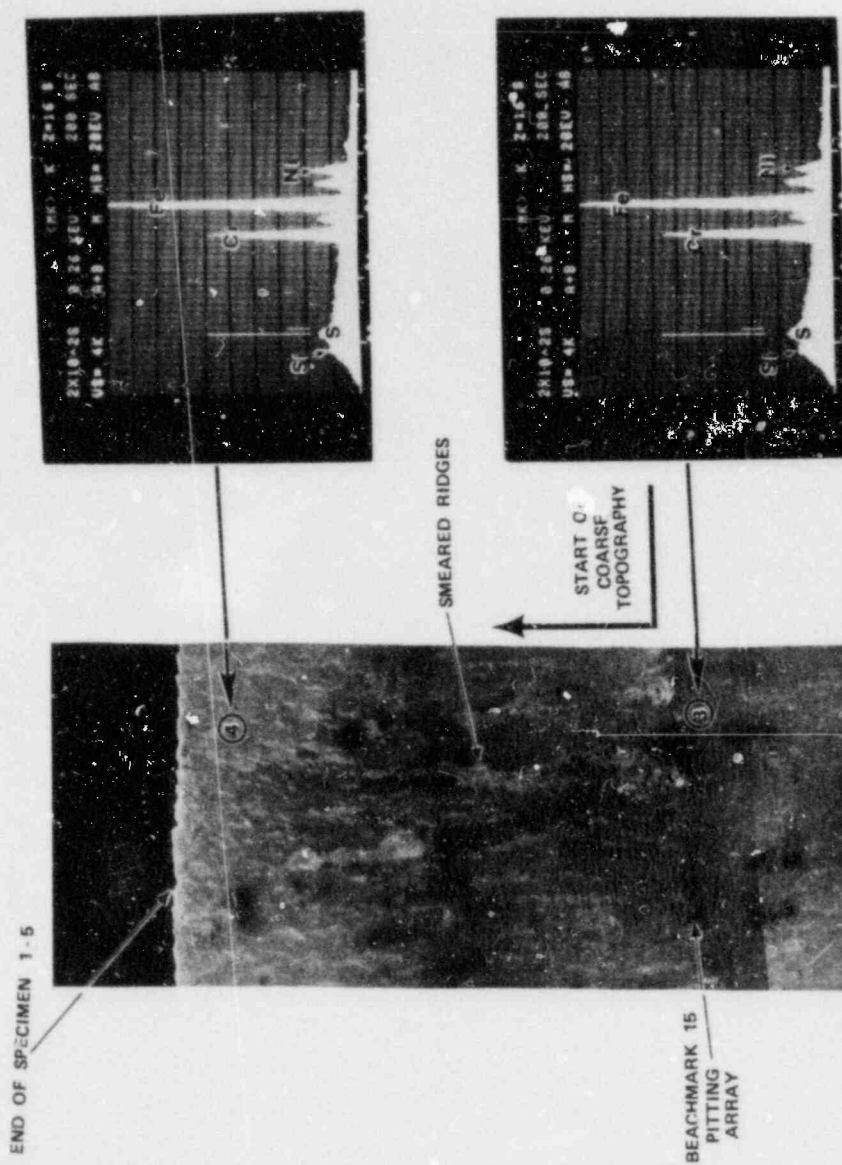
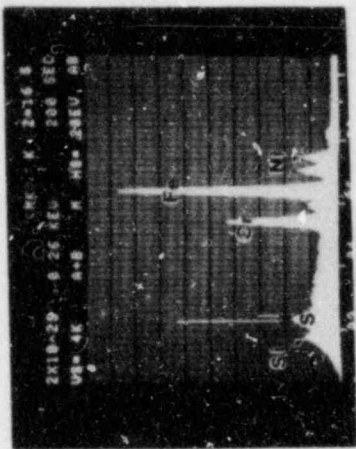
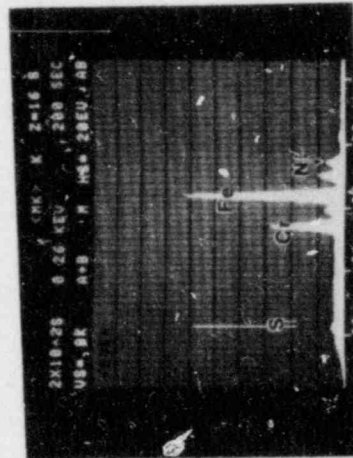
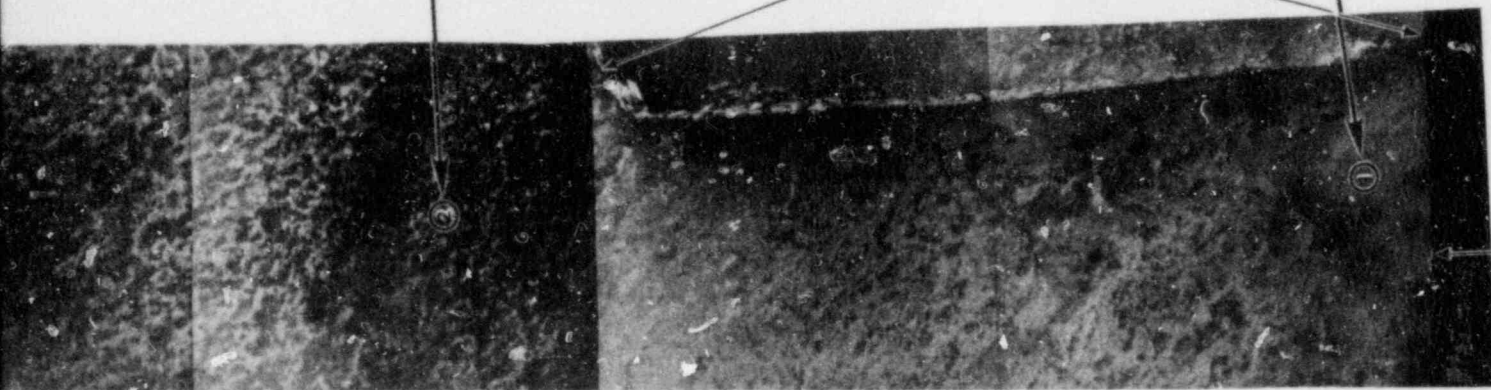
Figure 3.3-6. Low Magni
to Clean

ification SEM Montage of Specimen 1-5 Prior
ing EDS Spectra Taken at Several Locations

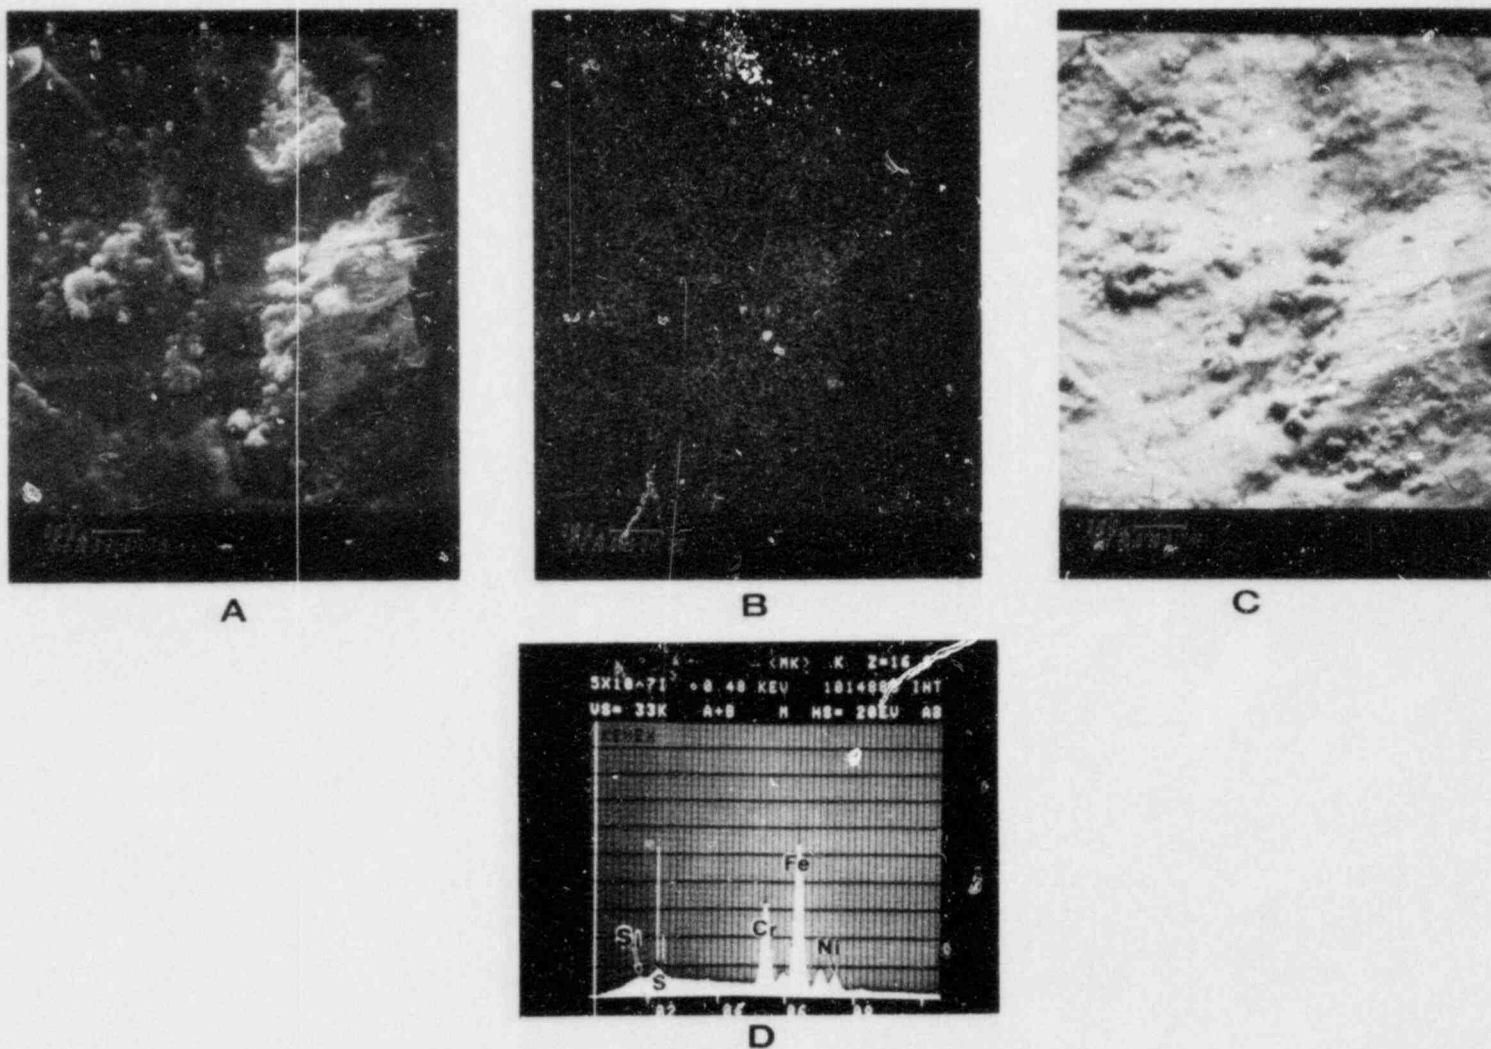
Figure 3.3-7. Typical Surface Film Structure in Specimen 1-5
A. Secondary Electron Image, B. Sulphur Dot Map
C. Backscatter Electron Image, D. EDS Spectrum of Film

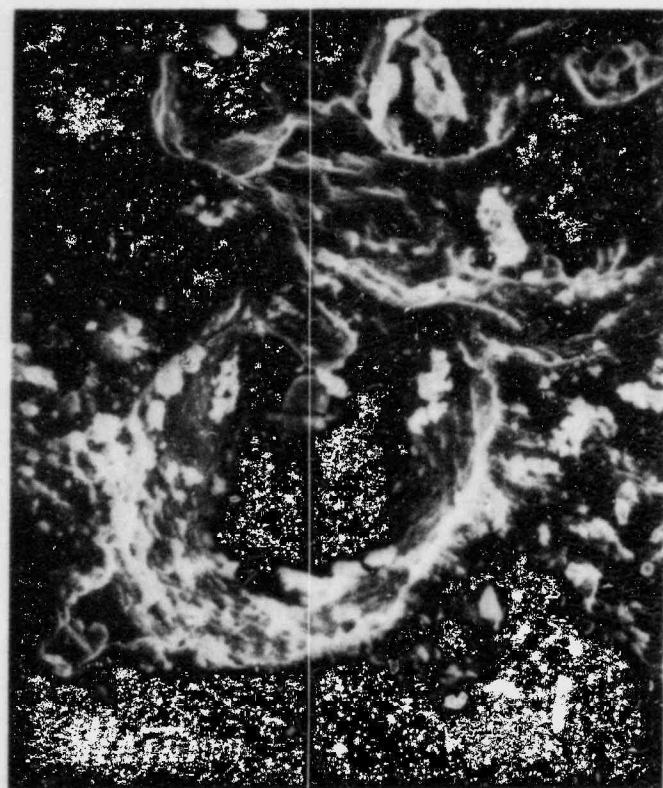
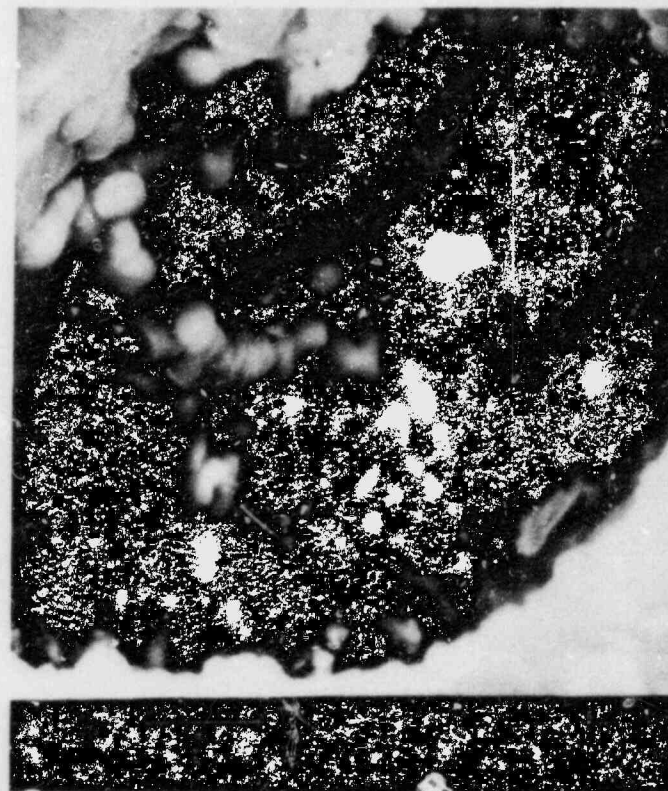
Figure 3.3-9. Appearance of Pits at Beachmark #15 Prior to Cleaning

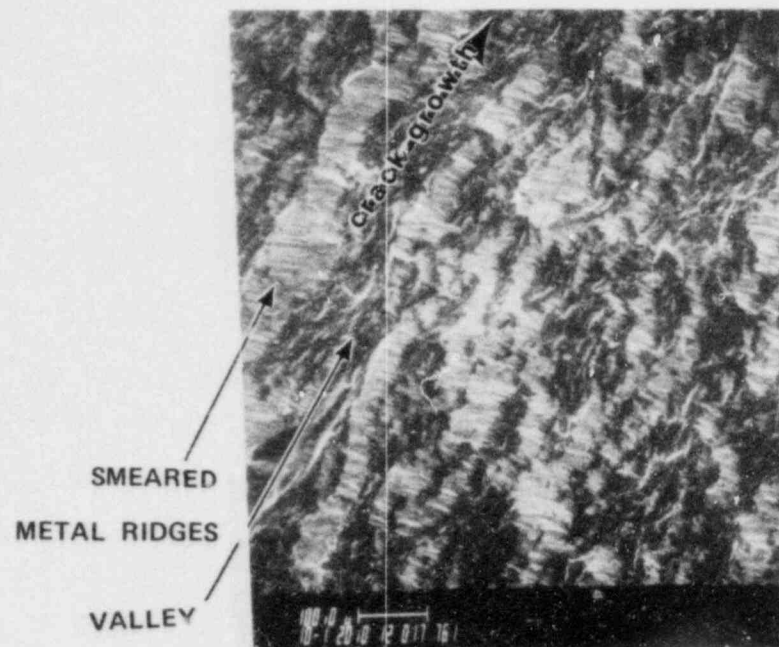
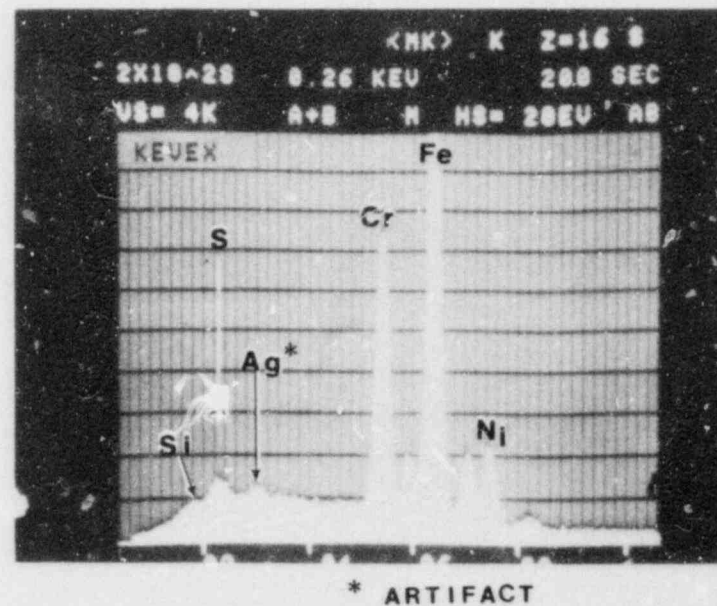
Figure 3.3-10. Ridge and Valley Structure on Specimen 6-9.
Examination Prior to Cleaning, Overall EDS
Spectrum Showing Sulphur

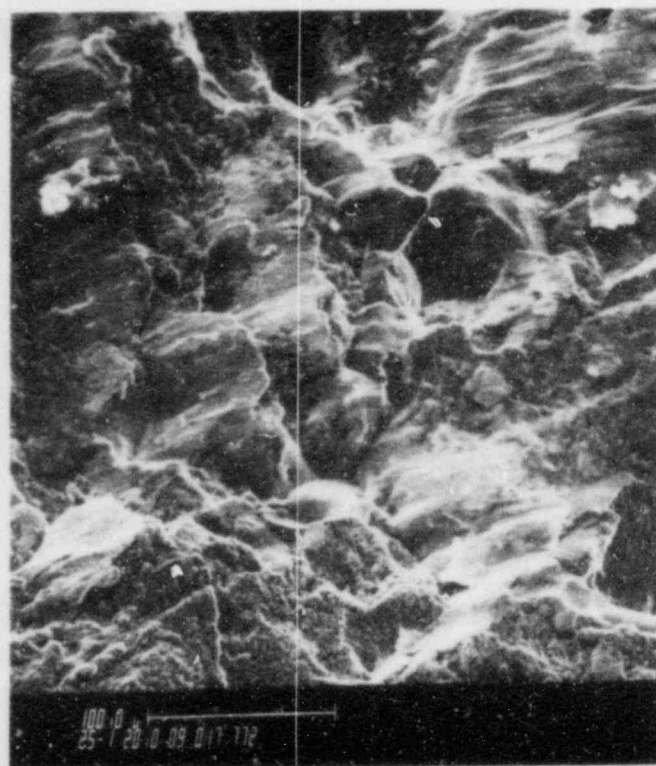
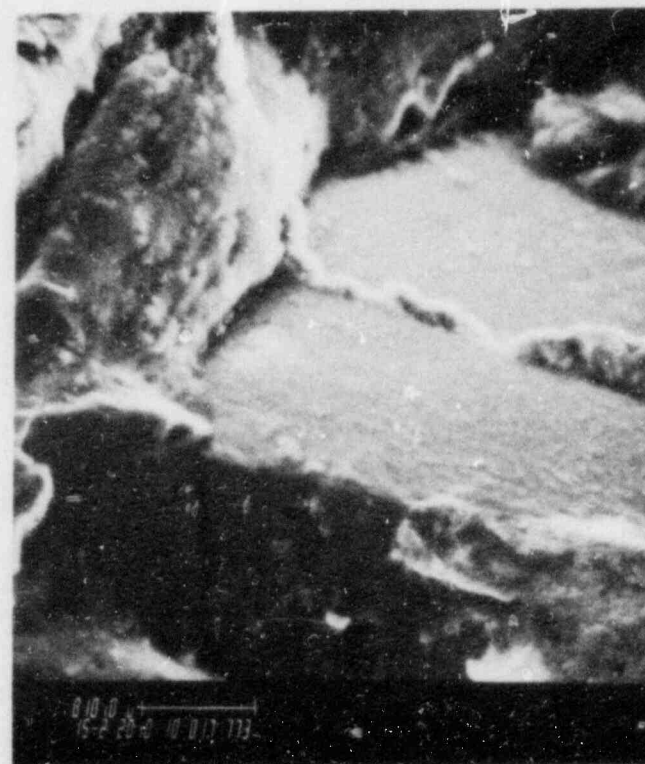
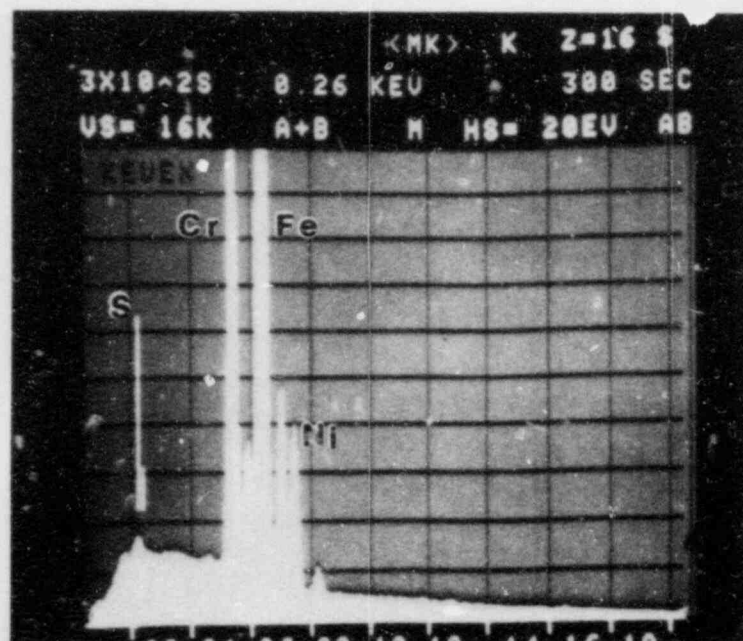
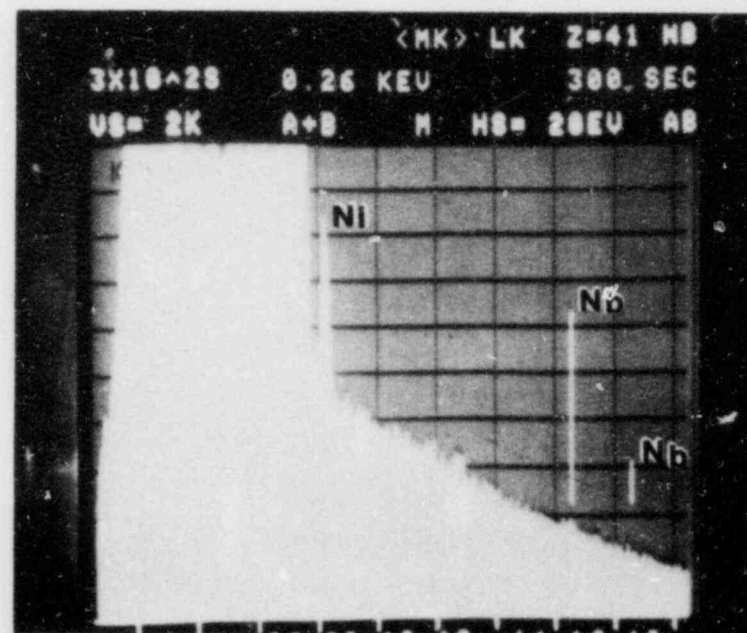
3.448	14-16	Fracture Detail A	17-898 to -900 No Montage	--	Island of IG fracture involving 9 grains. Some secondary IG cracking. Surrounded by feathery structure. Some smearing at elevated grain boundary corners. One face has coarse linear markings with a spacing of 0.6μ . Generally more IG showing up than on 10-13.

3.528	14-16-1	Fracture Detail B	18-098 to 102 Montage 17-092 to -097	--	Same as above for 14-16 Detail A.
4.00	14-16-2	Fracture Detail C	18-107 to 18-111 Montage 18-103 to 106 Detail	--	Same as above for 14-16 Detail A.

Figure 3.3-12. Typical Faceted Structure on Specimen 14-16
Prior to Cleaning. A and B are General
Views. C and D are EDS Spectra of B
