TMI-1 REACTOR COOLANT PUMP SHAFT FAILURE ANALYSIS

TMI-1 REACTOR COOLANT PUMP SHAFT
FAILURE ANALYSIS

Lynchburg Research Center Report
RDD:84:5183-06:01

August 1984

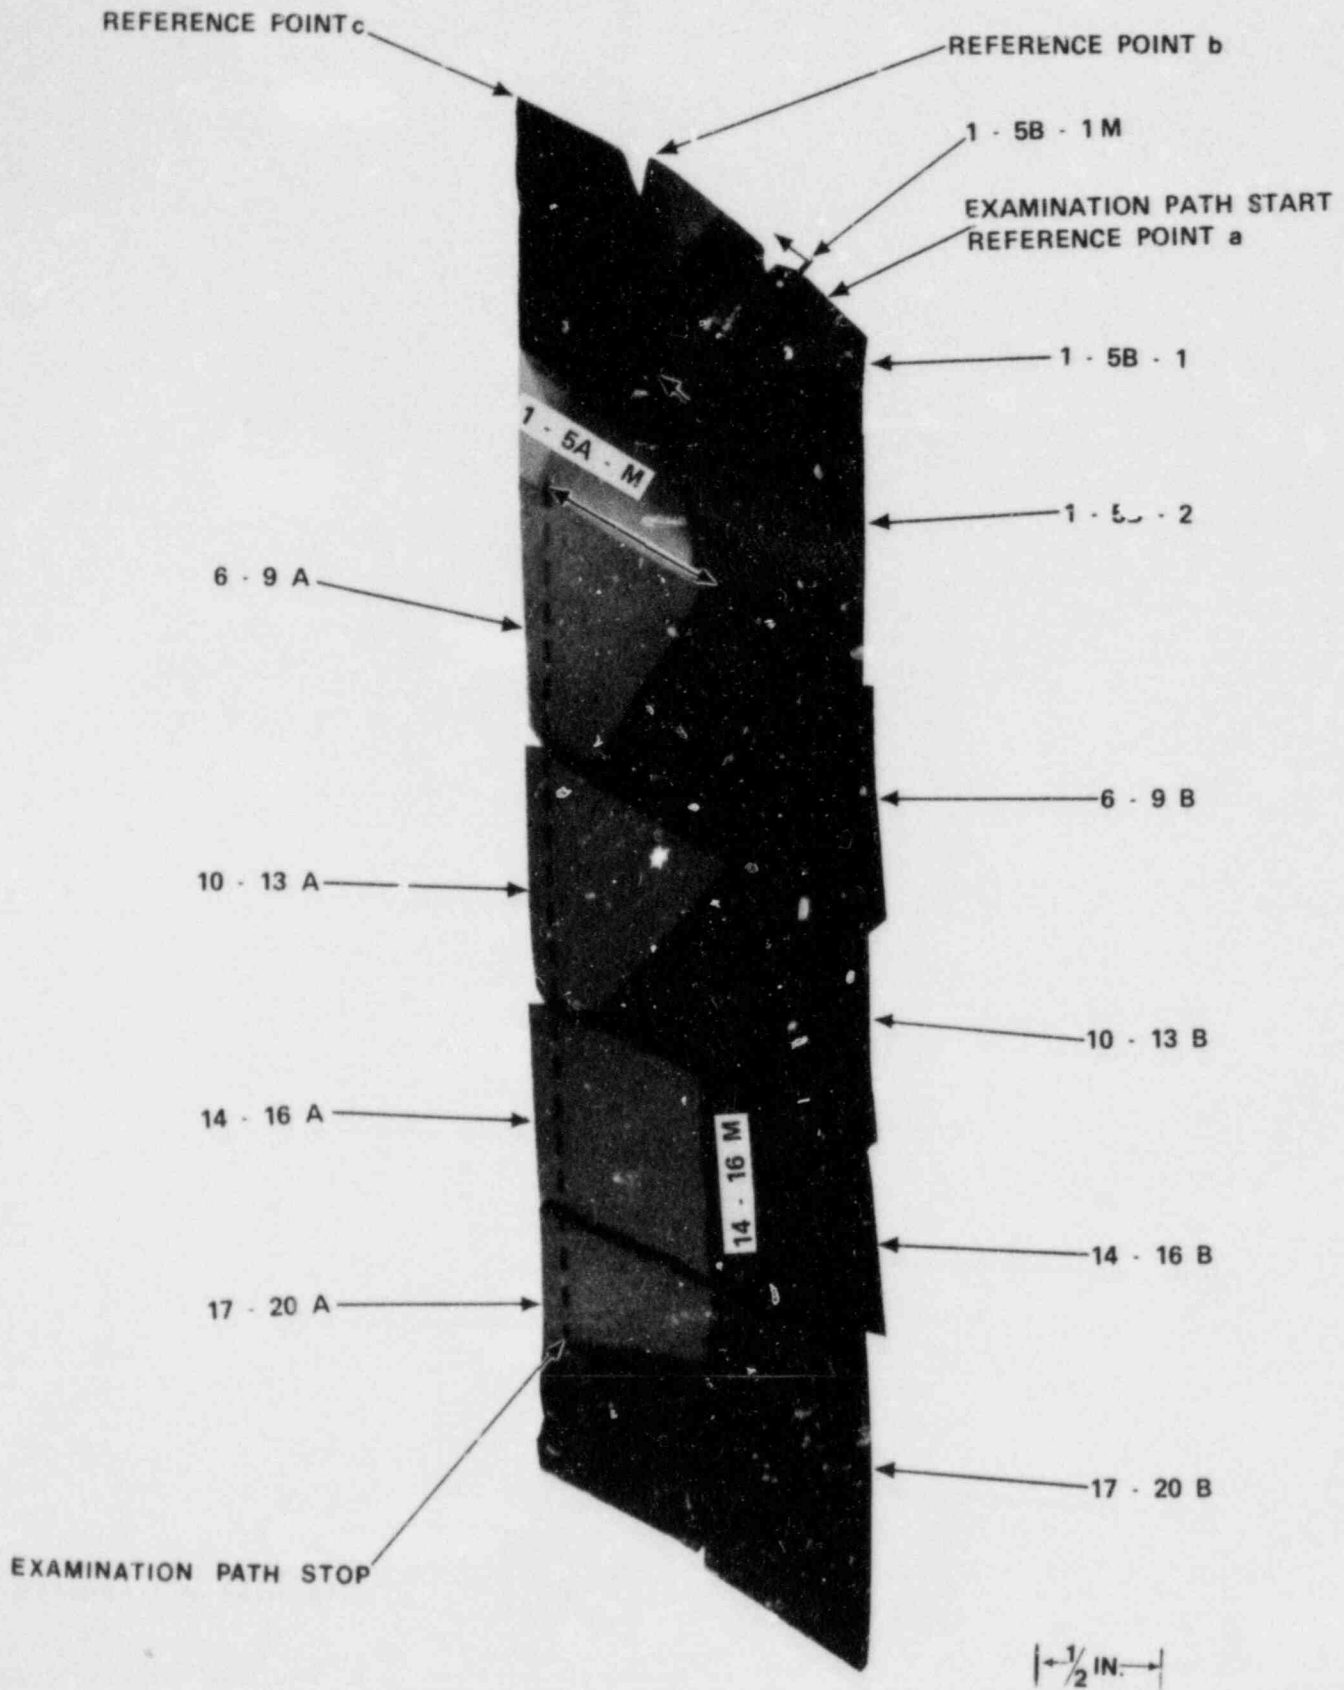
Figure 3.3-14. Section B1A1 Reconstructed
From Individual Specimens

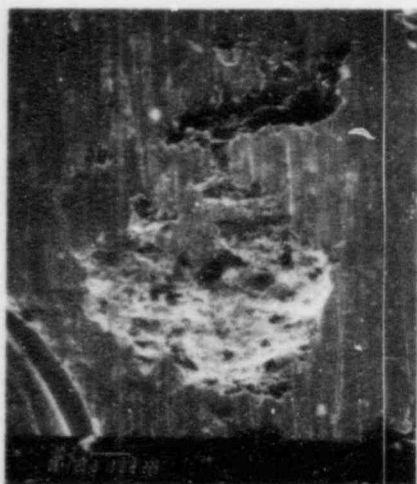
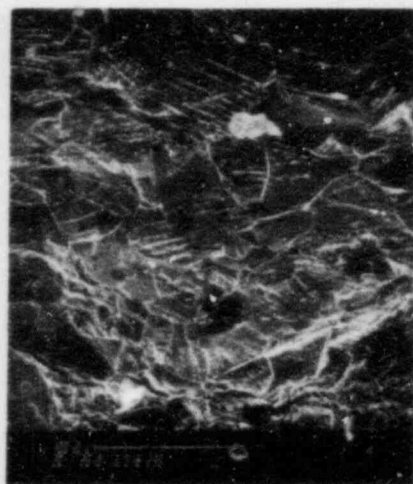
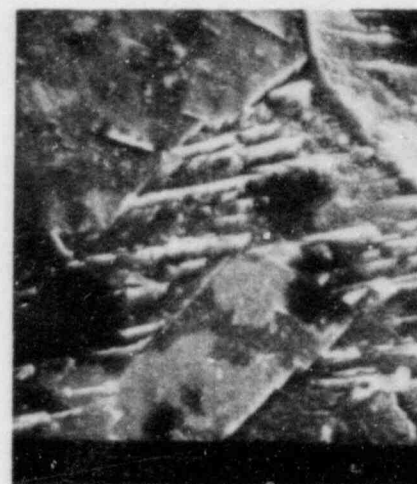
Figure 3.3-16. Typical Pit Structure Seen Near Cracked Pin Hole on Shaft Outer Surface. Views A, B, C Show Structure at Increasing Magnification

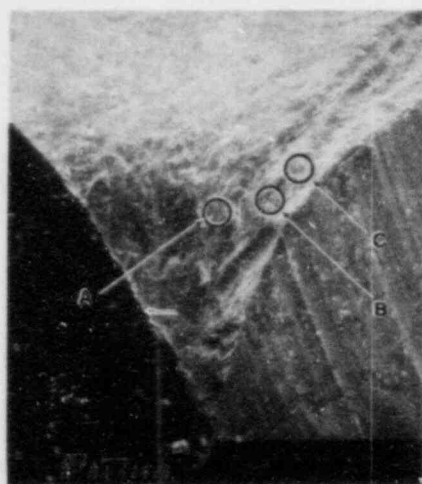
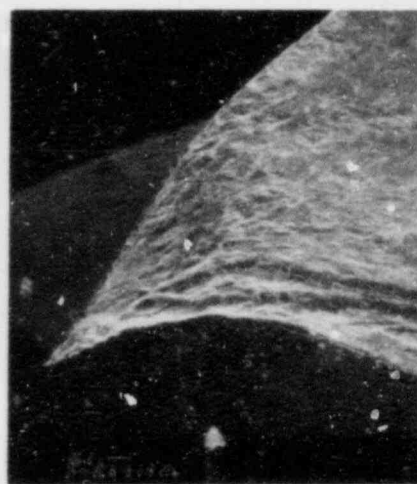
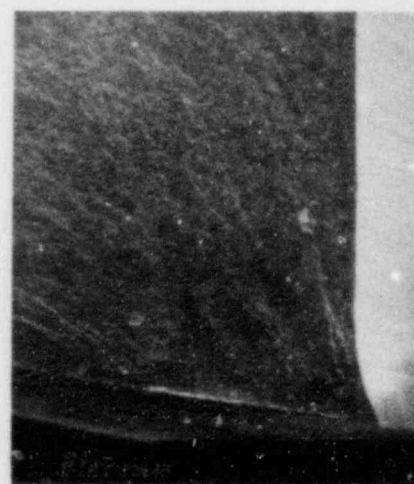
Figure 3.3-18. SEM Photomicrographs of Initiation Site from Different Angles

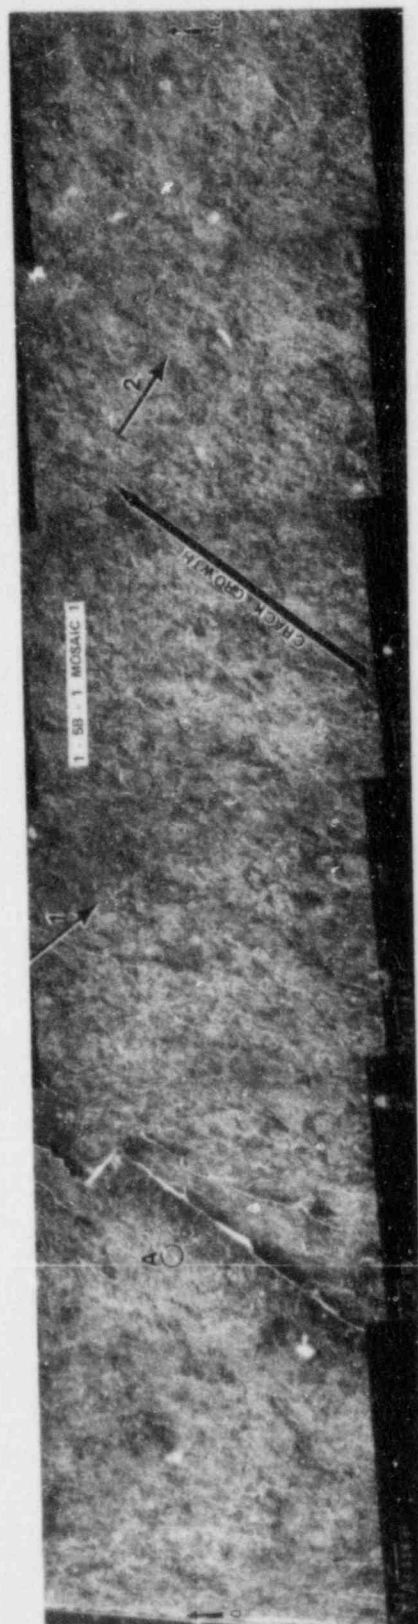
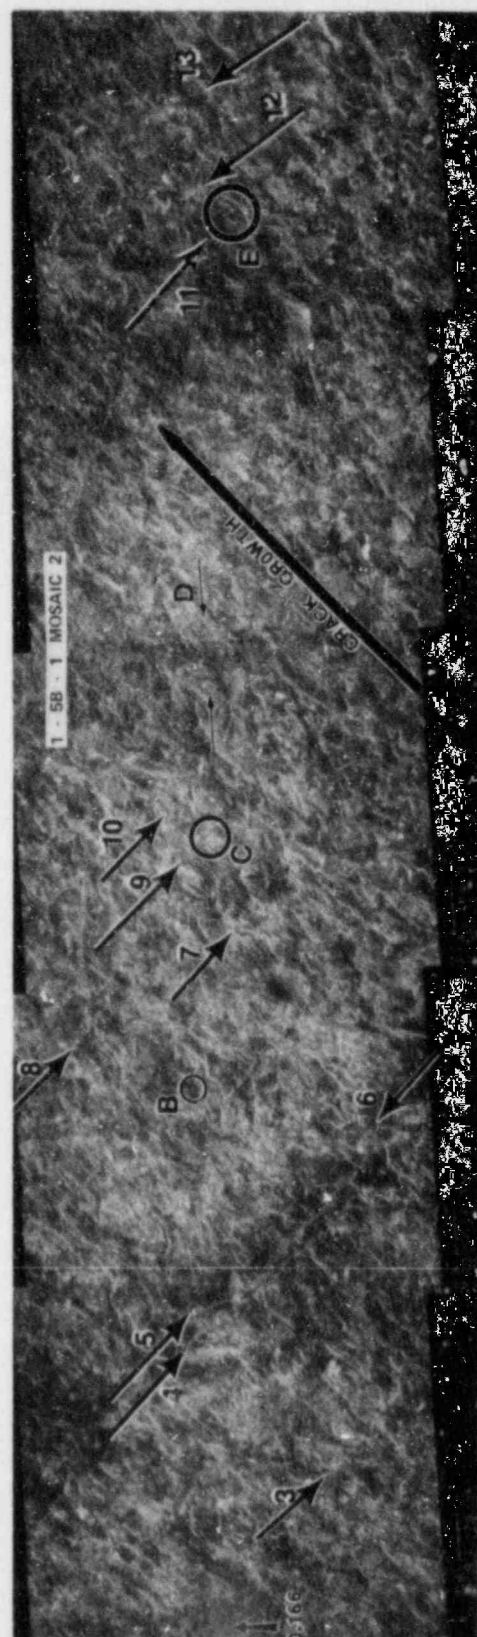
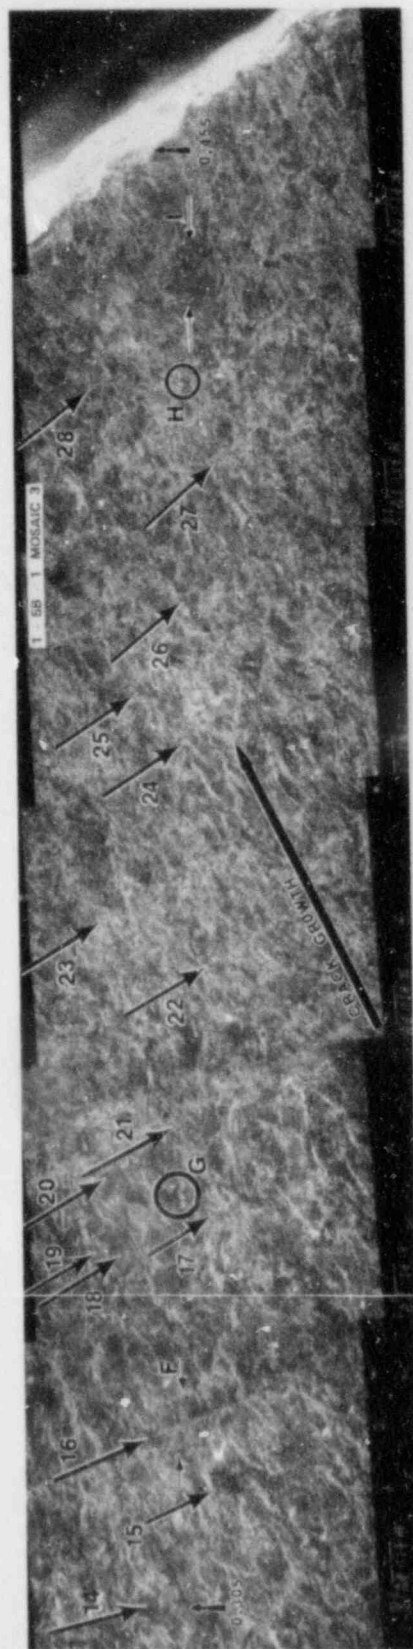
1.319	1-5B-1	Fracture Detail Beachmark	R #58	18-257, 18-288	--	Probably corresponds to beachmark #16 on light microscopy color montage. Change in fractography is going to a finer fracture structure.

1.411	1-5B-1	Beachmark	#60	18-260	--	Corresponds to starts of beachmark #18 on light microscopy color montage (initiation). Start at coarse fracture with adherent corrosion deposit.

Distance From Surface Reference Points, inches	Specimen	Fracture Surface Feature			Striation Spacing, μ	Comments
		Type	Label	Photo		
1.514	1-58-1	Beachmark	#61	18-263, -264	--	Corresponds to beachmark #19 on light microscopy color montage (initiation). Fracture becomes somewhat finer, smearing and much less corrosion product adherence.

Figure 3.3-21. SEM Photomontage of Specimen 1-58-1

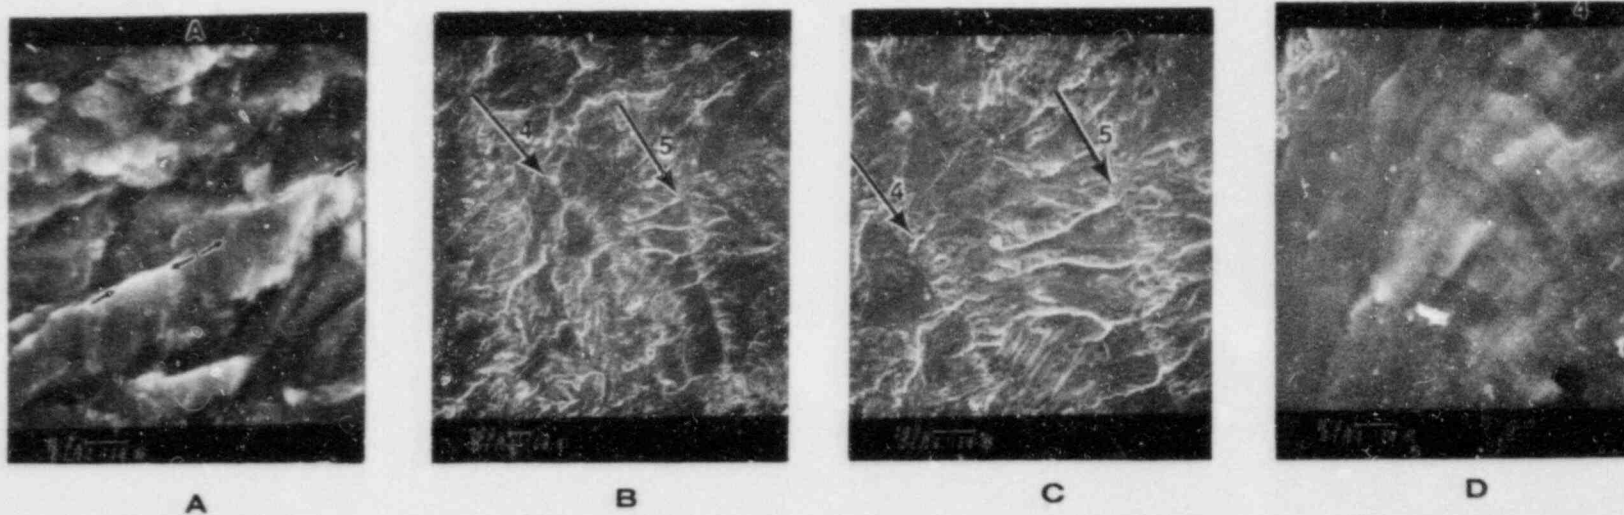
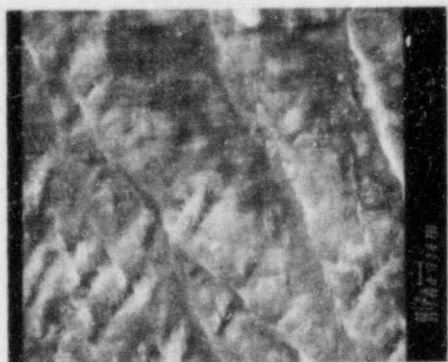
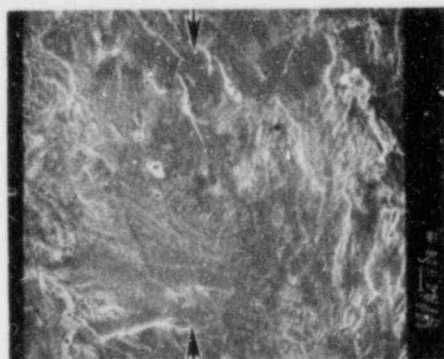
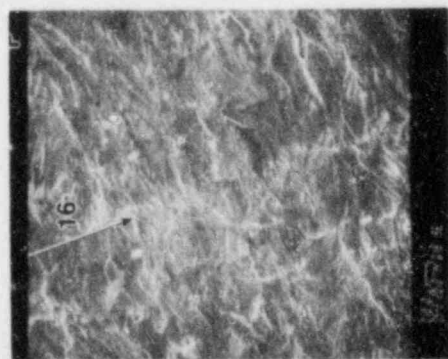
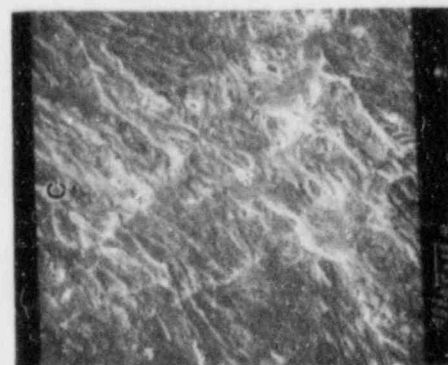
Figure 3.3-22. Typical Fractography Features on Specimen 1-5B-1. Letters and Numbers on Photomicrographs Refer to Previous SEM Montage

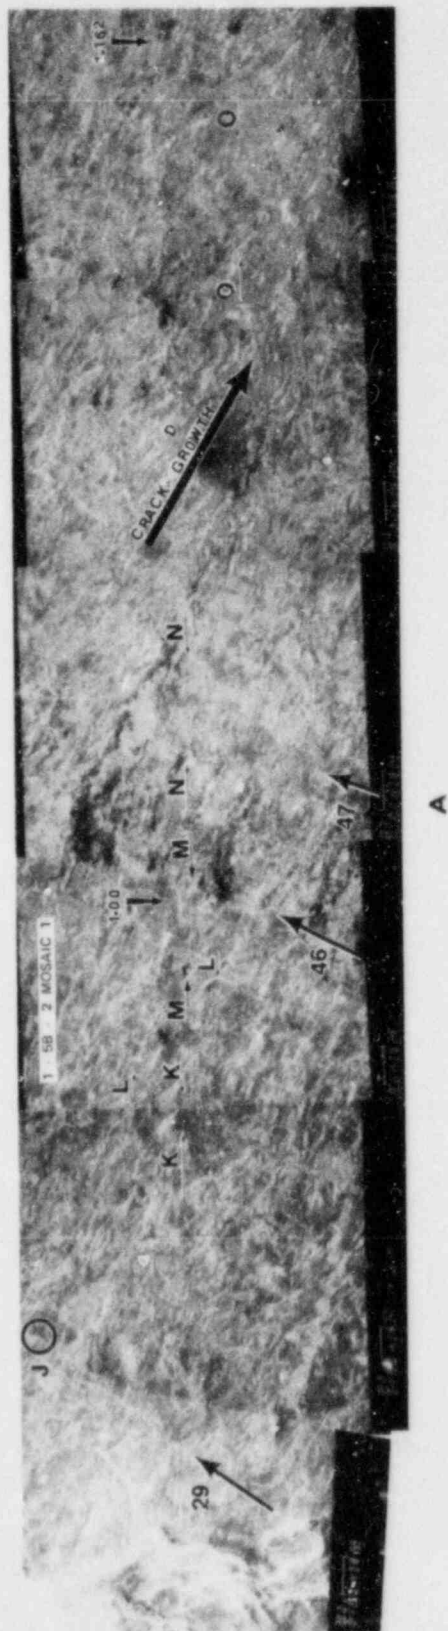
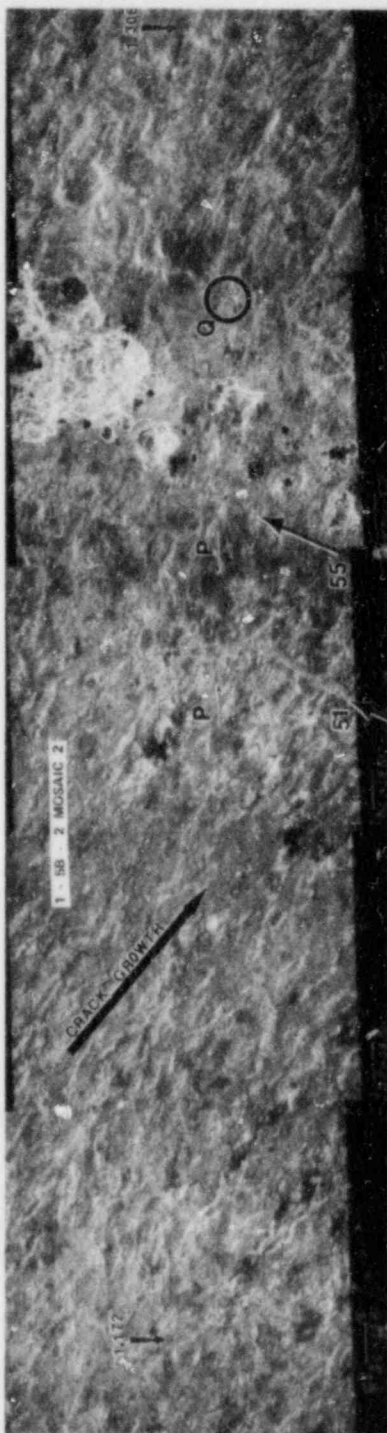
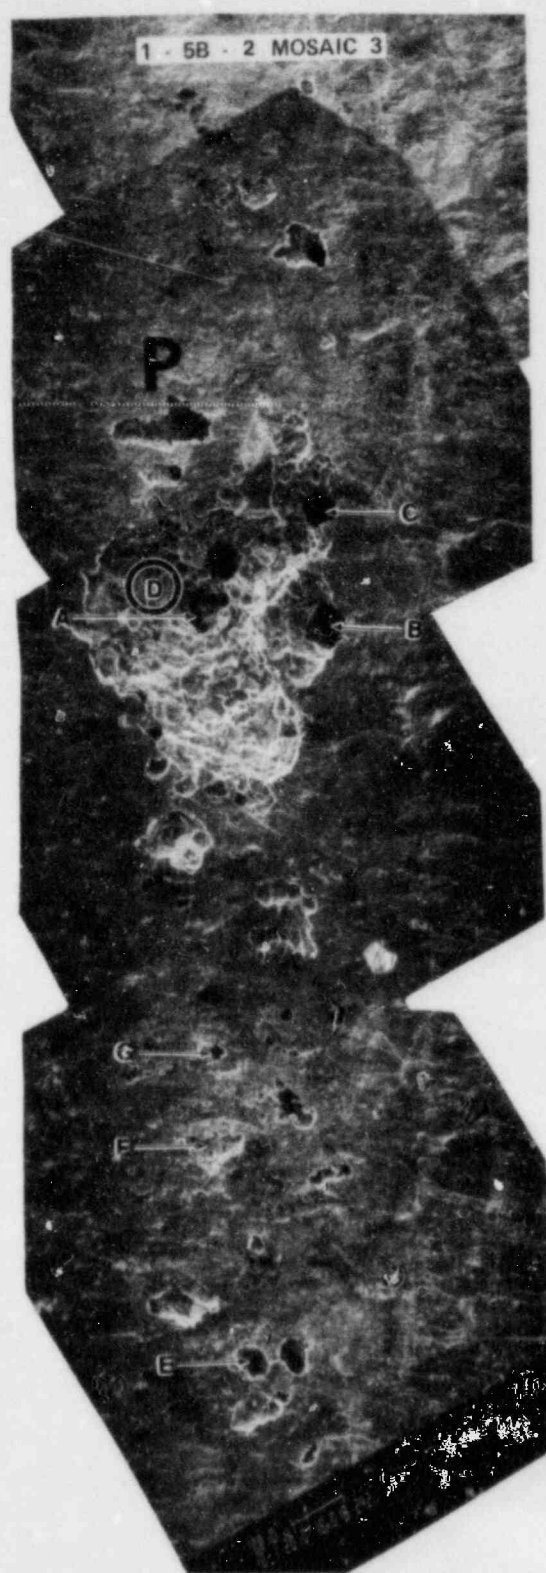
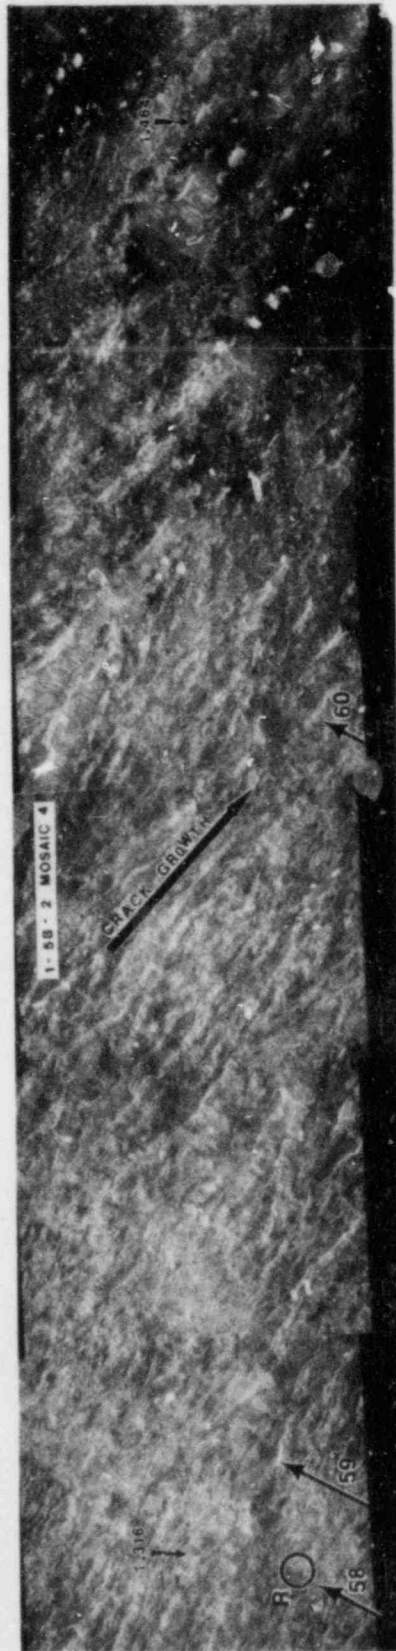
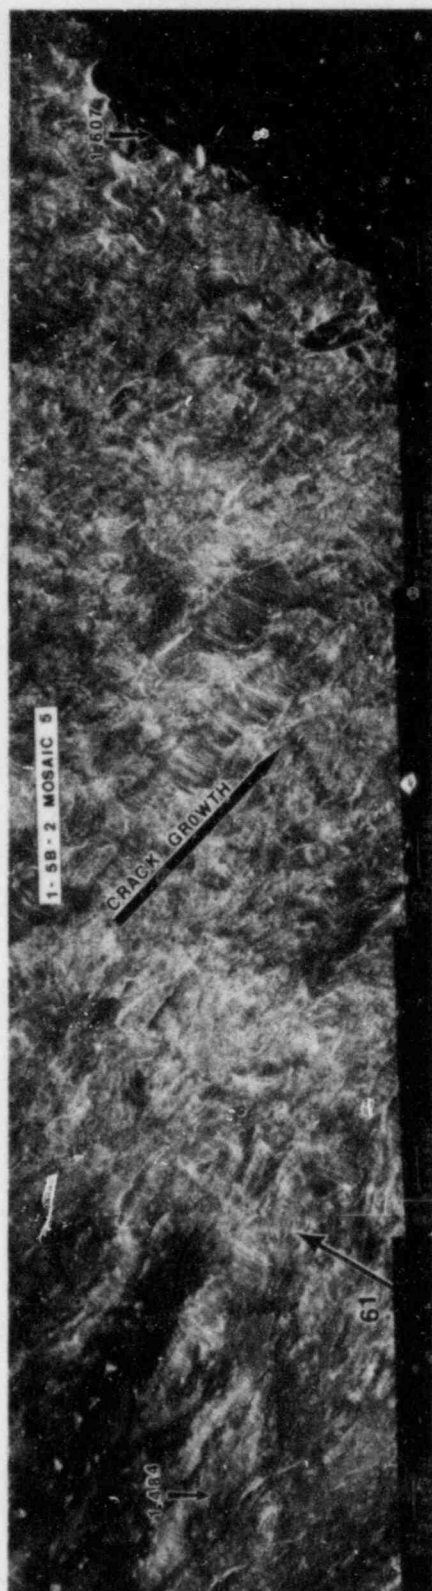
Figure 3.3-24. SEM Photomontages of Fracture Along Line M-M on Specimen 1-58-2
A. Montage 1, B. Montage 2, C. Montage 3, Pitting Near P on Montage 2, D. Montage 4, E. Montage 5

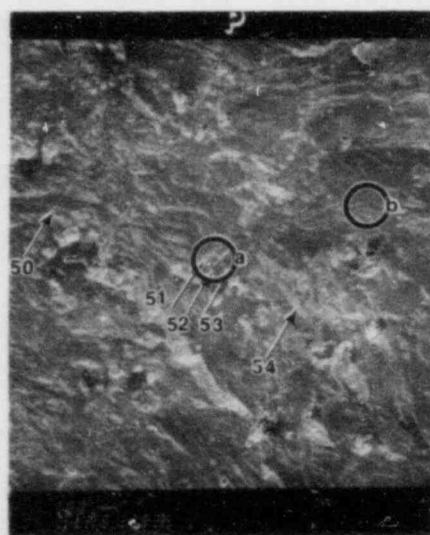
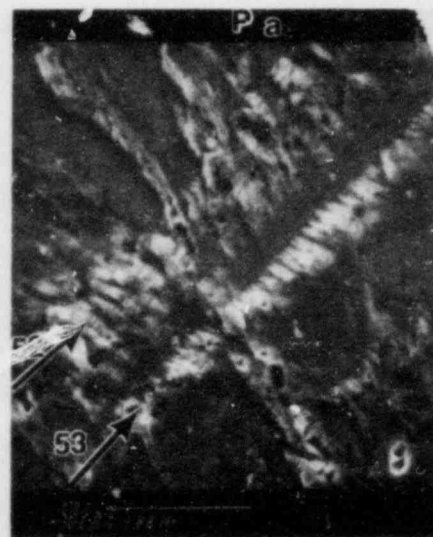
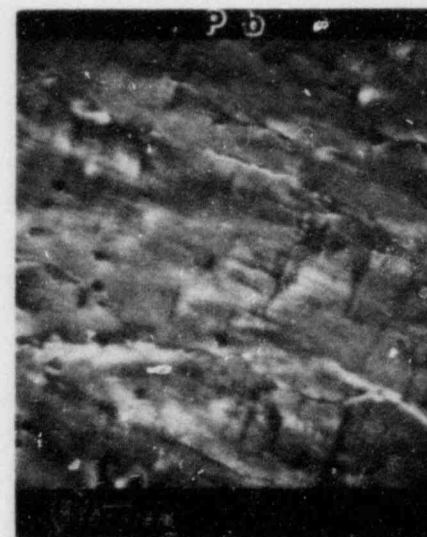
Figure 3.3-25. Typical Fracture Features
in 1-5B-2 at Location P

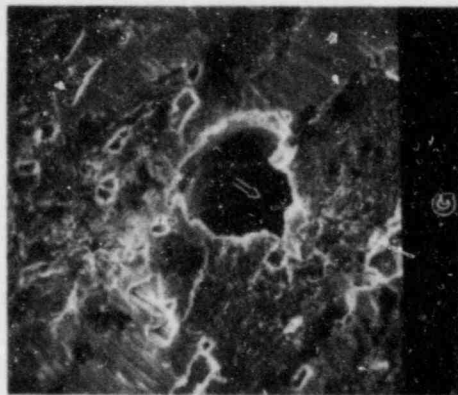
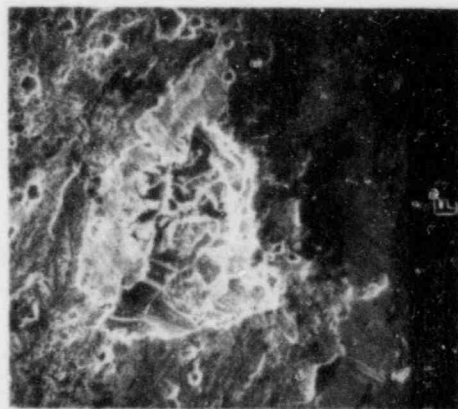
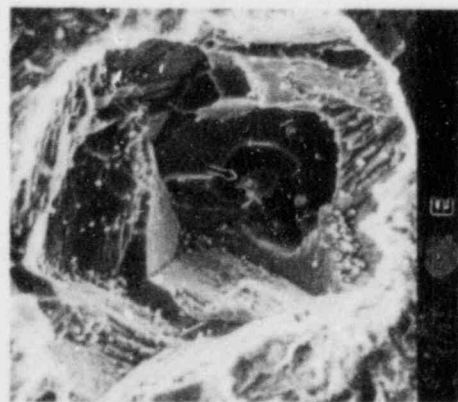
Figure 3.3-26. Typical Structure Inside Pits in Specimen 1-5B-2.
Arrows Show Inclusions or Inclusion Sites

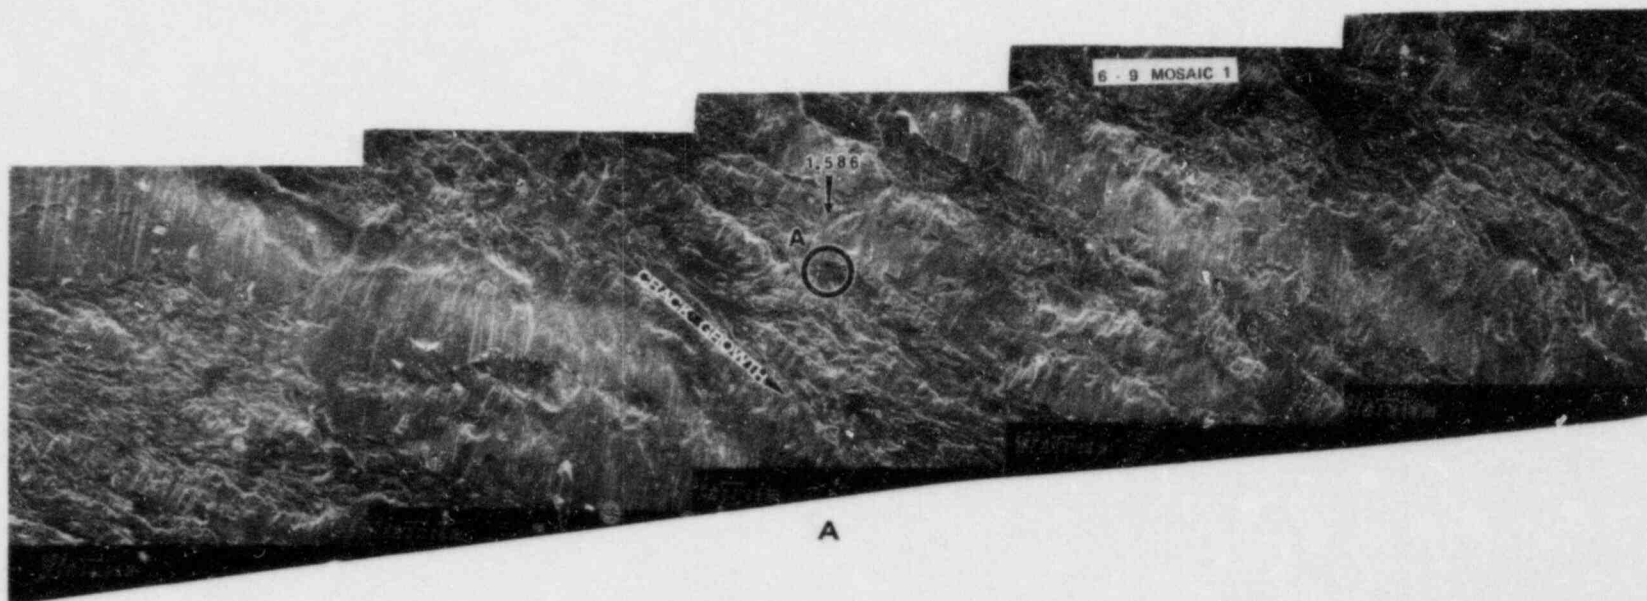
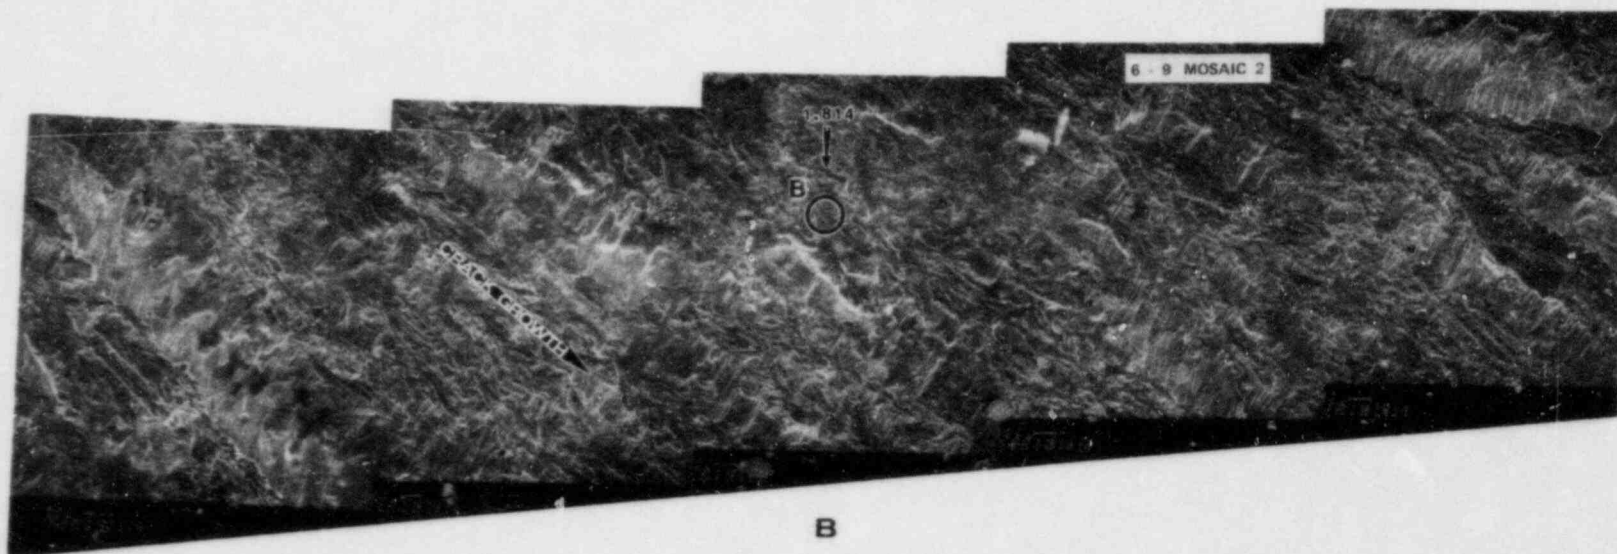
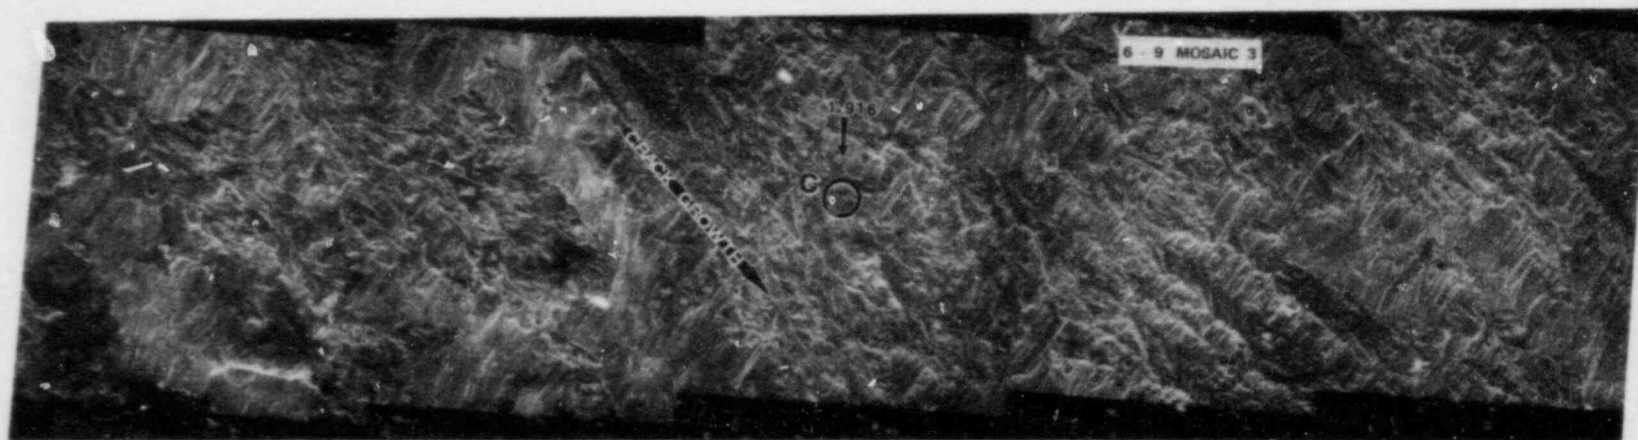
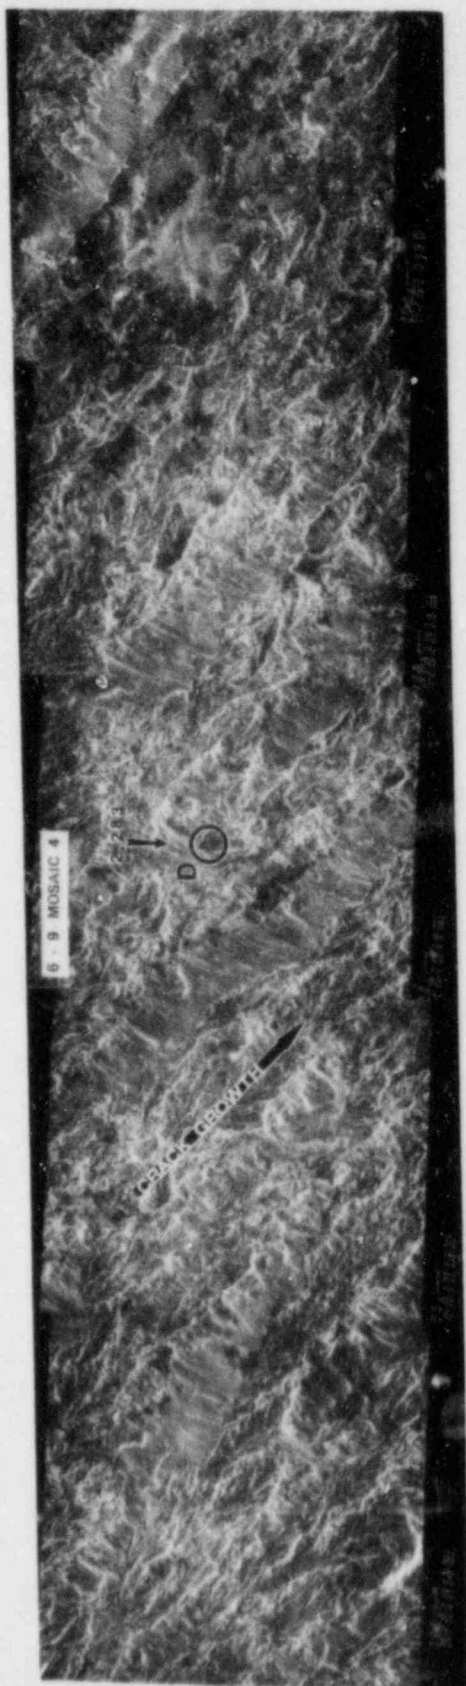
Figure 3.3-27. SEM Photomontages of Typical Fracture Structures Observed on Specimen 6-9
A. Montage 1, B. Montage 2
C. Montage 3, D. Montage 4

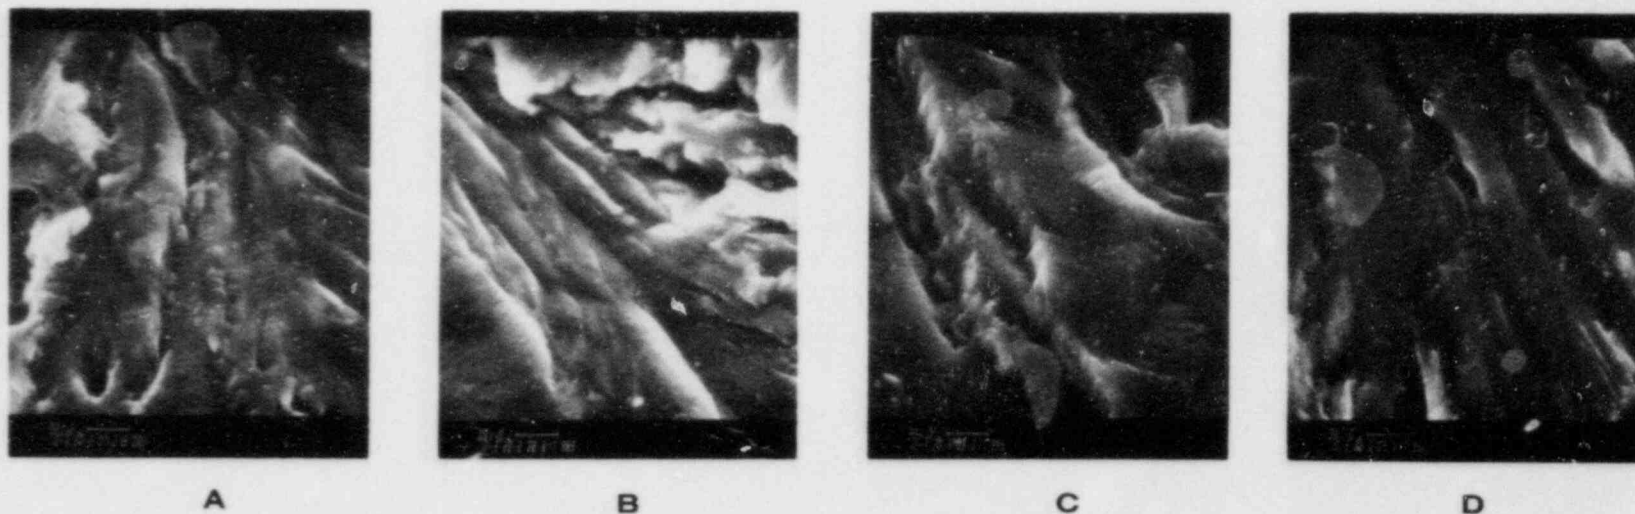
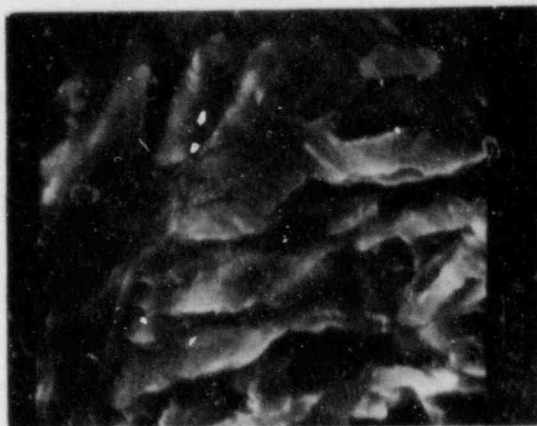
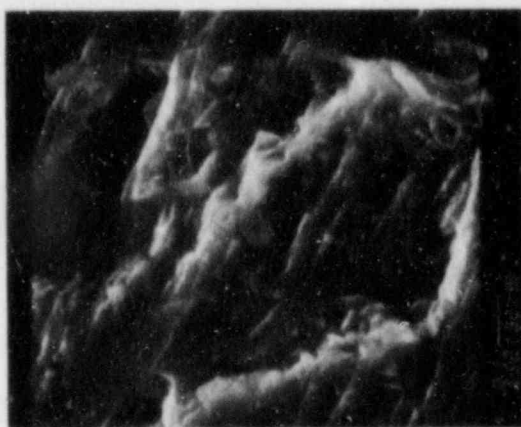
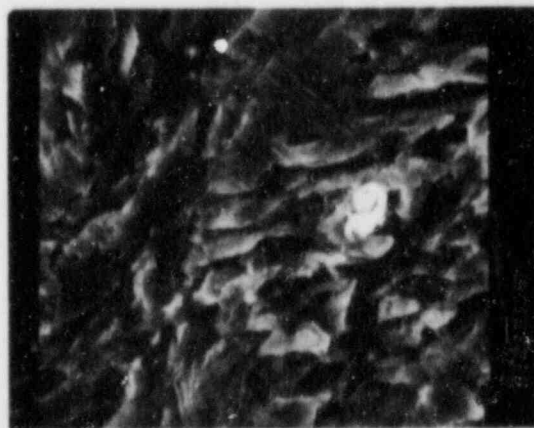
Figure 3.3-28. Typical Fractographic Features of Specimen 6-9 Viewed at High Magnification. Views A Through D Are Located on Previous Lower Magnification Montage of Specimen 6-9

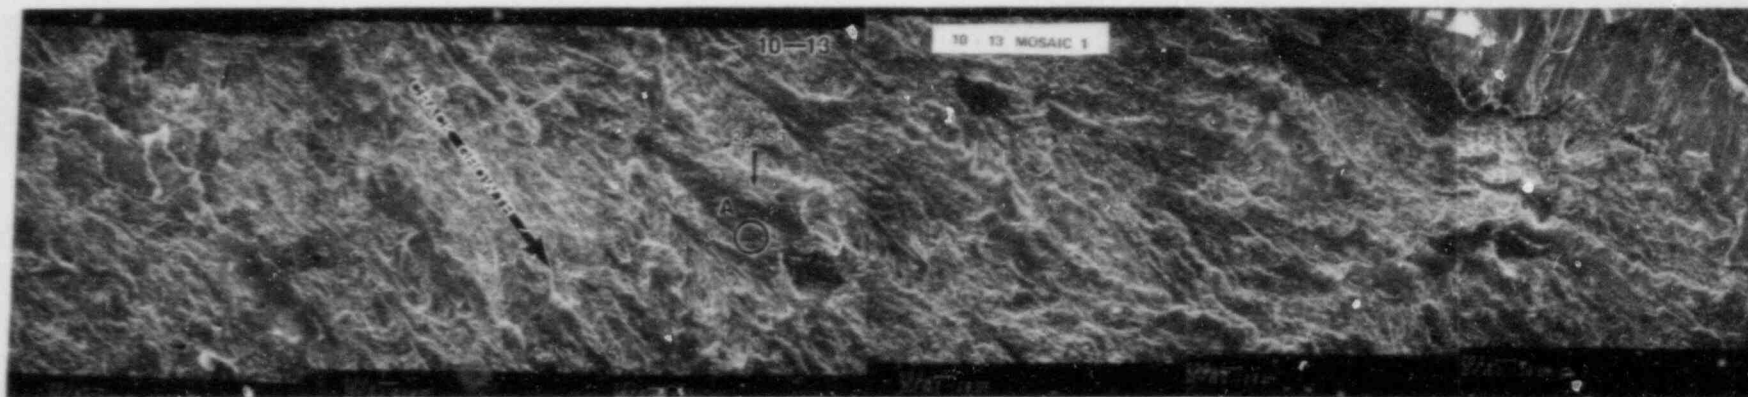
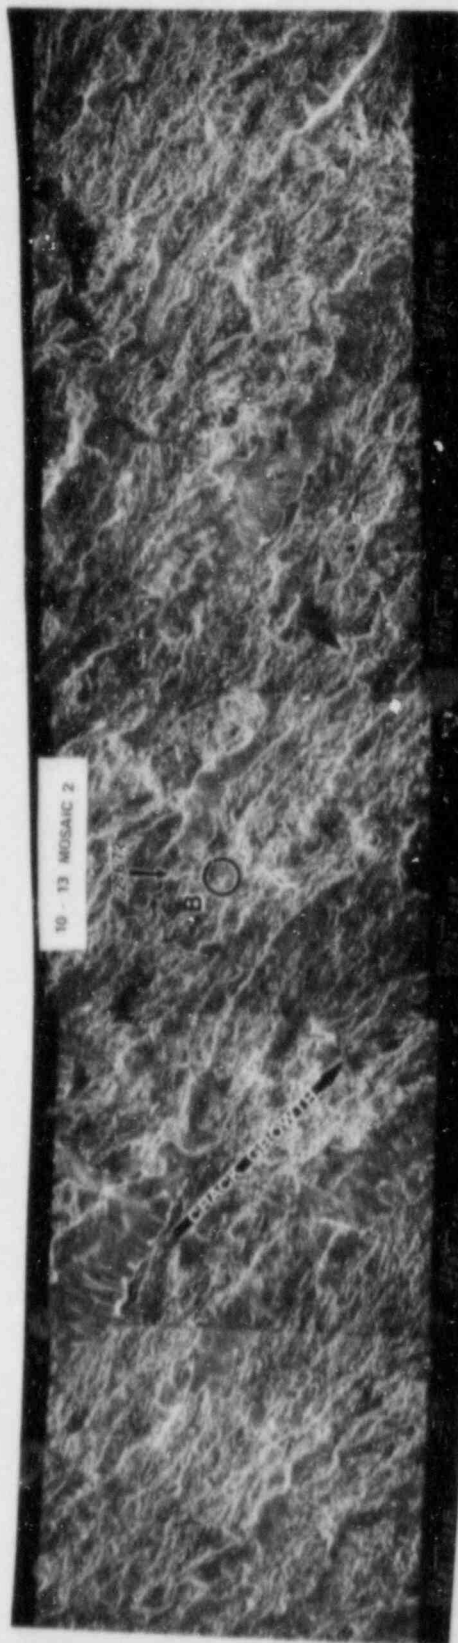
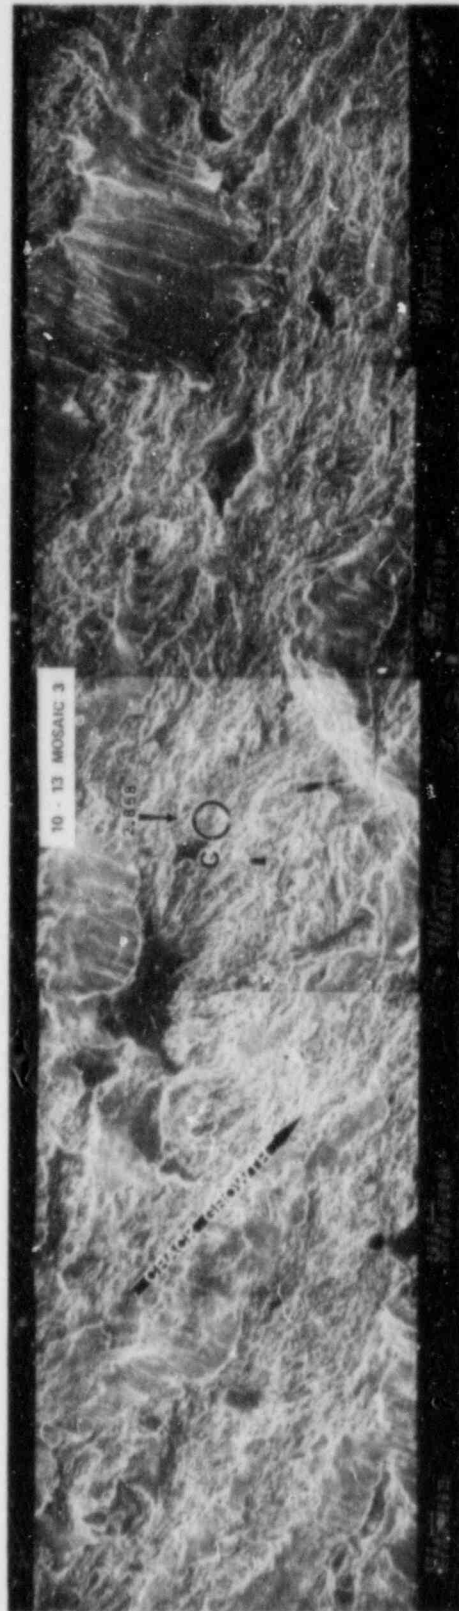
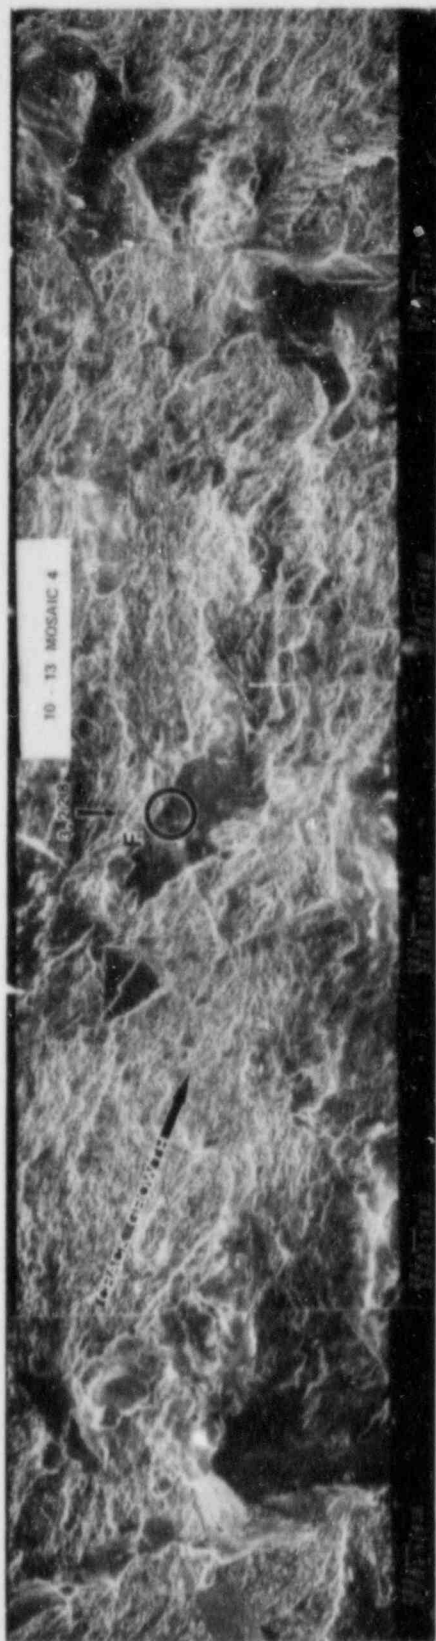
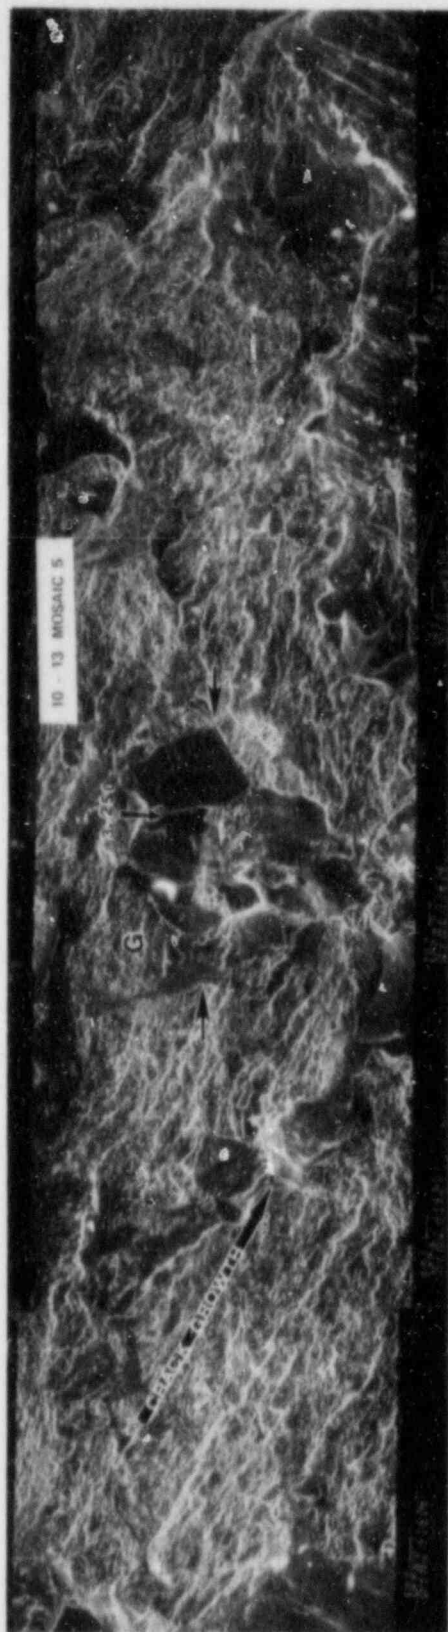
figure 3.3-29. SEM Photomontages of Typical Fracture
Structure Observed on Specimen 10-13
A. Montage 1, B. Montage 2
C. Montage 3, D. Montage 4
E. Montage 5

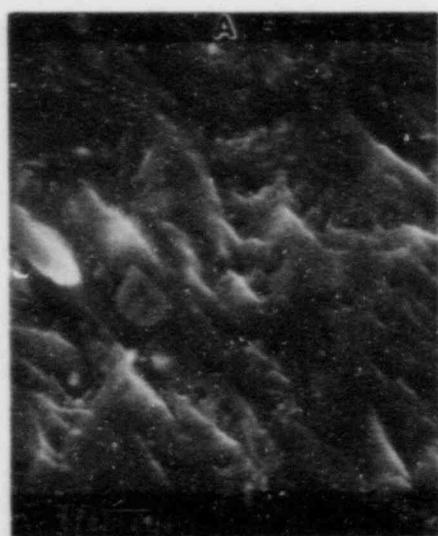
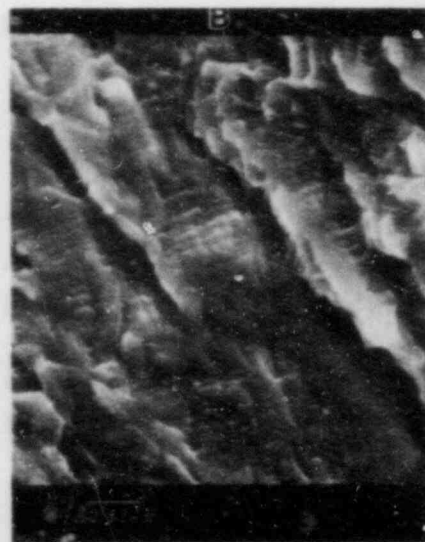
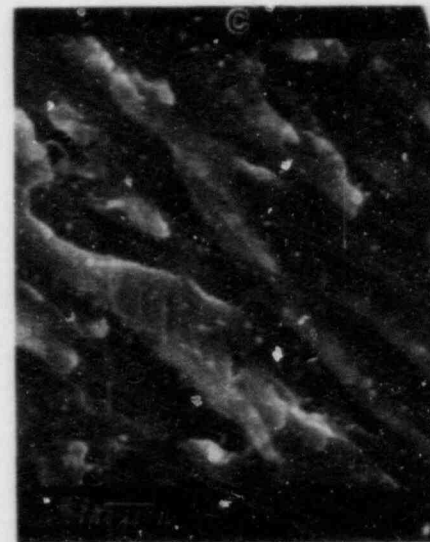
Figure 3.3-30. High Magnification SEM Photomicrographs of Fine Transgranular Fracture With Faint Striations in Specimen 10-13. Views Are at Locations A, B, and C of Previous Mosaic

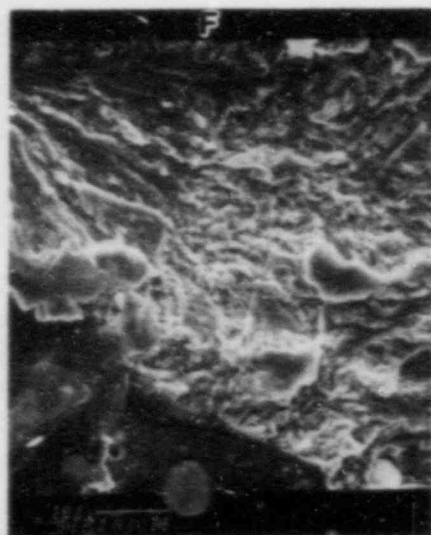
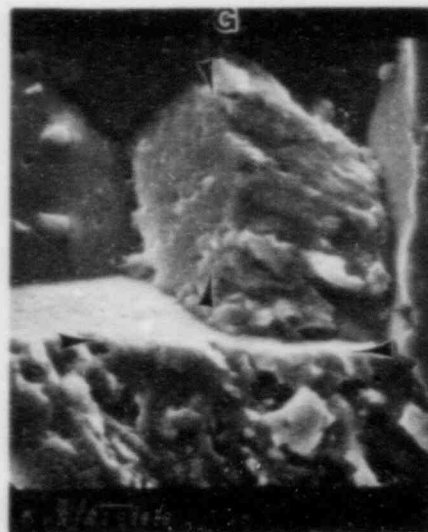
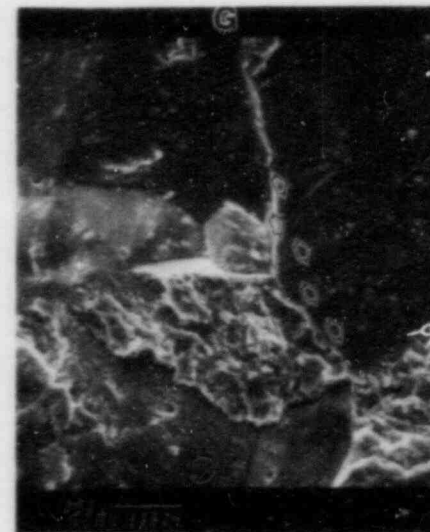
Figure 3.3-31. Typical Mixed Mode Fractography Seen on Specimen 10-13. Letter at Top of Photo Refer to Location on Previous Montage). Cleavage and Intergranular Separation Facets Occur in Colonies Surround by a Fine Transgranular Structure. A. Intergranular Separation, Enlarged in B, C. Intergranular Separation, Enlarged in D

- E,F. Intergranular, Plus Some Cleavage
- G. Enlarged View of F Showing Possible Crack Arrest Points on Facet Surface (Arrows)
