TMI-1 REACTOR COOLANT PUMP SHAFT FAILURE ANALYSIS

TMI-1 REACTOR COOLANT PUMP SHAFT
FAILURE ANALYSIS

Lynchburg Research Center Report
RDD:84:5183-06:01

August 1984

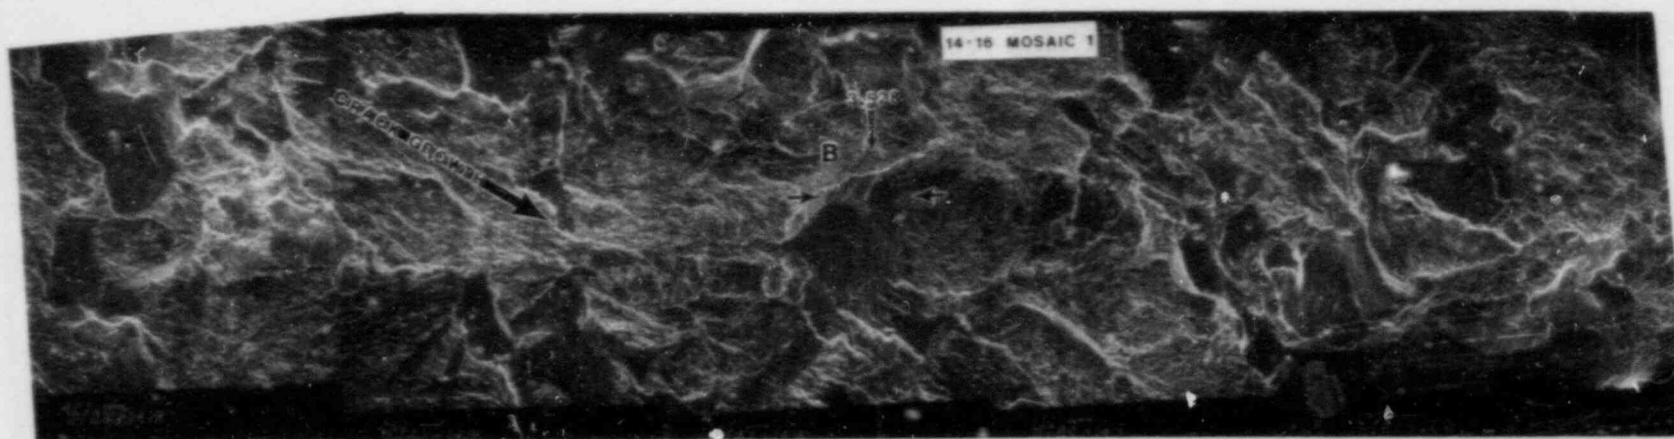
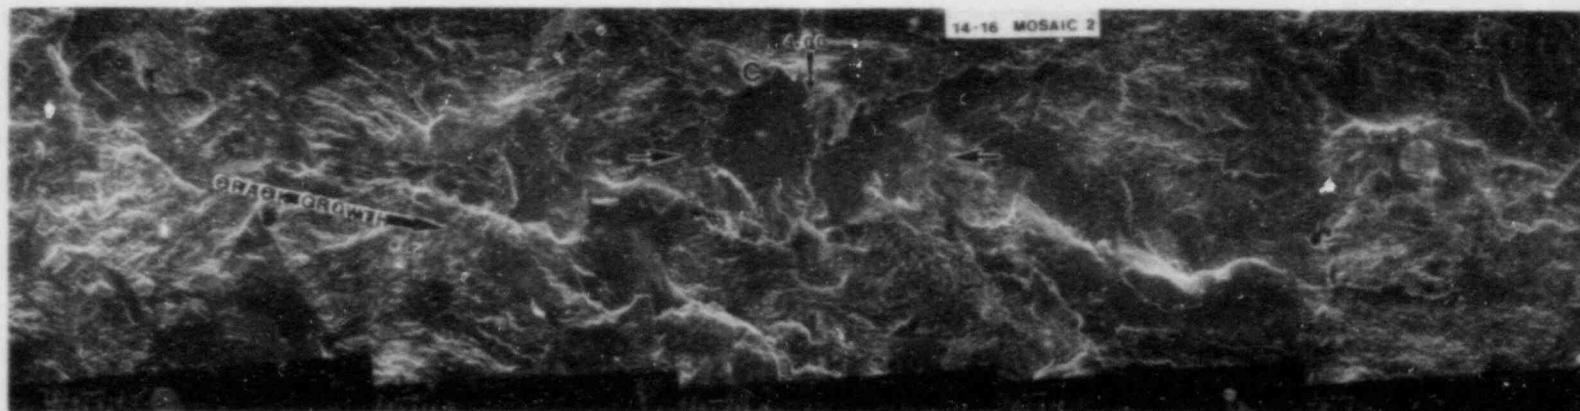
Figure 3.3-32. SEM Photomontage From Specimen 14-16
A. Montage 1, B. Montage 2

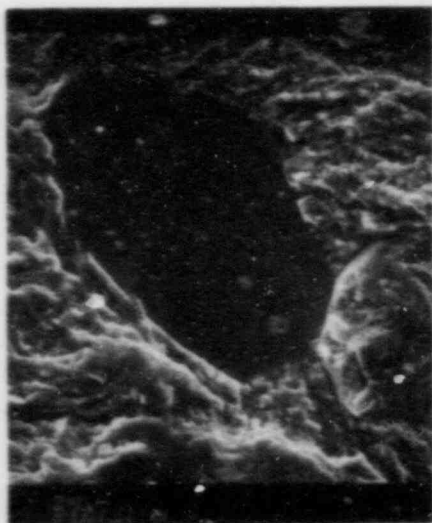
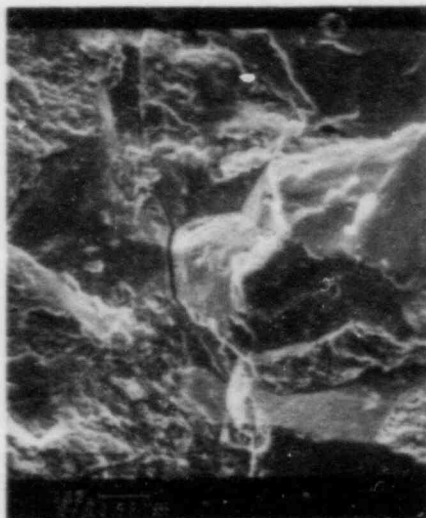
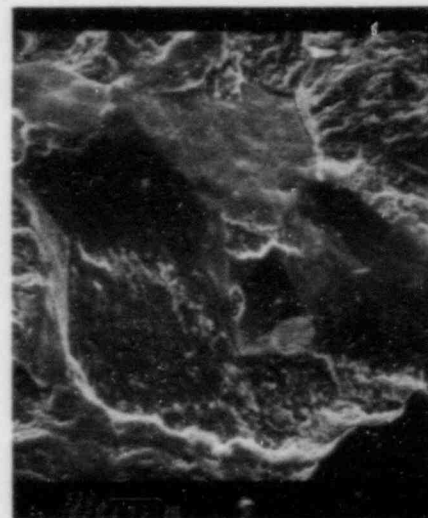
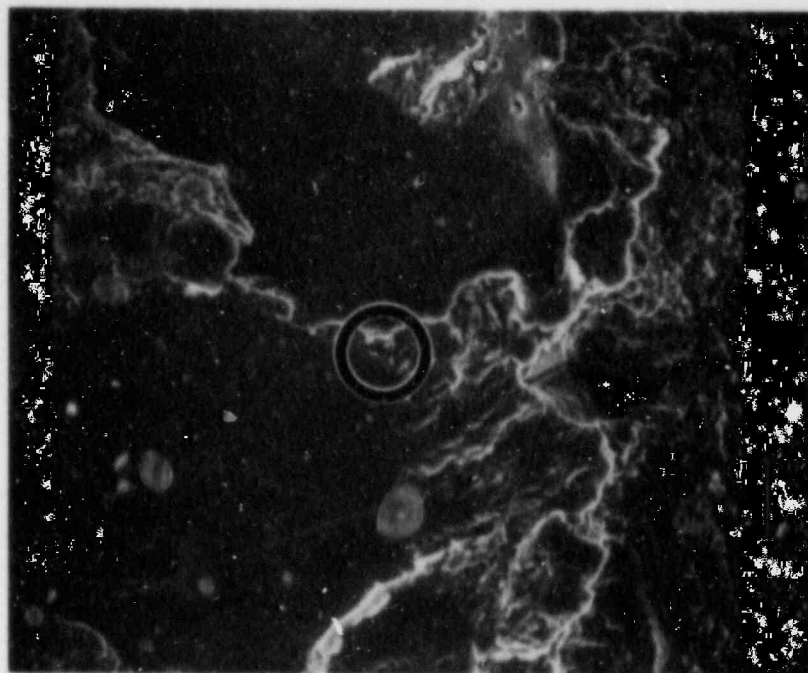
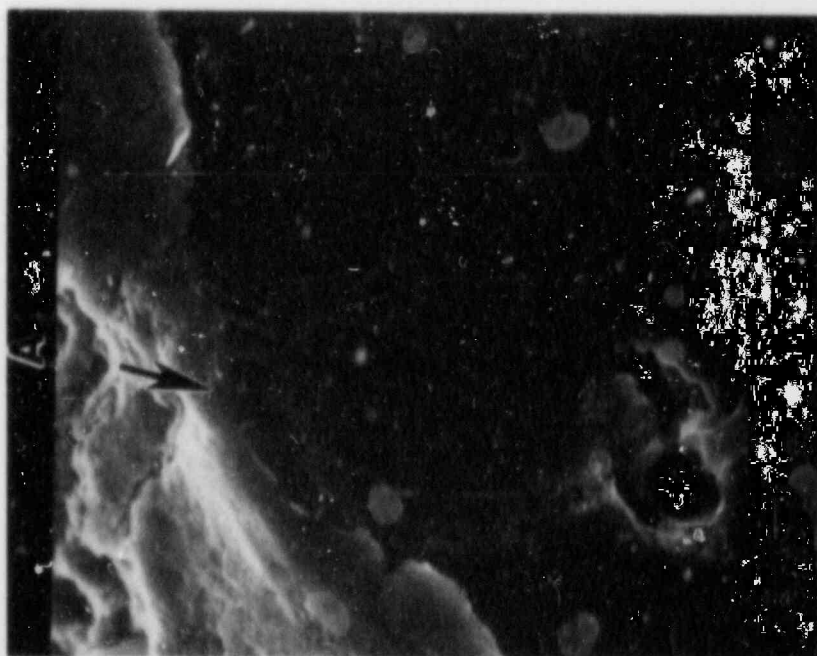
Figure 3.3-33. Typical Examples of Faceted Structure in Specimen 14-16.

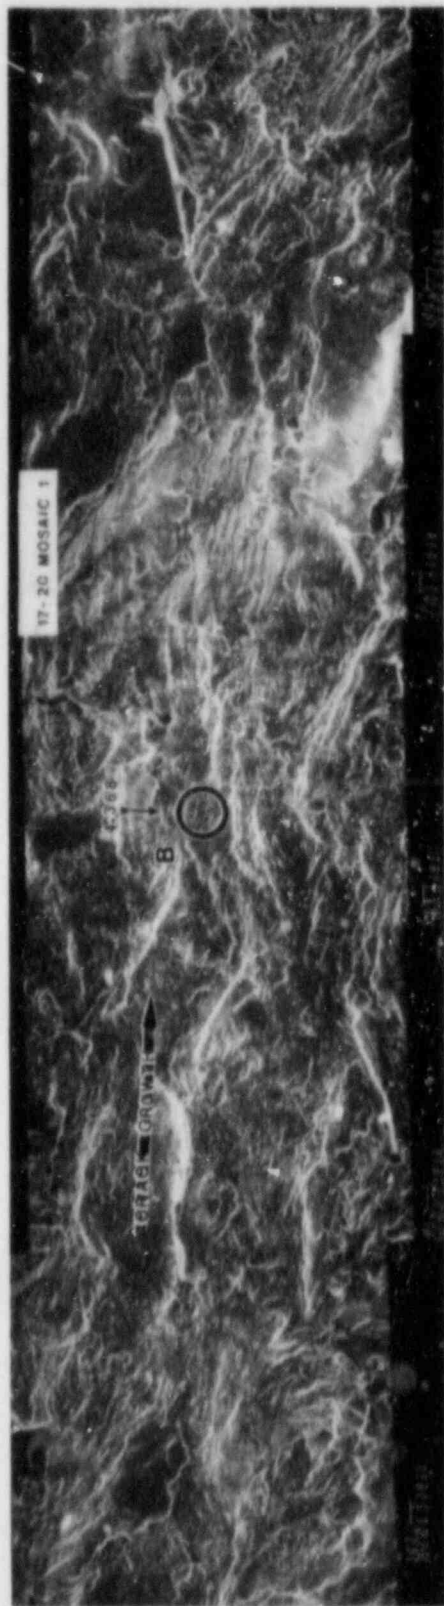
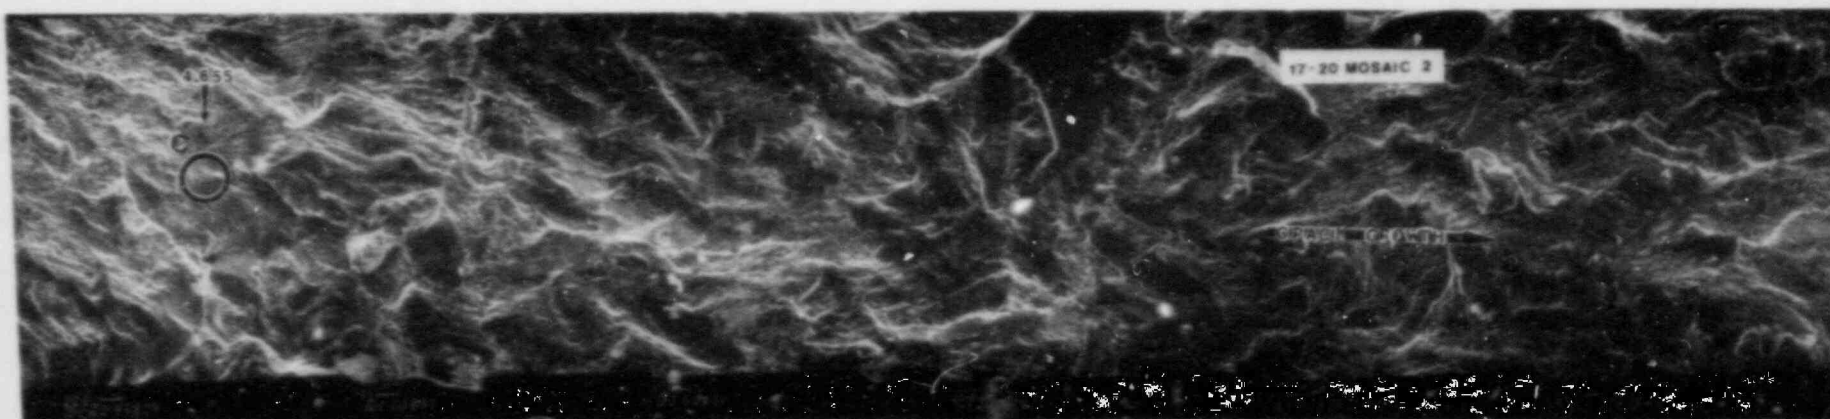
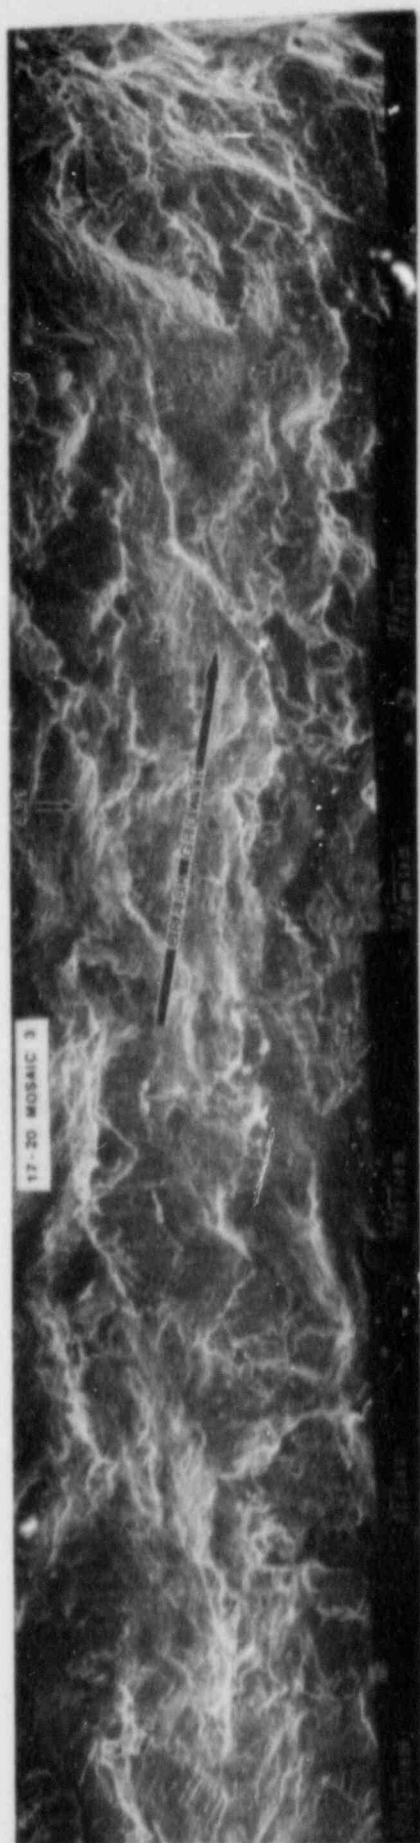
Figure 3.3-34. SEM Photomontage from Specimen 17-20
A. Montage 1, B. Montage 2, C. Montage 3

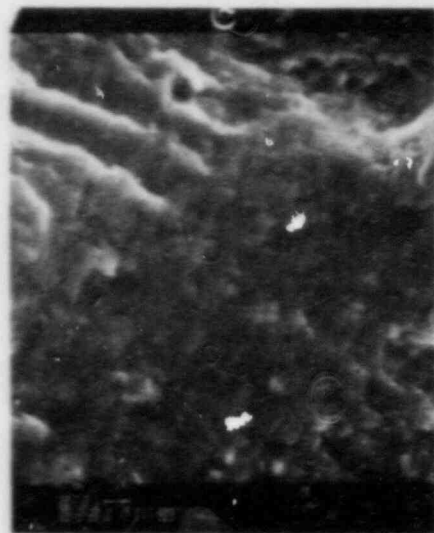
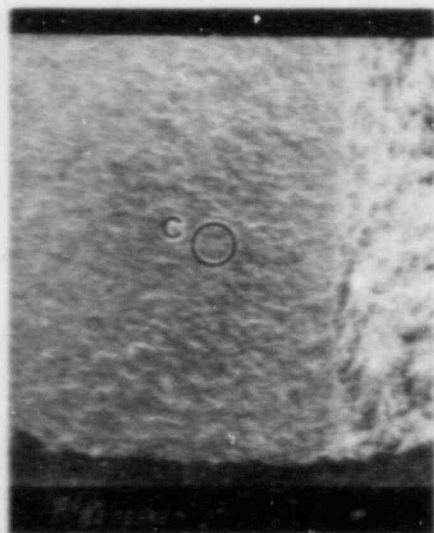
Figure 3.3-35. Higher Magnification Views of Fracture Surface Structure on Specimen
Views B and C Taken at Location A. Views D and E Taken at Location
B Shown on Previous Montage. Views F and G Taken at Location C.

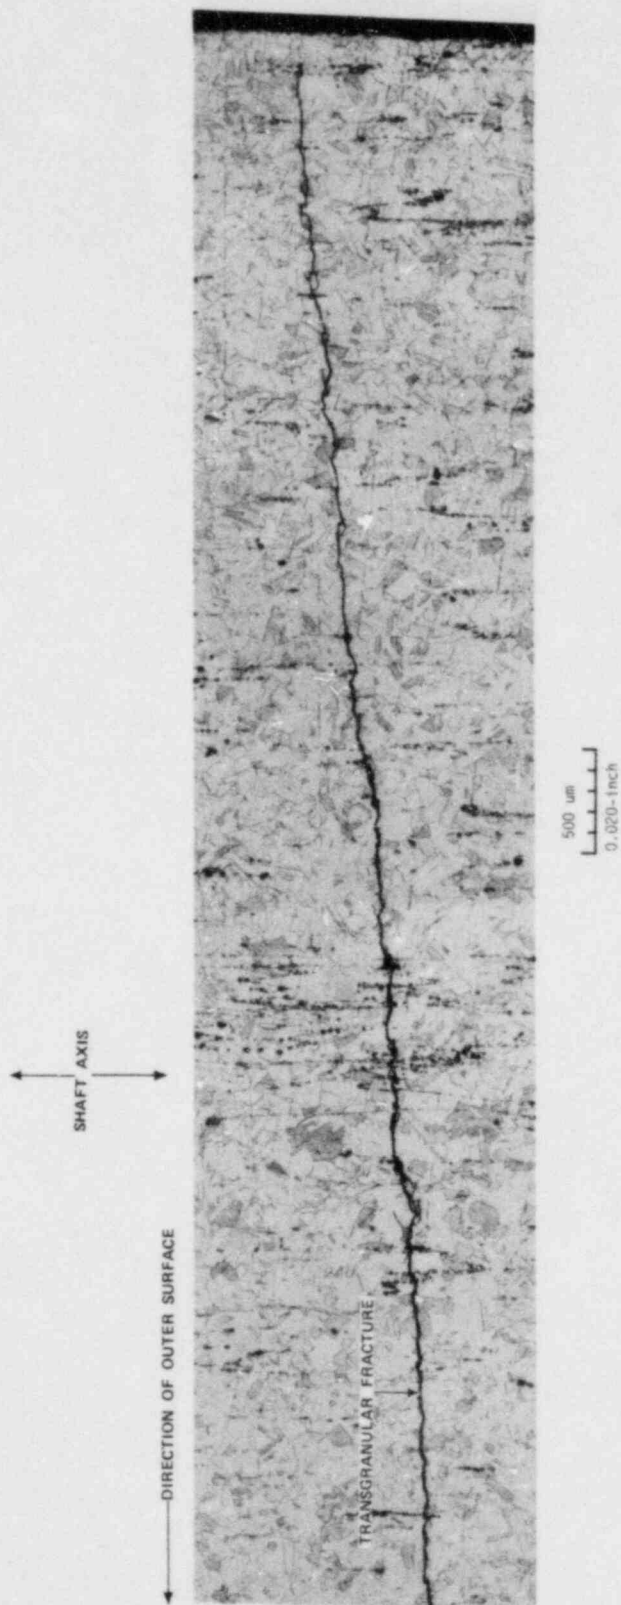
Figure 3.3-38. Longitudinal View of Specimen A1A-8

GRAIN SIZE ASTM 4-5
INCLUSION DENSITY ASTM TYPE C HEAVY

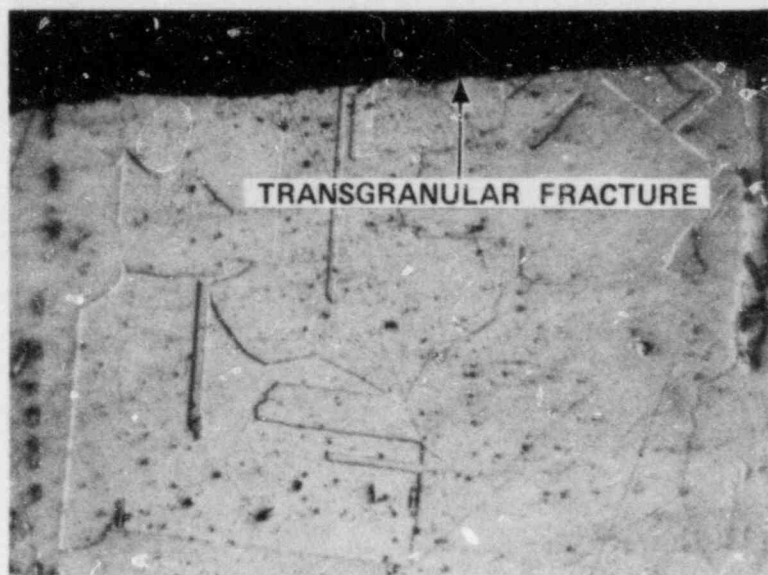
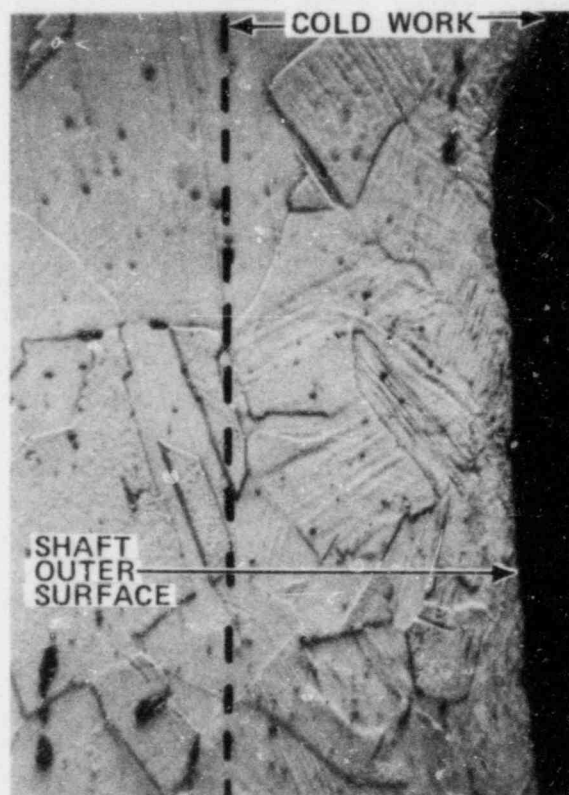
Figure 3.3-41. Longitudinal Views of Specimens B1A1 1-5B-1

GRAIN SIZE-ASTM 4.5
INCLUSION DENSITY-ASTM TYPE C THIN

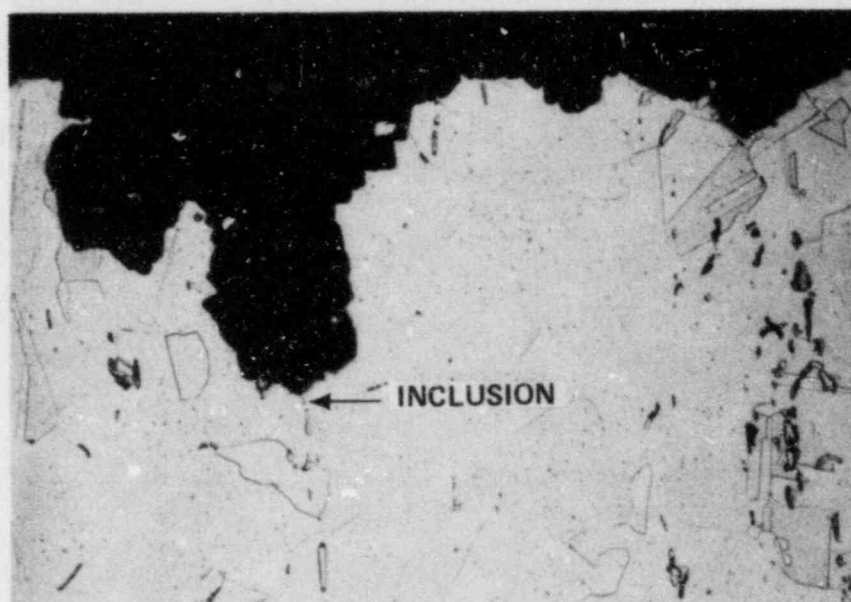
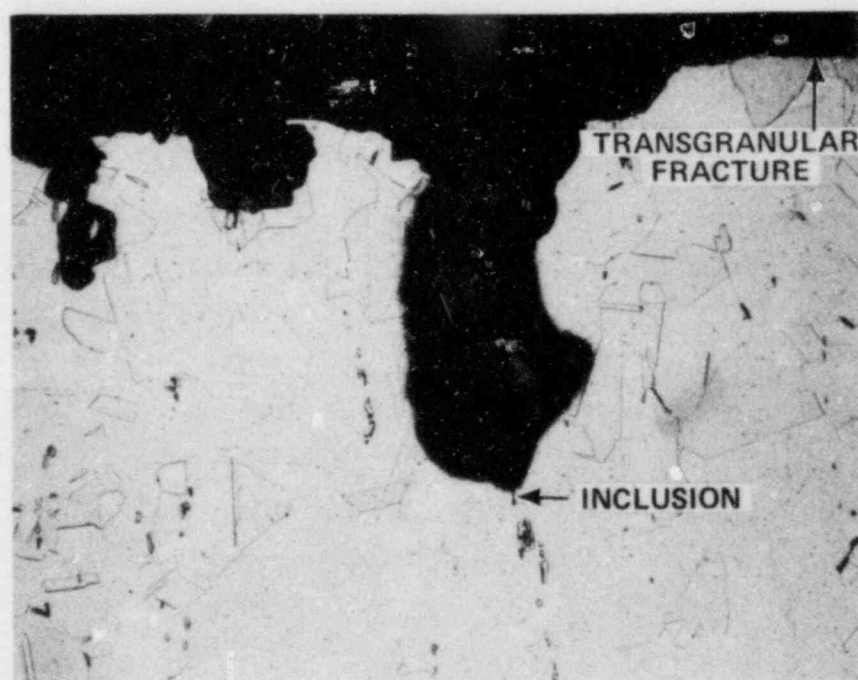
Figure 3.3-42. Longitudinal Views of Specimen B1A1, 1-5A-M Pit Region

GRAIN SIZE-ASTM 4-5
INCLUSION DENSITY-ASTM TYPE C THIN

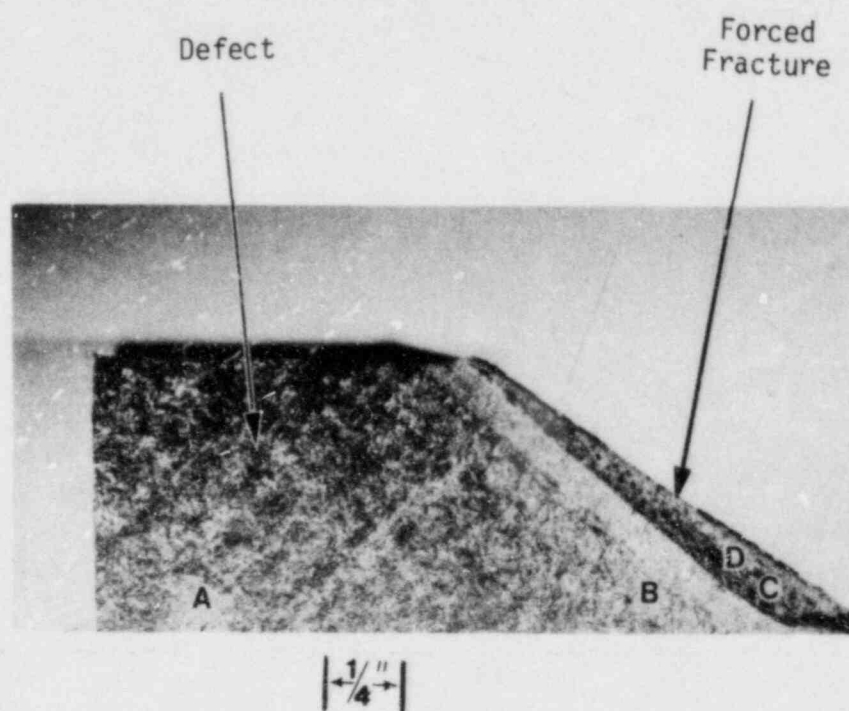
Figure 3.4-1. View of Fracture Surface on Specimen A1B Which Was Used for Auger Analysis

Sputter depth profiling was done at four locations, two on the failure area and two on the forced fracture as shown in Figure 3.4-1. The concentration in atomic percent of the elements found along with the depths at which they were detected are recorded in Table 6.

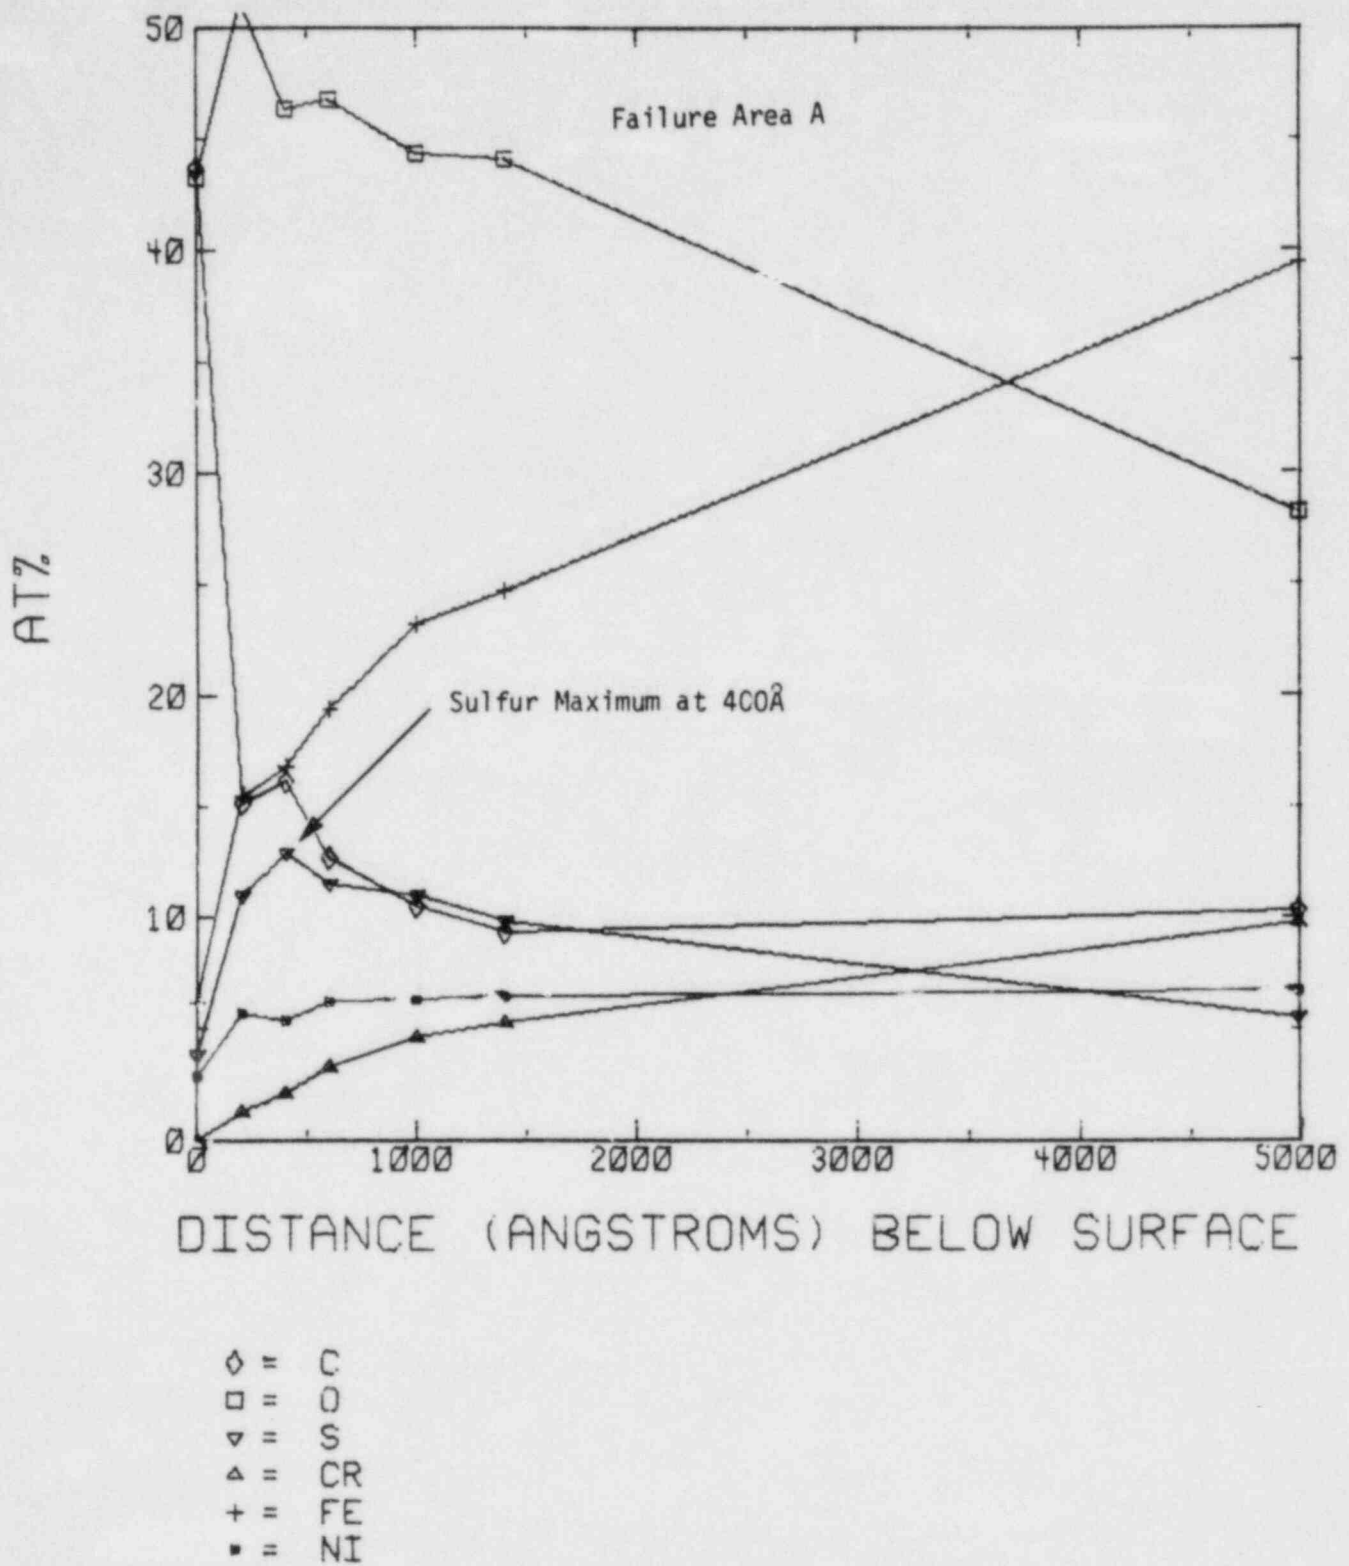
Figure 3.4-2. Auger Analysis Sputter Depth Profiles on the Fracture Surface in Figure 3.4-2

The graph seen in Figure 3.4-2 represents the sputter depth profile of the major elements to a depth of 5000Å taken at Location A on the surface as viewed in Figure 3.4-1. The sulphur concentration reaches a maximum of 13 atomic percent at 400Å and then decreases to 3.6 atomic percent at 9500Å. This indicates a film that was significantly enriched in sulphur when compared to the sputter depth profile of the forced fracture Area C. The sulphur concentration was highest at the surface (5.9 atomic percent) in the forced fracture region and decreased slightly at the 100Å and 200Å levels to 4 atomic percent.

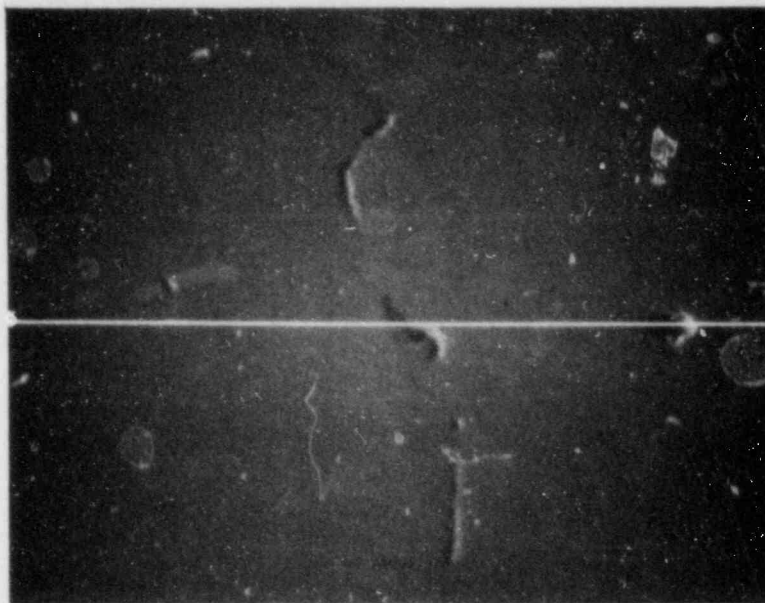
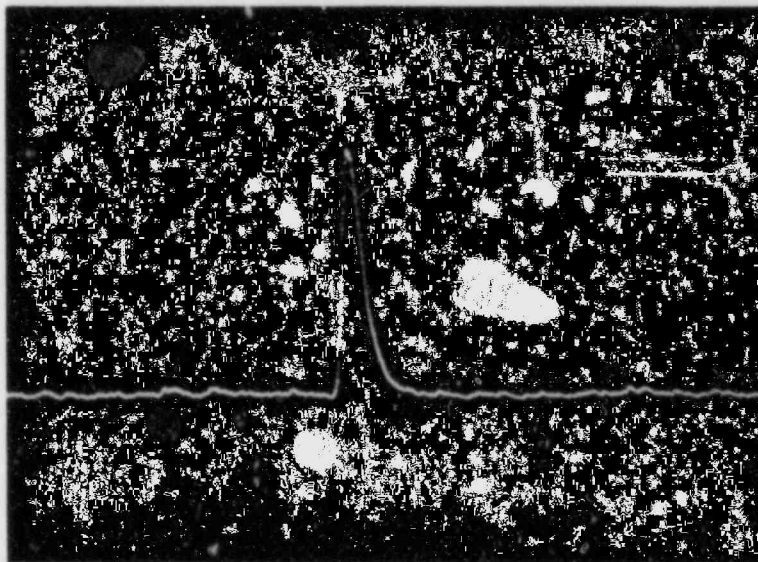
An SEM photomicrograph of the polished defect cross section can be seen in Figure 3.4-3. The crack was very tight and microanalysis along this plane only revealed occasional oxide patches. The white line in Figure 3.4-3a indicates the location of a beam traverse for oxygen while Figure 3.4-3b is the associated oxygen profile to illustrate the presence of oxides. No sulphur enrichment could be detected along the defect line in this sample orientation.

Figure 3.4-3. Specimen A1C Used for Microprobe Analyses.
A. SEM View of Crack, B. Oxygen Profile
Corresponding to the Beam Traverse Location
Shown by White Line in View A

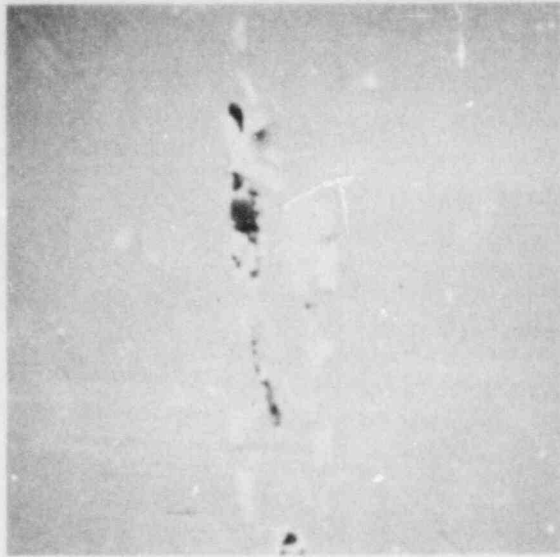
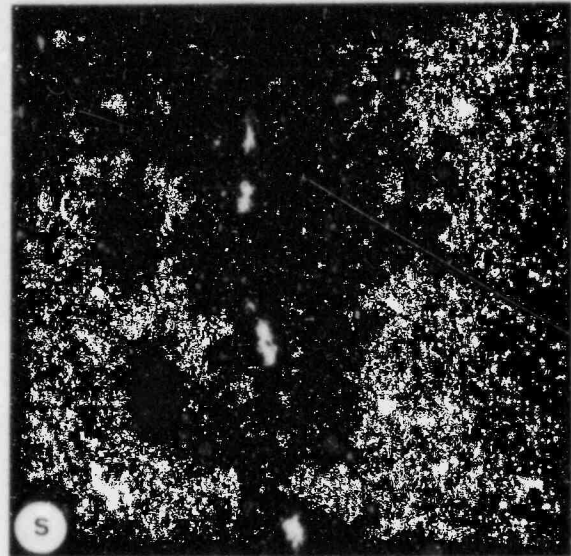
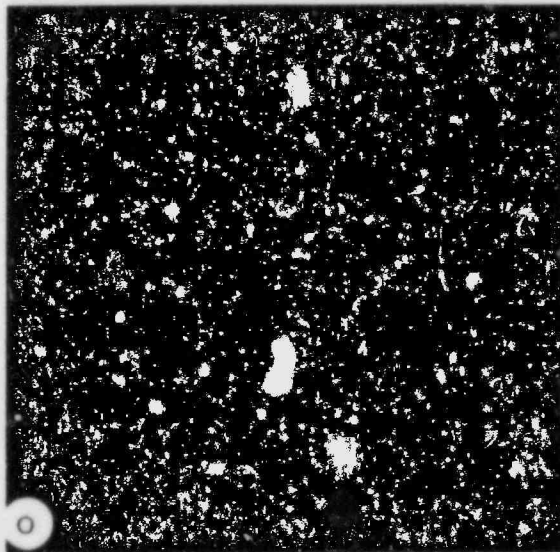
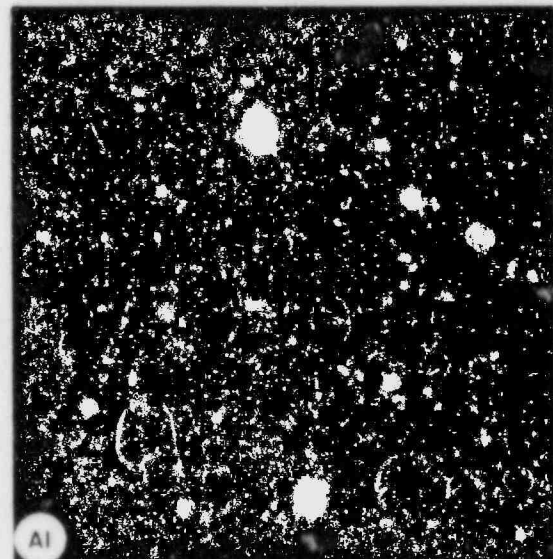
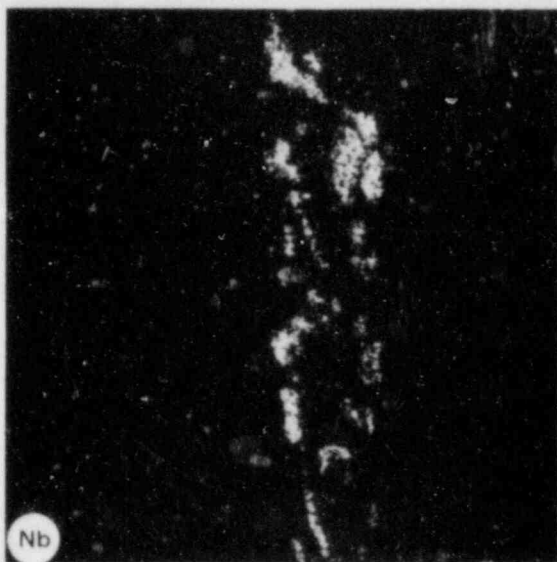
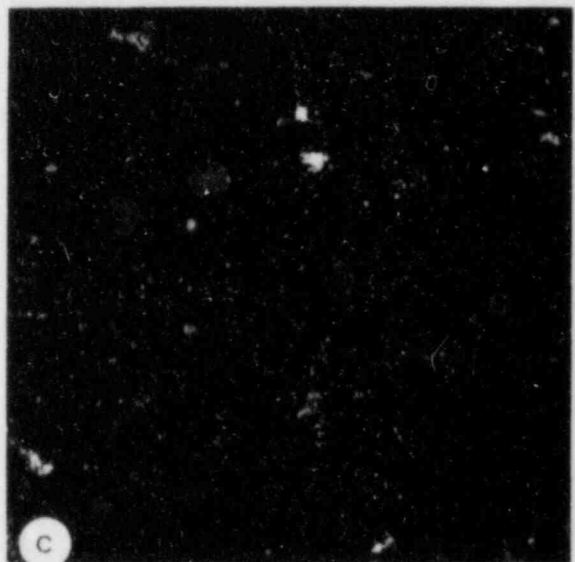
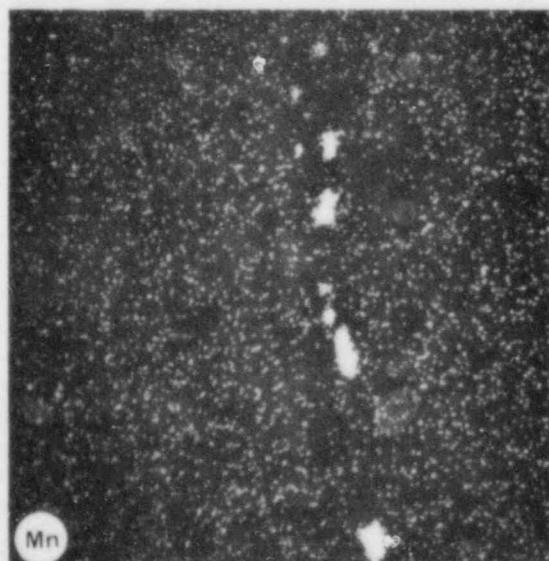
Several stringered inclusions were observed in the sample orientation analyzed. Elemental dot mapping was done on several inclusions for the following elements: C, N, Ta, S, O, Mn and Nb, and Al. It was observed that the majority of the inclusions were of the form Nb (C, N). Figure 3.4-4 displays an SEM photomicrograph and several associated element dot maps of a typical cluster of inclusions seen in the sample. The white appearing inclusions were niobium rich. The carbon and nitrogen maps were abnormally faint, most likely because material had smeared over during polishing. The surface was in the unetched condition. The grayish inclusion was identified by mapping as Al_2O_3 .

Figure 3.4-4. SEM Photomicrograph and Associated Element Maps of a Typical Stringer Formation Found in the 347SS Pump Shaft Material

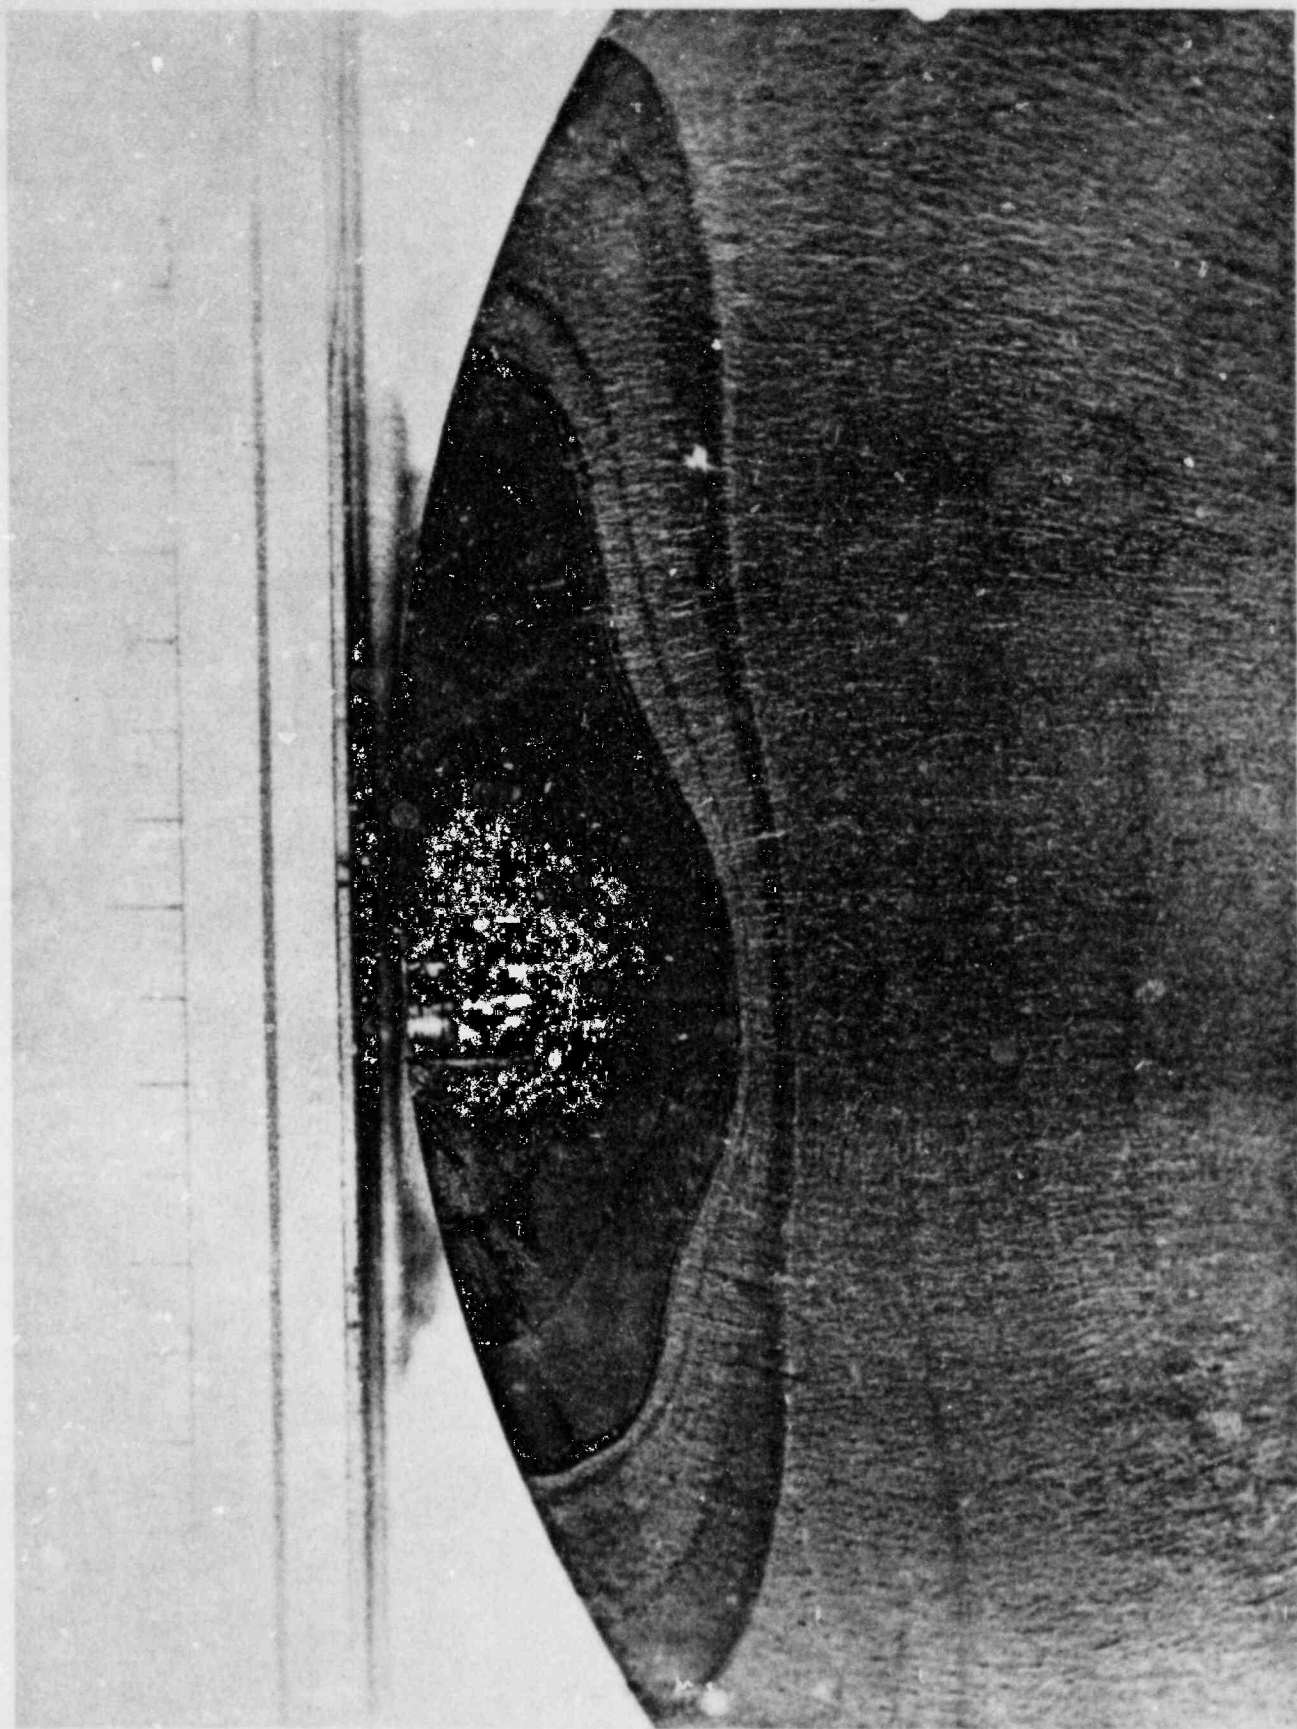
Samples of 347 SS pump shaft material were sent to ARC for microanalysis of a failed surface for its chemical composition and bulk material inclusion analysis. The original failed surface section from which the samples were removed can be seen in Figure 1. The samples were taken in the area away from the notch beyond the fatigue striations just beyond the view in Figure 1.

Identification of sulfide inclusions was desirable because of the possibility that the band of pits located in Figure 1 has been caused by corrosive attack of sulfide inclusions. There is evidence in the literature* to suggest that sulfides are sites for pitting attack. MnS inclusions were identified in the pump material. It has been found* that in the case of pitting at MnS sites, both the inclusion and metal are attacked while for FeS sites, the metal is attacked but the inclusion is not. Work done at LRC indicates no remaining material in the pits seen in Figure 1 which is consistent with the attack of MnS inclusions specifically. It has also been observed* that the most susceptible sites for pit formation are complex $\text{MnS-Al}_2\text{O}_3$ inclusions. Such complex inclusions were observed quite frequently in the pump shaft material so that a mechanism of pitting attack at either MnS or $\text{MnS-Al}_2\text{O}_3$ sites is consistent with the inclusion types found in the 347 material.

Figure 1. Original Failed Section from Which SAM and EPMA Samples Were Removed.

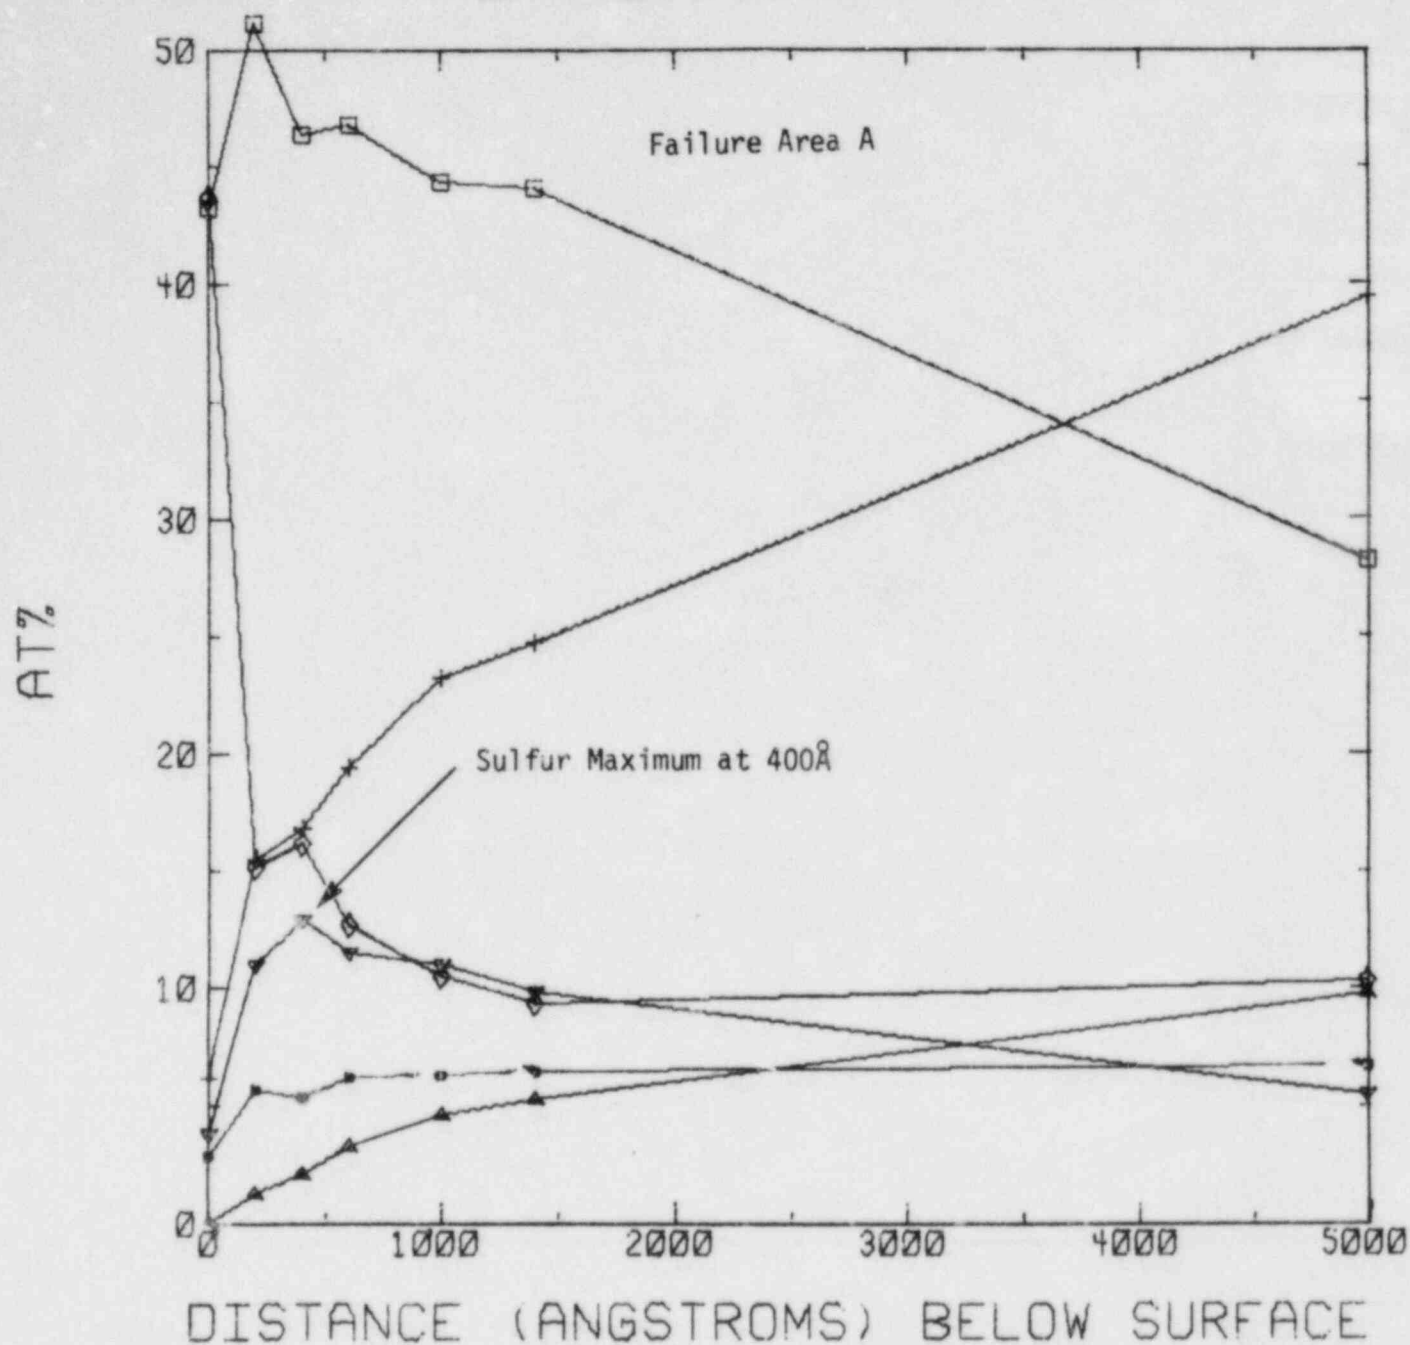
The graph seen in Figure 2 represents the sputter depth profile of the major elements to a depth of 5000Å taken at Location A on the surface as viewed in Figure 3. The sulfur concentration reaches a maximum at 400Å (13 atomic %) and then decreases to 3.6 atomic % at 9500Å. This indicates a film that is significantly rich in sulfur when compared to the sputter depth profile of the forced fracture Area C. The sulfur concentration is highest at the surface (5.9 atomic %) in the forced fracture region and has decreased slightly at the 100Å and 200Å levels to 4 atomic %.

Figure 2. Auger' Analysis Sputter Depth Profiles on the Surface seen in Figure 3.

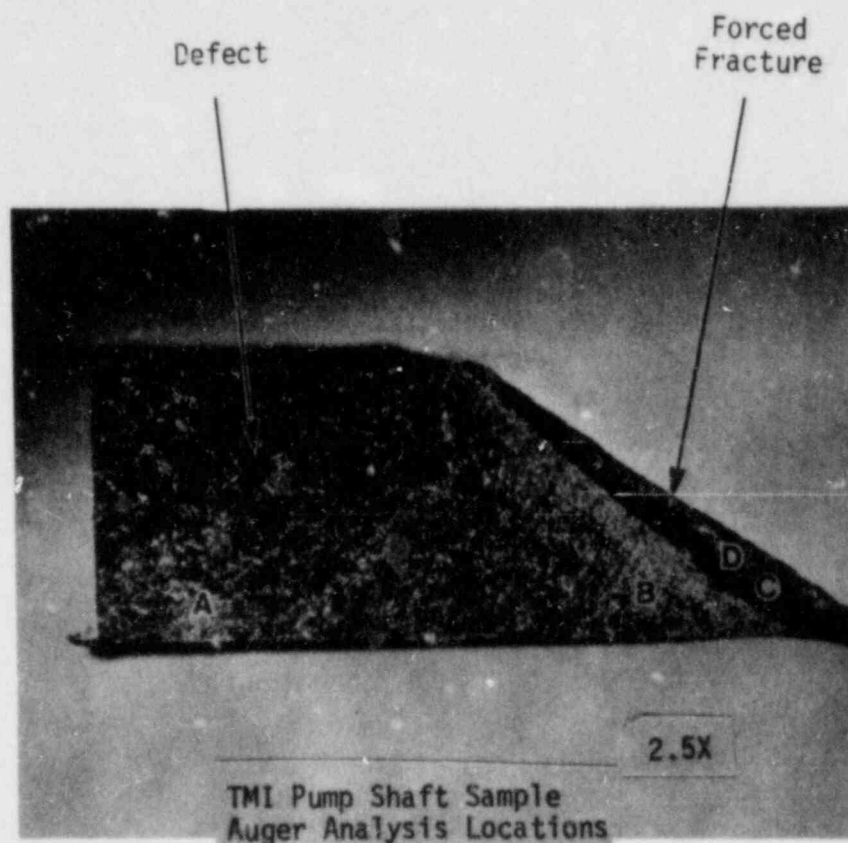
Based on the results of the Auger analysis, the following elements were included in the microprobe analysis: Cr, Mn, Fe, Ni, Nb, S, and O. The piece which was analyzed is the mating surface to the Auger sample (see Figure 3). The results of the quantitative analysis are given in Table 2. Four randomly chosen locations were analyzed on the surface away from the forced fracture. The readings were compared to normal base metal on a piece taken adjacent to the Auger sample such that a plane perpendicular to the defect surface was analyzed. Fracture surface readings were taken, but the surface roughness proved to be too great to achieve good quantitative results. A beam search for sulfur revealed high sulfur in rough surfaces adjacent to the forced fracture but again surface roughness made quantification impossible.

Figure 3. Defect Surface Examined by Auger Analysis. The Mating Face was Used for the Microprobe Analysis.

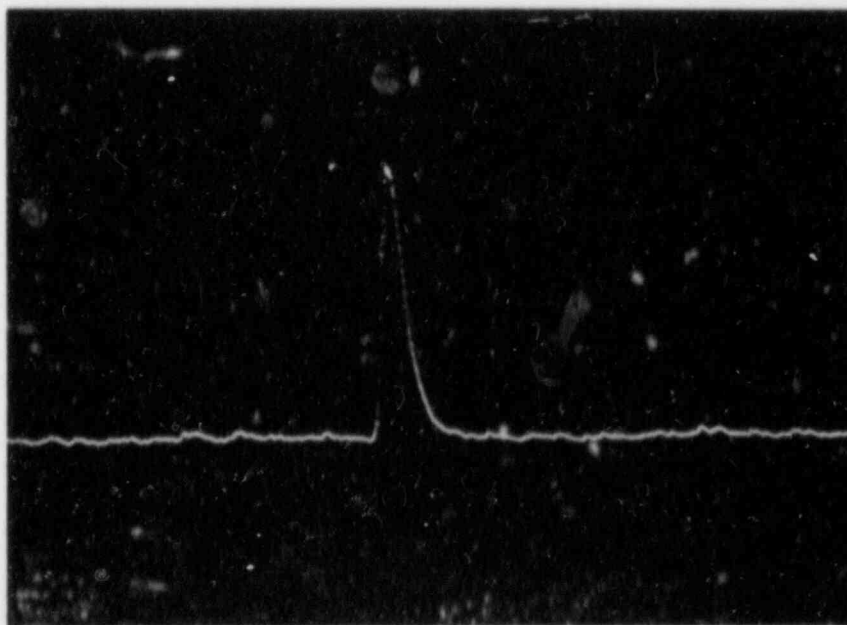
Figure 4b. Oxygen Profile Corresponding to the Beam Traverse Location (White Line) seen in Figure 4a.
