TMI-1 REACTOR COOLANT PUMP SHAFT FAILURE ANALYSIS

TMI-1 REACTOR COOLANT PUMP SHAFT
FAILURE ANALYSIS

Lynchburg Research Center Report
RDD:84:5183-06:01

August 1984

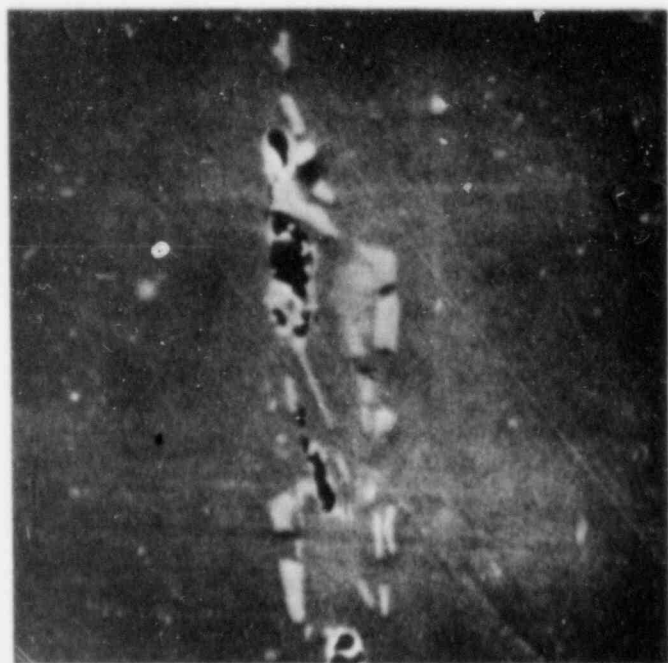
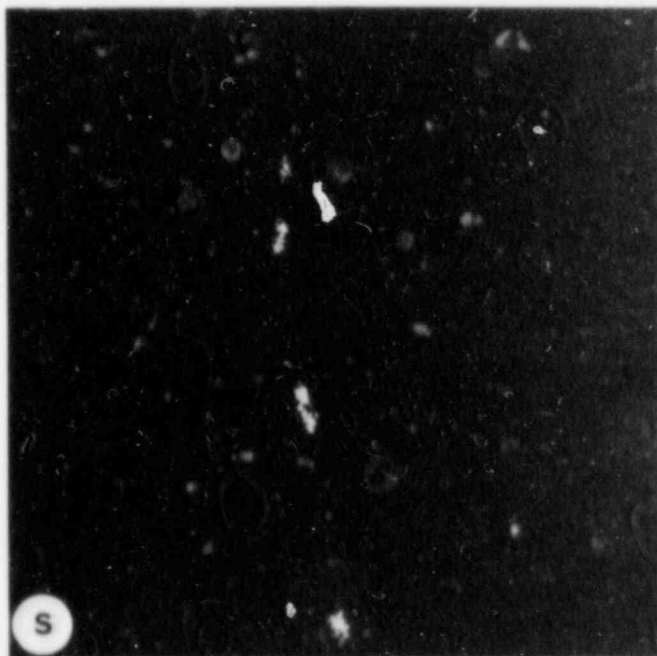
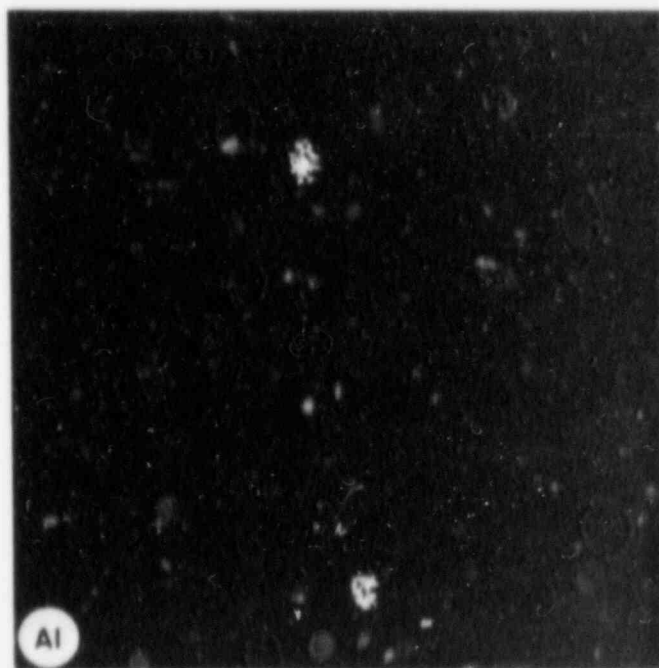
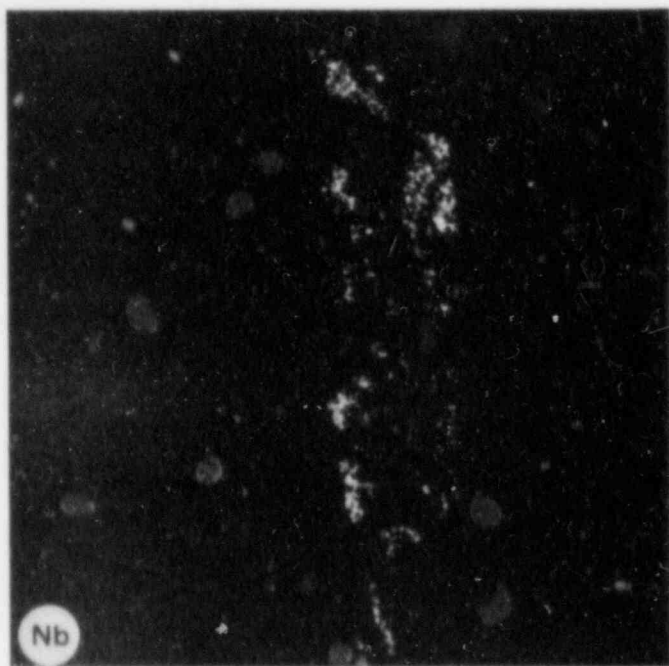
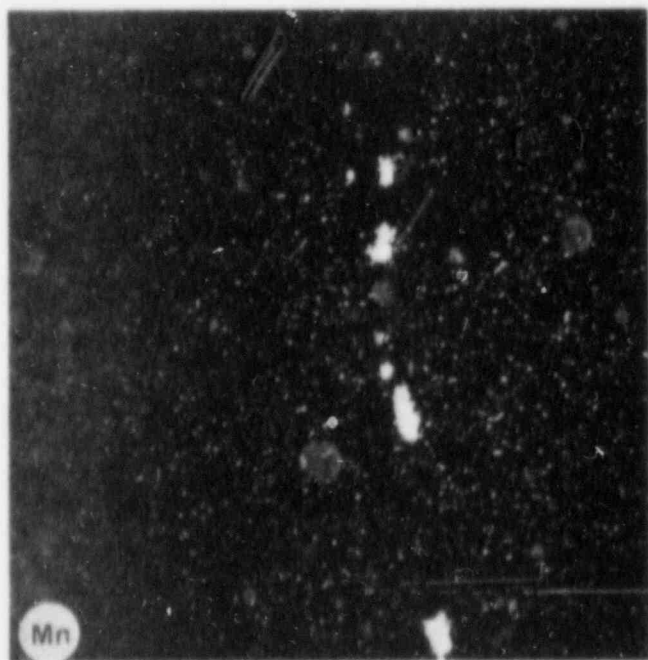
Elemental dot mapping was done on several inclusions for the following elements: C, N, Ta, S, O, Mn and Nb, and Al. It was observed that the majority of the inclusions are of the form Ti (C, N). Figures 5a through 5g display an SEM micrograph and several associated element maps of a typical cluster of inclusions seen in the sample. The white inclusions are niobium rich. The carbon and nitrogen maps were abnormally faint, most likely because material had smeared over during polishing. The surface is in the unetched condition. The grayish inclusion can be identified by mapping as Al_2O_3 . MnS has precipitated out around this and other observed oxide inclusions and MnS inclusions can also be found separately in clusters with oxides and Nb (C, N) as well as isolated in the matrix. Sulfide inclusions were found much less frequently than Nb (C, N) inclusions throughout the sample.

Figure 5. SEM Micrograph and Associated Element Maps of a Typical Stringer Formation Found in the 347SS Pump Shaft Material.
