LICENSEE EVENT REPORT (LER)

FACILITY NAME (1) Fort St. Vrain, Unit No. 1										DOCKET NUMBER (2) 0 5 0 0 0 2 6 7										PAGE (3) 1 OF 1	
TITLE (4) High Reactor Pressure Scram & Ensuing Control Rod Automatic Insertion Failures																					
EVENT DATE (5)			LER NUMBER (6)				REPORT DATE (7)			OTHER FACILITIES INVOLVED (8)											
MONTH	DAY	YEAR	YEAR	SEQUENTIAL NUMBER	REVISION NUMBER	MONTH	DAY	YEAR	FACILITY NAMES N/A						DOCKET NUMBER(S) 0 5 0 0 0						
0 6	2	3	8	4	8 4	0 0	8	0 0	0 7	2	3	8	4	0 5 0 0 0							
OPERATING MODE (9) N		THIS REPORT IS SUBMITTED PURSUANT TO THE REQUIREMENTS OF 10 CFR 5: (Check one or more of the following) (11)																			
POWER LEVEL (10) 0 2 3		20.402(b)				20.405(a)				X 50.73(a)(2)(iv)				73.71(b)

FACILITY NAME (1)	DOCKET NUMBER (2)	LER NUMBER (8)			PAGE (3)		
		YEAR	SEQUENTIAL NUMBER	REVISION NUMBER			
Fort St. Vrain, Unit No. 1	0500026784	—	008	—	00	02	OF 11

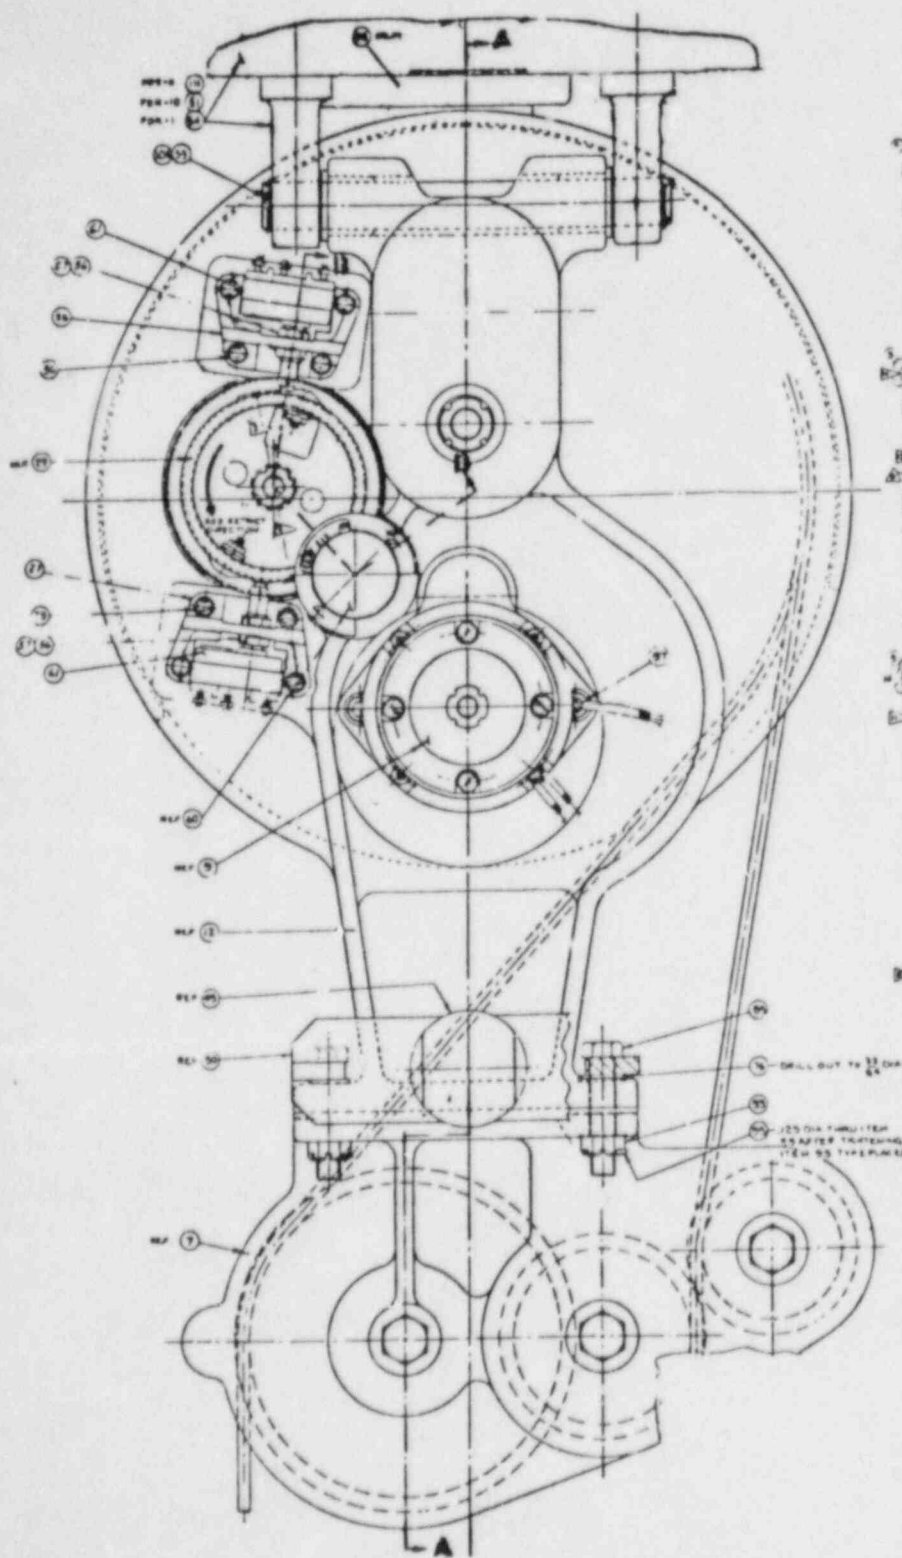
FIGURE 2

The control rod drive mechanism operates in a helium environment within the PCRV at reactor pressure (Figure 2). Ambient temperature is nominally maintained at approximately 150 degrees Fahrenheit by the refueling penetration cooling system and a thermal barrier between the drive and the reactor core. Shielding, interposed between the drive and the reactor core, limits the radiation level at the control rod drive to approximately 1 rad per hour. A helium-purge flow of about 5.5 pounds per hour floods the drive assembly and prevents the ingress of contaminated reactor helium coolant (Figure 3).
