Investigation and Analysis
of
Suspect Fasteners

Event 29257

Final Report

Prepared by
Cardinal Industrial Products
Division of B&G Manufacturing Co., Inc.

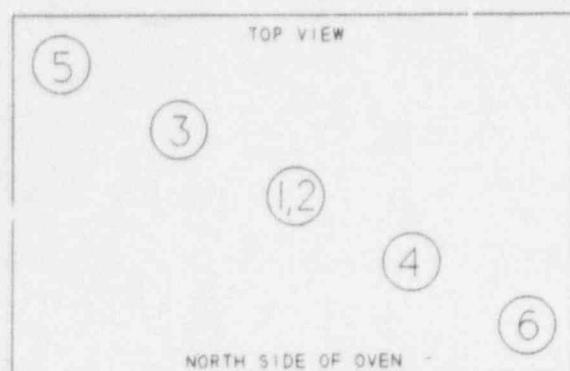
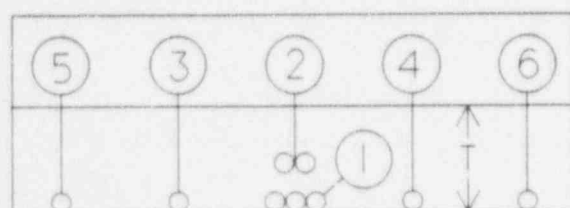
Test ZBG-TEST-08	Product 5/8-0 X 2½, 3 AISI 4140	Weight (pounds) 610
Date 9/12/95	Time @ Temperature (°F) 2 HRS 10 MIN @1575	Quench POLY

1	51	52	49	
2	55	54		
3	53			
4	52			
5	52			
6	52			
7				
8				
9				
10				
11				
12				
13

NON-HEAT TREATED BOLTS (2 1/2" LONG) WERE PLACED IN THE LOCATIONS SHOWN ABOVE. THE TEST COUPON BOLTS WERE IDENTIFIED BY STAINLESS STEEL WIRE WRAPPED AROUND THE SHANK. THE REMAINDER OF THE CHARGE CONSISTED OF BOTH HEAT TREATED AND NON-HEAT TREATED BOLTS OF THE SAME DIAMETER.

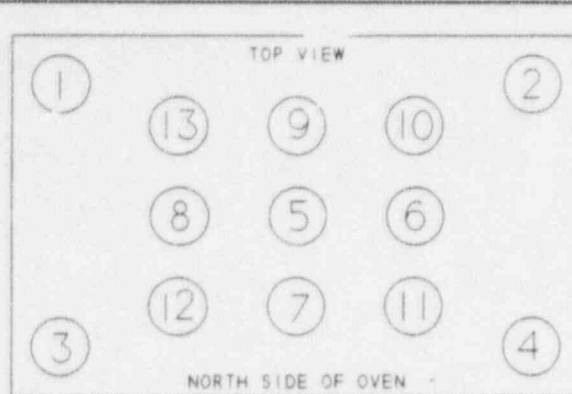
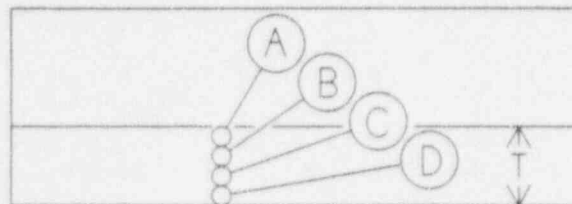
Test ZBG-TEST-09	Product 3/4-0 X 2 ½, 3 ½, 6 AISI 4140	Weight (pounds) 400
Date 9/13/95	Time @ Temperature (°F) 1 HR 30 MIN @1575	Quench POLY

A	B	C	D
1	54	51	55	53
2	50	52	54	52
3	55	55	51	54
4	49	53	54	54
5	53	53	50	53
6	53	54	52	52
7	53	51	53	54
8	55	53	53	53
9	54	53	55	53
10				53
11				54
12				52
13				54

NON-HEAT TREATED BOLTS (2 1/2" LONG) WERE PLACED IN THE LOCATIONS SHOWN ABOVE. THE TEST COUPON BOLTS WERE IDENTIFIED BY STAINLESS STEEL WIRE WRAPPED AROUND THE SHANK. THE REMAINDER OF THE CHARGE CONSISTED OF BOTH HEAT TREATED AND NON-HEAT TREATED BOLTS OF THE SAME DIAMETER.

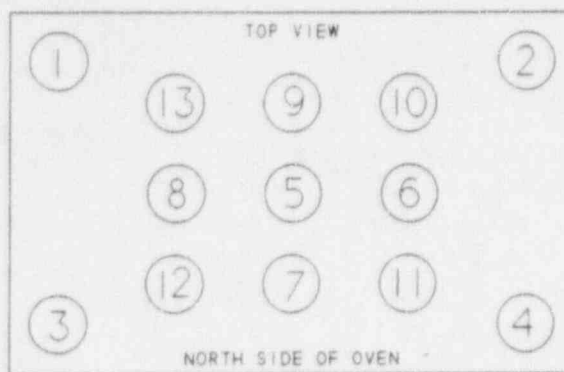
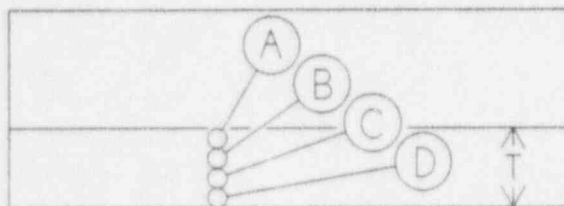
Test ZBG-TEST-12	Product 1/2-0 X 2 1/2 AISI 4140	Weight (pounds) 360
Date 9/14/95	Time @ Temperature (°F) 1 HOUR @1575	Quench POLY

A	B	C	D
1	52	53	51	52
2	53	52	53	52
3	50	52	54	53
4	50	53	53	52
5	52	55	48	50
6	50	51	51	51
7	52	54	51	51
8	51	52	50	50
9	52	53	51	53
10				51
11				51
12				51
13				50

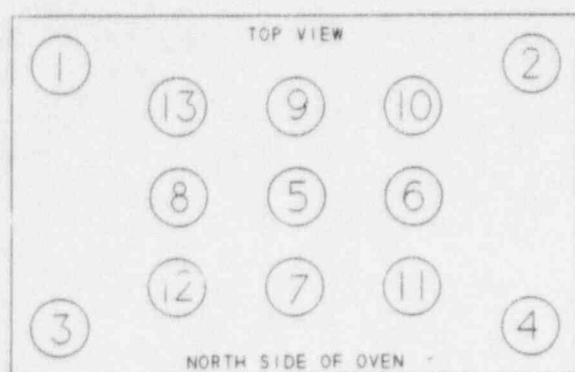
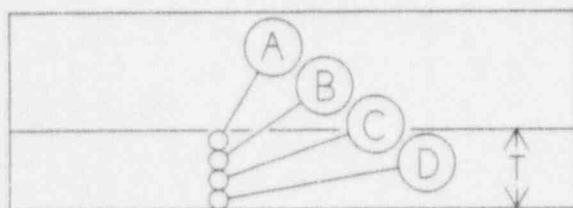
Test ZBG-TEST-16	Product 1-0 X VARIOUS AISI 4140	Weight (pounds) 578
Date 9/16/95	Time @ Temperature (°F) 2 HOURS @1575	Quench POLY

A	B	C	D
1	58	56	54	54
2	55	54	54	55
3	55	53	54	53
4	55	55	53	57
5	55	55	56	54
6	56	54	55	56
7	51	52	51	52
8	55	58	54	57
9	52	56	53	52
10				56
11				61
12				57
13				53

NO HEAT TREATED BOLTS AND 1" DIAMETER X 4" COUPONS WERE PLACED IN THE LOCATIONS SHOWN ABOVE. THE TEST COUPONS WERE IDENTIFIED BY STAINLESS STEEL WIRE WRAPPED AROUND THE SHANK. THE REMAINDER OF THE CHARGE CONSISTED OF HEAT TREATED BOLTS OF THE SAME DIAMETER.

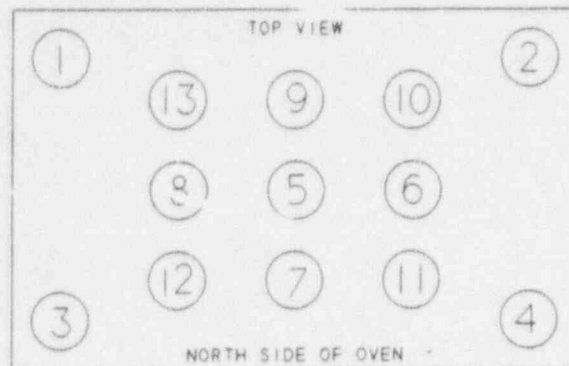
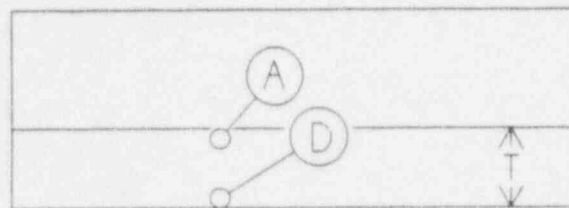
Test ZBG-TEST-17	Product 1 1/2-0 x 5 AISI 4140	Weight (pounds) 516
Date 9/18/95	Time @ Temperature (°F) 1 1/2 HOURS @1575	Quench POLY

A	B	C	D
1	51			54
2	50			51
3	54			52
4	54			51
5	52			52
6	52			53
7	51			54
8	54			52
9	54			54
10				53
11				53
12				53
13				53

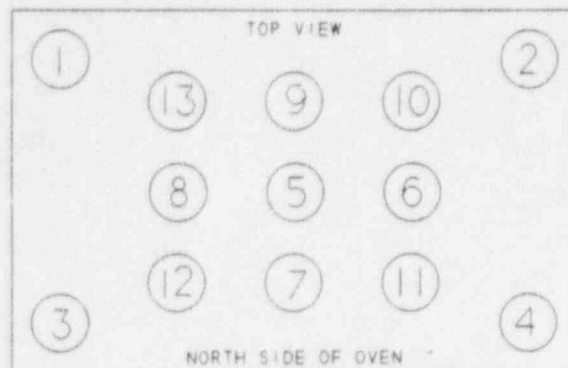
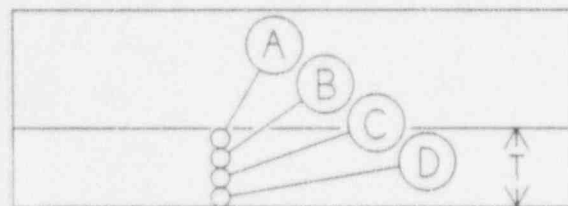
Test ZBG-TEST-20	Product 1-0 X VARIOUS AISI 4140	Weight (pounds) 516
Date 9/19/95	Time @ Temperature (°F) 1 1/2 HOURS @1575	Quench POLY

A	B	C	D
1	57	55	55	55
2	54	56	57	51
3	54	55	55	50
4	55	54	55	54
5	56	56	54	53
6	54	55	55	55
7	54	55	55	53
8	52	54	55	55
9	55	55	55	54
10				55
11				55
12				55
13				56
