JOB NO. 7597-20	ACCESSION NO.
UNIT <u>2</u>	U- <u>406385</u>
TITLE ENVIRONMENTAL QUALIFICATION TEST REPORT OF RAYCHEM NUCLEAR CABLE BREAKOUT AND END SEALING KITS	
JOB: JOSEPH M. FARLEY NUCLEAR PLANT ALABAMA POWER CO.	
Supplier: RAYCHEM CORPORATION  (071508)	F.O. APCO Req. APCO PCN No. (If Applic.) <u>R-87-0-4475</u>

REPORT NO. 58442-2  
OUR JOB NO. NDQ 58442  
CONTRACT ---  
YOUR P. O. NO. A01183

ENVIRONMENTAL QUALIFICATION TEST REPORT  
OF  
RAYCHEM NUCLEAR CABLE BREAKOUT AND END SEALING KITS  
FOR  
RAYCHEM CORPORATION  
MENLO PARK, CALIFORNIA

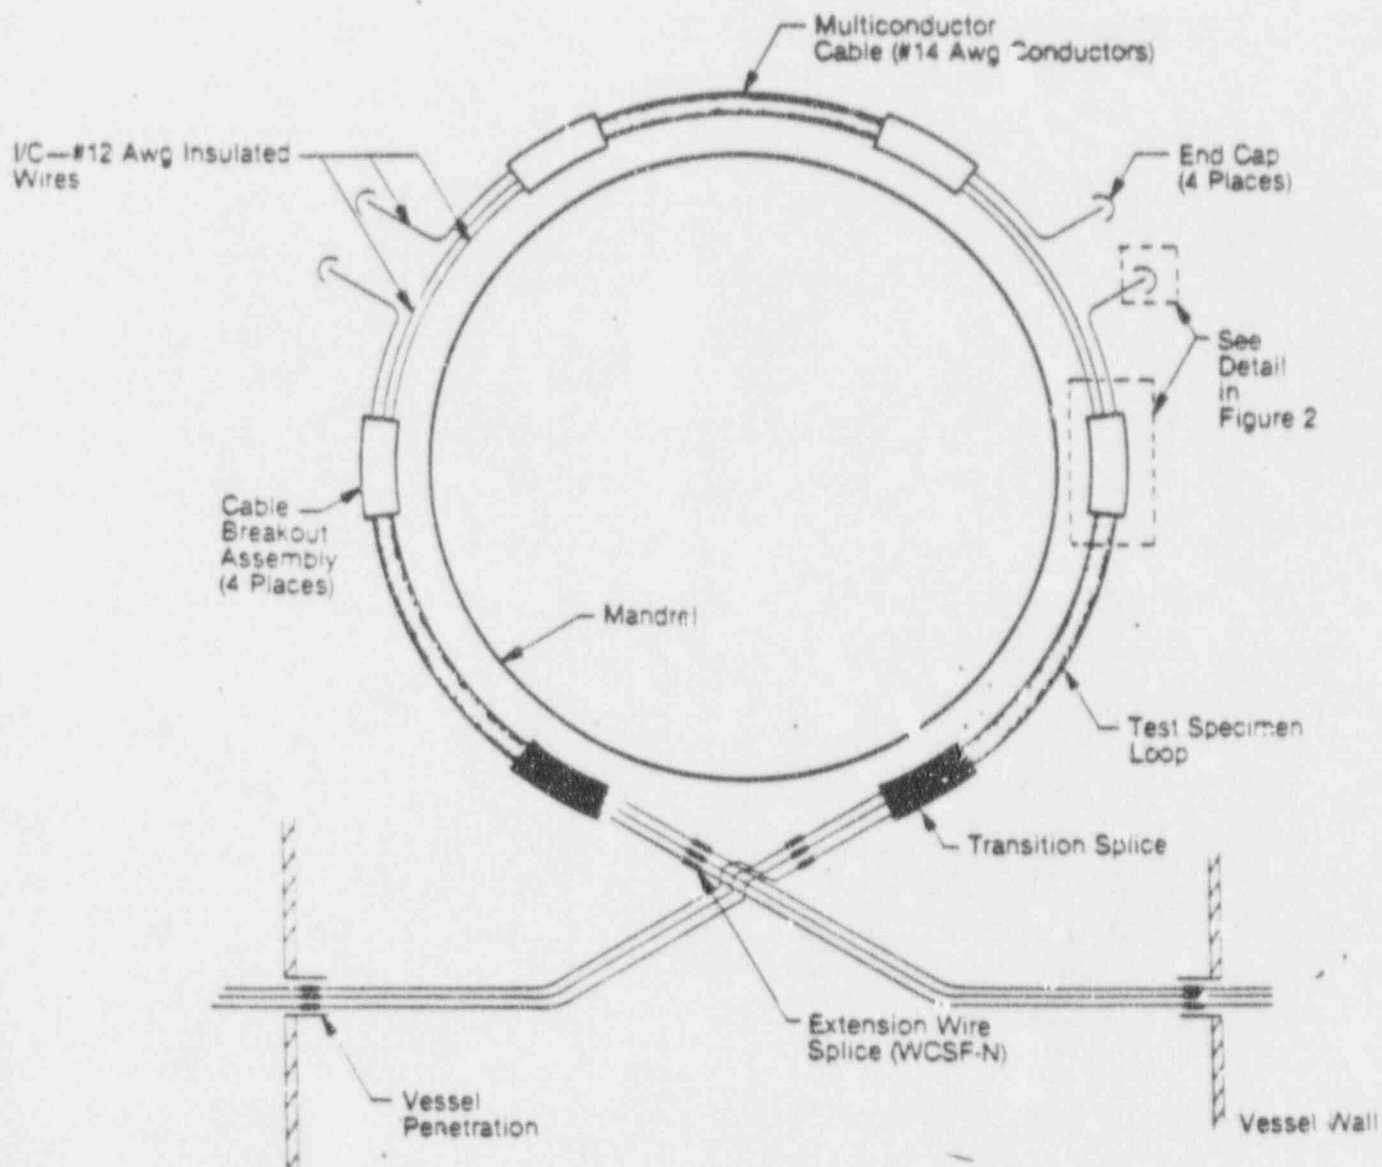
Figure 1 SAMPLE CONSTRUCTION

Each test specimen was comprised of four cable breakouts and four end caps forming a loop as shown in Figure 1. The cable breakouts were tested as part of a transition splice assembly

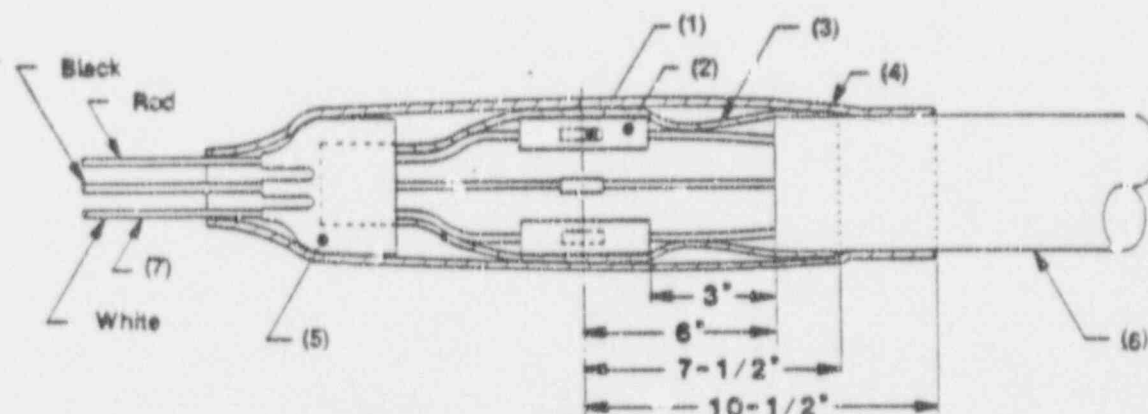
- (1) Raychem Crimp Connector, D609-1
- (2) Raychem WCSF-N, Insulating Sleeve, Size 115, 6 inches, S-1119 Adhesive
- (3) Raychem WCSF-N, Insulating Sleeve, Size 300, 15 inches, S-1119 Adhesive
- (4) Raychem WCSF-N, Insulating Sleeve, Size 300, 21 inches, uncoated
- (5) Raychem 403A112-52, Cable Breakout S-1119 Adhesive
- (6) Rockbestos Firewall III Insulated Cable, 5/C, 14 Awg, XLPE Insulation and Jacket
- (7) Rockbestos Firewall III Insulated Wire, 1/C, 12 Awg, .030 inch XLPE Insulation

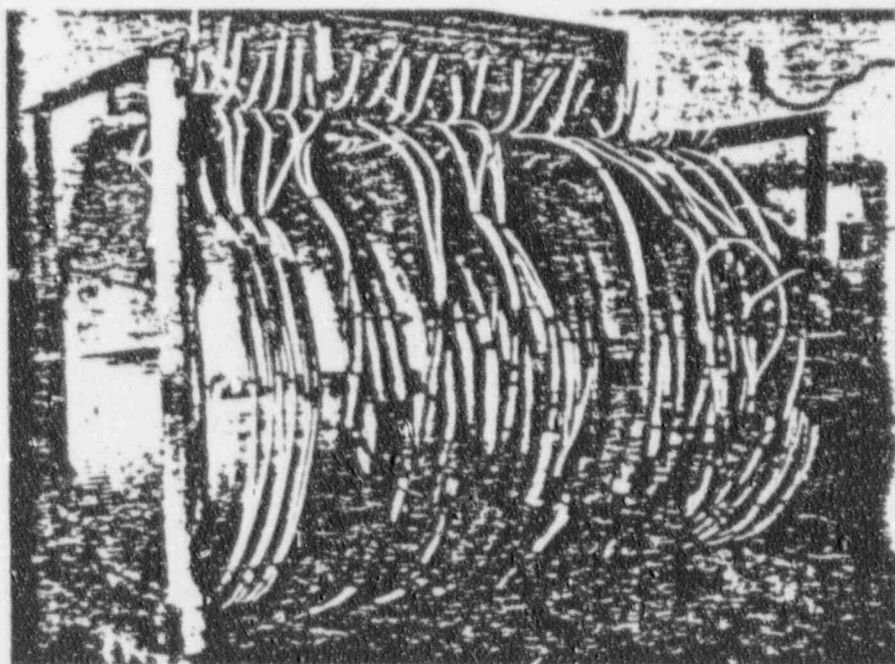
FIGURE 3. Mandrel and Samples

(Specimens 2-1 through 2-6 are located in the center section of the mandrel.)

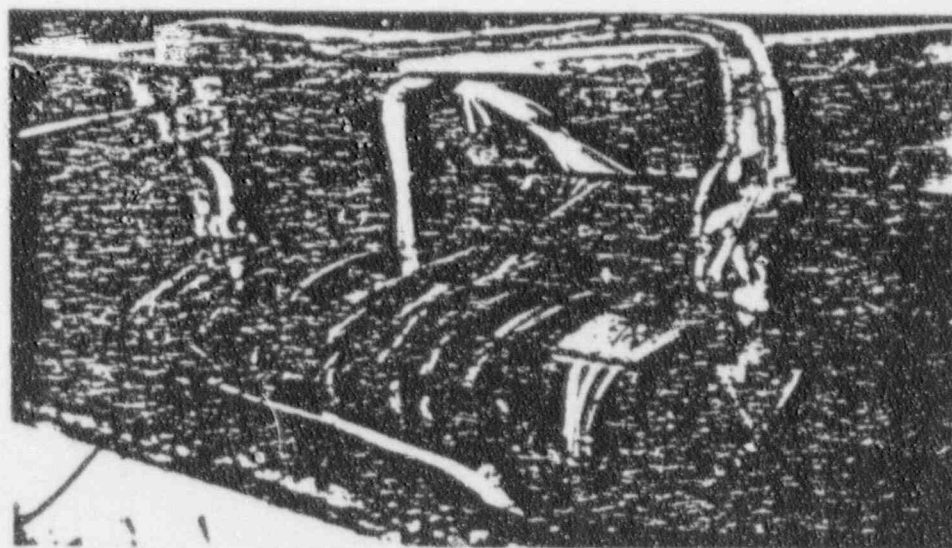
FIGURE 4. Mandrel and Samples Immersed in Water

The mandrel with the specimens in place was immersed in water for functional tests as described in 3.1.1. This was accomplished by splicing long extension leads to each end of the test loops. The splices between the specimens and the extension leads were covered with WCSF-N heat shrinkable tubing. The mandrel in the water is shown in Figure 4.

All specimens again passed the 3.6kV a-c voltage withstand test for five minutes. The insulation resistance values are given in Table 1 on page 14.

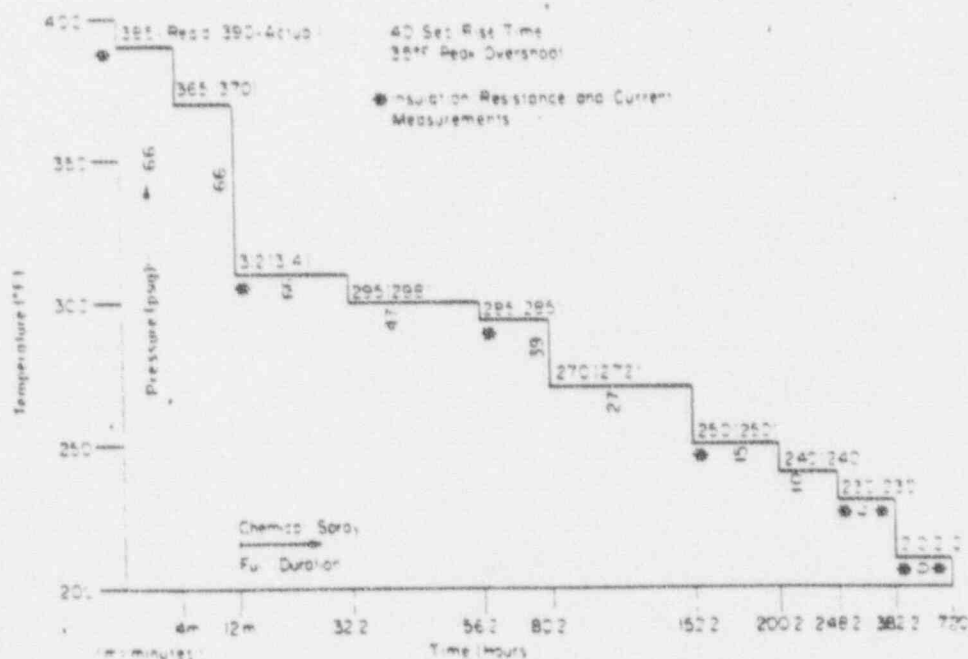
Figure 5. Temperature/Pressure Profile for Simulation of LOCA/MSLB Environment

The specimens on the mandrel were placed in a test chamber capable of exposing the specimens to the steam and chemical spray environment shown in Figure 5.

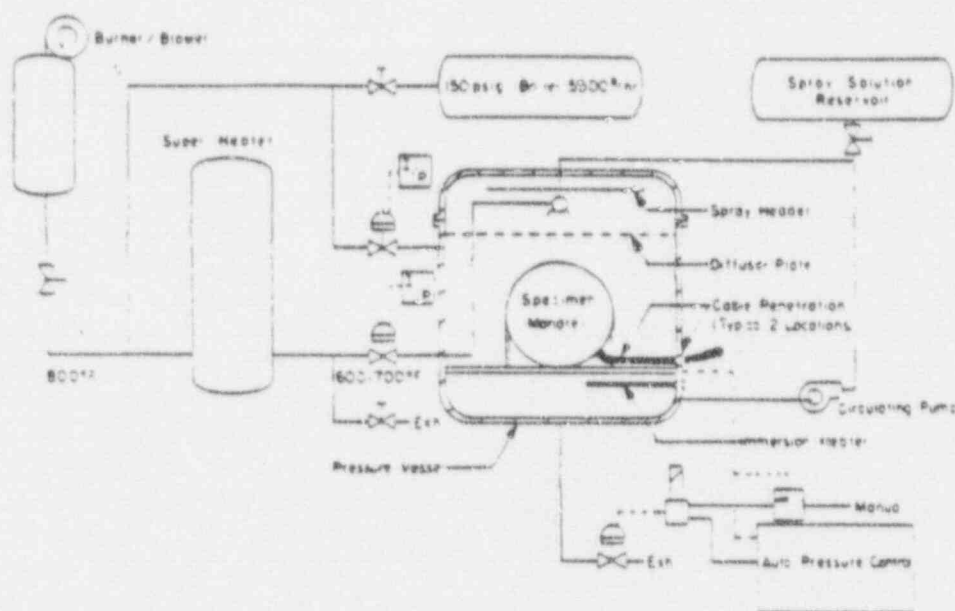
FIGURE 6. LOCA/MSLB Pressure Vessel and Auxiliary Equipment

Fuses were installed in the voltage circuit for each specimen so that during the exposure a breakdown in the insulation of one specimen would not affect the voltage applied to the others. Schematics of the test chamber and energizing circuit are given in Figures 6 and 7 respectively. All data acquisition instruments used in the test program are listed in Appendix B.

The extension wires were cut inside the vessel so that the mandrel could be removed. This also allowed the test vessel penetrations to be inspected. It was found that some of the wires in the penetration had a low insulation resistance and would not pass the 3.6kV a-c voltage withstand test. The specimens associated with the penetration wires having a low insulation resistance were retested immersed in water (see Figure 4). The retest of specimens 2-1R, 2-2B, and 2-5W2 showed high values of insulation resistance and all specimens passed the voltage withstand test. The low values previously measured on these specimens can therefore be attributed to the test vessel penetrations and not the specimens.
