RESOLUTION OF HIGH GROUND WATER LEVELS AT
GRAND GULF NUCLEAR STATION

Prepared for
Entergy Operations NPE
April 1992

Bechtel Corporation
Gaithersburg, Maryland

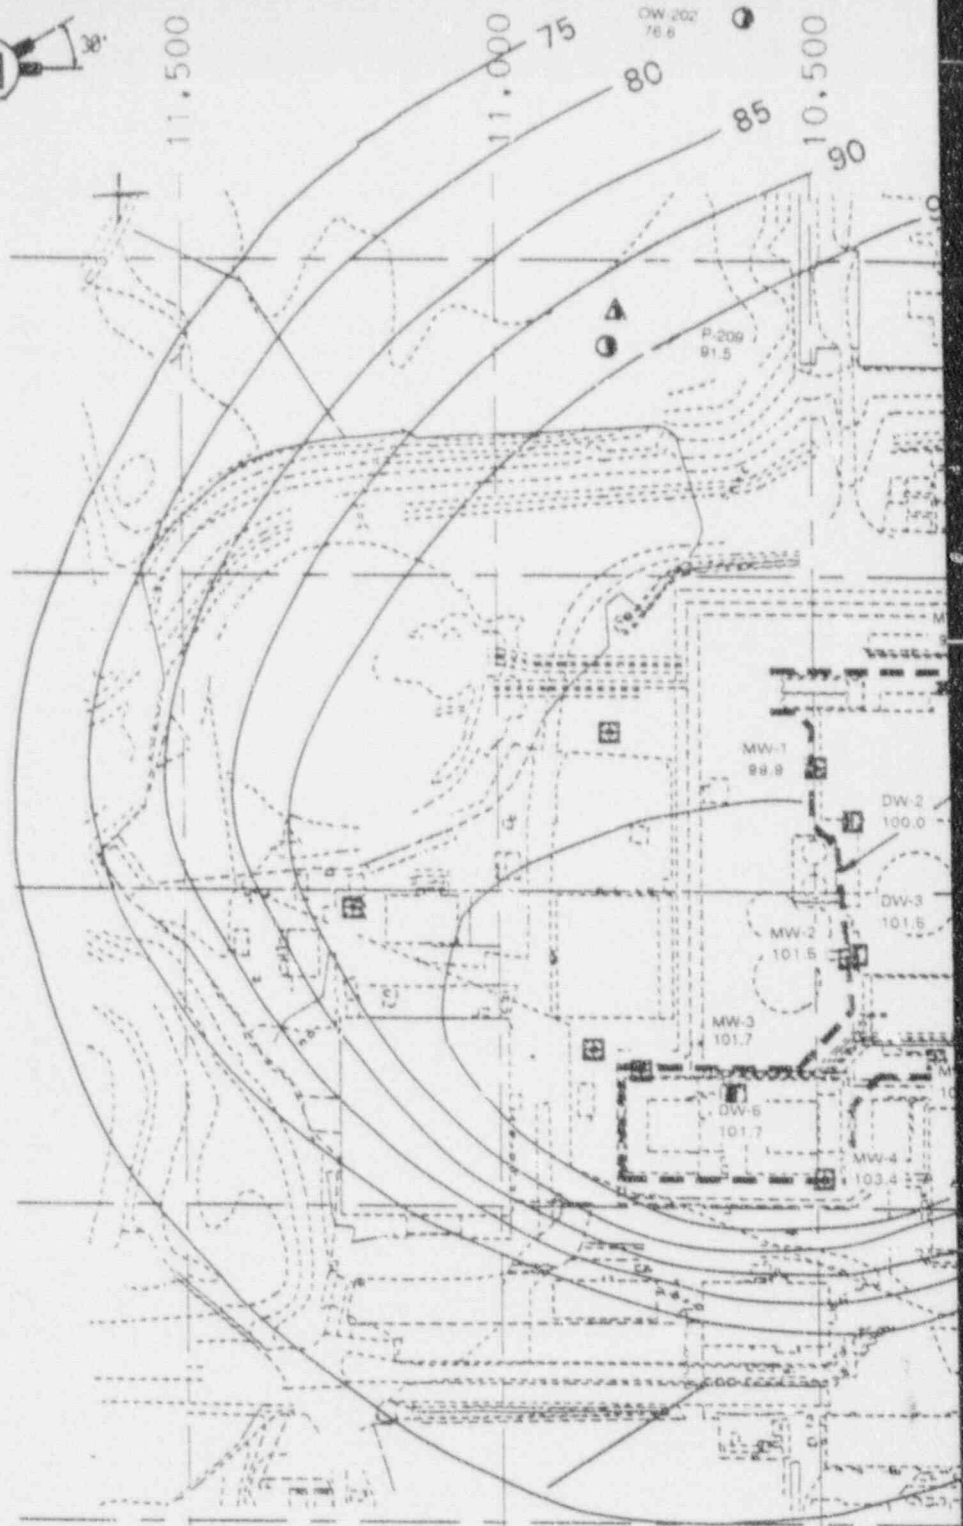
Figure 2 - Average Post-Construction Ground Water Elevations

- The average post-construction ground water level contour map is attached as Figure 2. The map will be incorporated into the UFSAR.
- Sufficient precipitation, ground water level, and hydrogeologic data exist to predict the maximum expected site ground water level based on current plant conditions excluding the effect of leakage from the cooling tower. The maximum expected post-construction ground water level in the power block area is estimated to be El. 113 ft.
