BRUNSWICK STEAM ELECTRIC PLANT, UNIT 2
NRC DOCKET NO. 50-324
OPERATING LICENSE NO. DPR-62
NUREG-0619 FEEDWATER NOZZLE AND SPARGER EXAMINATION RESULTS

FEEDWATER SPARGER
CIRCUMFERENTIAL CRACKING EVALUATION
FOR BRUNSWICK UNITS 1 AND 2
General Electric Report GE-NE-523-112-1191
November 1981

FEEDWATER SPARGER
CIRCUMFERENTIAL CRACKING
EVALUATION FOR
BRUNSWICK UNITS 1 AND 2

BRUNSWICK STEAM ELECTRIC PLANT UNIT 2
NINETH REFUELING OUTAGE - OCTOBER, 1991
INVESSEL VISUAL INSPECTION (IVVI)
INSPECTION REPORT AND VIDEO REVIEW

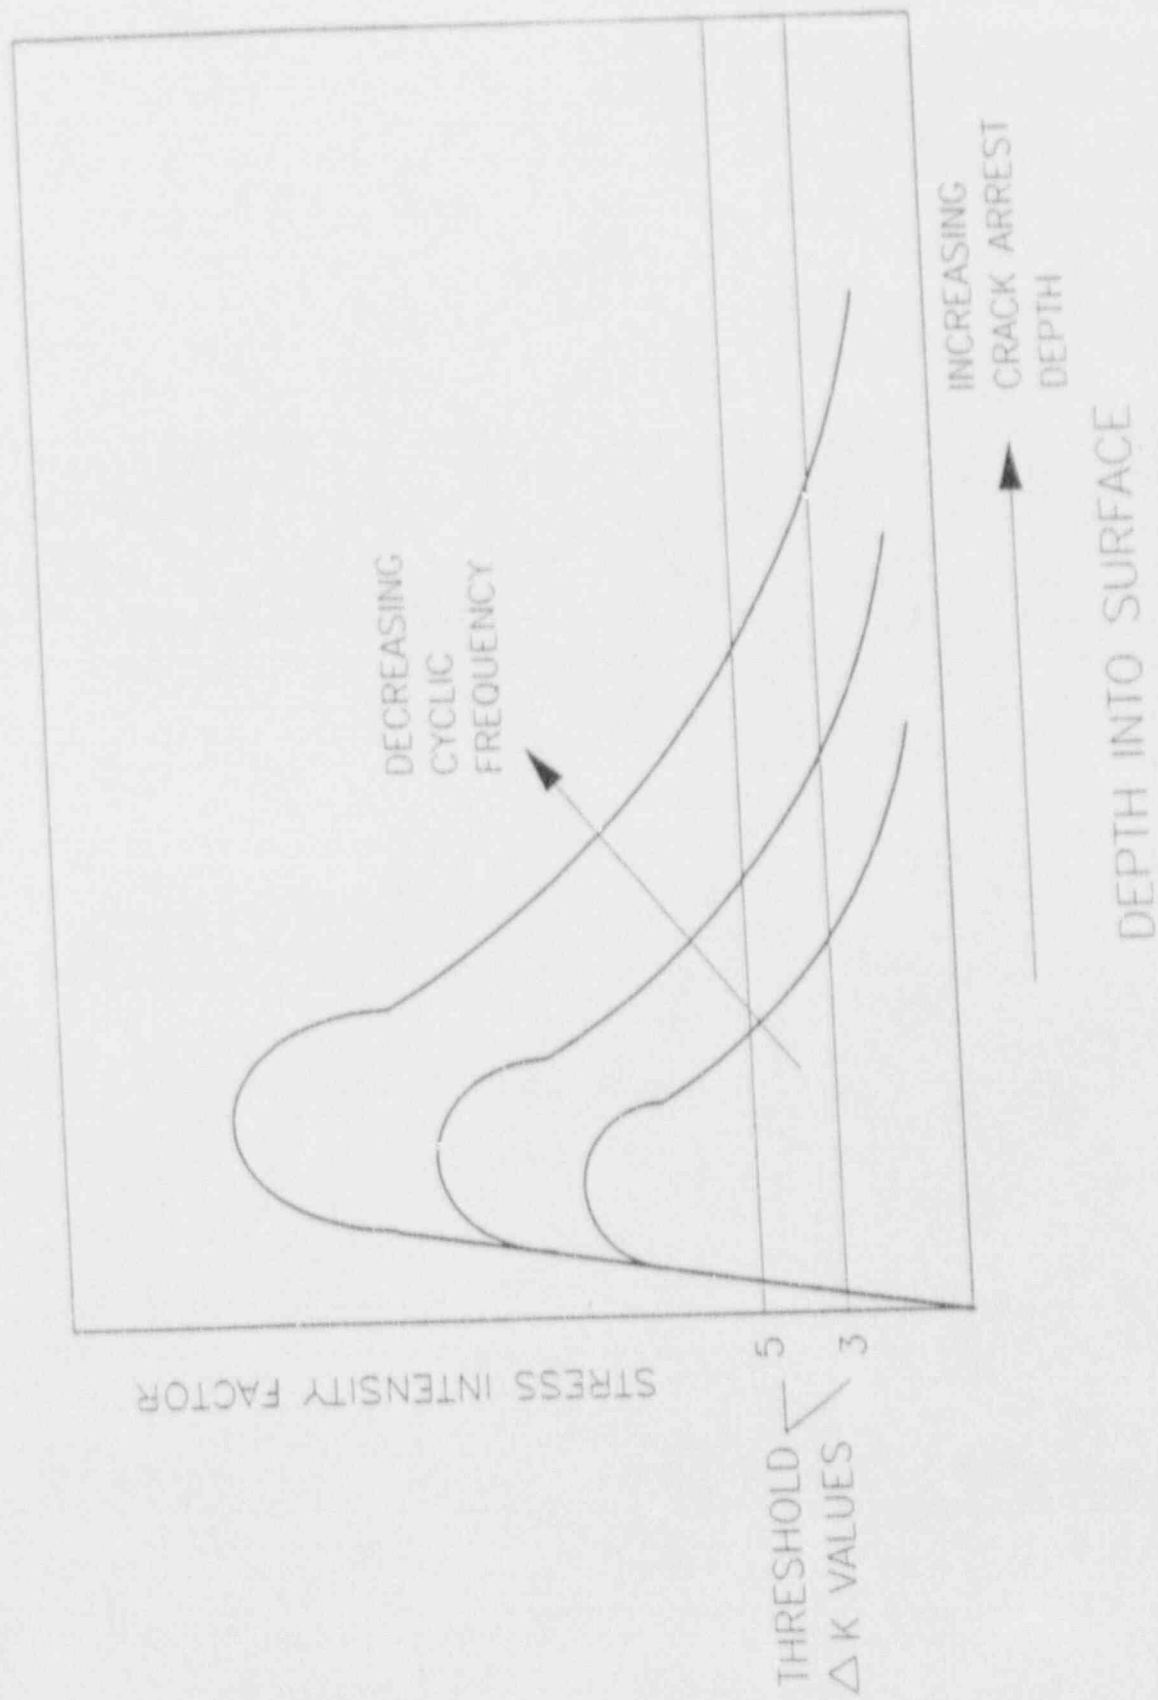
Figure 4-1. Schematic of Frequency Dependency on Crack Arrest Depth

Extensive testing and analysis of the thermal sleeve leakage rapid cycling was conducted in the process of designing the triple thermal sleeve. Among the analyses done was an evaluation of the expected crack growth in the blend radius due to rapid cycling [4]. The results showed that ΔK values associated with the rapid thermal cycling drop as a crack proceeds into the nozzle until the crack arrest ΔK threshold of 3 ksi- $\sqrt{\text{in}}$ (for high R-ratios) is reached. The depth of the arrested crack is a function of the frequency of the cycling, as shown in Figure 4-1.

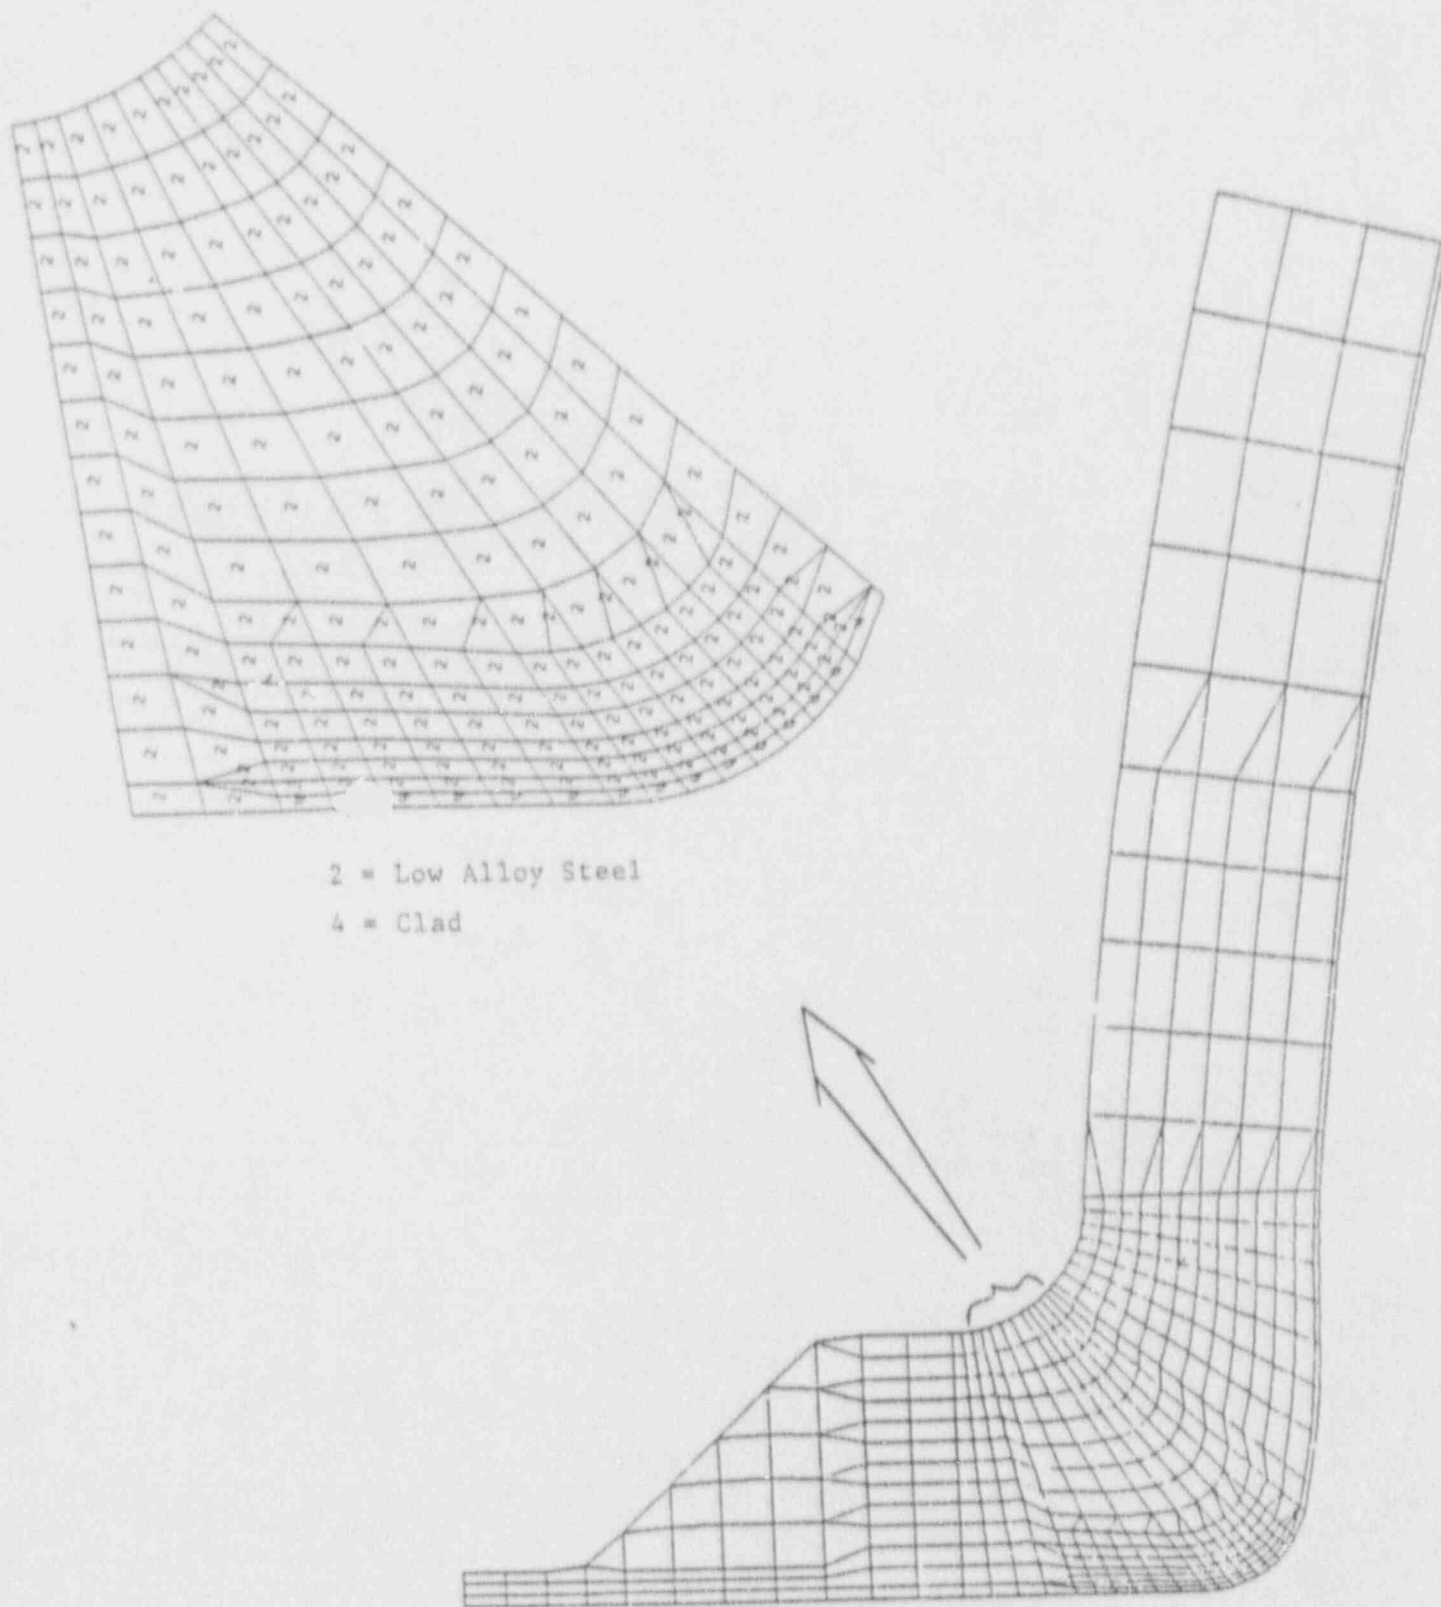
Figure 4-2. ANSYS Model of Feedwater Nozzle Blend Radius

The feedwater nozzle blend radius was modeled, as shown in Figure 4-2, for finite element analysis by ANSYS. The model was subjected to cycles of 130°F step changes between 550°F and 420°F at varying frequencies, and thermal and stress computations were performed. The ANSYS results were used with the ΔK relationship from [4]:

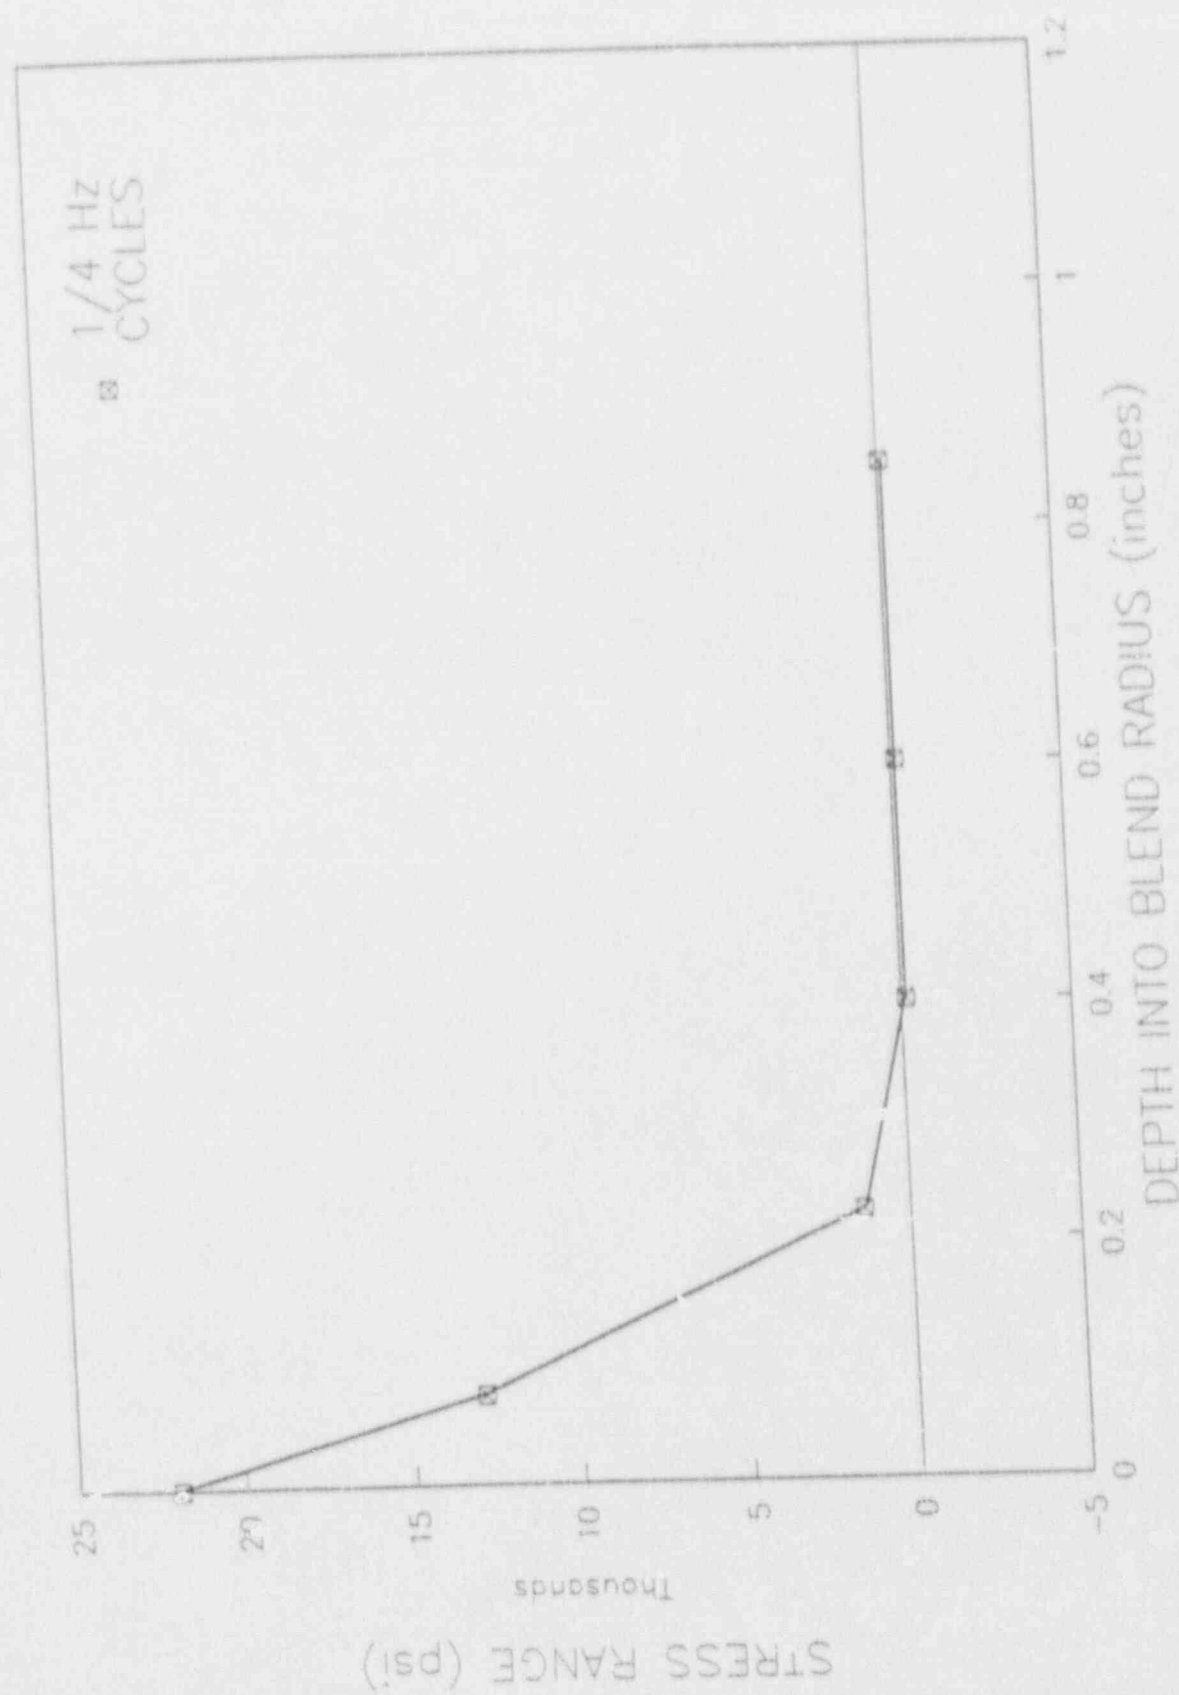
Figure 4-3. Stress Range Profile for Cyclic Leakage on Nozzle

Stress range and ΔK profiles were developed for frequencies of 1/8, 1/4 and 1/3 Hz. The 1/4 Hz case was found to come closest to meeting the benchmark condition of 5 ksi- $\sqrt{\text{in}}$ at 0.5 inches. The stress range profile is shown in Figure 4-3. The stress range profile was fit with a cubic polynomial, and then the coefficients were adjusted slightly until the benchmark conditions were met. The resulting ΔK vs. depth plot is shown in Figure 4-4. The curve extends to the high mean stress threshold of 3 ksi- $\sqrt{\text{in}}$ at a depth of 0.85 inches. Therefore, rapid cycling behavior which causes a crack of 0.5 inches at the flow holes is predicted to cause a crack of 0.85 inches in the blend radius.
