ENGINE REBUILD REPORT

Motor Vessel Columbia

State of Alaska
Division of Marine Transportation
Department of Public Works

March 31, 1981

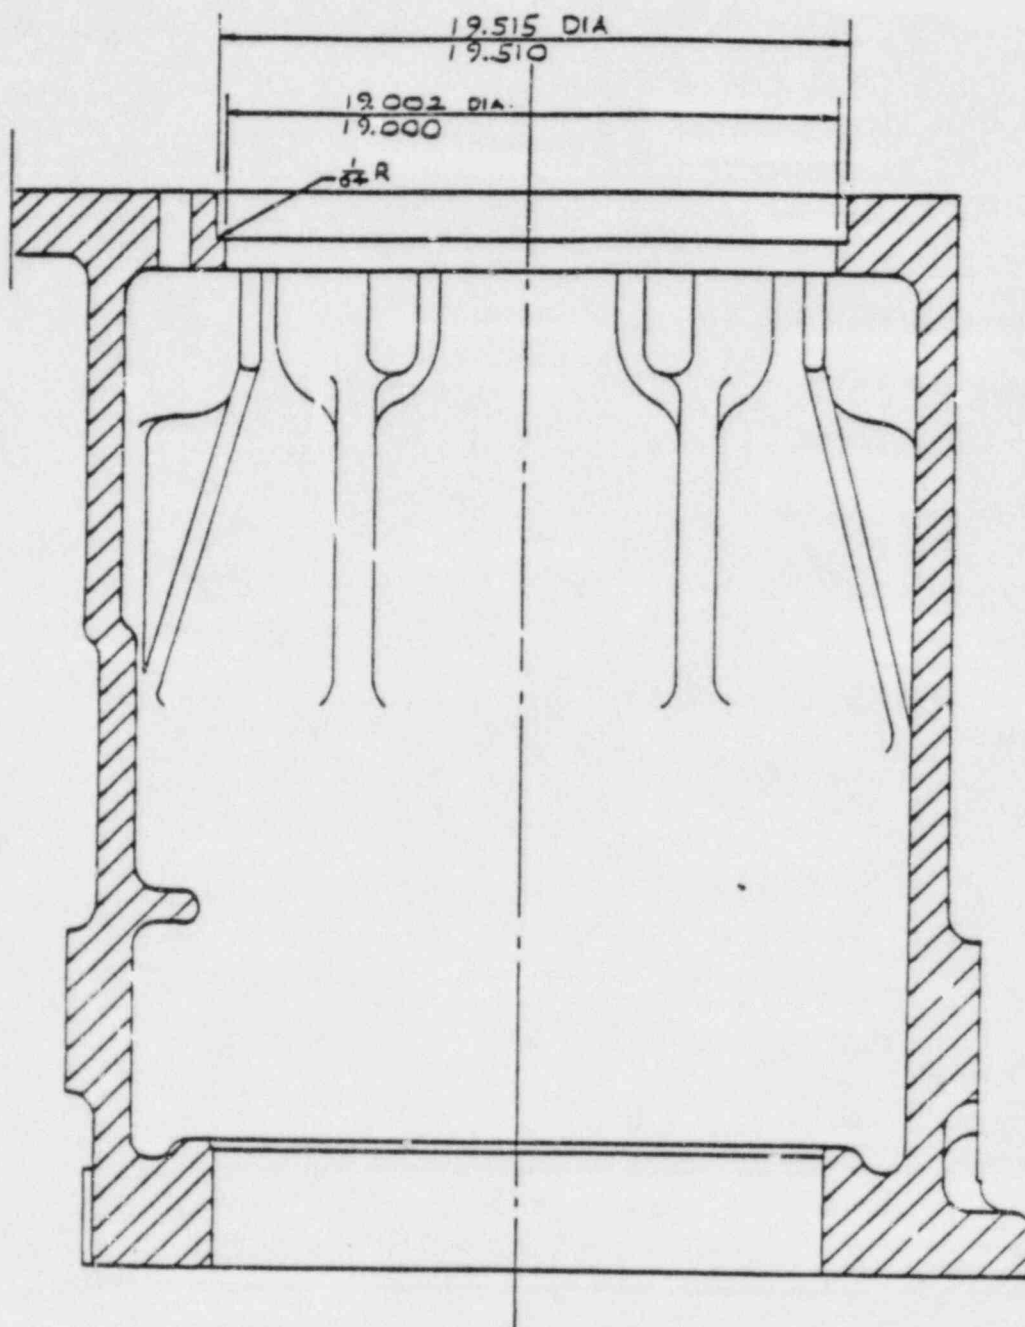
Figure 1. Cylinder Configuration, Engine Block

The firing surface of the block and bore and counterbore dimensions are shown in Figure 1 (p. I-6). The corresponding dimensions for the cylinder liners are shown in Figure 2 (p. I-7). Measurements of the diameter of the bore of the blocks were taken at perpendicular directions to show the degree to which the openings had deformed, symmetrically and non-symmetrically. These values are plotted in Figure 3 (p. I-8) for both main engines.

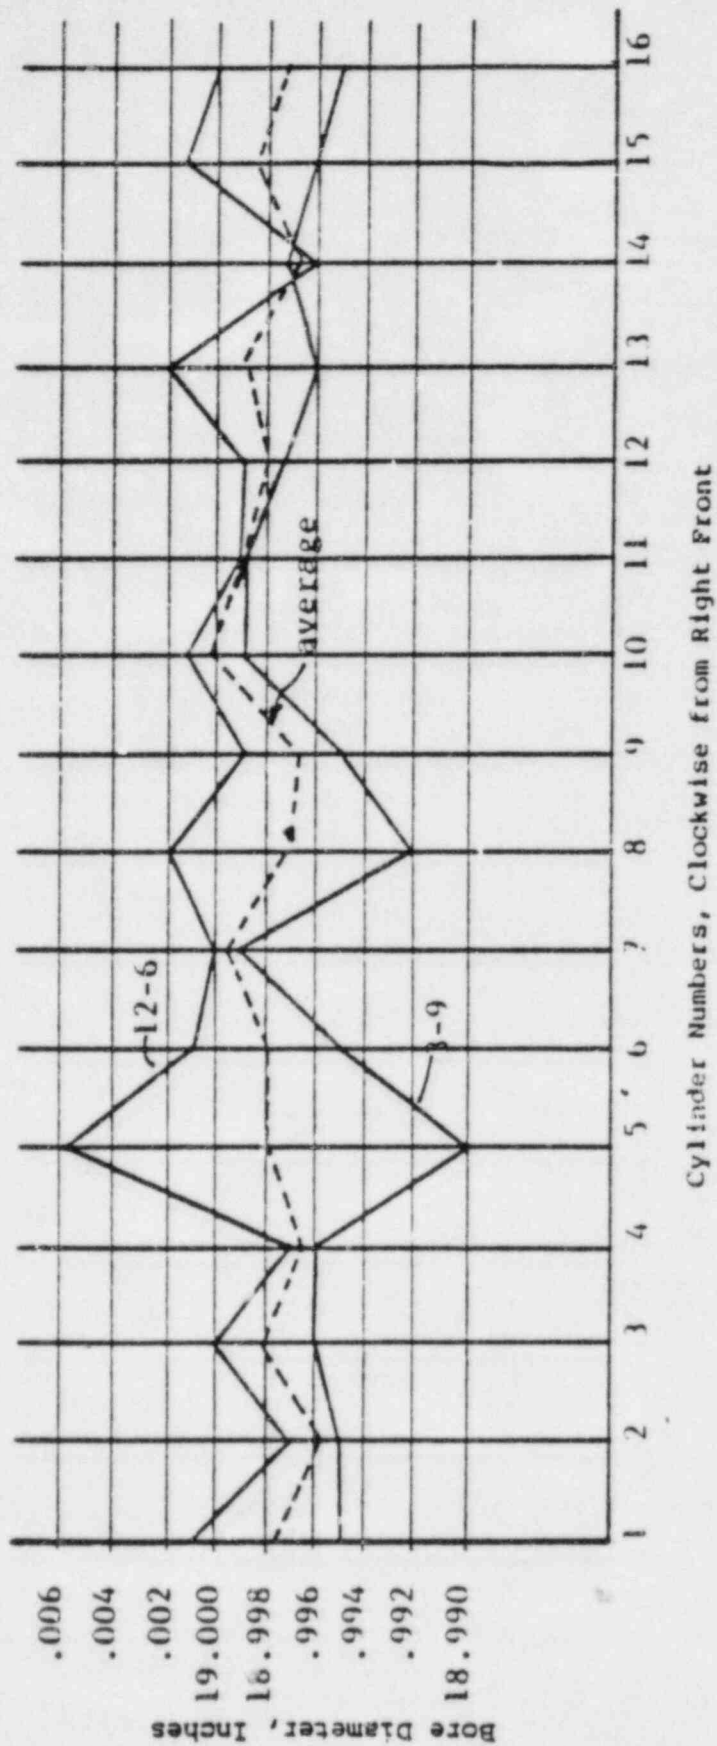
Figure 8. Permanent Liner Deformation, Bore Diameter
Starboard Main Engine

Because of deformation of the blocks, the cylinder liners, which must mate with the block for proper function, required examination. These liners were measured at the same time as the blocks and their dimensions are shown in Tables 1, 2, 3 and 4 (pp. I-2 to I-5). Bore diameters for the starboard and port main engines are shown in Figures 8 and 11 (pp. II-2 and II-5). The diameter changes indicating ovalness of the cylinder liners are less dramatic than those for the block and may not be overly significant. But the liners may not have been in the block in the same cylinder for the lifetime of the engine. Because deformation of the liners had to follow that of the block, the effects of permanent deformation were less. The liner and the blocks are probably of different material specifications and the liner material may not be as subject to creep as is the block. 5

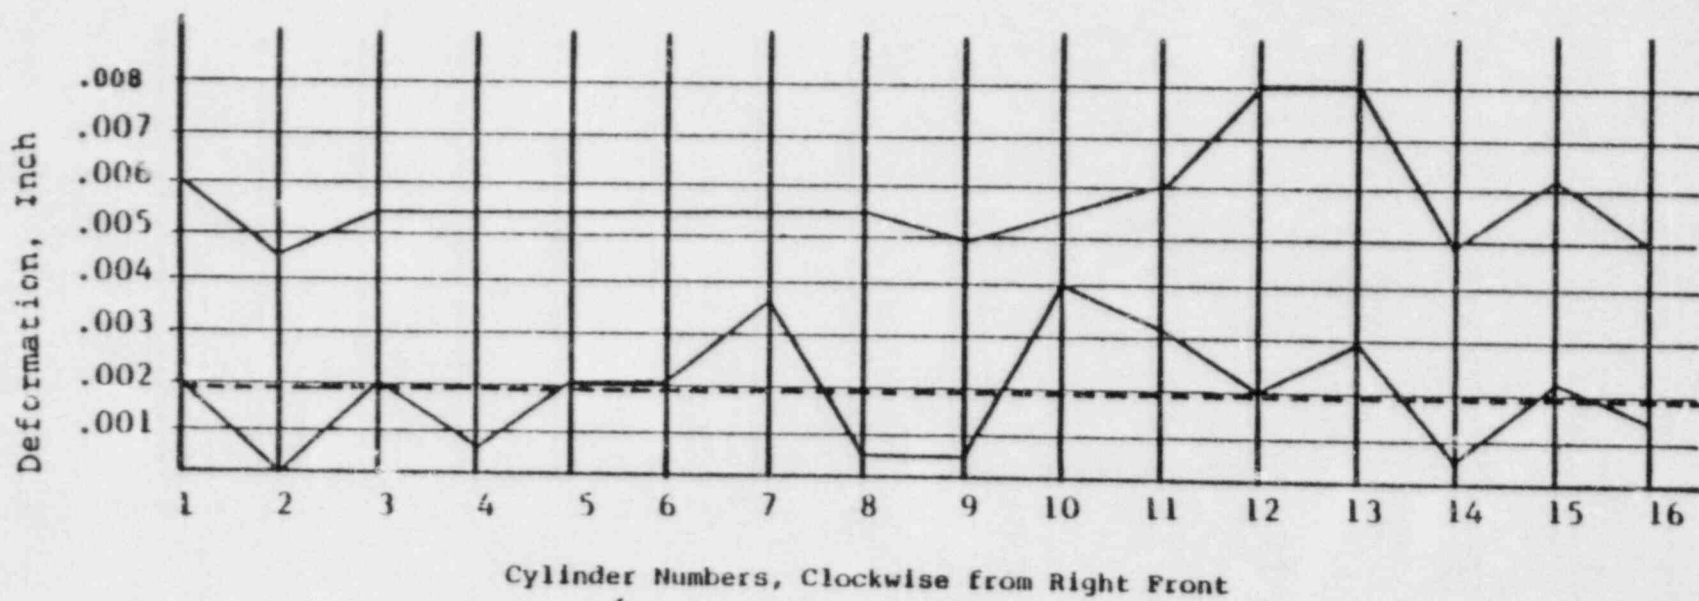
Figure 10. Average Difference Between the Block and the Liner Bore Diameter,
Starboard Main Engine

A comparison of the difference in deformation of the blocks and that of the cylinder liners is shown for the starboard engine in Figures 9 and 10 (pp. II-3 and II-4). Figure 9 shows the average deformation of the block and the liners for each cylinder. Figure 10 shows that the design clearance of .005 inch had increased to a clearance of .009 inch. This difference explains why the liners were easier to remove than when they were new.

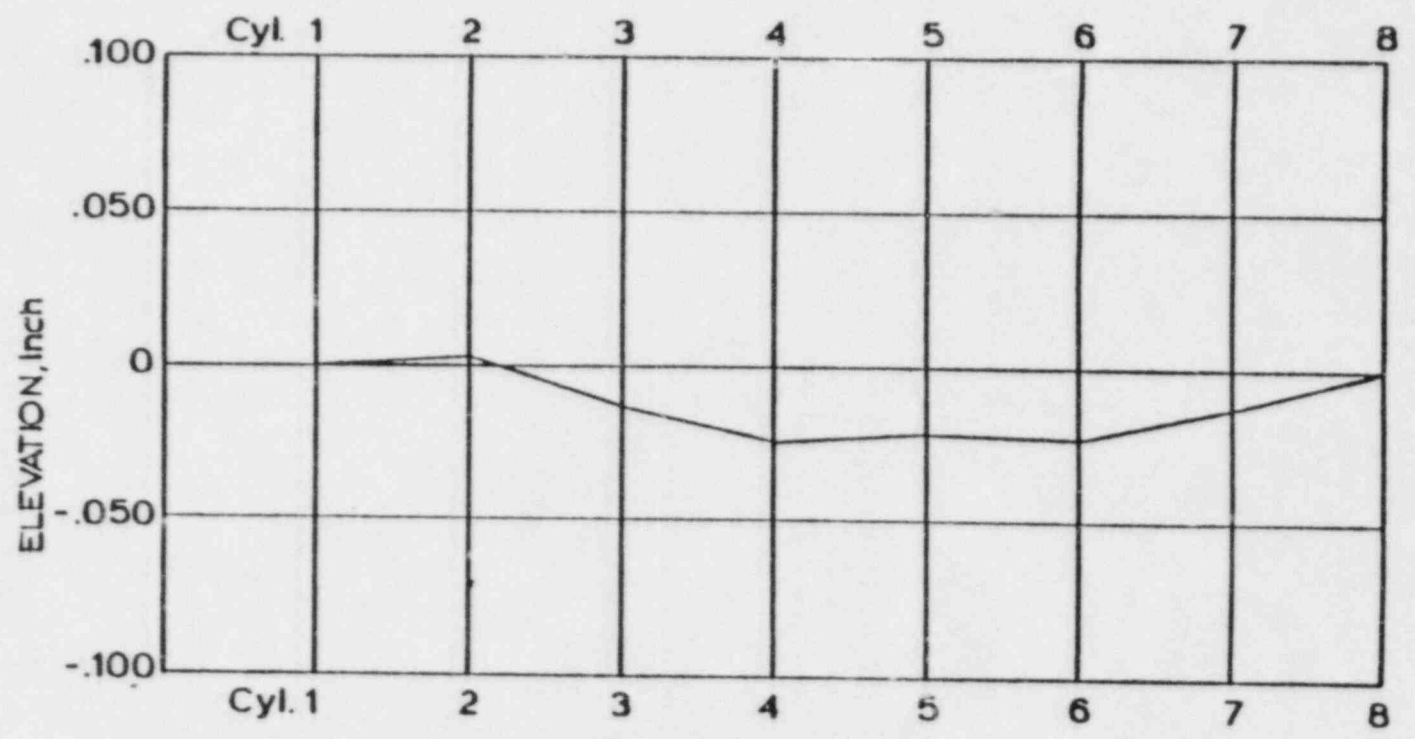
Figure 16. Elevation of the Air Side of the Cylinder Block for the Right Bank, Port Main Engine

Figures 16 and 17 (pp. V-2 and V-3) show a sag in the middle of the engine from front to rear of .030 inch. Cylinder 4 shows a slight warping where the exhaust or top of the block is .020 inch below the bottom side. All other cylinders follow a uniform trend. Warping was a concern in setting up equipment to refinish the bore and counterbore surfaces.

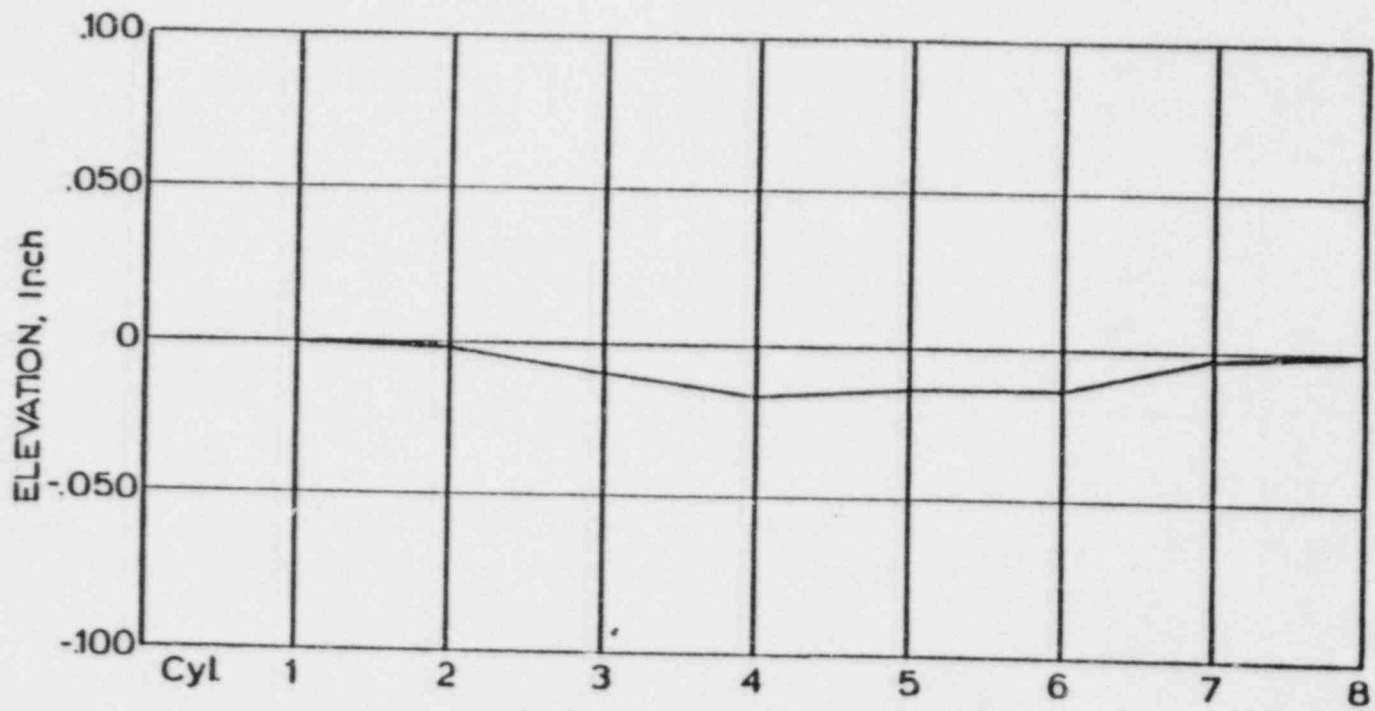
Figure 20. Elevation of the Air Side of the Cylinder Block for the Right Bank, Starboard Main Engine

Figures 20 and 21 (pp. V-6 and V-7) show a sag in the center of the engine and a slight twist with the block dropping on the exhaust side.

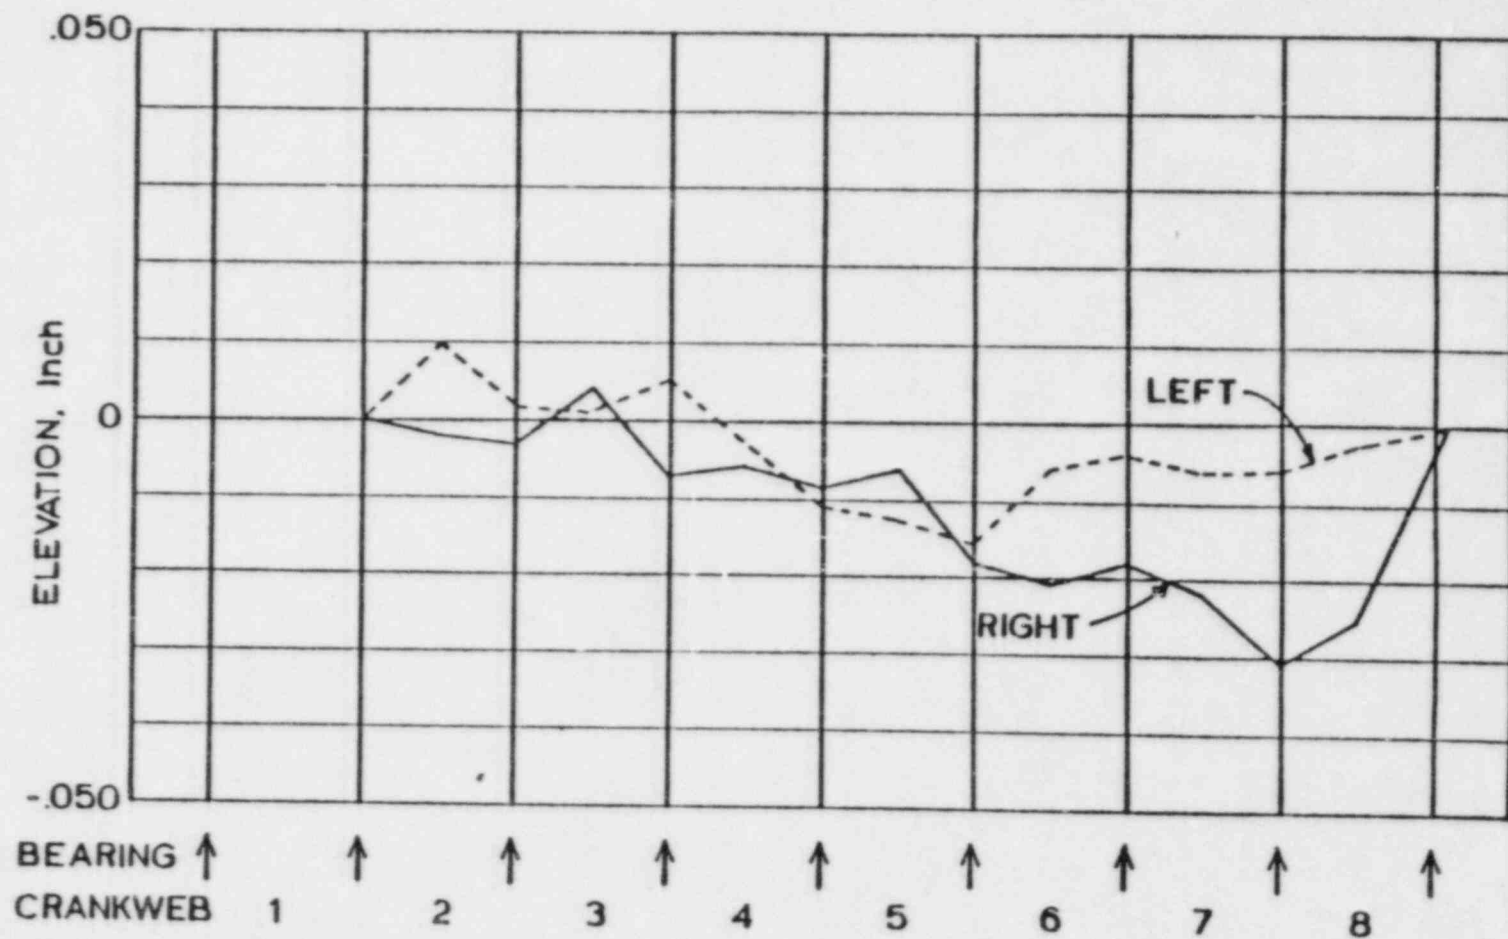
Figure 24. Elevation of the Subbase of the Port Main Engine

Optical sighting of the base of the port engine produced the data in Figure 24 (p. V-11). It shows the elevation of the engine from front to rear for the right and left sides of the engine. The front half of the engine was flat with some variation, but nothing over .010 inch. The rear of the engine showed a dramatic difference between the right and left sides. The left side returns to its zero point in a gradual fashion while the right side continues to drop to nearly .030 inch between cylinders 7 and 8. The dropping of the base explains variations in crankshaft deflection data.

Comparison between crankshaft deflection data (Figures 25, 26 and 27 and subbase elevation data (Figure 24) indicates the rear of the engine is out of alignment. The engines should be aligned before putting them back in service.

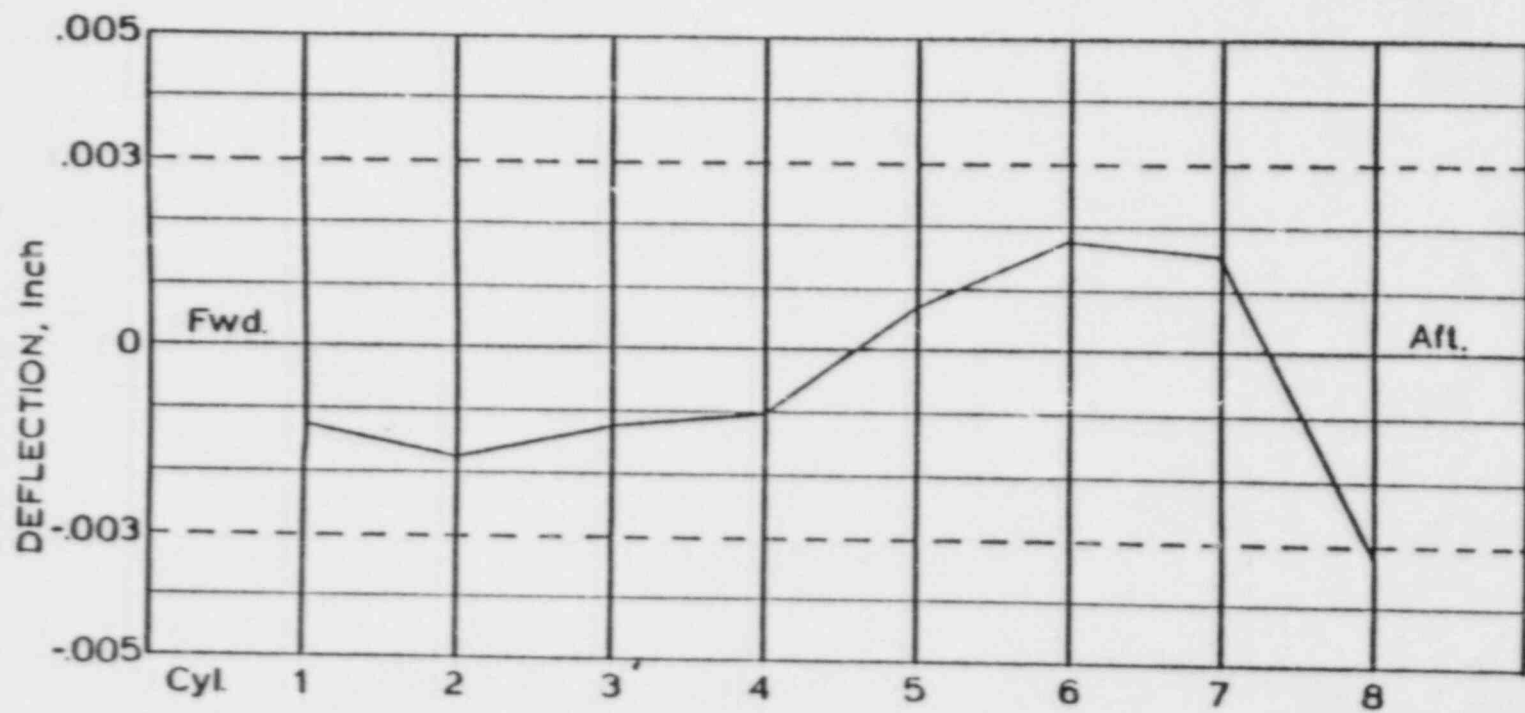
Figure 25. Crank Deflection of the Port Main Engine, Hot

Figure 25 shows historical data when the engine was hot and Figure 26 during rebuilding when the engine was cold. Deflection tolerance of .003 inch is allowed. The forward end of the engine, although changing sign (+ or -), is within acceptable limits. The aft end of the engine, however, is outside acceptable limits in both hot and cold conditions. Figure 27 shows the comparison between hot and cold. The front end of the engine is within acceptable limits. At the rear, both readings are similar and thermal changes do not alter the out-of-tolerance readings. Cold readings at the rear of the engine accurately represent hot reading for operating conditions.
