DESIGN REVIEW OF TDI R-4 AND RV-4 SERIES  
EMERGENCY DIESEL GENERATOR CYLINDER BLOCKS AND LINERS

Prepared by  
Failure Analysis Associates  
Palo Alto, California

TDI Diesel Generator Owners Group

June 1984

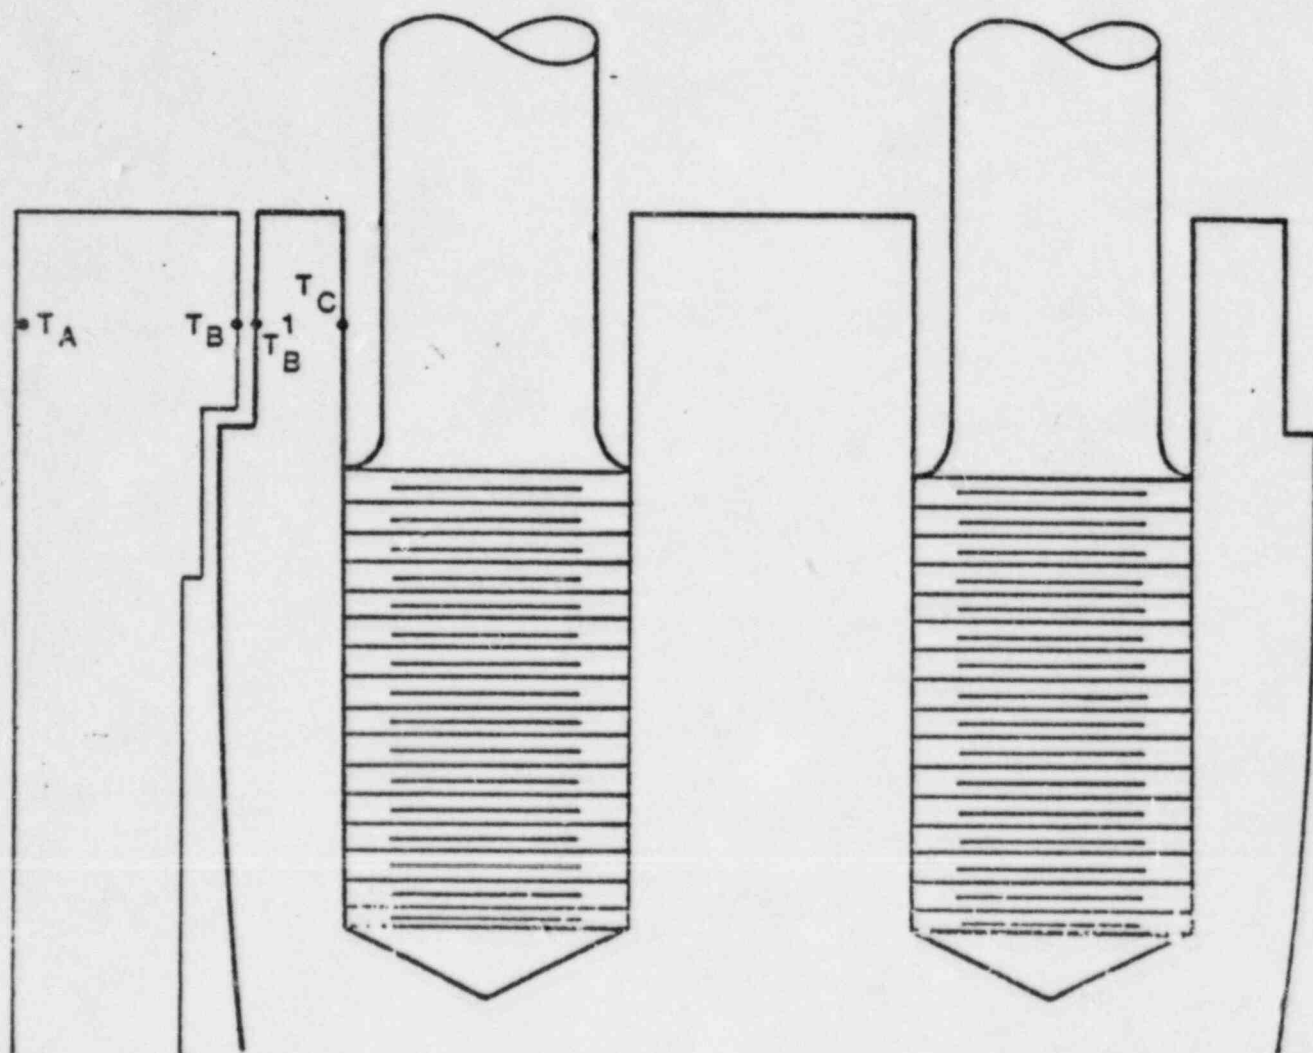
Figure 2-1. Location of  $T_A$ ,  $T_B$ ,  $T_B^1$ ,  $T_C$ .

The liner and block top have a thermal gradient from the cylinder bore to the centerline between adjacent cylinders, such that  $T_A > T_B > T_B^1 > T_C$  in Figure 2-1. The liner and block both expand radially from the cylinder centerline as the temperatures rise, creating thermal stresses. Because of the thermal gradient, the liner expands more than the block, closing the liner-to-block clearance gap and adding interference stresses. The combined effect is a radial stress in the block top that is resisted by circumferential tension. The effect of the stud holes is to make the stresses non-uniform in the circumferential direction, with circumferential tension near the stud holes and compression midway between adjacent stud holes for the same cylinder.

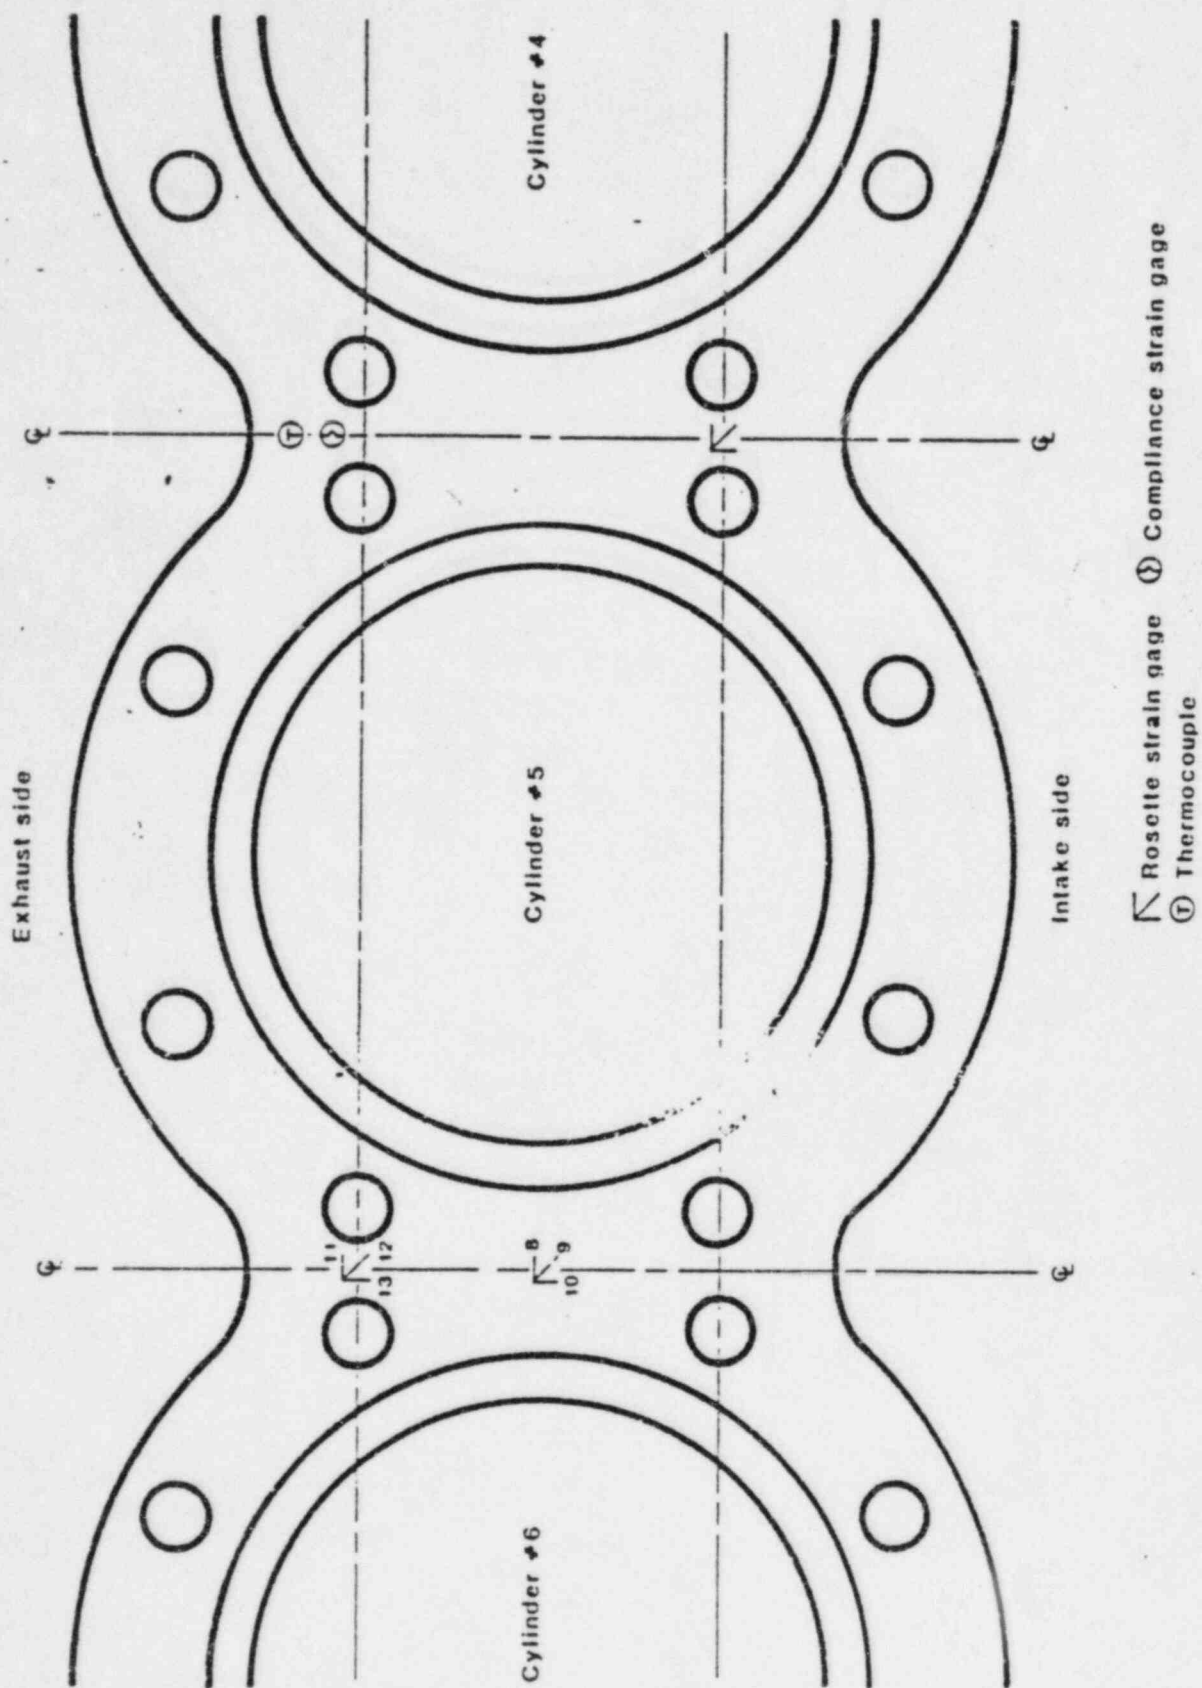
Figure 3-1. Strain gage placement.

After the 100 hour full power endurance test run on SNPS DG103, a cylinder block strain gage test was conducted by FaAA. The test included strain measurements at three locations: midway between Cylinder Nos. 5 and 6, on the centerline between the adjacent exhaust side cylinder head studs; between Cylinder Nos. 5 and 6 at the intersection of the longitudinal and transverse centerlines between the cylinders; and at Cylinder No. 1 between the No. 3 cylinder stud and the edge of the engine. The location and nomenclature for the three gages are shown on Figures 3-1 and 3-2.

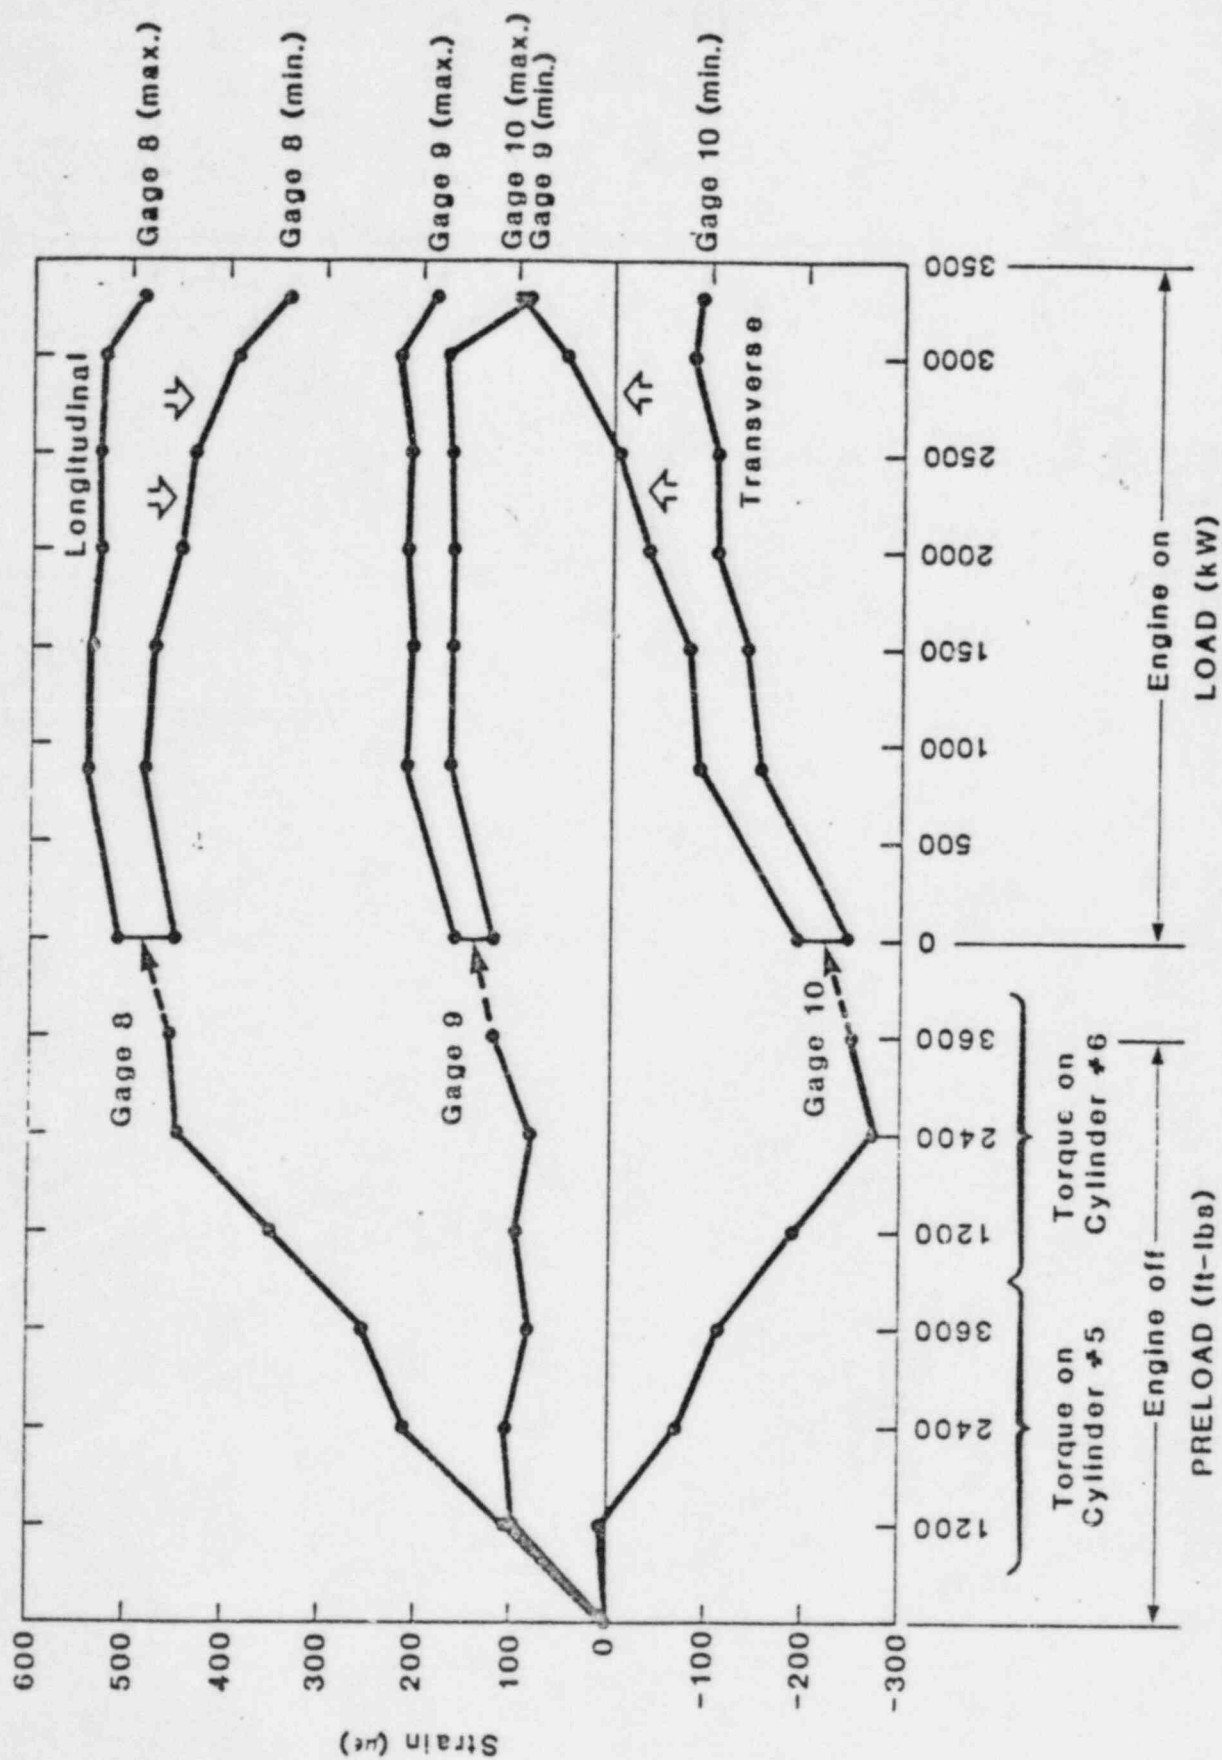
Figure 3-3. Strain vs. Load for Gages 8, 9 and 10 (located on engine centerline).

Figures 3-3 and 3-4 depict the strain components for each gage during preload and operation. The band of data at operational loads depicts the range of the signal from each gage in the rosette for Gage Nos. 8 through 13. The arrows represent the direction of the strain during firing. This data was reduced to principal stresses as shown in Figures 3-5 and 3-6 for Gage Nos. 8 through 13. The maximum principal stresses were approximately parallel to Gage Nos. 8 and 13. The key stresses for stud-to-stud crack initiation and propagation are those measured by Gage No. 13.

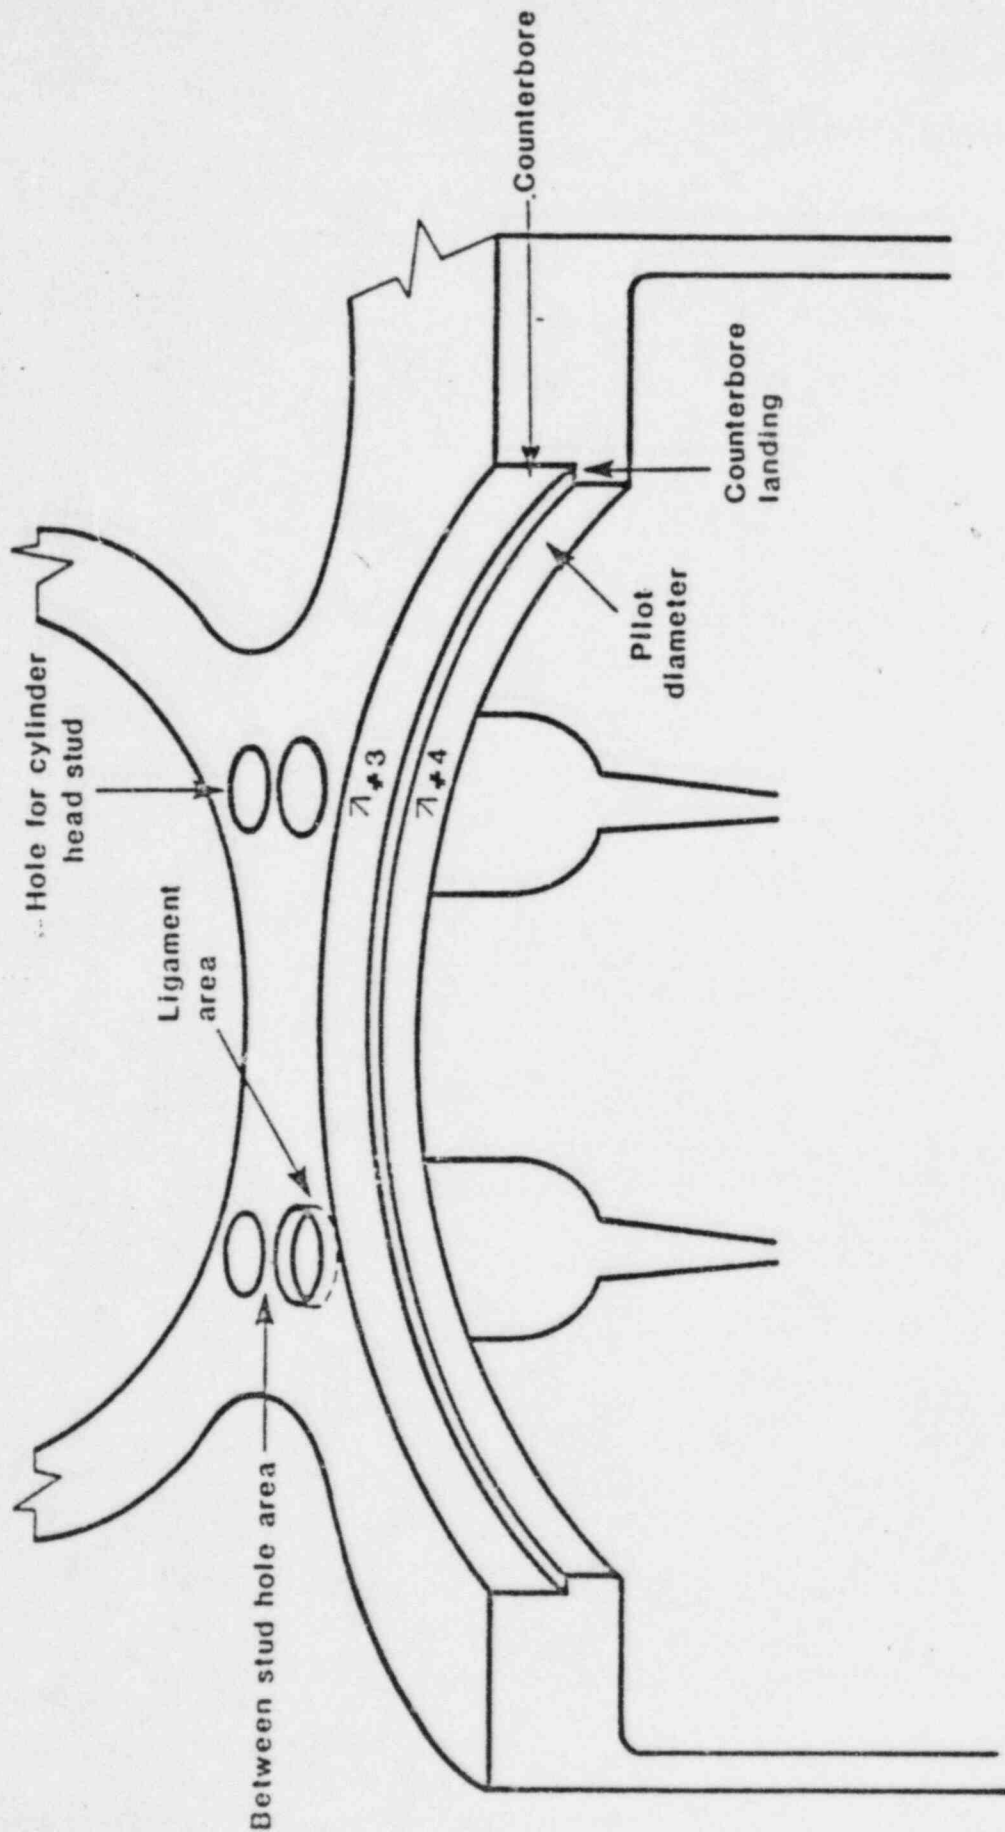
Figure 3-7. IDI strain gage location.

TDI also conducted strain gage testing of preload and operating stresses in the liner and liner counterbore regions [3-2]. Selected results are given in Table 3-2 for their Gage Nos. 3 and 4, which were reading hoop strains in the locations shown in Figure 3-7. These gages measure key stresses for ligament cracking.

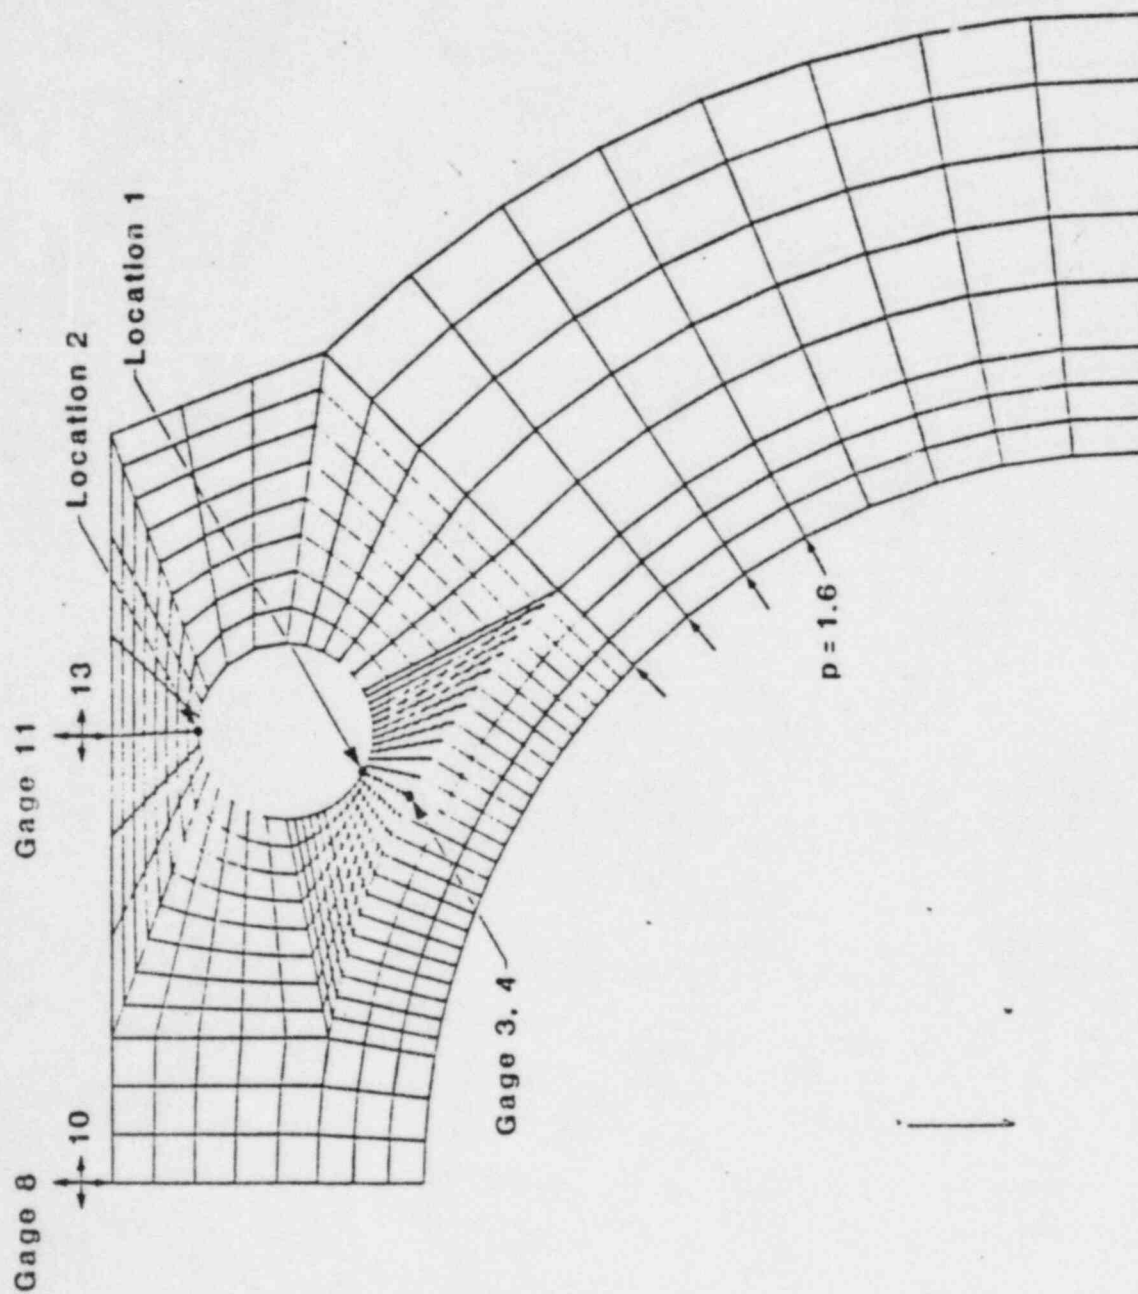
Figure 3-8. Block top model with internal pressure equal to 1.6 ksi.

A qualitative understanding of the effects of pressure, liner temperature, and assembly clearance on stresses at the stud hole counterbores has been obtained from a 2-D finite element model of a quarter section of the block top. The finite element model, shown in Figure 3-8, represents the block top and liner between the engine centerline and the midplane between adjacent cylinders. The liner is assumed to have expanded due to thermal stresses such that the gap is closed. The inner boundary of the liner was subjected to uniform pressure loading, and the symmetrical boundaries were restrained against rotations and displacements normal to the boundaries. Two sets of boundary conditions were analyzed, symmetric (both adjacent cylinders have internal pressure) and antisymmetric (one has pressure, the other zero pressure). Both thermal and pressure effects could be analyzed by combinations of these two cases. The model neglected the 3-D effects of the web between the cylinders and the cylinder head stud bosses beneath the block deck. Forces and deflections out of the plane of the block top were not included in this analysis.

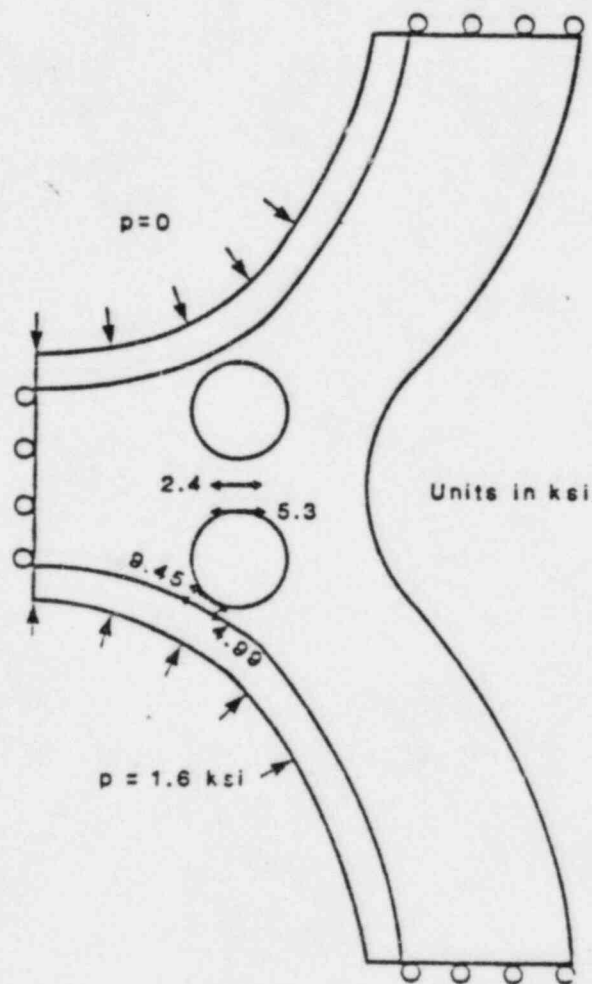
Figure 3-9. Effect of one cylinder firing.

This model was used directly to analyze the stresses in the ligament resulting from firing pressure in one cylinder, given appropriate clearances such that the liner-to-block gap is closed by thermal expansion. The results are shown in Figure 3-9 and Table 3-2. Reasonably good agreement with the pressure stress at full load at TDI Gage No. 4 is apparent in Table 3-2. The experimental pressure stress at Location 1 was scaled up from TDI Gage No. 4 using the stresses at the corresponding locations, i.e.,  $6.3 \text{ ksi} = 3.3 (9.5/5)$ , and the result is in reasonable agreement with the analysis at full load.

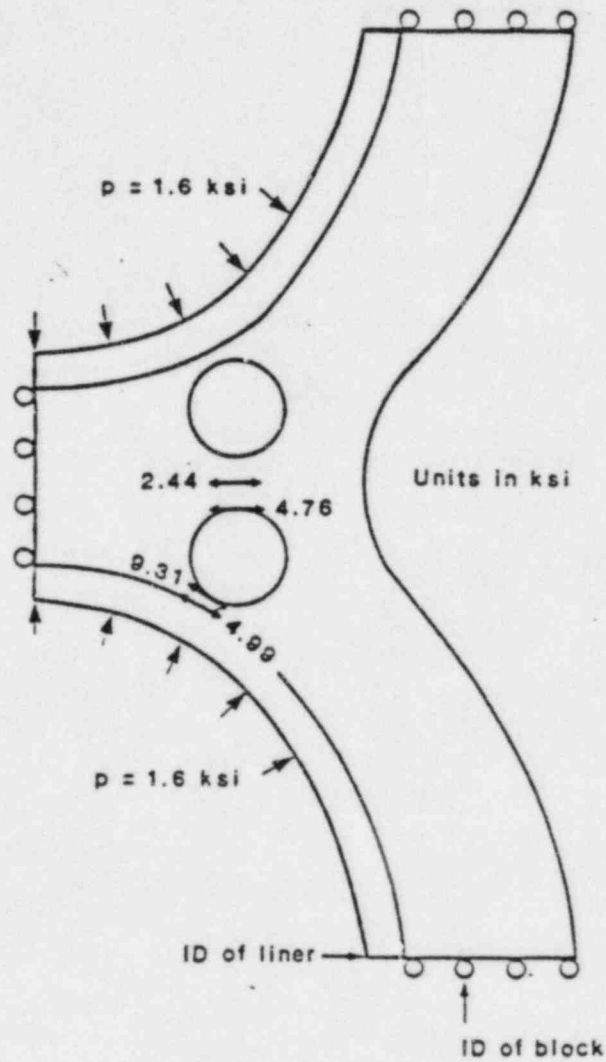
Figure 3-10. Block-top model (2-D) with liner subjected to internal pressure  $p = 1.6$  ksi in adjacent cylinders.

The model was also used to obtain the ratio of stresses in the ligament resulting from thermal expansion, using symmetric boundary conditions as in Figure 3-10. The thermal stresses are symmetric between cylinders because both cylinders heat up, analogous to both cylinders firing at once. All thermal stresses are assumed to act radially in the plane of the block top.

Under this assumption, Figure 3-10 can be used to scale the thermal stress from the Gage No. 13 reading to the ligament Location 1. However, Gage No. 13 corresponds to a cracked ligament, so it is necessary to scale the reading to reflect an uncracked ligament. For this computation the thermal stress is taken to be  $\sigma_{\min}$  minus  $\sigma_{\text{preload}}$ . The result is 14.9 ksi = 9.7 (9.31/6.06) at 100% load.

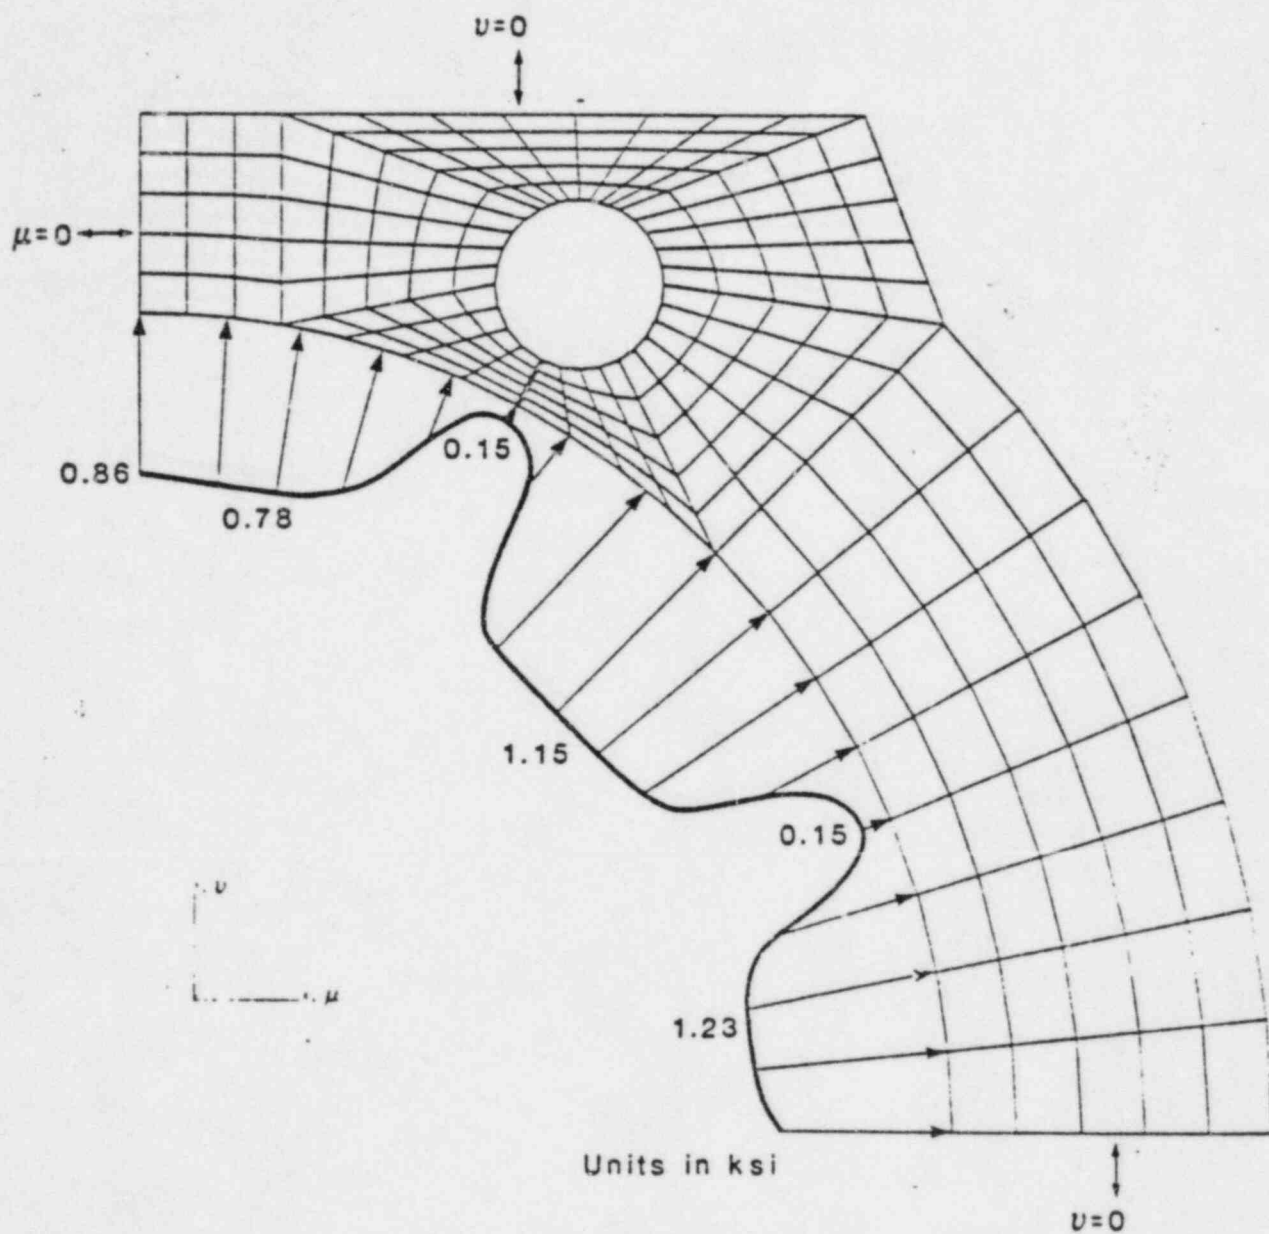
Figure 3-11. Cracked ligament block model with radial stress distribution due to liner under uniform pressure.

The third application of the model was to determine the radial stress distribution on the inside surface of the block resulting from a uniform pressure on the inside surface of the liner. This distribution is not uniform around the circumference, as shown by Figure 3-11, where the distribution is superimposed on the cracked ligament model discussed below. The ligament will not support as much radial stress as the surrounding regions; rather, it bends away from the liner, which must therefore carry higher stress locally.

Once a ligament crack is present, the transverse stress between the stud holes increases by a factor of 2. This is shown (for pressure stresses) by the model shown in Figure 3-11, where the radial stress distribution was determined from the stress at the liner/block interface in the uncracked model. The results are shown in Table 3-2 and Figure 3-12, which may be compared with Figure 3-9 at Location 2 and Gage No. 13. The stress at Location 2 is obtained by scaling the gage reading, i.e., 6.6 ksi = 3.7 (10.85/6.06) at 100% load.

As in Section 3.2.2, the thermal stress is obtained by scaling the stress measured at Gage No. 13, using the model in Figure 3-11 to obtain the scaling factor. The primary assumption in this process is that the thermal stress acts in the plane of the block top, analogous to pressure. The result is 17.3 ksi = 9.7 (10.85/6.06) for 100% load.
