NED-84-605

December 10, 1984

NRC DOCKET 50-321
OPERATING LICENSE DPR-57
EDWIN I. HATCH NUCLEAR PLANT UNIT 1
INSERVICE INSPECTION OF STAINLESS STEEL PIPING -
1984 REFUELING OUTAGE

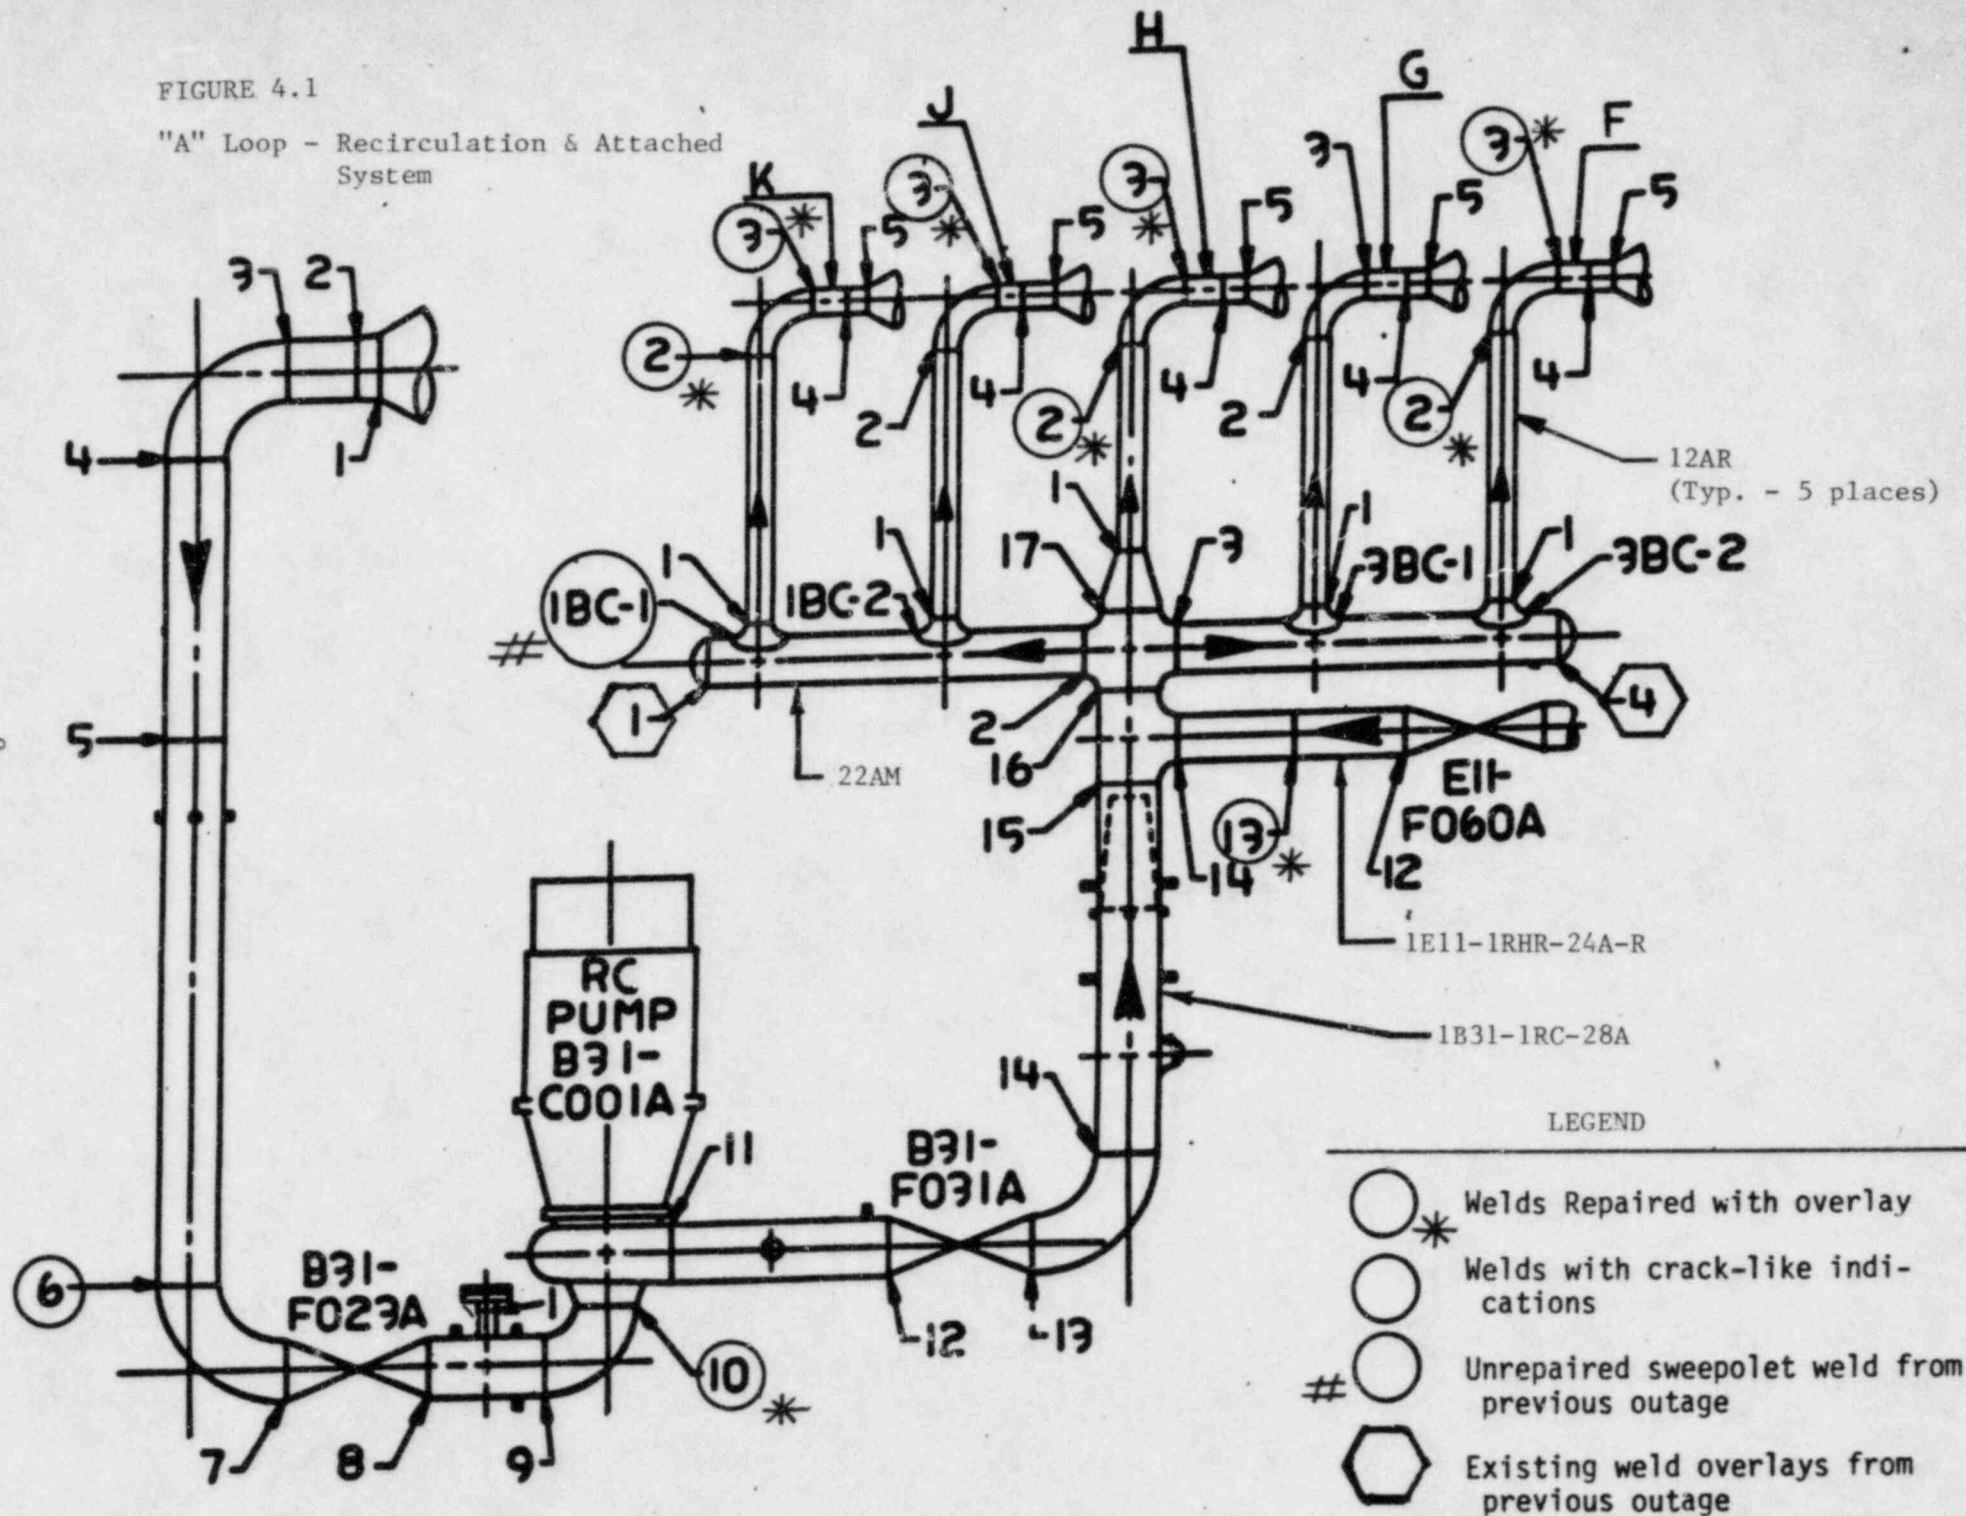
FIGURE 4.1

"A" Loop - Recirculation & Attached System

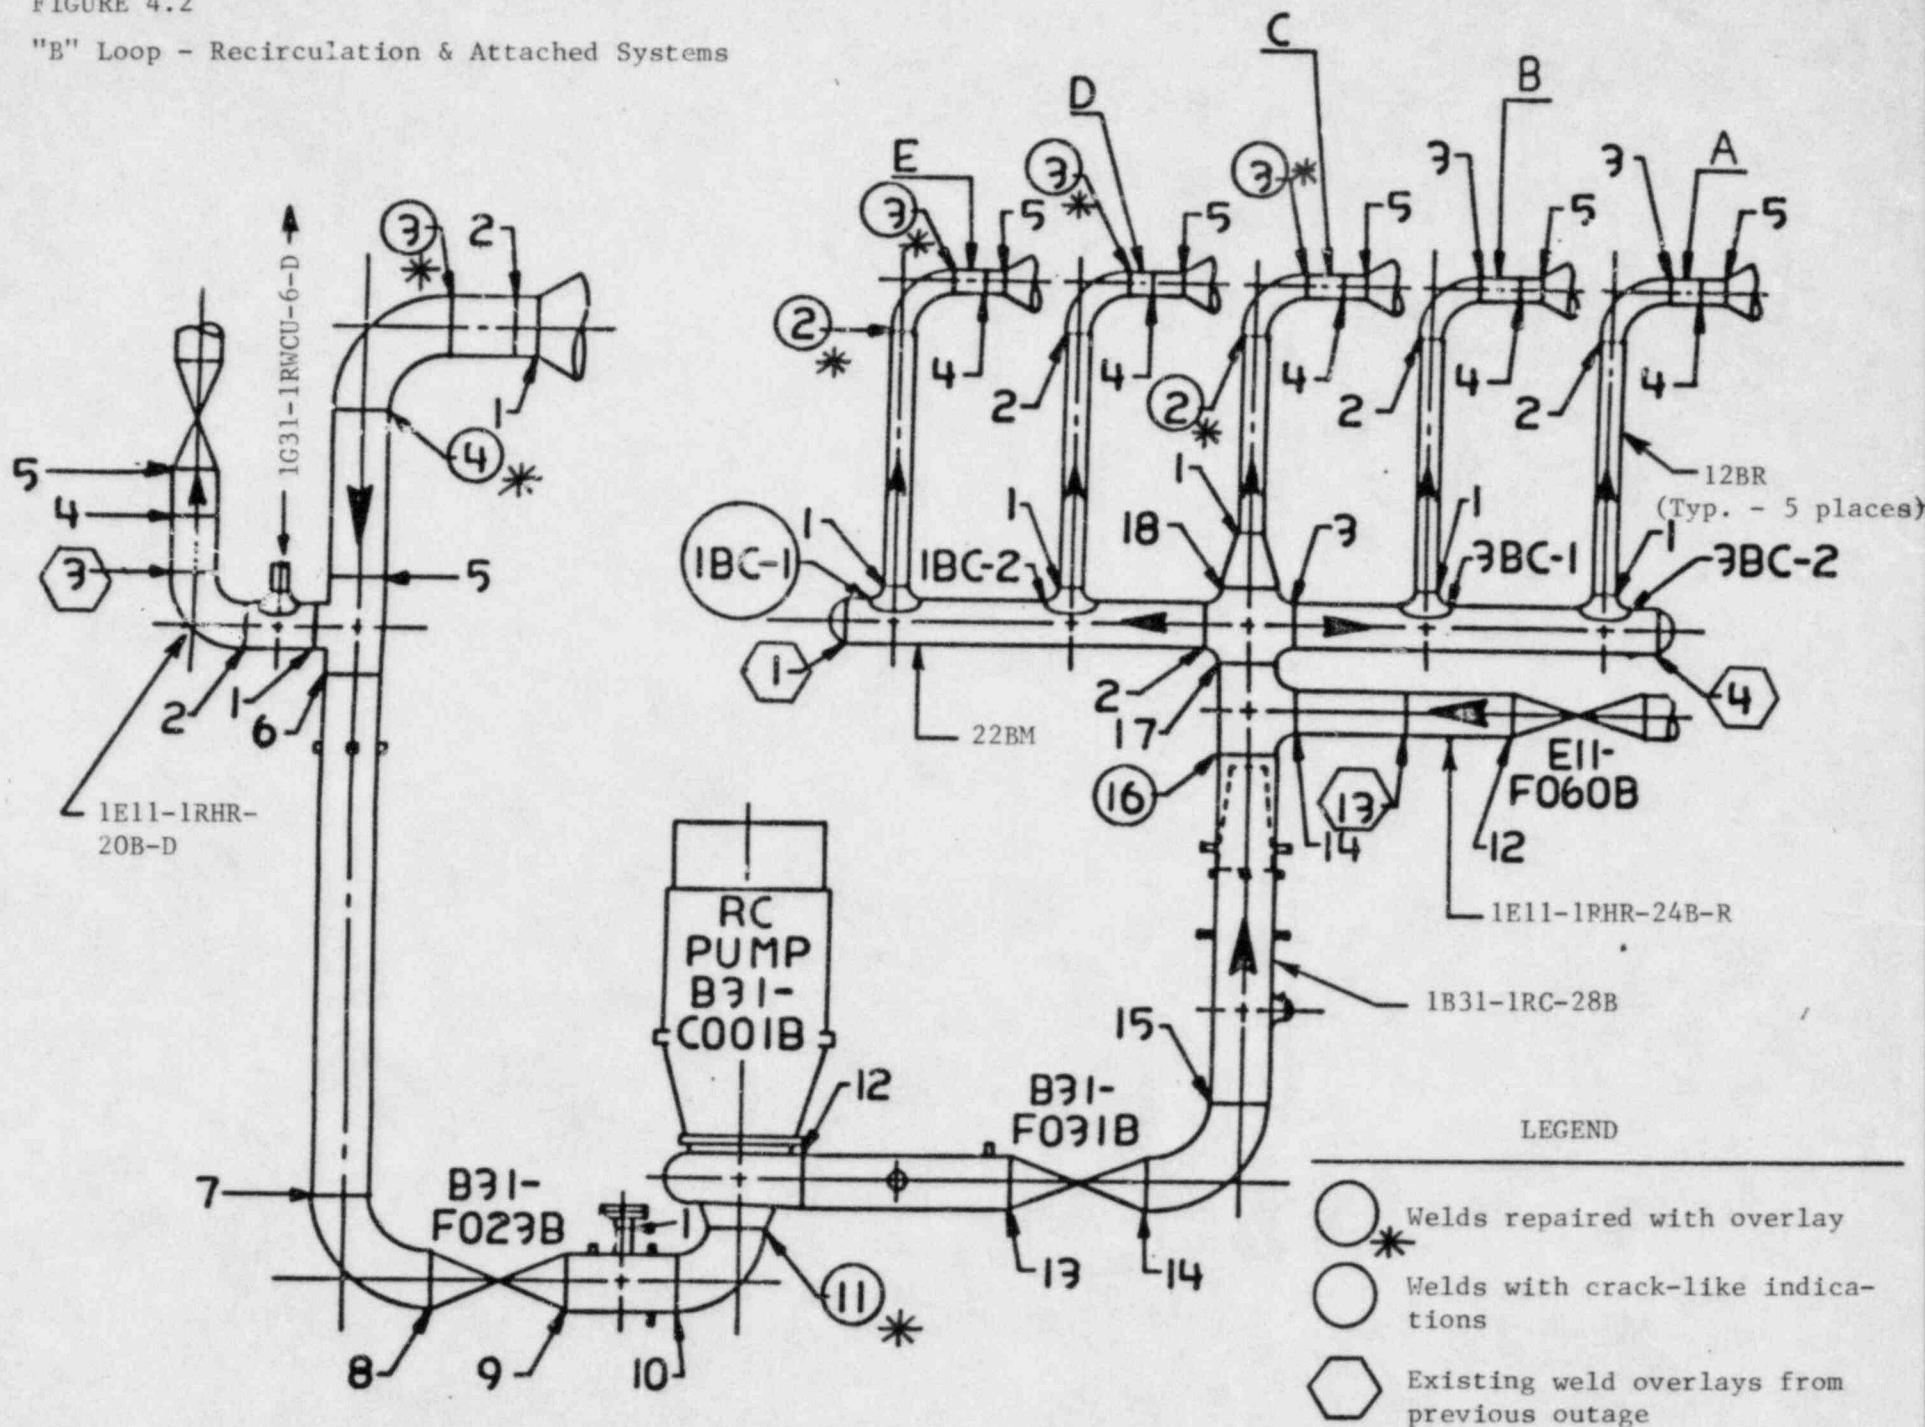
FIGURE 4.2

"B" Loop - Recirculation & Attached Systems

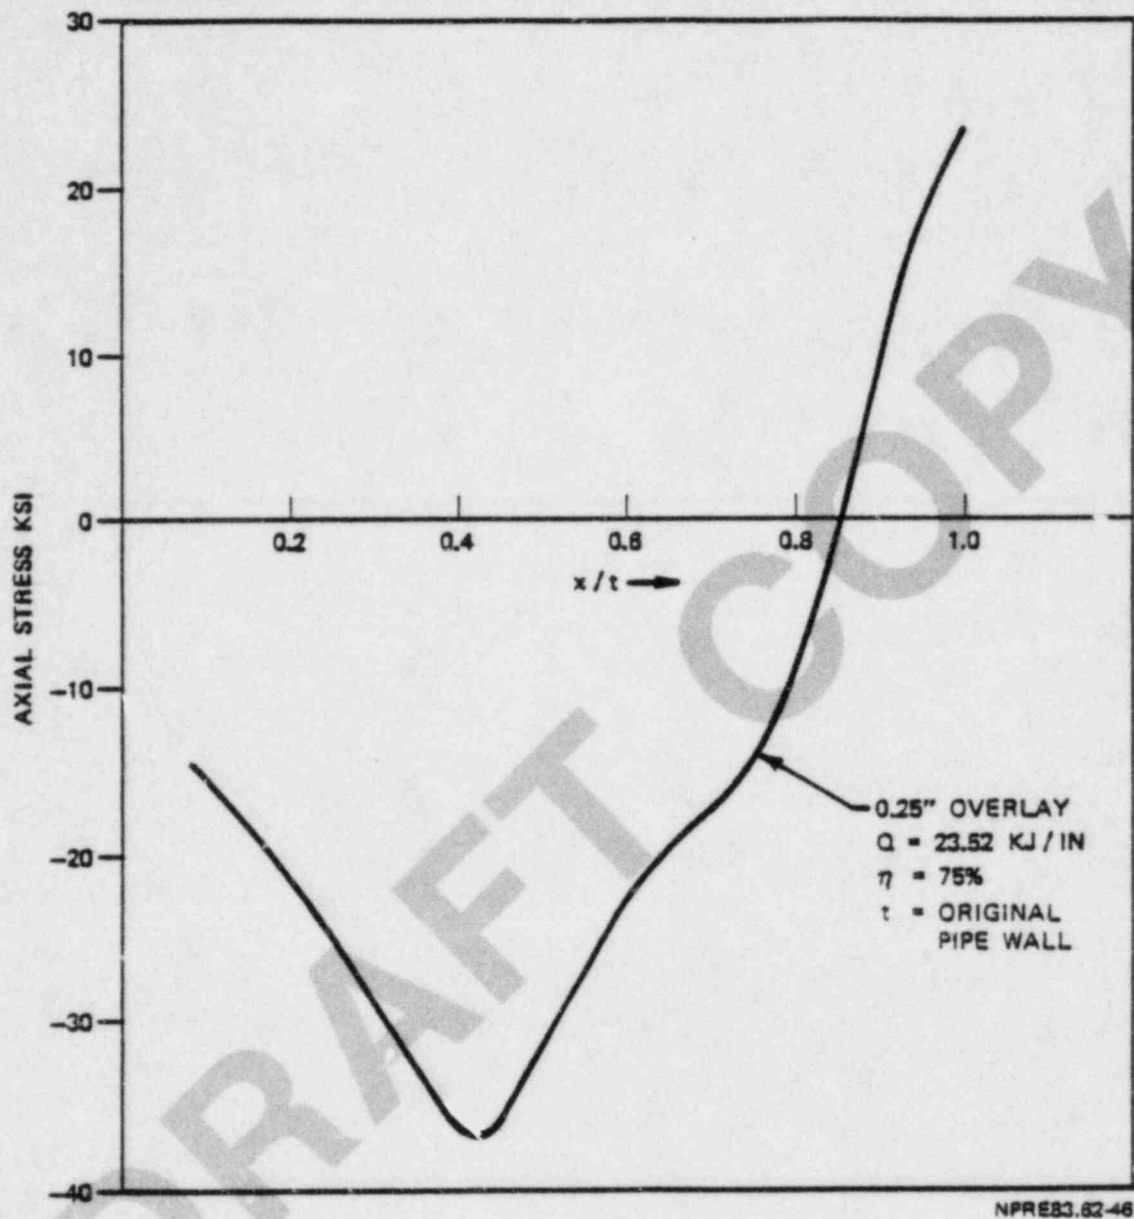
Figure 5.4
Typical Axial Weld Residual Stress Distribution
in 12" Pipe After Overlay

From Reference 11, the calculated fatigue crack growth is less than 0.01 inch during the next five years. The weld overlays applied to welds at Plant E. I. Hatch Unit 1 produce a highly compressive residual stress pattern in the inside portion of the pipe wall. For the circumferential flaws identified, this residual stress pattern will effectively arrest further IGSCC crack growth. Thus, no further degradation of the integrity of these welds is anticipated. Crack growth analyses using the calculated residual stress pattern (Figure 5.4) and a conservative crack growth law (see Section

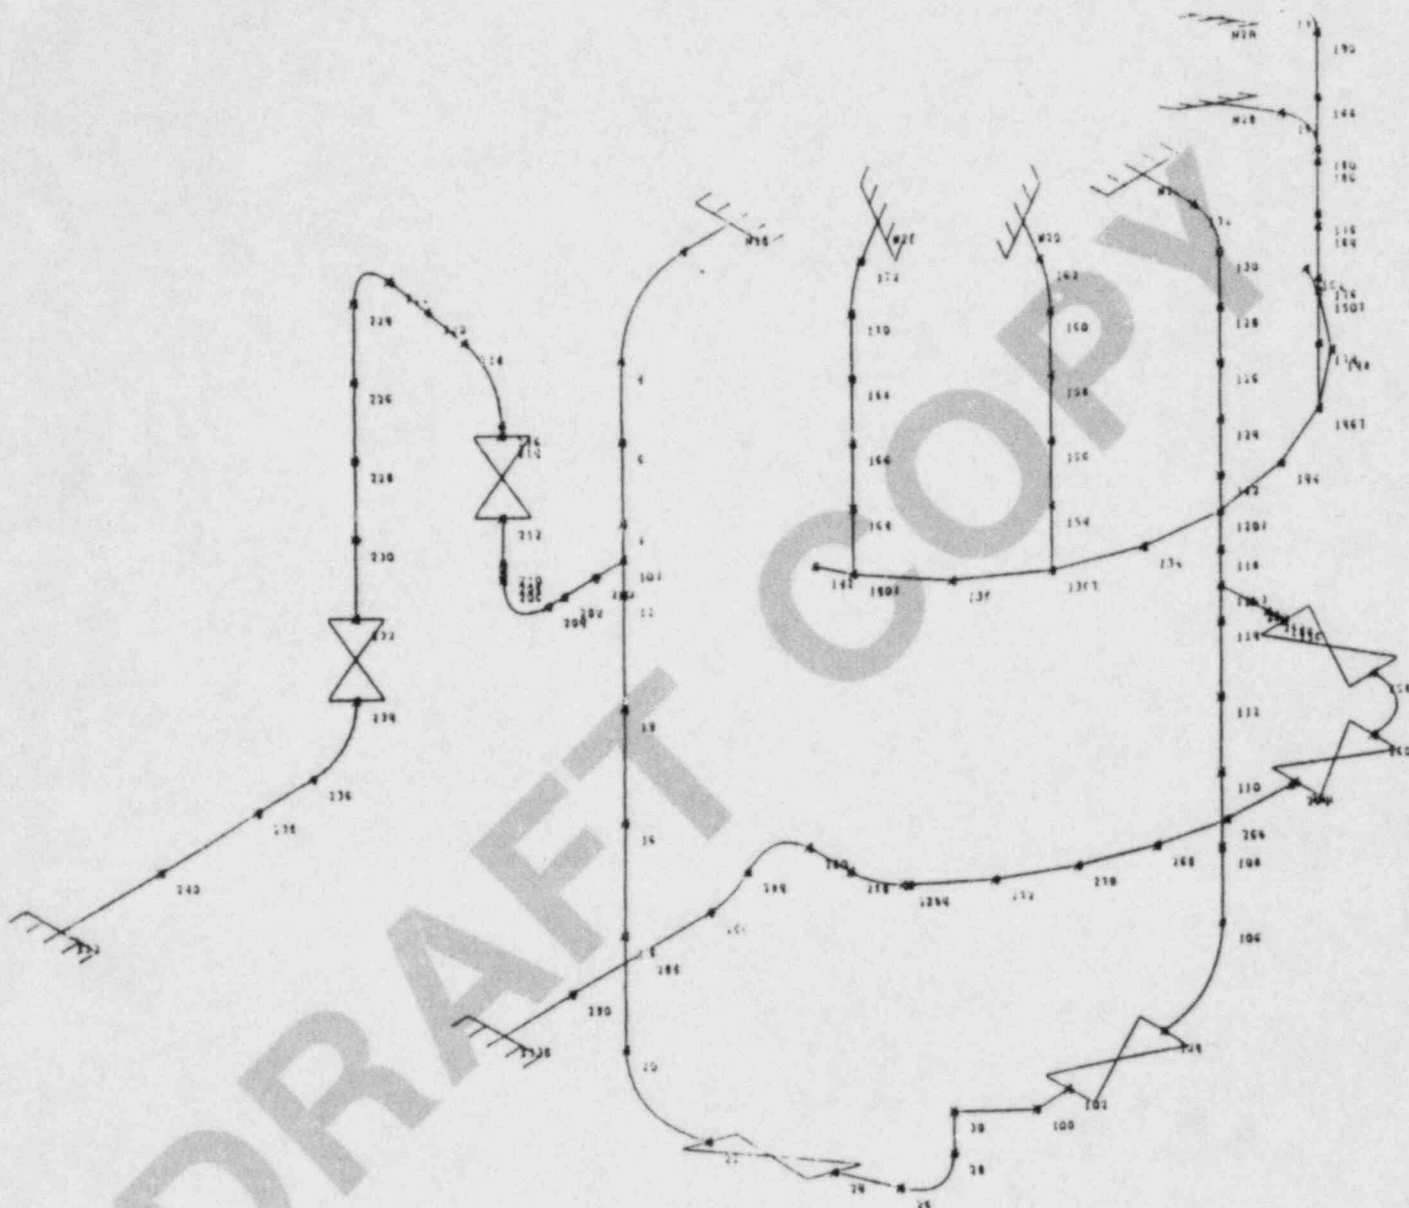
Figure 5.5

Figure 5.5. The measured shrinkages of all weld overlay repairs were imposed as boundary conditions on this model. Since the ASME Code does not limit weld residual stress, all stress indices were set equal to 1.0.

E. I. Hatch Unit 1 Recirculation
System Piping Model

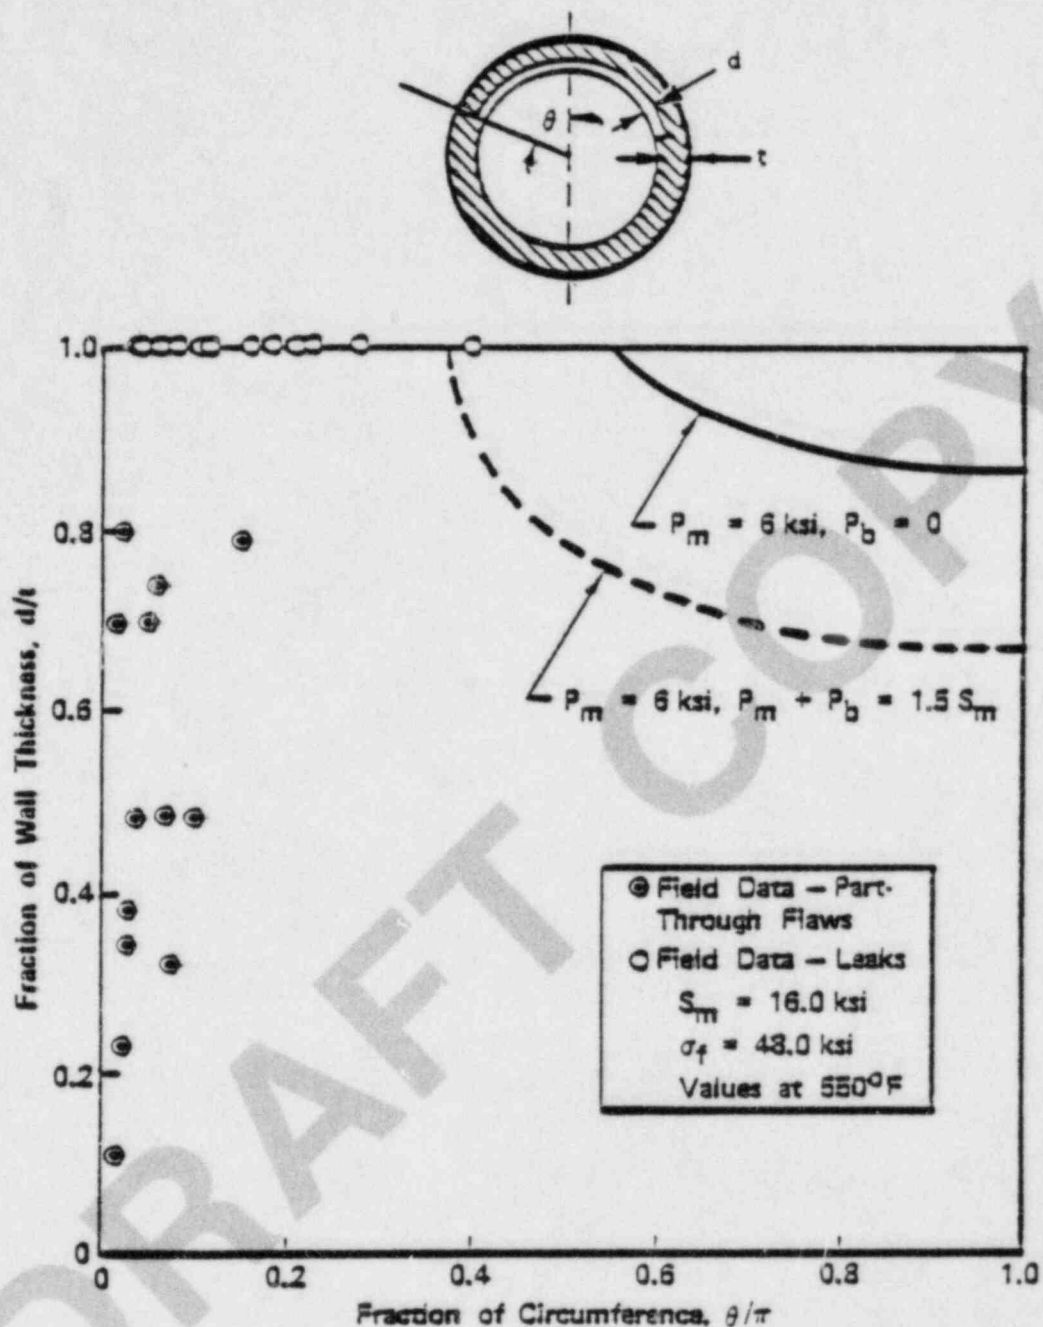
Also shown in Figure 6.1 is a sampling of cracks which have been detected in service, either through UT examination or leakage. In each case there has been a significant margin between the size of crack observed and that predicted to cause failure under service loading conditions. Also, as discussed below, there is still considerable margin between these net section collapse limits and the actual cracks which would cause instability.

Typical Result of Net Section Collapse Analysis of
Cracked Stainless Steel Pipe

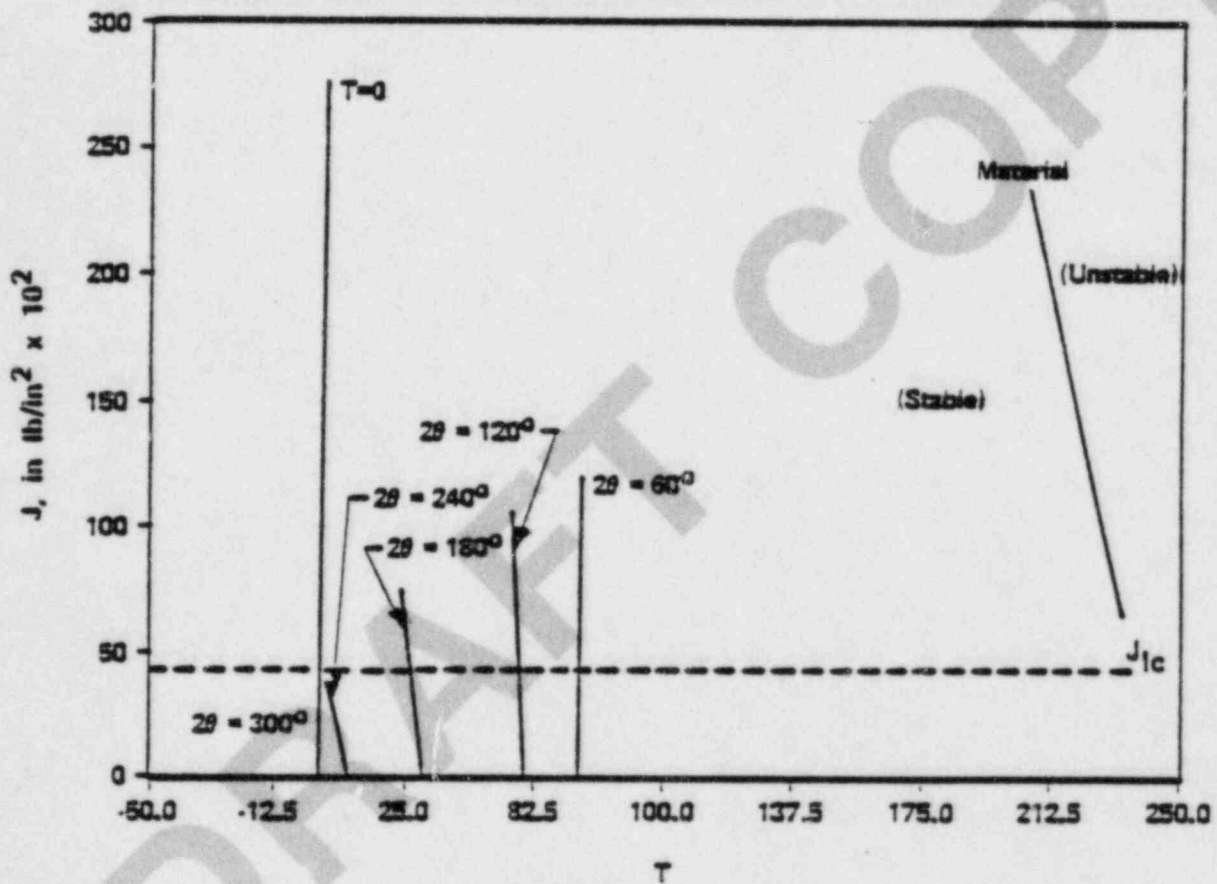
Figure 6.2

Recirculation System. Loads were applied to these sections of sufficient magnitude to produce net section limit load, and the resulting values of tearing modulus were compared to that required to cause unstable fracture (Figure 6.2). Note that in all cases there is substantial margin, indicating that the net section collapse limits of the previous section are not really failure limits. Figure 6.3 summarizes the results of all such analyses performed for 60° through-wall cracks in terms of margin on tearing modulus for stability. The margin in all cases is substantial.

Stability Analysis for BWR Recirculation System
(Stainless Steel)

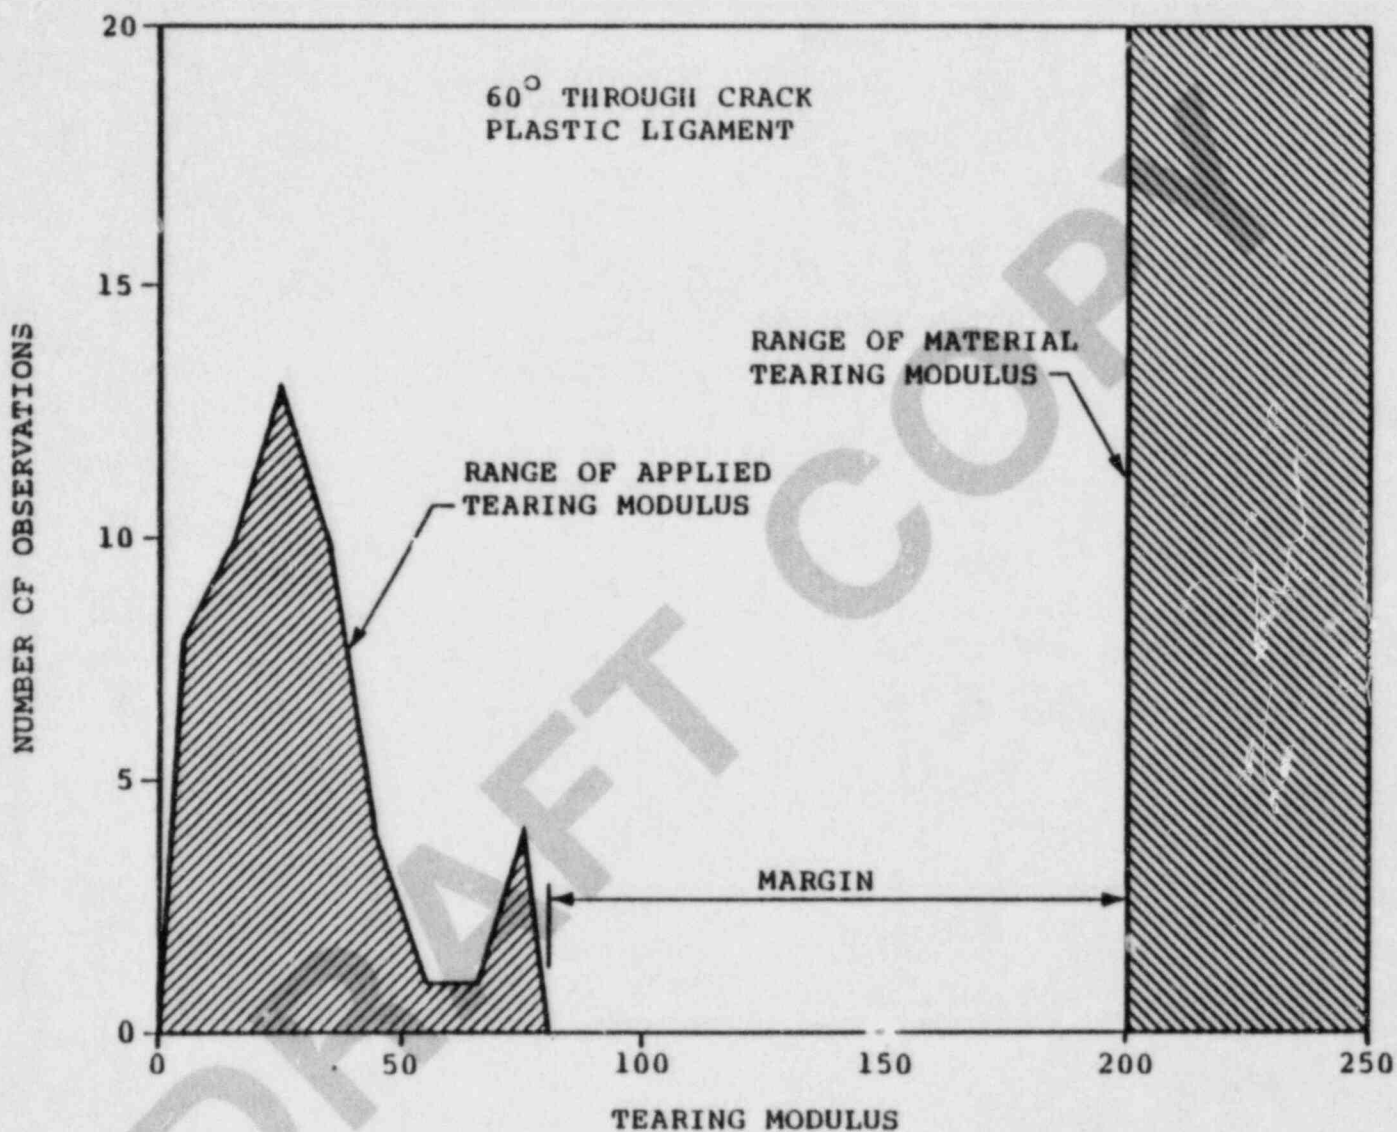
Figure 6.3

Elastic-plastic fracture mechanics analyses are presented in Reference 14 which give a more accurate representation of the crack tolerance capacity of stainless steel piping than the net section collapse approach described above. Figures 6.2 and 6.3 graphically depict the results of such an analysis (Reference 14). Through-wall circumferential defects of arc length equal to 60° through 300° were assumed at various cross sections of a typical BWR

Summary of Leak-Before-Break Assessment
of BWR Recirculation System

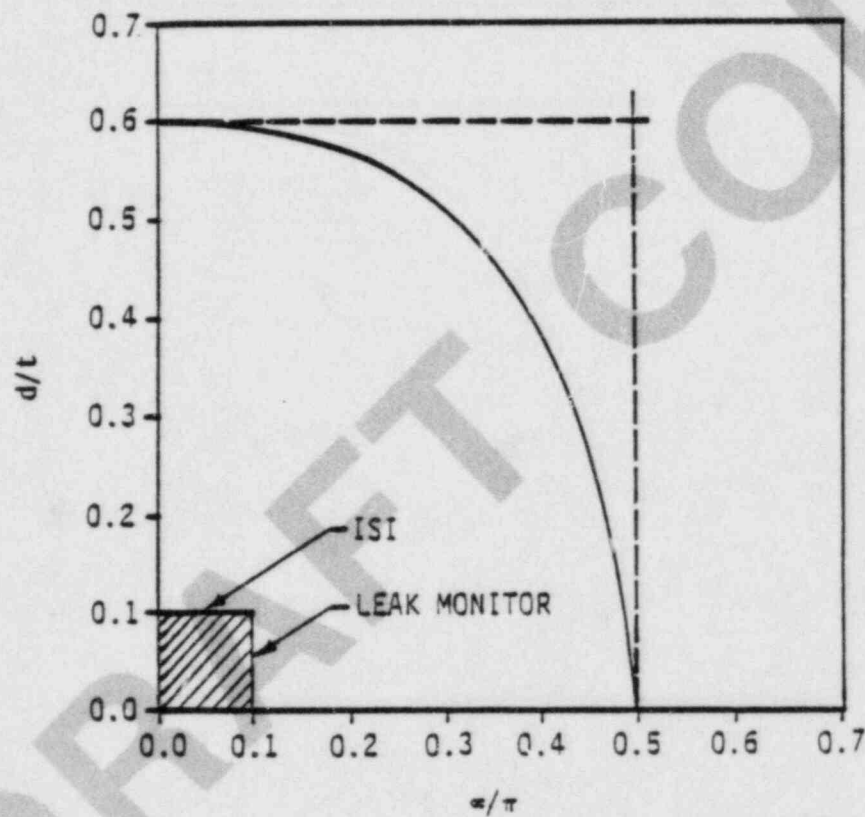
Of perhaps more significance to the leak-before-break argument is the flaw configuration depicted in Figure 6.4. This configuration addresses the concerns raised by the occurrence of part-through flaws growing circumferentially before breaking through the outside surface to cause leakage. Figure 6.4 presents typical size limitations on such flaws based on the conservative net section collapse method of Section 6.1. Note that very large crack sizes are predicted. Also shown on this figure are typical detectability limits for short through-wall flaws
