Northern States Power Company
Prairie Island Nuclear Generating Plant
1717 Wakonade Dr. East
Welch, Minnesota 55089

PRAIRIE ISLAND NUCLEAR GENERATING PLANT
Docket Nos. 50-282 License Nos. DPR-42
50-306 DPR-60

Steam Generator Inspection Reports

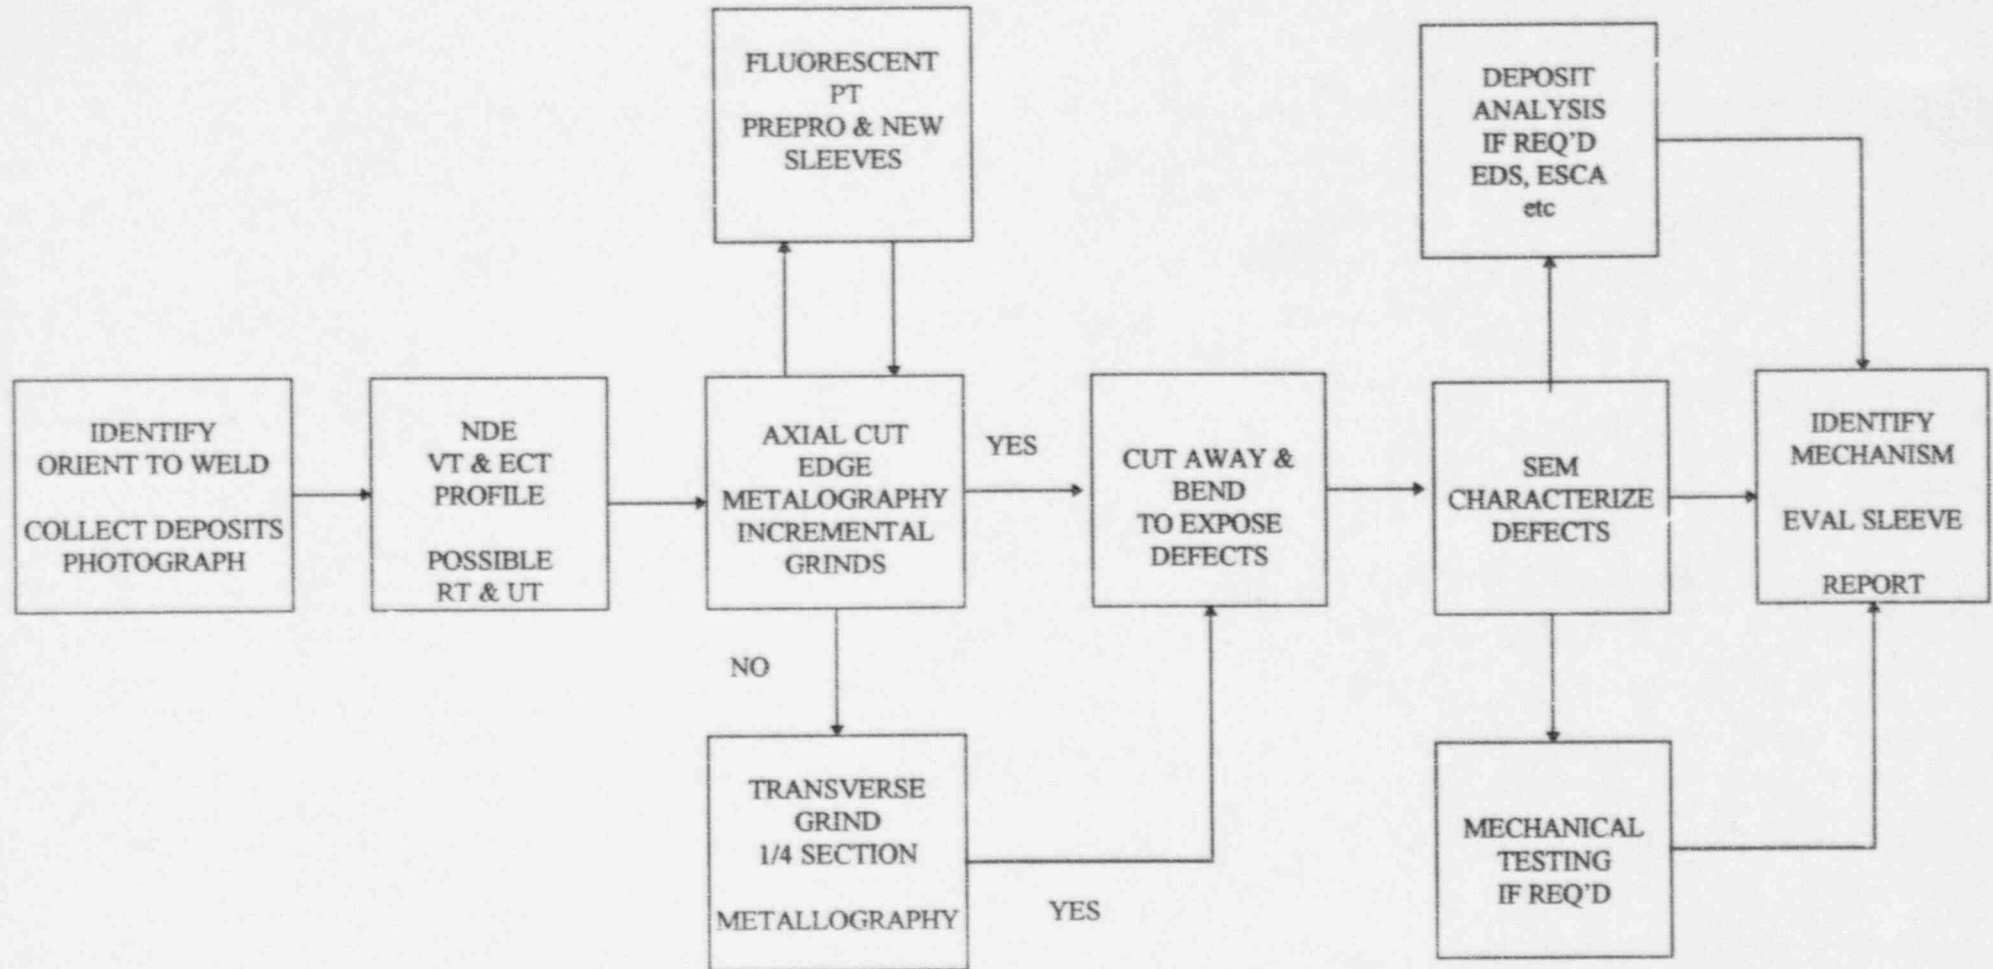
FIGURE 2
PRAIRIE ISLAND SLEEVE SAMPLE EXAMINATION
LOGIC NETWORK

Once the assemblies have been received at the ABB-CENO laboratory in Windsor, Connecticut, the following NDE and destructive examinations will be performed in accordance with the logic diagram shown in the Figure 2.

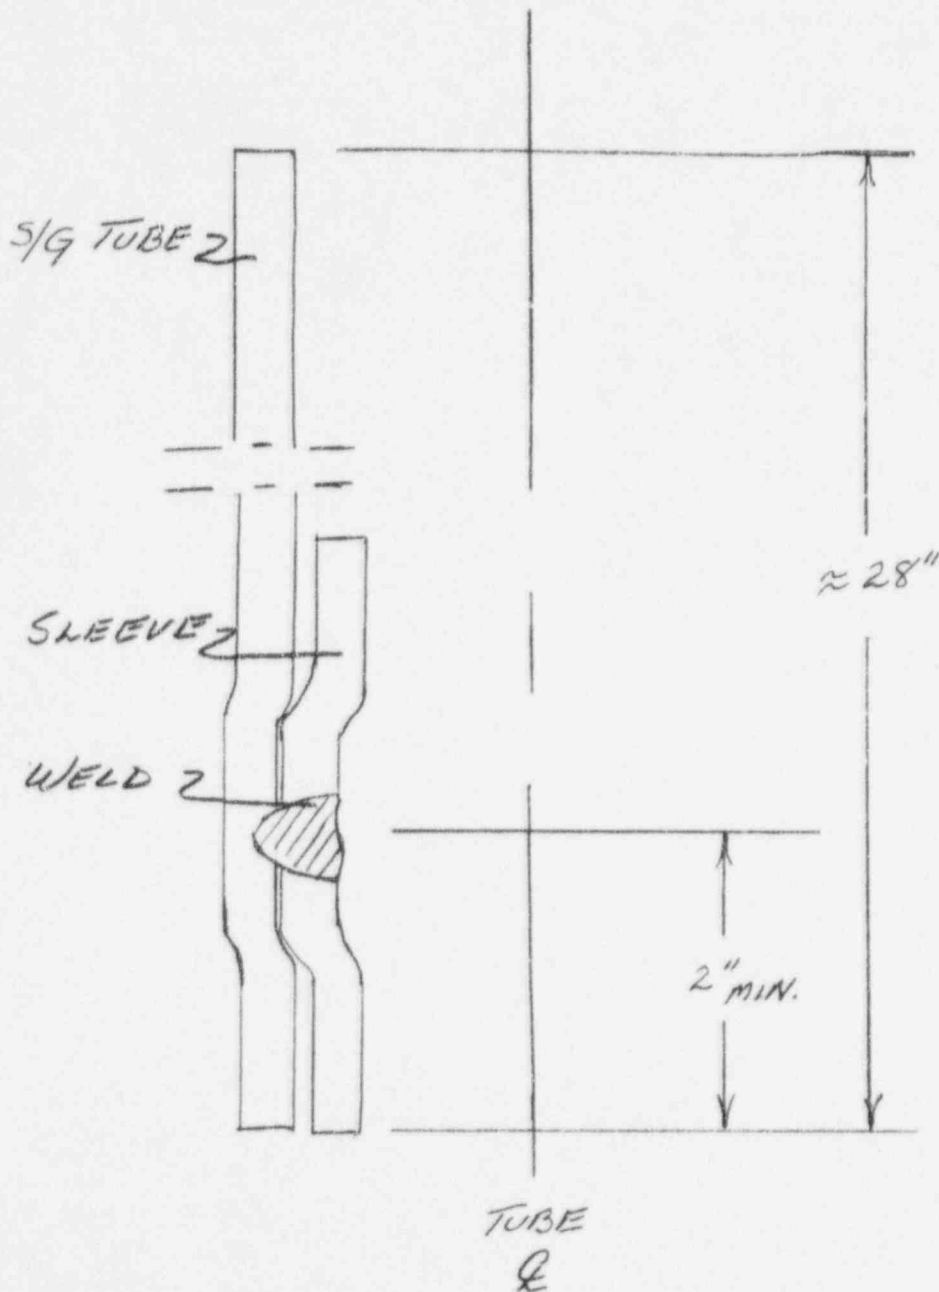
FIGURE 1

The sleeved tube sample set will consist of six (6) sleeve/tube upper weld sections as shown in Figure 1. Two (2) samples are pre-production samples, one (1) is a sleeve installed during the current January 1996 outage, and three (3) are sleeves that have been in service. Specifically these samples are:

REMOVED STEAM GENERATOR
TUBE-SLEEVE
SAMPLE

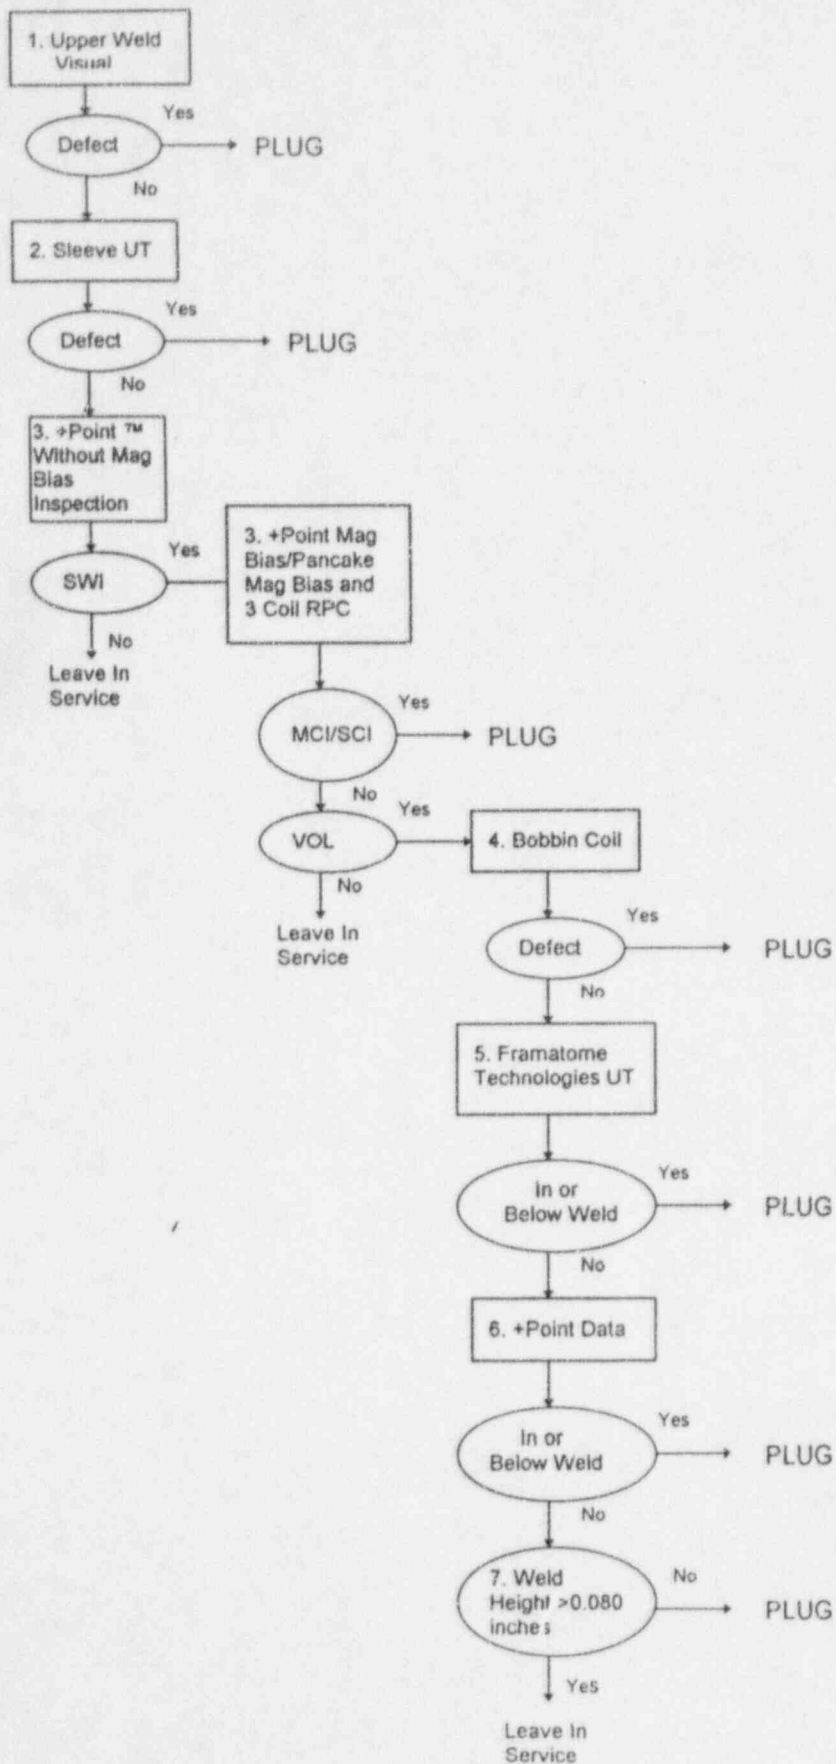
PRAIRIE ISLAND UPPER SLEEVE WELD PLUGGING CRITERIA

The weld shall be considered to have acceptable fusion of the weld for 360 degrees at any single elevation, or any combination of elevation positions. A continuous indication of lack of fusion across the entire width of the weld (i.e., a leak path) shall be cause for rejection.

Initial +Point™ calls shall be examined by magnetic biased +Point™ coils. Any indications which remain and are crack like are unacceptable. This includes single and multiple axial and circumferential indications.

Any Sleeve Weld Indications which remain in the magnetically biased +Point™ data and are volumetric require disposition. Those volumetric indications which are in the lower half of the weld region are unacceptable. Those indications which are at the top of the weld are acceptable. Even though indications at the top of the weld may proceed into the weld (possibly to the centerline), the leaktightness criteria and minimum average weld height are still met (determined by UT as discussed in Items 2 and 7). The eddy current signatures of the pre-production samples (see Attachment 9) 2B (volumetric) and 13B (blow hole) were used to evaluate the sleeve weld indications.

Welds are considered defective if an indication is greater than 40% through wall. (Bobbin coil data is not normally taken when rotating coil probes are used, but was done this outage for all of the volumetric indications).
