LONG ISLAND LIGHTING COMPANY

(Shoreham Nuclear Power Station,
Unit 1)

SUFFOLK COUNTY'S EXHIBITS TO JOINT DIRECT TESTIMONY

DESIGN REVIEW OF TDI R-4 AND RV-4 SERIES
EMERGENCY DIESEL GENERATOR CYL. DER BLOCKS AND LINERS

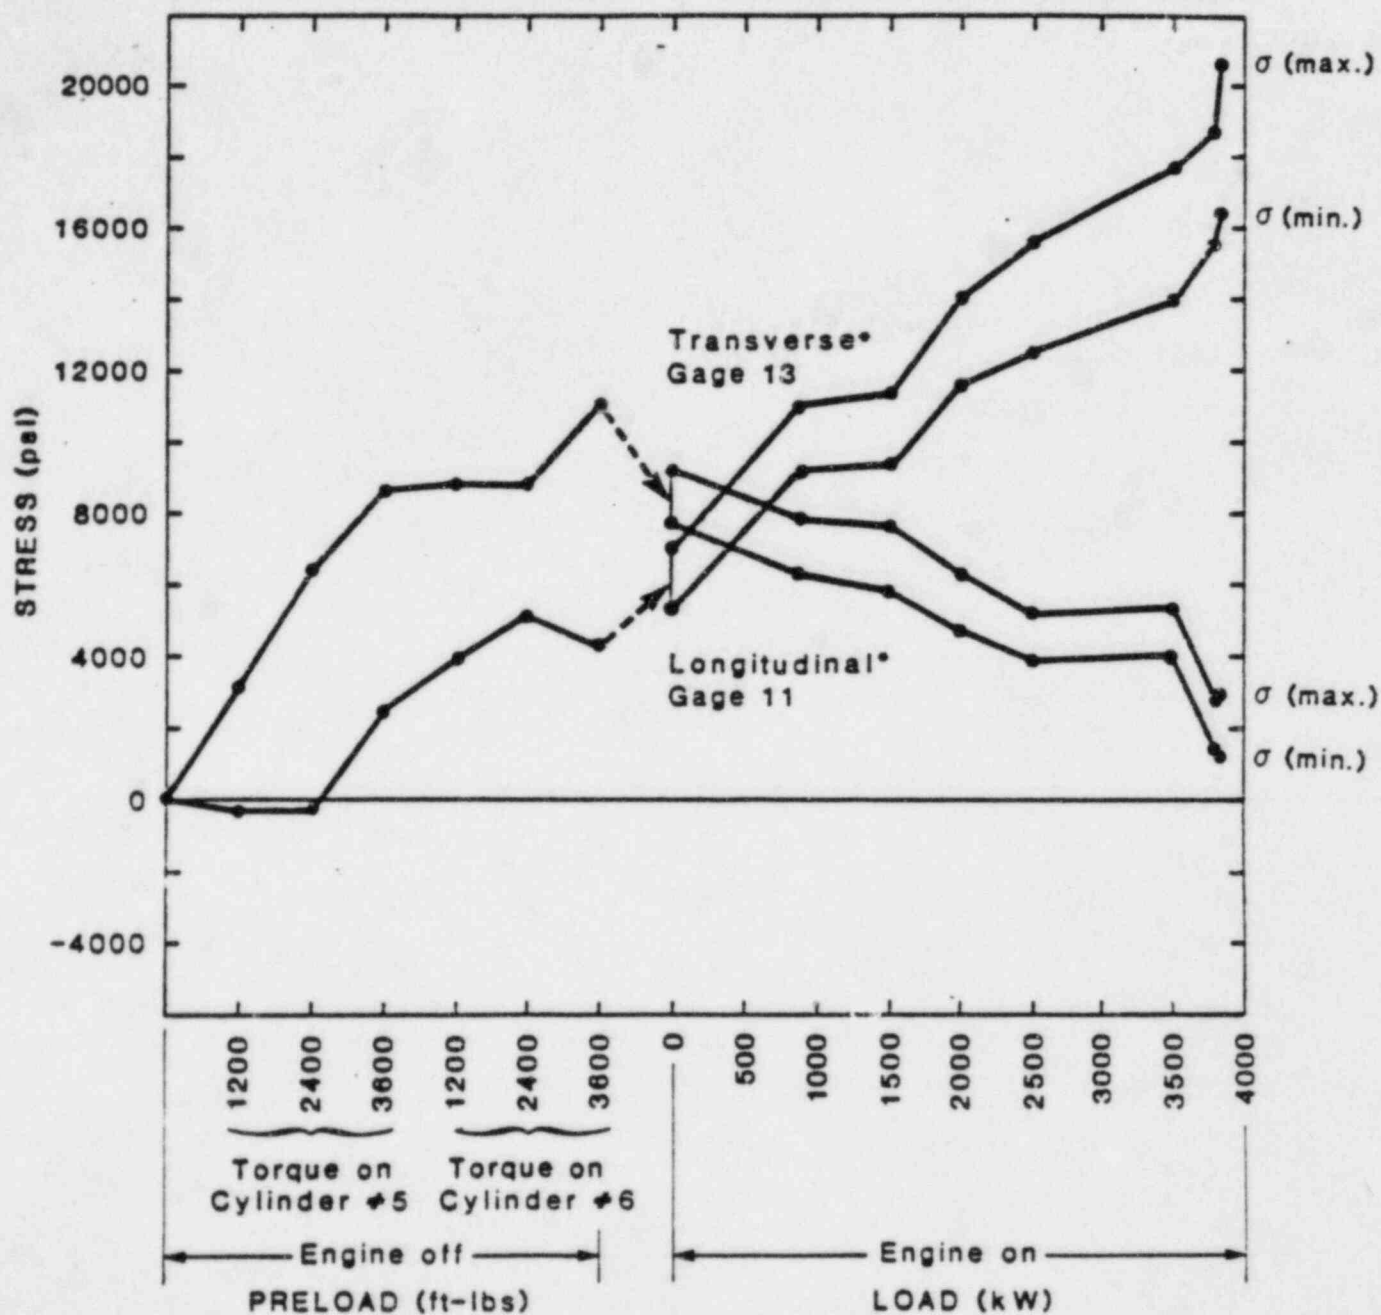
Figure 3-6. Principal stresses vs. load for Gages 11, 12 and 13 (located between studs.
 *Principal stresses are located within 15° of gage axis.
